**BAT SURVEYS AT  
GWERN-Y-TO, SHOCKLACH LANE,  
WORTHENBURY, WREXHAM  
2018**

**RACHEL HACKING ECOLOGY**

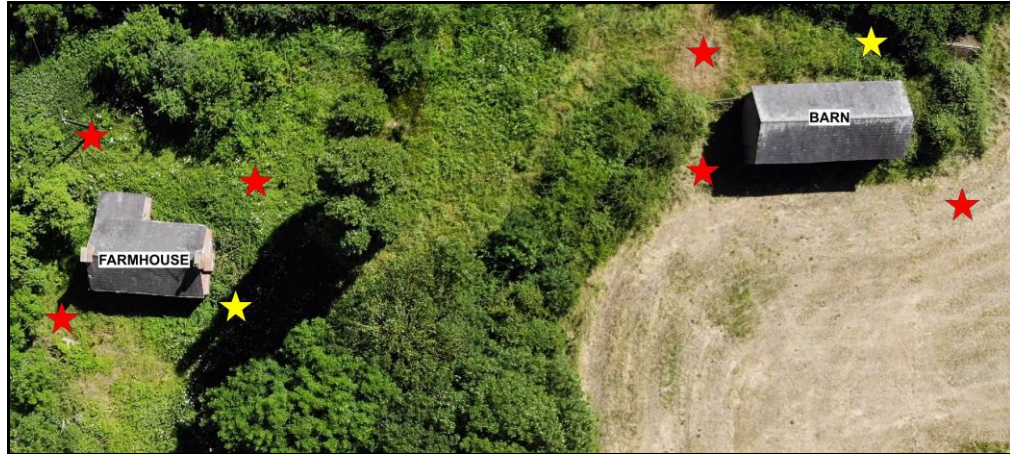
- 3.13 Figure 1 shows the approximate locations of the surveyors during the survey.

**Figure 1 showing the locations of surveyors (red stars) and infra-red cameras (yellow stars) during the survey. The farmhouse is the building on the left and the barn is the building on the right**
