# Preliminary Arboricultural Impact Assessment

BS5837:2012 Trees in Relation to Design, demolition and construction –  
Recommendations

| SITE REFERENCE: | Wrexham Technology Park |
| REFERENCE: | DEV016.WAL.04GM |

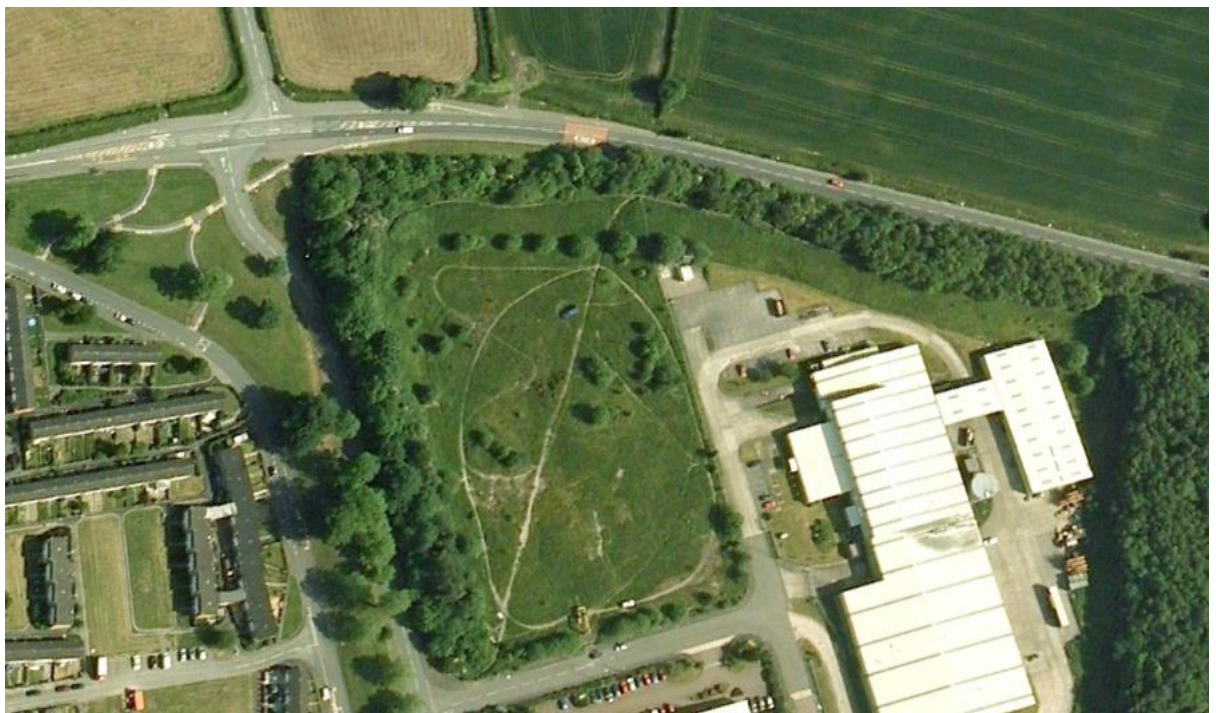
- 3.1 The site at Wynnstay Technology Park is an open area of brownfield land that has not been developed. The northern boundary (Llangollen Road) and the western boundary (Plas Bennion Road) of the site are comprised of a bund, the edge of which with the road contains some mature trees.
- 3.2 In the past the bund was planted with some trees i.e. one Oak together with Silver Birch and Alder. Some trees were planted as part of the management plan produced by the Landscape Planning Group in 2008 (the scheme was for 5 years).
- 3.3 The rest of the wooded area comprises self-set specimens.
- 3.4 The bulk of the site was cleared historically and over time the site has been colonised by pioneer / scrub species such as willow / hawthorn / birch etc. The photo below shows an aerial photo of the site in 2006 and gives an indication of the history.

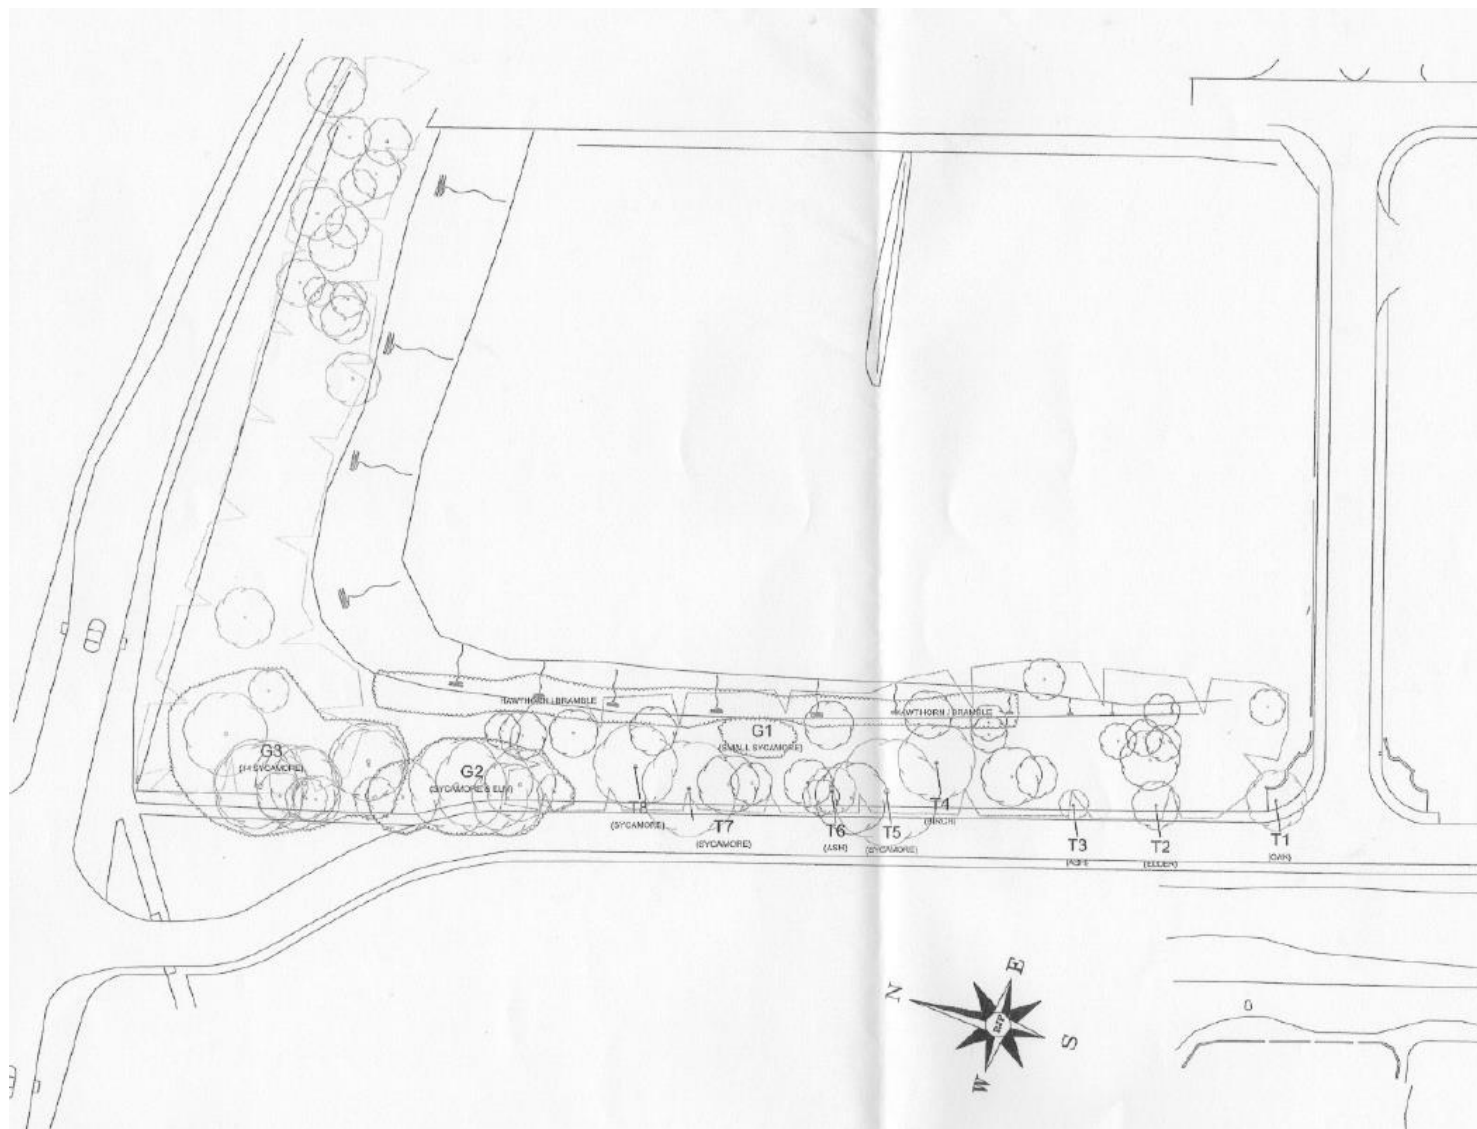
The proposed location of the new entrance on to Plas Bennion Road runs through the edge of group G2 which is composed of early mature Sycamore with a small Elm component.
