**Report No.:** SH33185

**Nature of Work:** Refurbishment Survey

Clwyd Alyn Housing Association  
72 Ffordd William Morgan  
St Asaph Business Park  
St Asaph  
LL17 0JD

3-5 Grosvenor Road  
Wrexham  
LL11 1DY

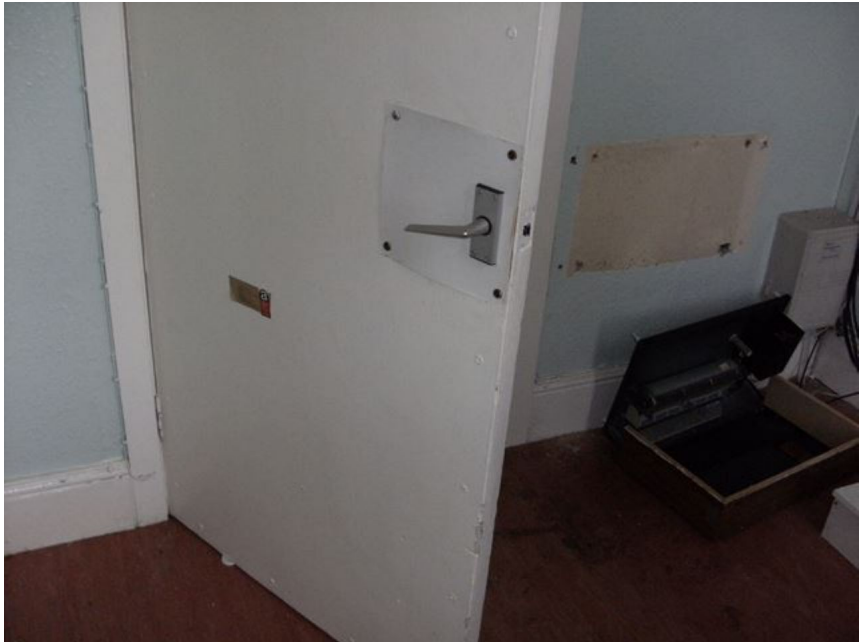
| Comments: | Damage to edge of door, debris visible. Consider the whole room contaminated. | | |
| Condition: | 2 (Local damage) | Priority Assessment: | 6 |

| Accessibility: | 3 (Routinely disturbed) | Recommendation: | Program removal |

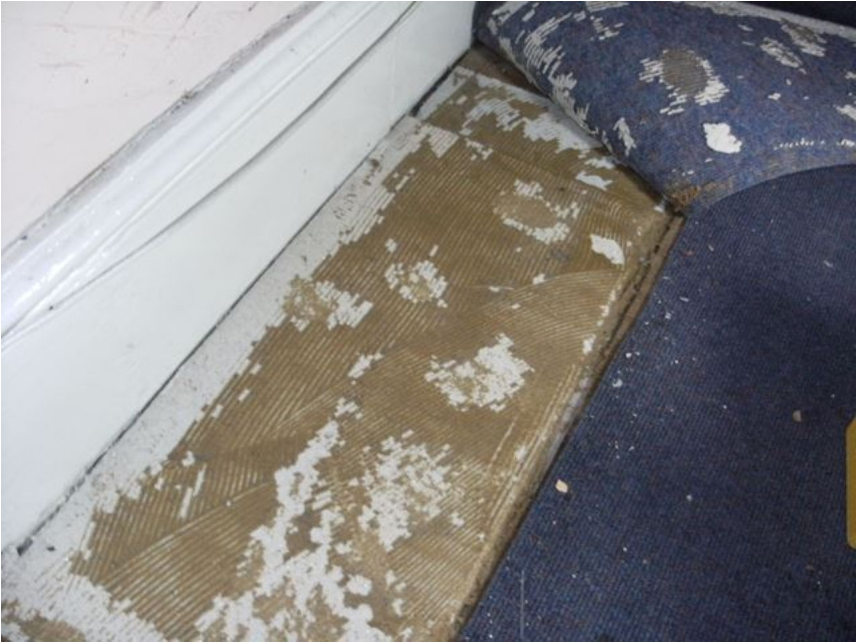
| Location: | 047 Office | Block: | Main Block | Floor Level: | 01 - First |

| Item: | Asbestos insulating board to floor | | | |
| Asbestos Content: | Amosite Identified<br>Chrysotile Identified | | | |
| Condition: | 2 (Local damage) | Priority Assessment: | 5 | |

| Accessibility: | 2 (Easily disturbed) | Recommendation: | Program removal | |

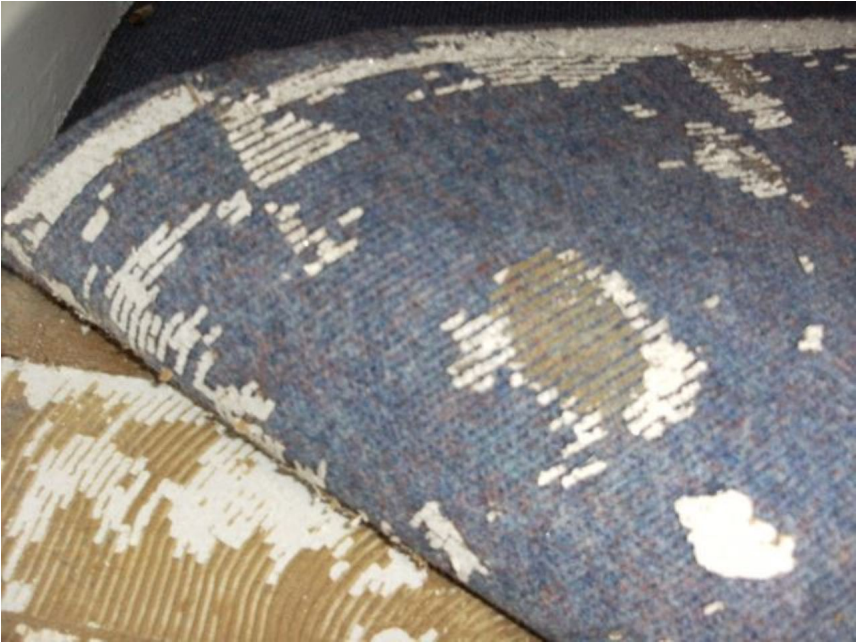
| Location: | 047 Office | Block: | Main Block | Floor Level: | 01 - First |

| Item: | Asbestos insulating board debris | | | |
| Asbestos Content: | Amosite Strongly Presumed<br>Chrysotile Strongly Presumed | | | |
| Comments: | Present to reverse side of carpet. Carpet to be noted as contaminated. | | | |
| Condition: | 3 (Significant damage) | Priority Assessment: | 6 | |

| Accessibility: | 2 (Easily disturbed) | Recommendation: | Program removal | |

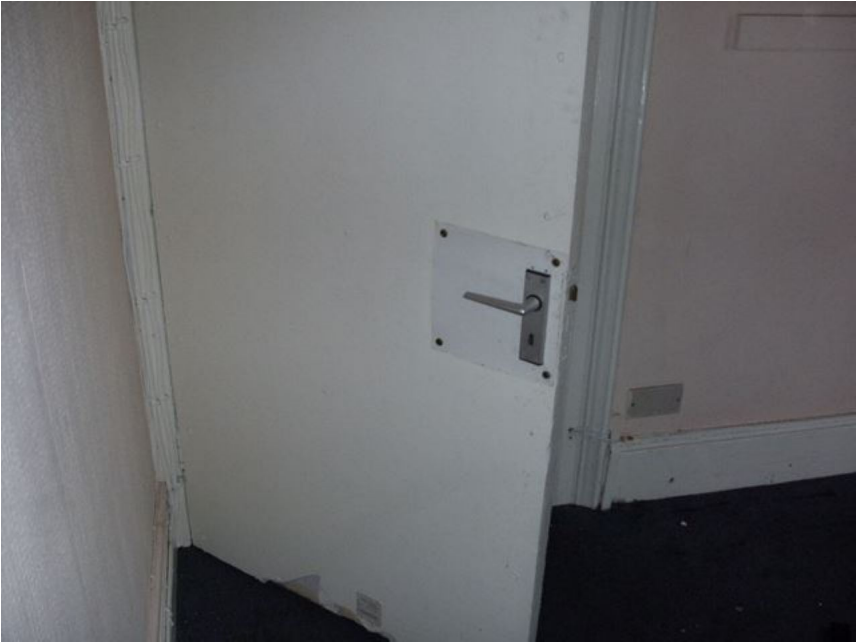
| Location: | 047 Office | Block: | Main Block | Floor Level: | 01 - First |

| Item: | Asbestos insulating board lining to door | | | |
| Asbestos Content: | Amosite Strongly Presumed<br>Chrysotile Strongly Presumed | | | |
| Condition: | 3 (Significant damage) | Priority Assessment: | 6 | |

| Accessibility: | 3 (Routinely disturbed) | Recommendation: | Program removal | |

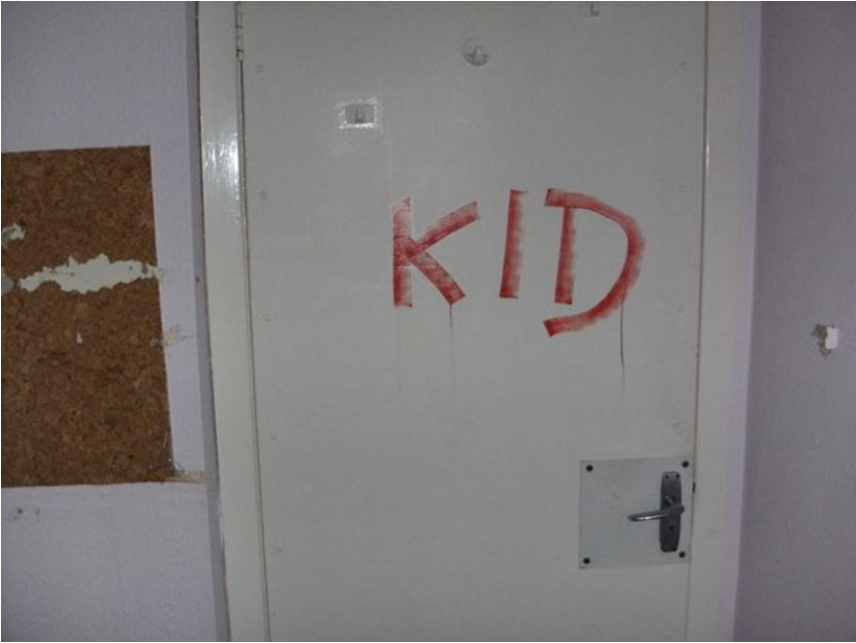
| Location: | 048 Office | Block: | Main Block | Floor Level: | 01 - First |

| Item: | Asbestos insulating board lining to door | | | |
| Asbestos Content: | Amosite Strongly Presumed<br>Chrysotile Strongly Presumed | | | |
| Condition: | 1 (Minor scratches) | Priority Assessment: | 6 | |

| Accessibility: | 3 (Routinely disturbed) | Recommendation: | Program removal | |

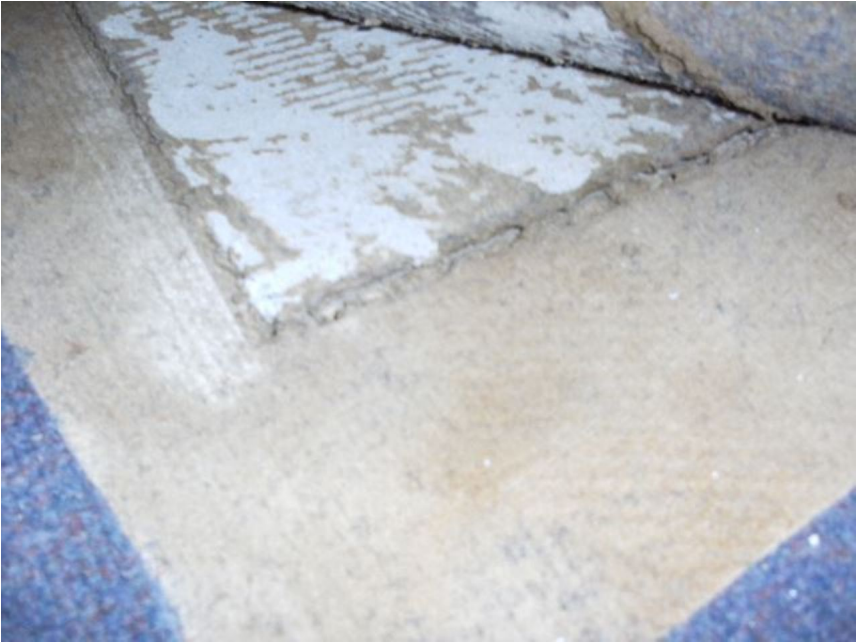
| Location: | 049 Office | Block: | Main Block | Floor Level: | 01 - First |

| Item: | Asbestos insulating board to floor | | | |
| Asbestos Content: | Amosite Strongly Presumed<br>Chrysotile Strongly Presumed | | | |
| Condition: | 2 (Local damage) | Priority Assessment: | 5 | |

| Accessibility: | 2 (Easily disturbed) | Recommendation: | Program removal | |

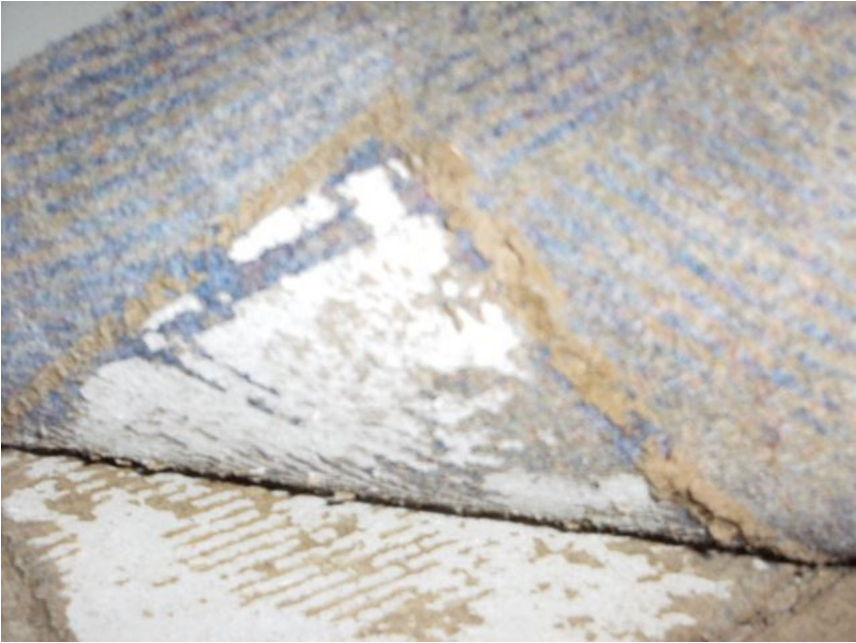
| Location: | 049 Office | Block: | Main Block | Floor Level: | 01 - First |

| Item: | Asbestos insulating board debris | | | | |
| Asbestos Content: | Amosite Strongly Presumed<br>Chrysotile Strongly Presumed | | | | |
| Comments: | Present to reverse side of carpet. Carpet to be noted as contaminated. | | | | |
| Condition: | 3 (Significant damage) | | | Priority Assessment: | 6 |

| Accessibility: | 2 (Easily disturbed) | | | Recommendation: | Program removal |

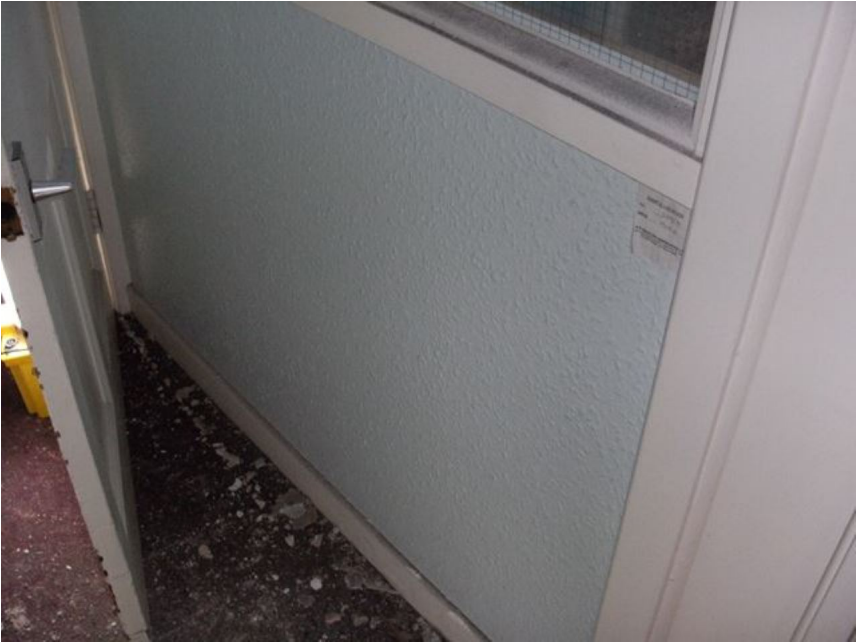
| Location: | 050 Hall | Block: | Main Block | Floor Level: | 01 - First |

| Item: | Asbestos insulating board to wall(s) | | | |
| Asbestos Content: | Amosite Strongly Presumed<br>Chrysotile Strongly Presumed | | | |
| Condition: | 1 (Minor scratches) | Priority Assessment: | 5 | |

| Accessibility: | 2 (Easily disturbed) | Recommendation: | Program removal | |

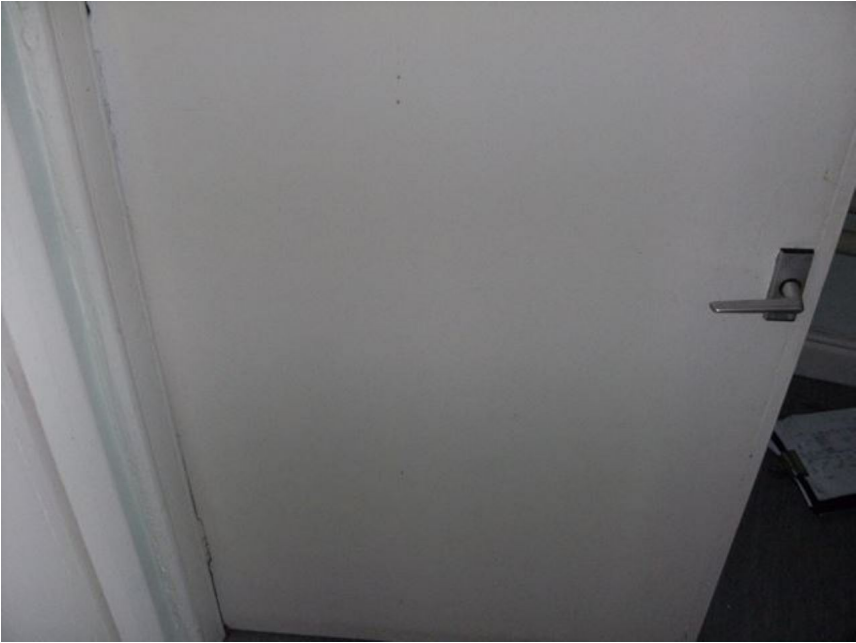
| Location: | 057 Lobby | Block: | Main Block | Floor Level: | 01 - First |

| Item: | Asbestos insulating board lining to door | | | |
| Asbestos Content: | Amosite Identified<br>Chrysotile Identified | | | |
| Condition: | 2 (Local damage) | Priority Assessment: | 6 | |

| Accessibility: | 3 (Routinely disturbed) | Recommendation: | Program removal | |

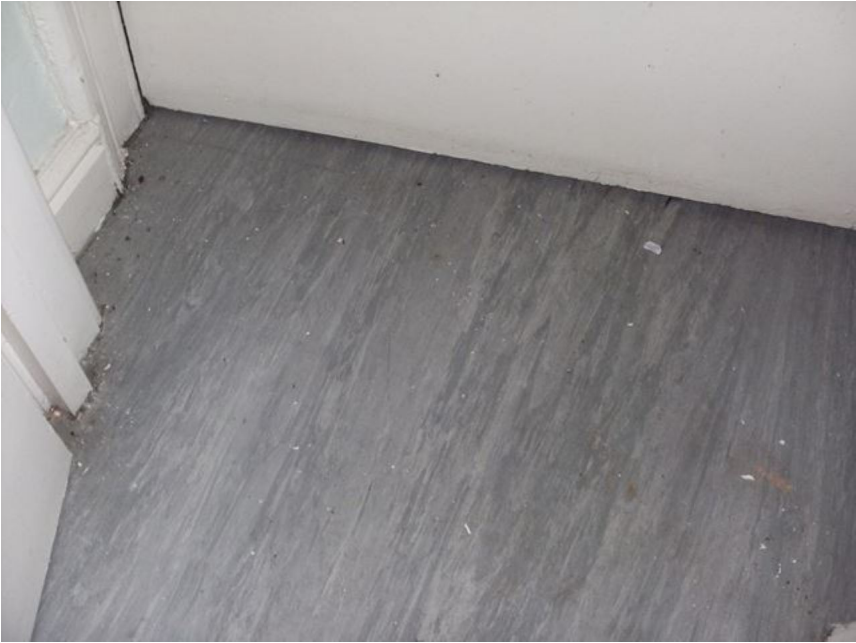
| Location: | 057 Lobby | Block: | Main Block | Floor Level: | 01 - First |

| Item: | Asbestos insulating board debris to floor | | | |
| Asbestos Content: | Amosite Strongly Presumed<br>Chrysotile Strongly Presumed | | | |
| Condition: | 3 (Significant damage) | Priority Assessment: | 6 | |

| Accessibility: | 3 (Routinely disturbed) | Recommendation: | Program removal | |

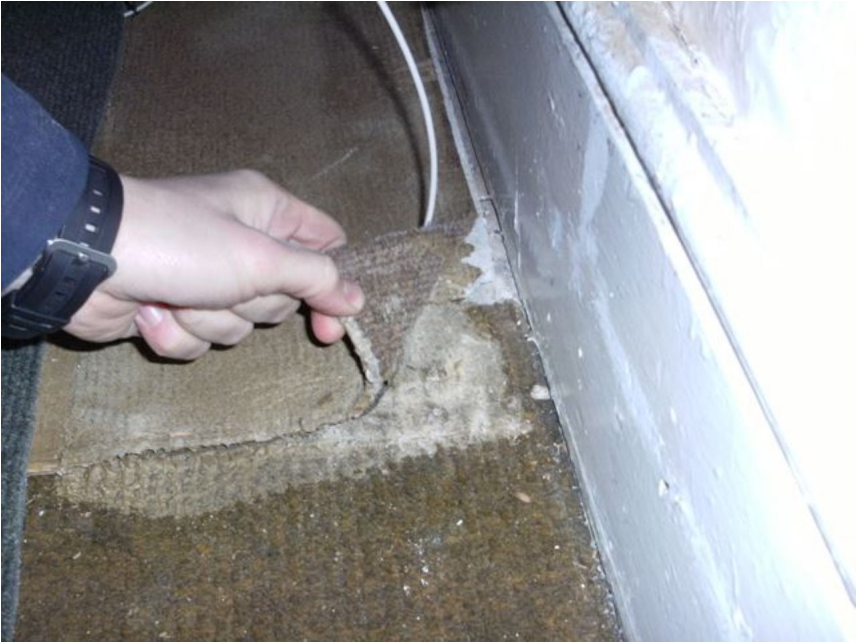
| Location: | 060 Office | Block: | Main Block | Floor Level: | 02 - Second |

| Item: | Asbestos insulating board to floor beneath heater | | | |
| Asbestos Content: | Amosite Identified<br>Chrysotile Identified | | | |
| Condition: | 2 (Local damage) | Priority Assessment: | 6 | |

| Accessibility: | 2 (Easily disturbed) | Recommendation: | Program removal | |

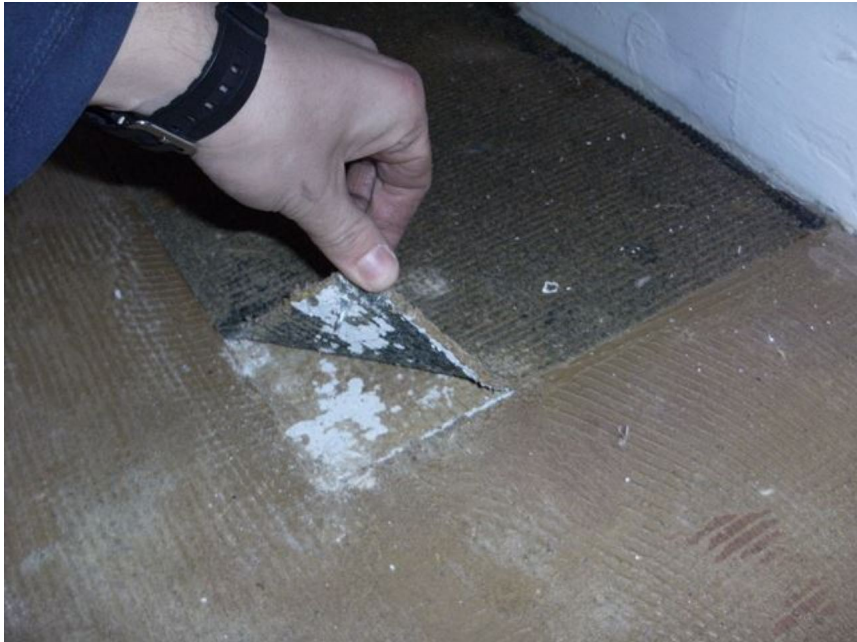
| Location: | 063 Office | Block: | Main Block | Floor Level: | 02 - Second |

| Item: | Asbestos insulating board to floor beneath heater | | | | |
| Asbestos Content: | Amosite Strongly Presumed<br>Chrysotile Strongly Presumed | | | | |
| Condition: | 2 (Local damage) | | | Priority Assessment: | 6 |

| Accessibility: | 2 (Easily disturbed) | | | Recommendation: | Program removal |

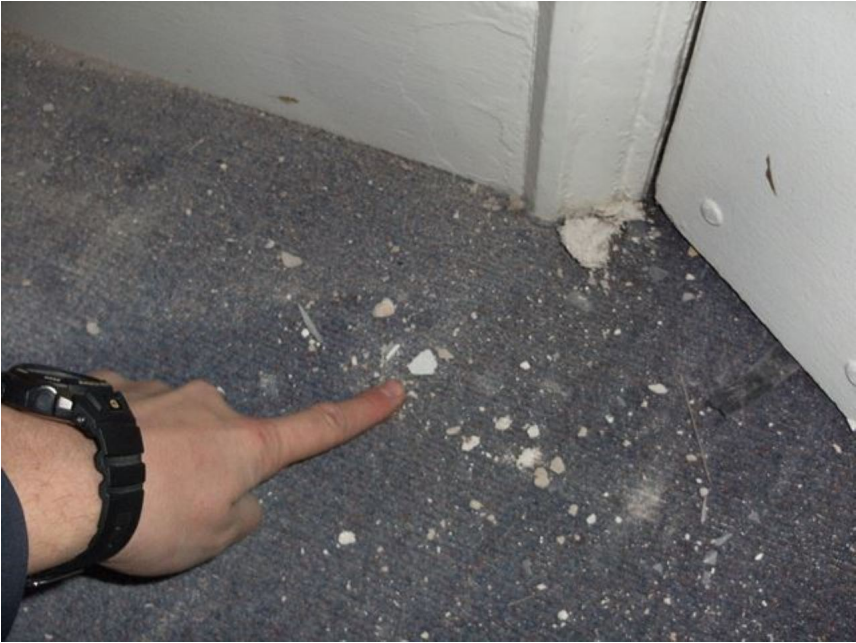
| Location: | 067 Office | Block: | Main Block | Floor Level: | 02 - Second |

| Item: | Asbestos insulating board debris | | | |
| Asbestos Content: | Amosite Strongly Presumed | | | |

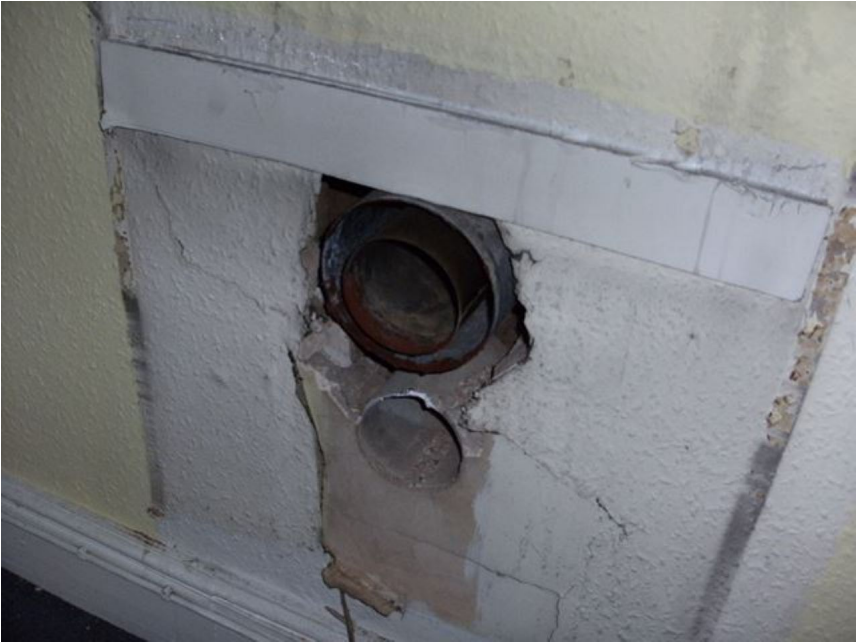
| Location: | 067 Office | Block: | Main Block | Floor Level: | 02 - Second |

| Item: | Asbestos cement flue pipe | | | | |
| Asbestos Content: | Chrysotile      Identified | | | | |

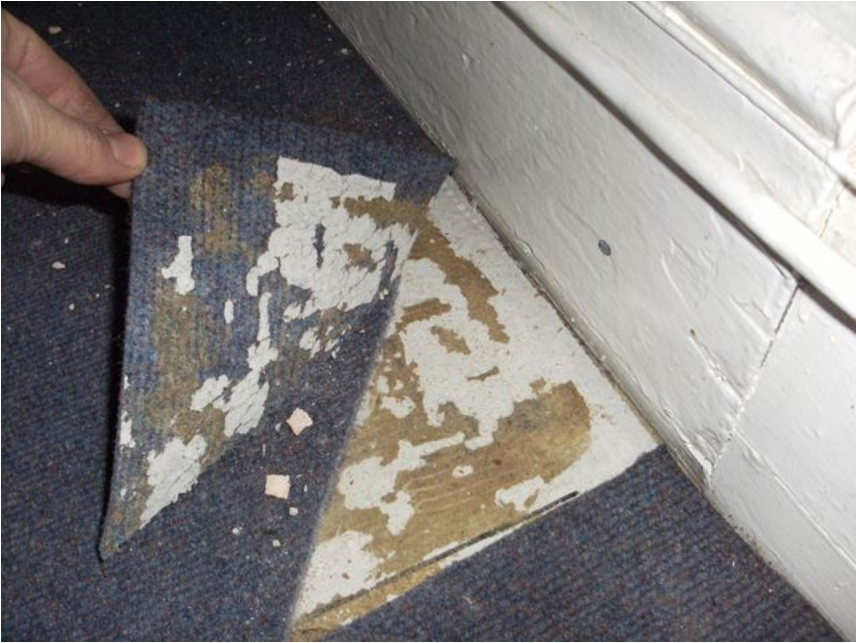
| Location: | 067 Office | Block: | Main Block | Floor Level: | 02 - Second |

| Item: | Asbestos insulating board to floor beneath heater | | | |
| Asbestos Content: | Amosite Strongly Presumed<br>Chrysotile Strongly Presumed | | | |

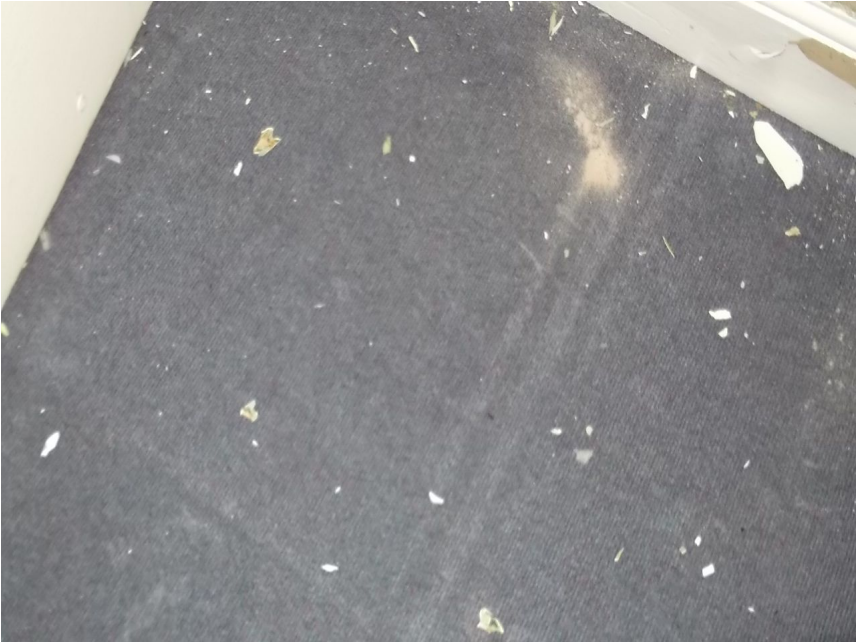
| Location: | 070 Office | Block: | Main Block | Floor Level: | 02 - Second |

| Item: | Asbestos insulating board debris | | | |
| Asbestos Content: | Amosite Strongly Presumed<br>Chrysotile Strongly Presumed | | | |

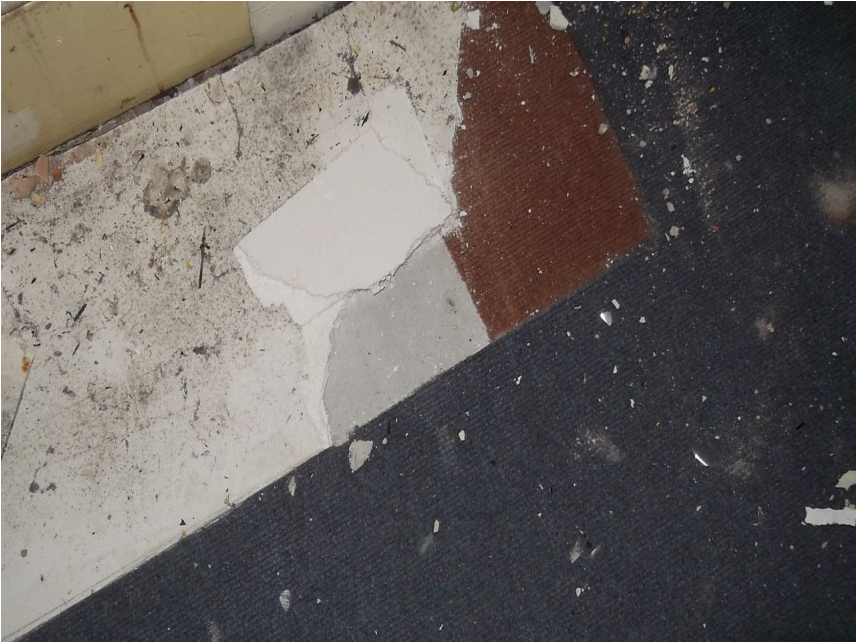
| Location: | 070 Office | Block: | Main Block | Floor Level: | 02 - Second |

| Item: | Asbestos insulating board to floor beneath heater | | | |
| Asbestos Content: | Amosite Strongly Presumed<br>Chrysotile Strongly Presumed | | | |

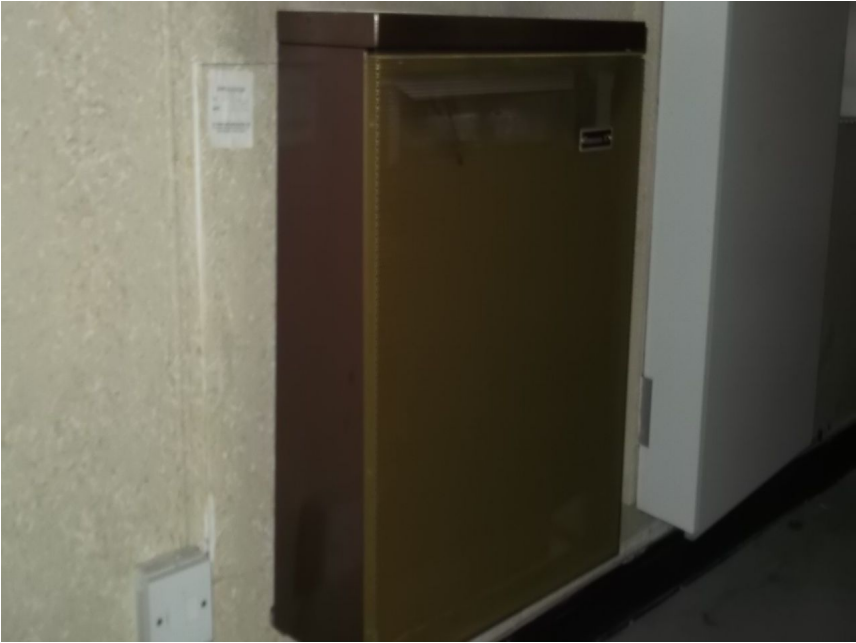
| Location: | 076 WC | Block: | Annex | Floor Level: | 0 - Ground |

| Item: | Asbestos insulating board to wall(s) | | | | |
| Asbestos Content: | Amosite      Identified | | | | |

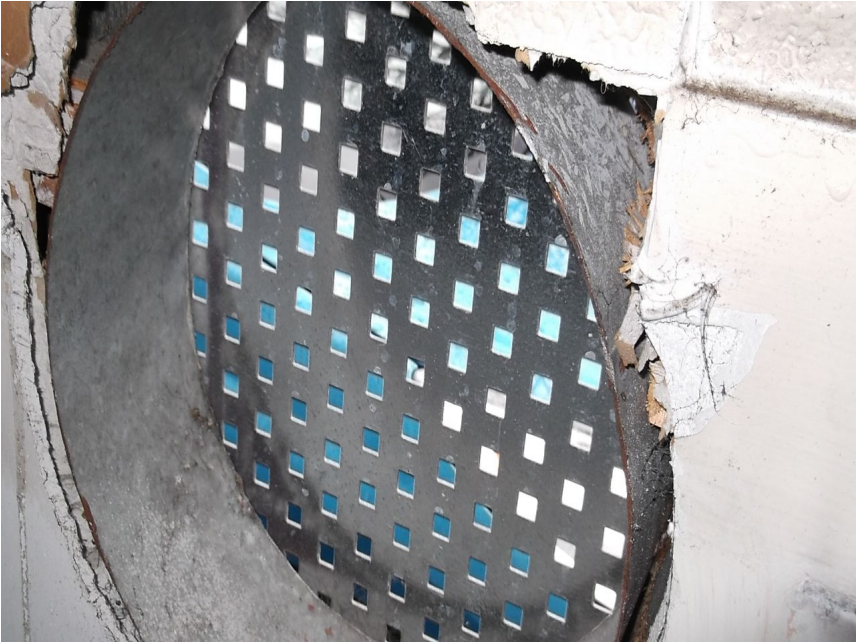
| Location: | 087 External to Annexe | Block: | Annex | Floor Level: | External |

| Item: | Asbestos insulating board around flue to wall(s) | | | |
| Asbestos Content: | Amosite      Identified | | | |

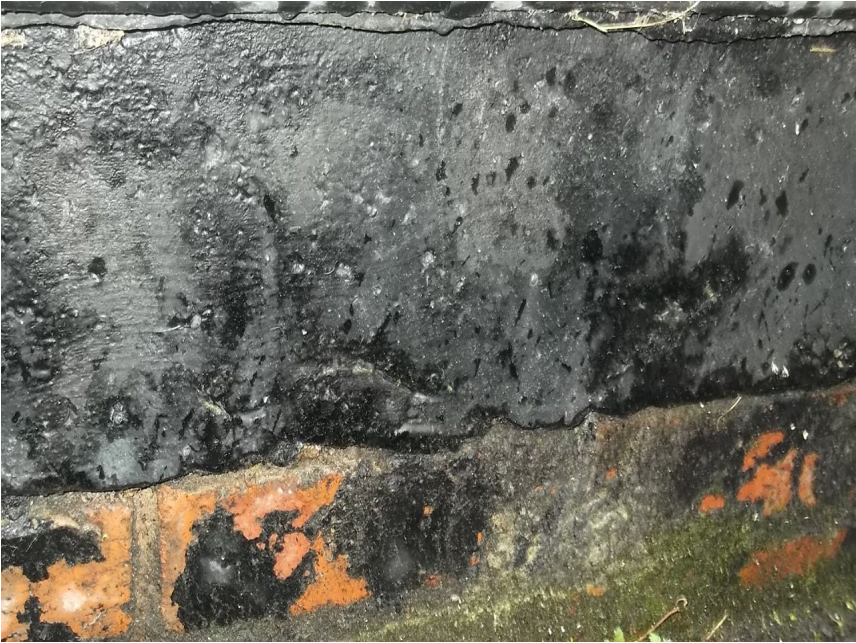
| Item: | Bitumen to wall(s) | | | |
| Asbestos Content: | No asbestos detected Identified | | | |

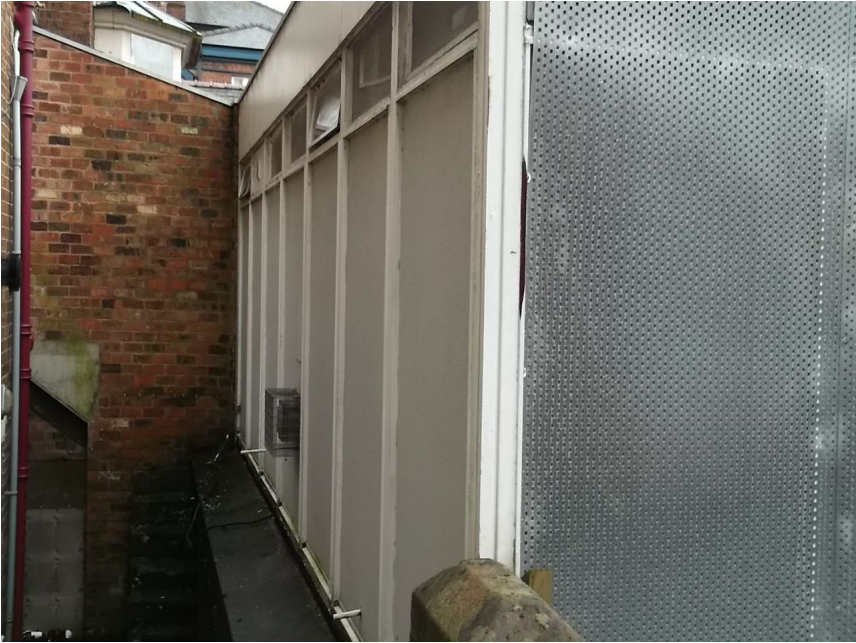
| Item: | Textured coating to wall(s) | | | |
| Asbestos Content: | No asbestos detected Identified | | | |

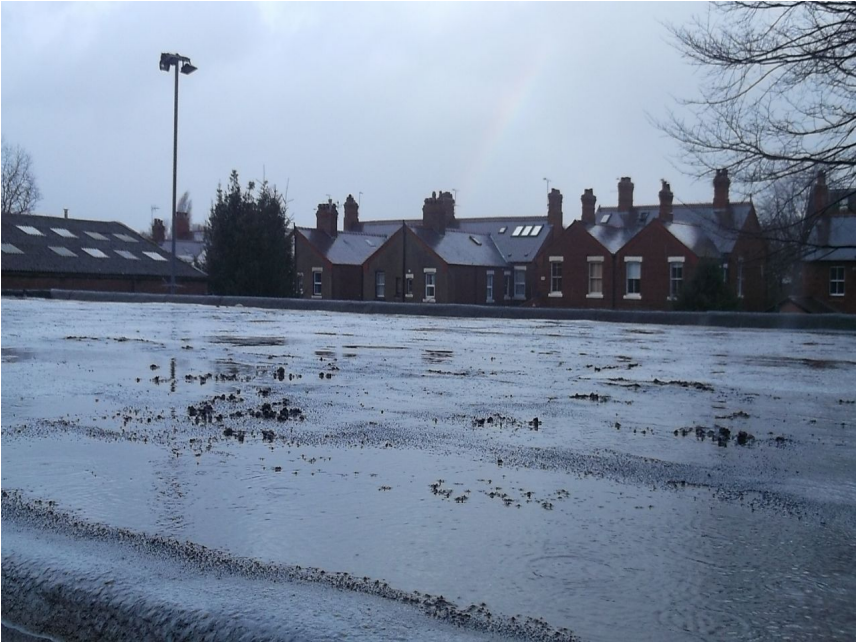
| Item: | Bitumen roofing felt | | | |
| Asbestos Content: | No asbestos detected Identified | | | |
