Our Ref: 01016/Rep 01  
Date: 10<sup>th</sup> July 2015

## **STRUCTURAL INSPECTION AND LETTER REPORT – GAMFORD FARM, ROSSETT**

We thank you for instructing Woodbank Consulting Engineers Ltd (Woodbank) to carry out a visual survey of the barns and main property at Gamford Farm, Rossett, which are to form part of a planning application.

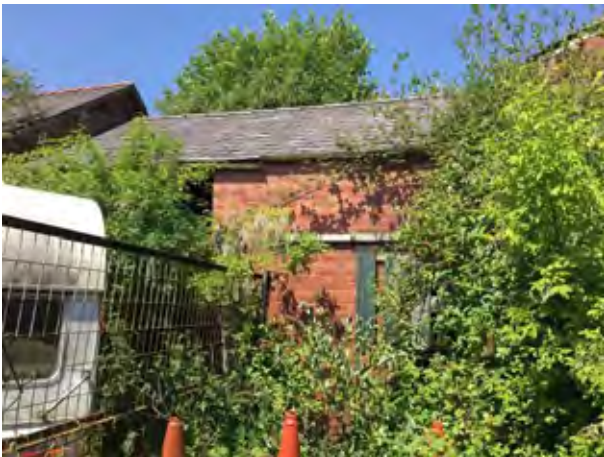
Towards the right hand side of the elevation, the barn had been extended. This area was substantially covered by vegetation and therefore we are not able to comment further on this elevation; however, there were no obvious signs of structural movement where the elevation was visible. A caravan was also parked next to the elevation preventing full and unobstructed visual access.

Extended part of barn hidden by vegetation

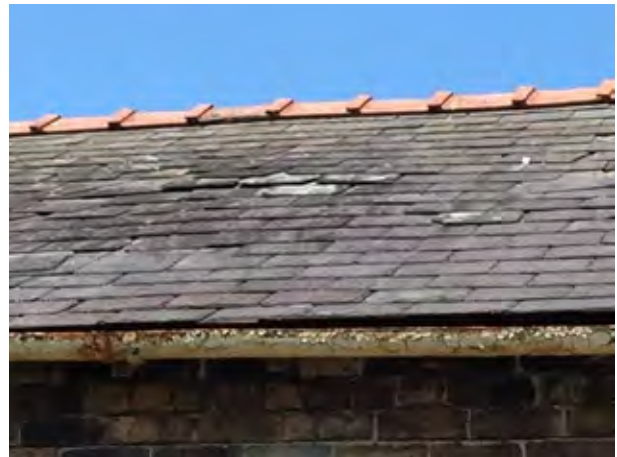
Holes through roof. Slipped tiles.

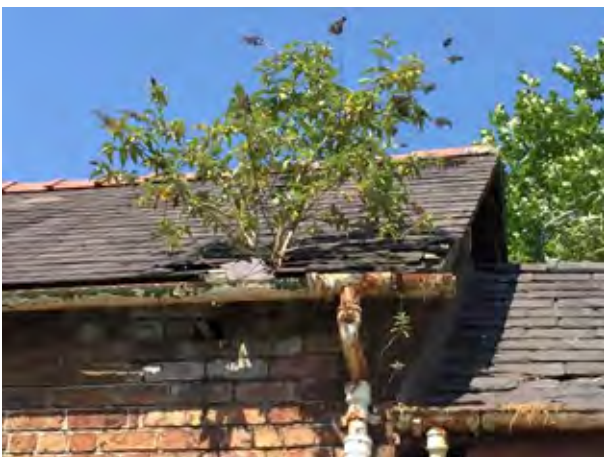
Vegetation growing through the structure.

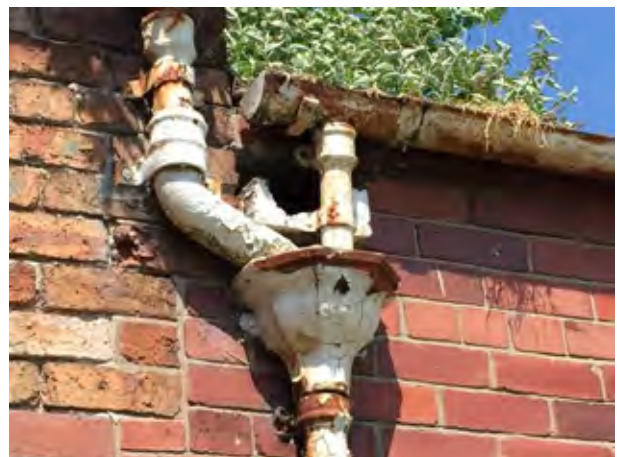
Holes through elevation.

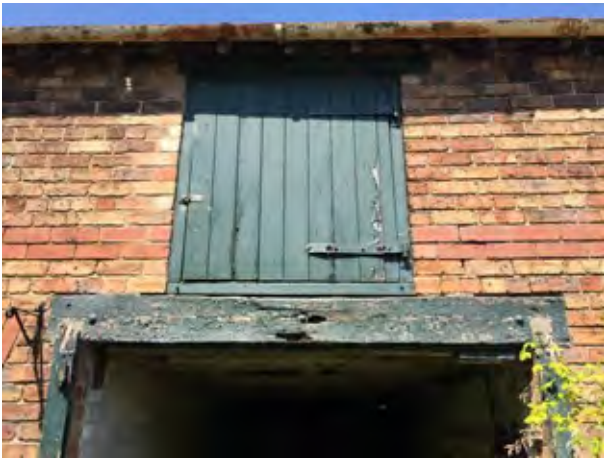
Deflecting and weathered timber lintel.

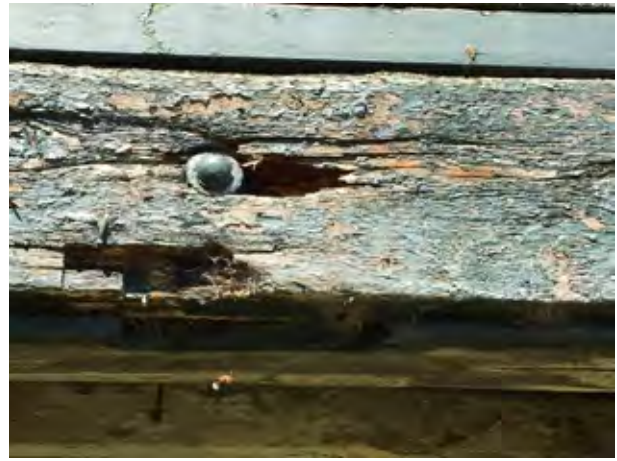
Weathered timber lintel.

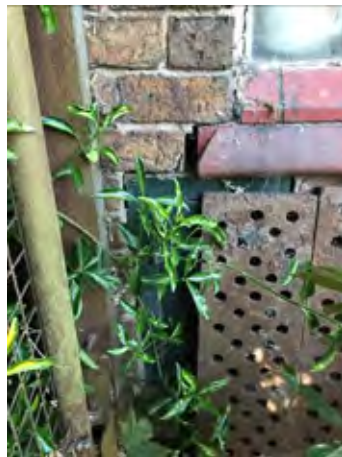
Cracking below window to Room 1.

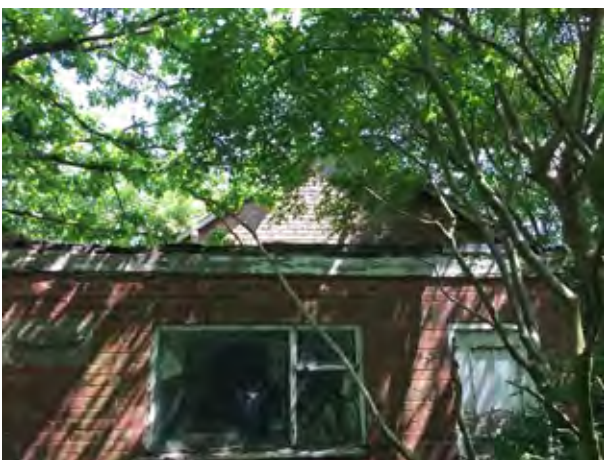
Single storey structure in front of elevation.

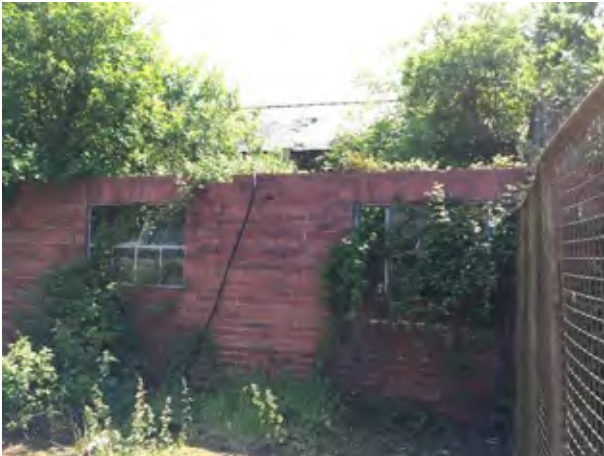
Structure in front of rear elevation.

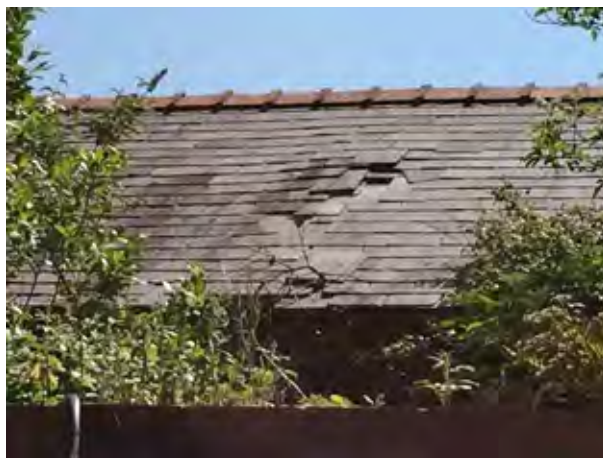
The rear slope of the roof to Barn 1 was visible in a few locations. Holes were noted through the roof and slates had slipped or were missing. The roof line was slightly uneven and there was no rainwater gutter, so water was able to run down the face of the building. Roof repairs and replacement of rainwater goods is necessary.

Slipped tiles and hole through roof.

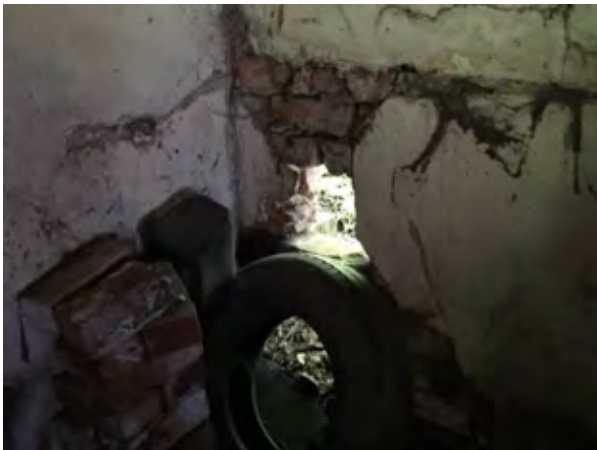
Hole through wall in Room 4.

A hole was noted extending through the wall at low level, to the left hand side of the room. This will require localised re-building.

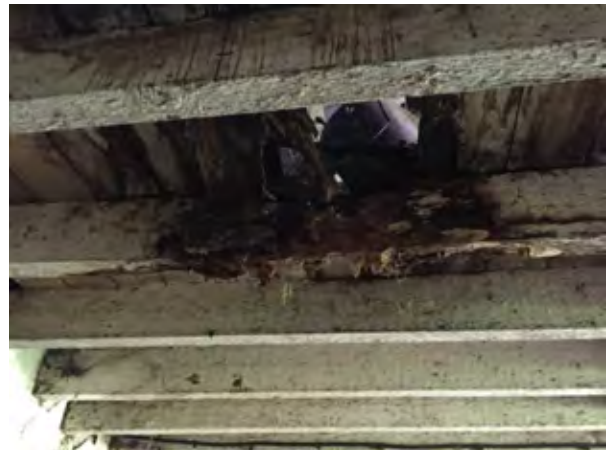
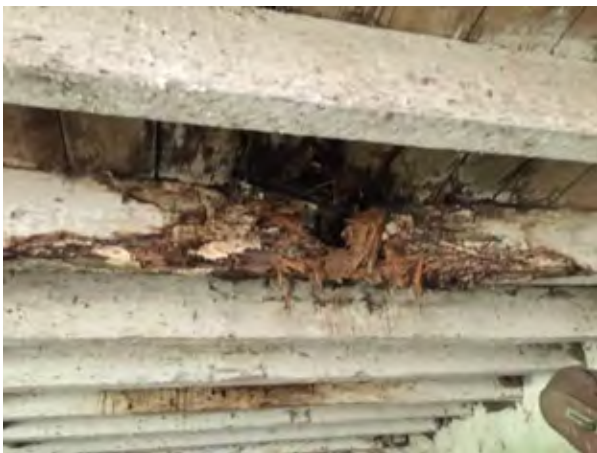
It was noted that the timber floor joist over Room 4 spanned from front to rear. Some of the joists appeared to have over-deflected and some had rotted through, due to water ingress from above. It is anticipated that there is a hole in the roof above. Some of the timber joist ends appeared to have rotted. Some / or all of the floor joists will require replacement.

Hole through floor in Room 4.

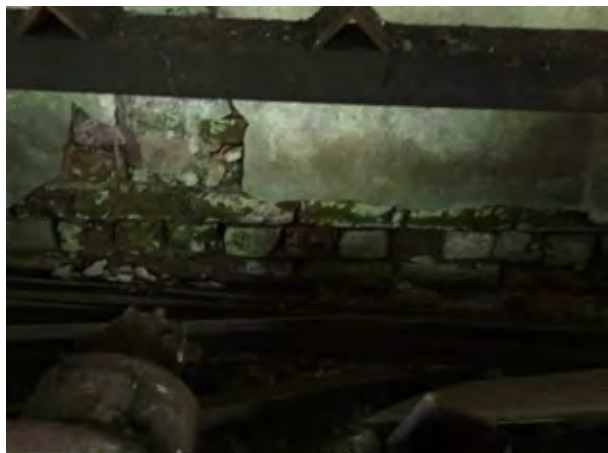
Water staining to rear wall, Room 4.

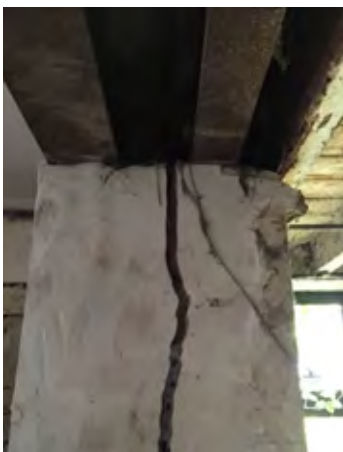
Cracking to bearing below steelwork in Room 4.

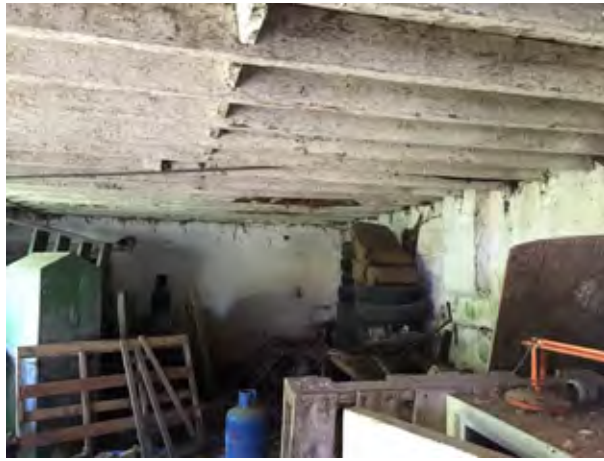
Over deflecting floor joists over Room 4.

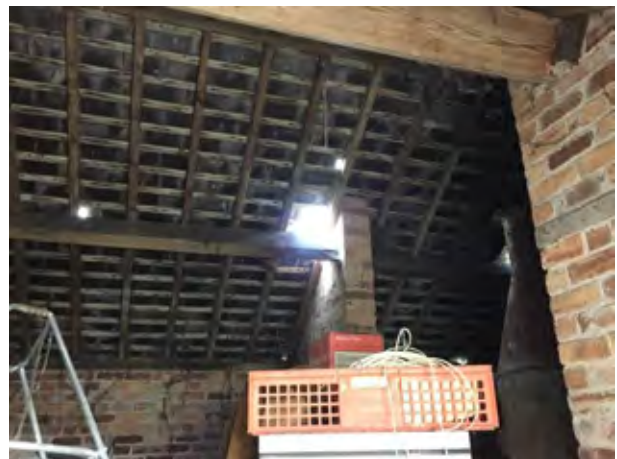
Holes through roof over rooms 1 and 2.

Some holes were noted through the roof which had allowed rainwater to enter the building. The holes should be repaired as part of the refurbishment scheme proposed.

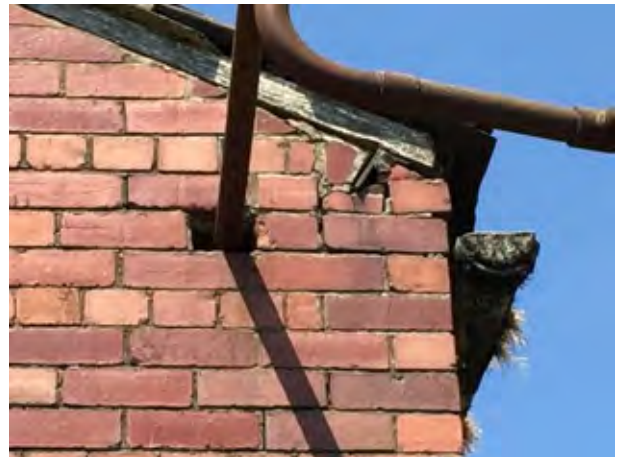
A pipe was also noted protruding through the elevation.

Holes through elevation for pipework.

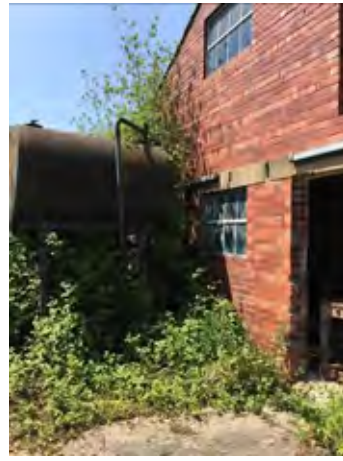
Tank and vegetation hiding elevation to right hand side.

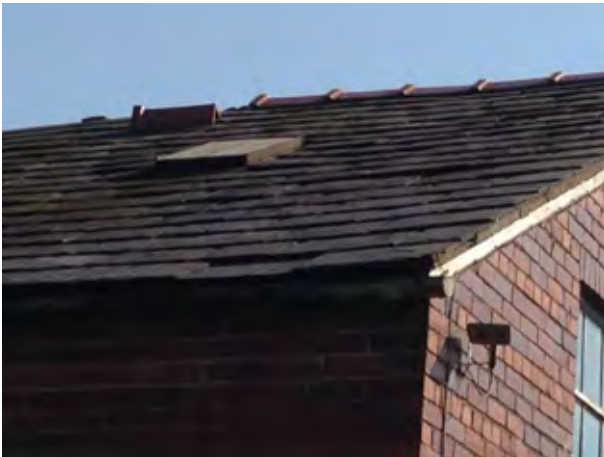
The roof line appeared to be fairly level, but some of the clay ridge tiles had slipped or were missing. At least one slate was missing from the roof slope visible.

Slipped slates and ridge tiles.

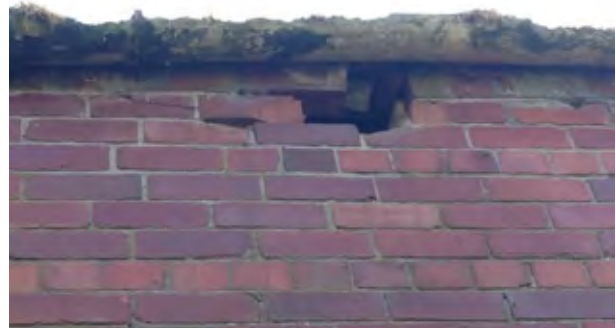
Holes through elevation and damaged gutters which may contain asbestos.

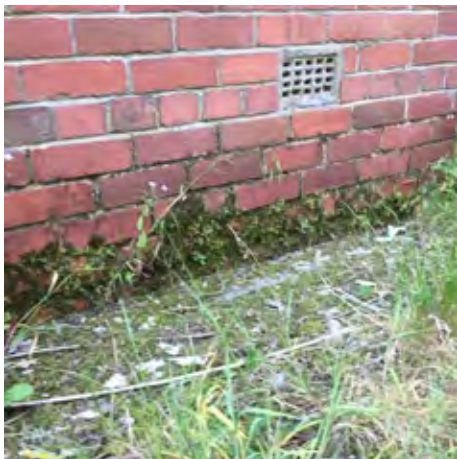
It was noted that generally the full length of the elevation had moss growing along the elevation at low level. We assume this will be dealt with during the refurbishment scheme involving the installation of a damp proof course.

Moss growth indicating possible damp.

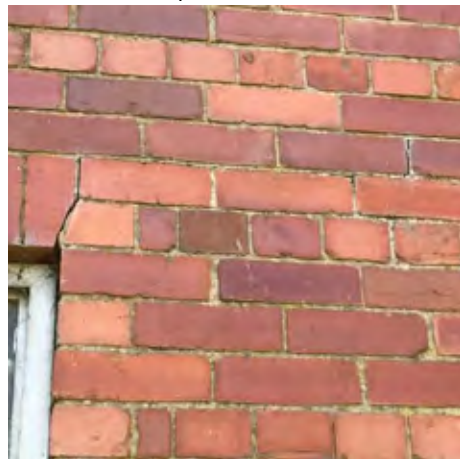
At low level on the right hand corner of the elevation, the mortar in the brickwork joints had eroded. This is likely to be due to the age of the structure and should be repointed.

Cracking to right hand, rear corner masonry.

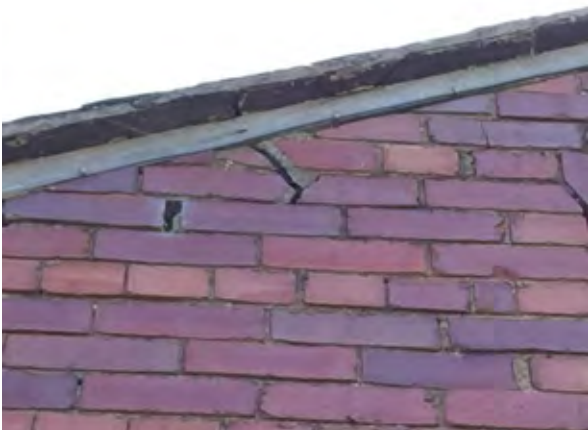
Cracking to brickwork where steel purlins are built into the masonry.

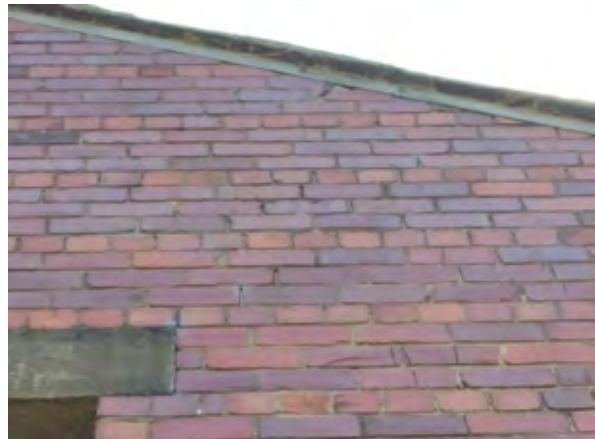
Cracking to the right hand side of the central opening at first floor level.

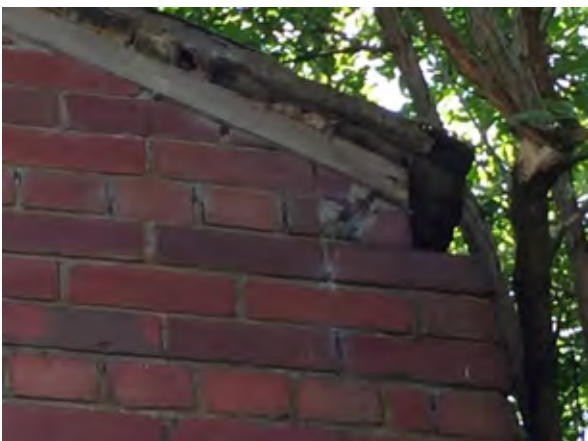
Damage to eaves and verges.

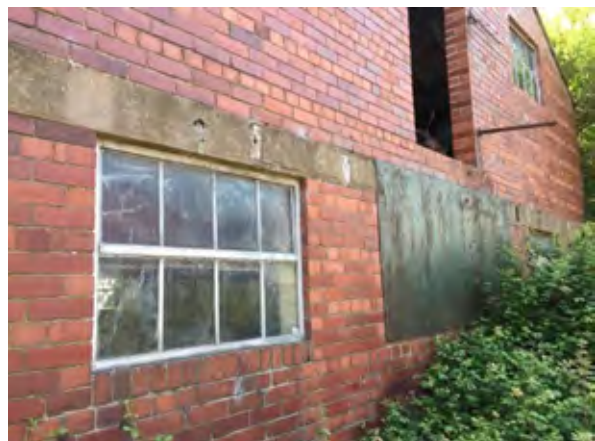
Concrete ring beam with timbers built in.

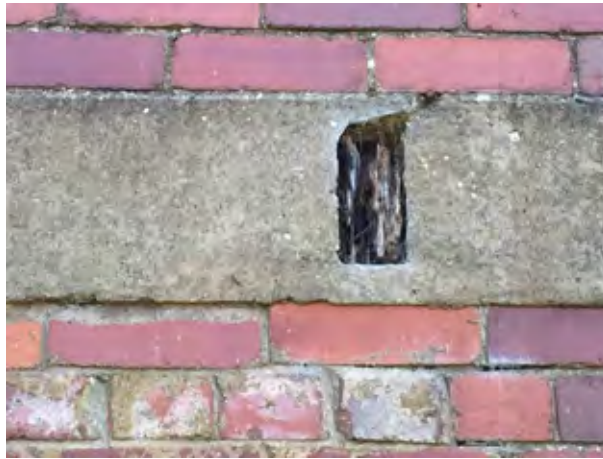
Rotten timbers within concrete ring beam.

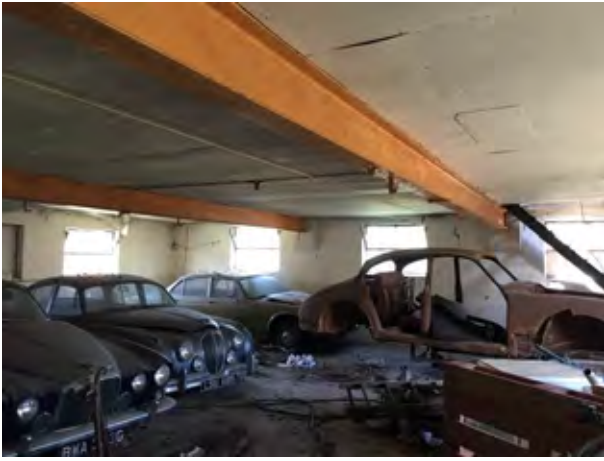
Steel beams supporting the first floors.

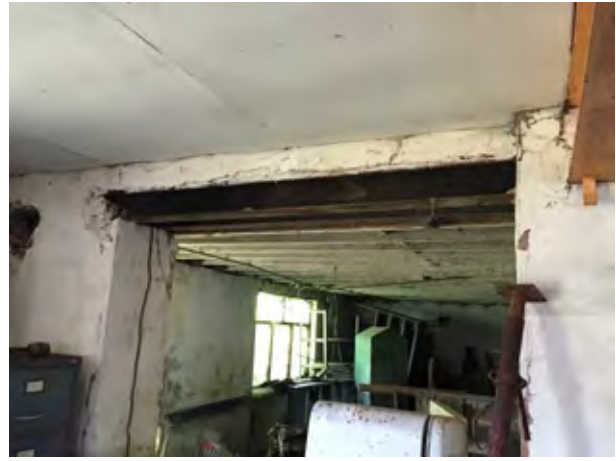
Steel beams forming the opening between Barns 1 and 2.

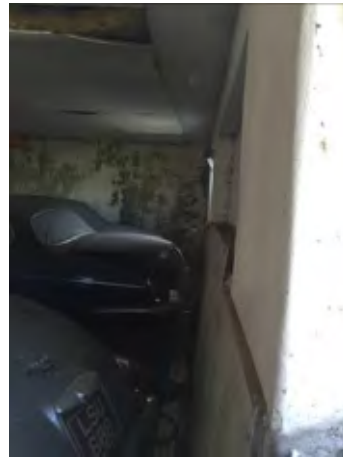
It would appear that the rear wall and the right hand side walls are leaning outwards slightly. Additional restraint should be provided by the installation of galvanised straps at floor level throughout and at rafter level, to both gables.

Rear wall leaning outwards.

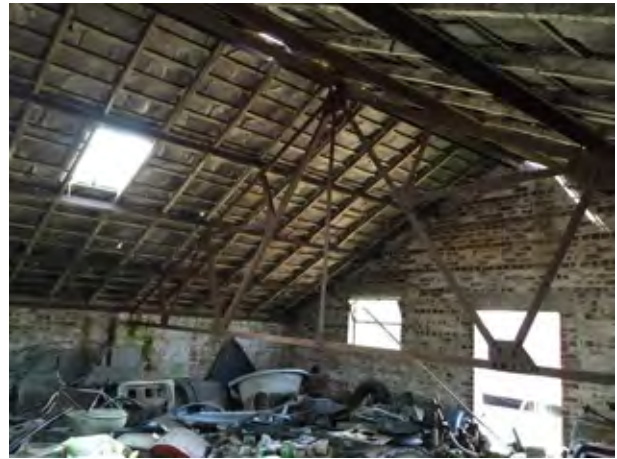
Steel truss supporting roof structure.

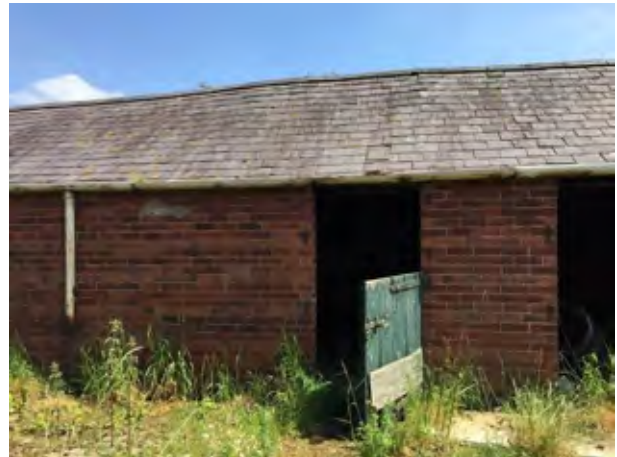
Central area of front elevation.

Horizontal and some stepped cracking was noted in a number of places across the elevation. This had generally occurred where steelwork was embedded within the brickwork. It is anticipated that the steelwork has corroded and delaminated, opening up the bed joints. A similar crack had occurred where there was a pipe penetration through the elevation.

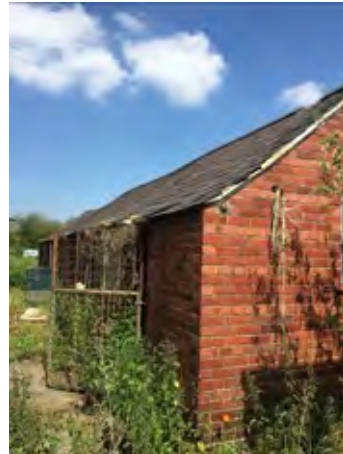
The roof line is undulating considerably, suggesting that the roof has spread substantially. It was noted that there were no ridge beams or purlins. Rafters were provided with ties across at regular centres, but not all rafters had ties across. Some of the ridge tiles and slated were missing or had slipped.

Undulating roof slope.

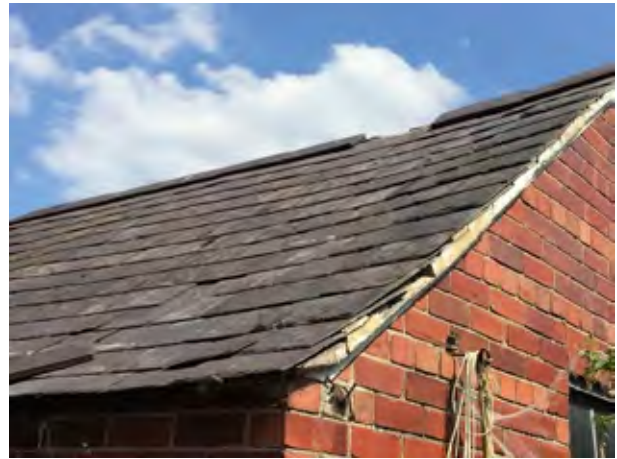
Slipped slated and ridge tiles.

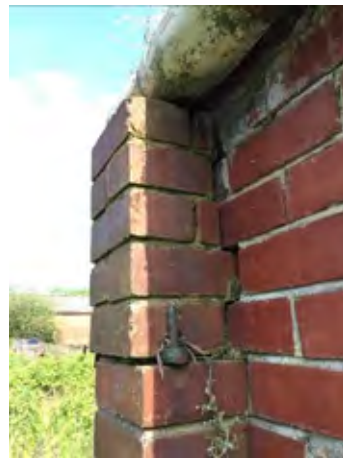
A pier / buttress had been constructed on the left hand end of the elevation. The brickwork at the top was loose. Steelwork in this location had corroded, lifting the masonry.

Cracking and movement of pier / buttress.

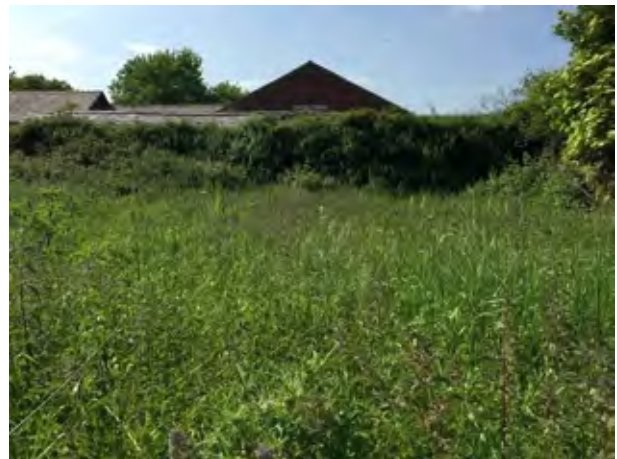
Visual access to the rear elevation was extremely limited and could only be viewed from a distance due to the height of the overgrowing vegetation at the rear of the barn. Vegetation was also growing up the elevation masking any possible defects.

Vegetation growing up the face of the structure.

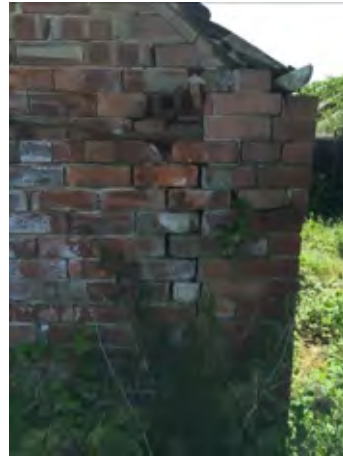
Penetrations through the elevation have damaged the integrity of the wall.

The pier / buttress on the right hand side had moved outward leaving a gap of approximately 10 mm. We suspect that the pier has an inadequate foundation. This should be exposed and confirmed. It may be necessary to install a single underpin to stabilise the pier. The pier should be re-built on a suitable base or at the very least it should be partially rebuilding or tied back to the structure.

Movement of piers / buttress and damage to brickwork due to pipe penetration.

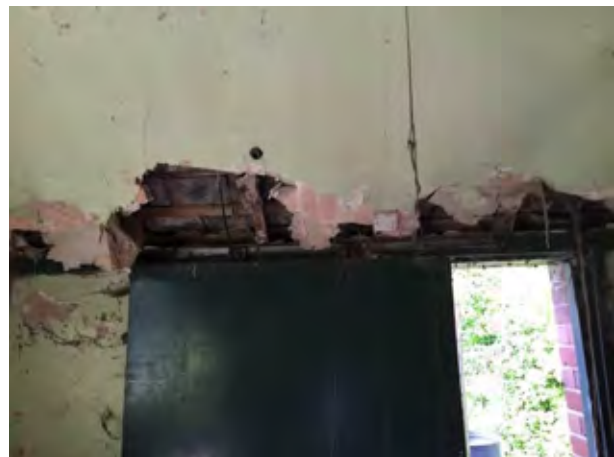
Holes through roof at eaves level on front elevation, Room 1.

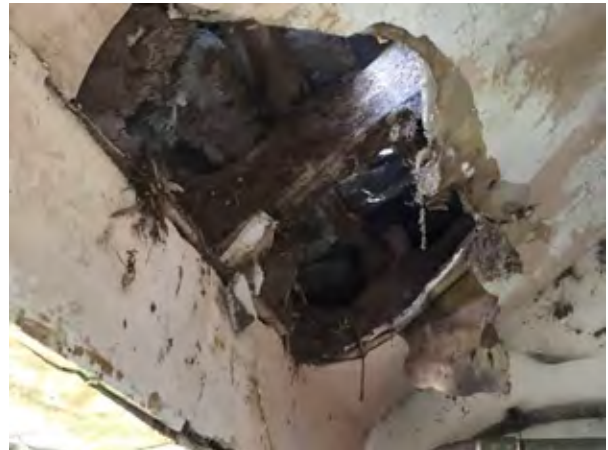
The gap between the cross wall between Rooms 2 and 3 and the rear wall was wider, approximately 7 mm. A similar gap was noted between the same cross wall and the front elevation wall, although the width was approximately 5 mm wide. It was noted that the rafter ends were rotting.

Rotten rafter ends visible.

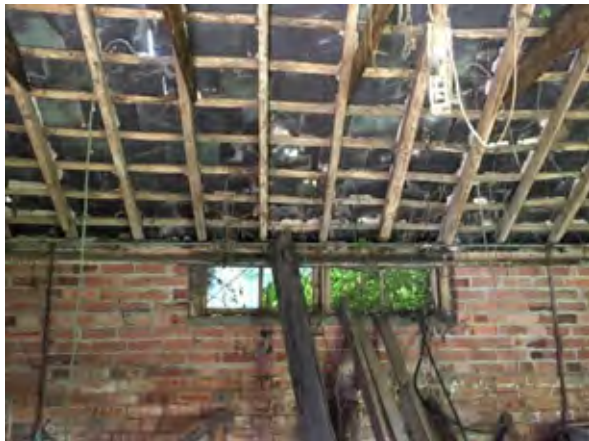
Deflecting roof timbers.

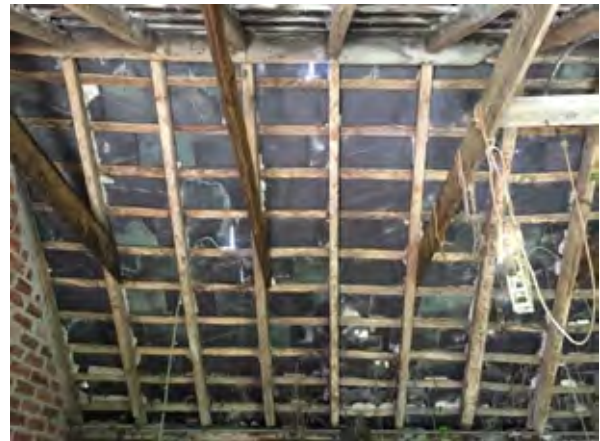
Existing ties across roof. Hole through roof.

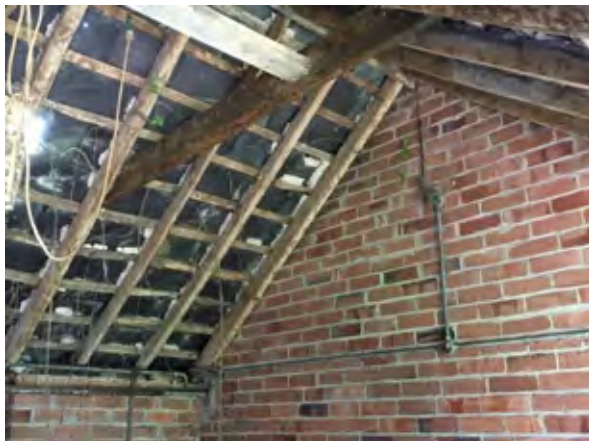
Holes through roof structure.

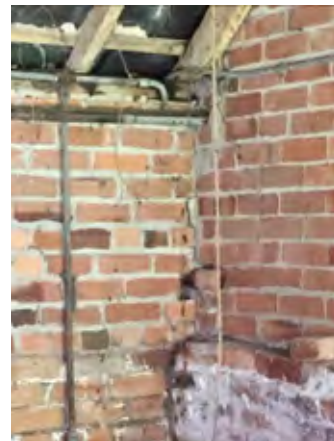
Vertical cracking of approximately 2 mm width was noted at the junction of the cross wall between Rooms 1 and 2 and the rear wall. It is likely that the rear wall has moved outwards slightly as the roof has spread.

The gap between the cross wall between Rooms 2 and 3 was slightly larger on this face of the wall, it ranged from 7 mm to 10 mm. A further 10 mm wide gap was noted between the cross wall between Rooms 3 and 4 and the front wall.

As in the previous rooms there is a lack of restraint between the cross walls and the front and rear walls and gaps of up to 10 mm were noted.

Crack formed between cross wall and front elevation wall.

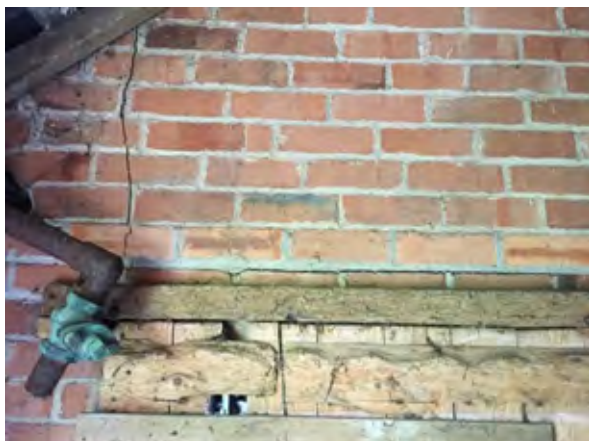
An opening has been formed between Room 4 and 5. It is assumed that a timber lintel which has been provided over the opening has deflected / moved downwards by approximately 5 mm as a horizontal gap has opened up. A vertical crack was also noted to the left hand side of the opening. This was approximately 3 mm wide. A large hole has also been formed in the wall to allow the penetration of a pipe. We would recommend that the cracks are stitched using a proprietary stitching system involving installing helical reinforcement bars in the bed joints. A new lintel should also be provided for this opening is retained. The wall was checked on the opposite face and found to have a large steel bolt embedded in the masonry, it is possible that the embedded steelwork may have caused the cracking noted. Partial rebuilding of this wall may be necessary. The masonry should be fully keyed and bonded.

Cracking over lintel in cross wall.

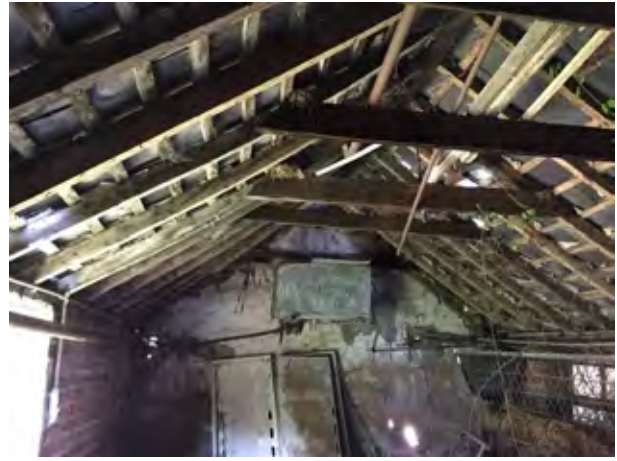
There were not ridge beams or rafters. Rafters were provided with ties across at regular centres, but not all rafters had ties across. We would recommend that a ridge beam be provided for the full length of the barn.

Typical roof configuration.

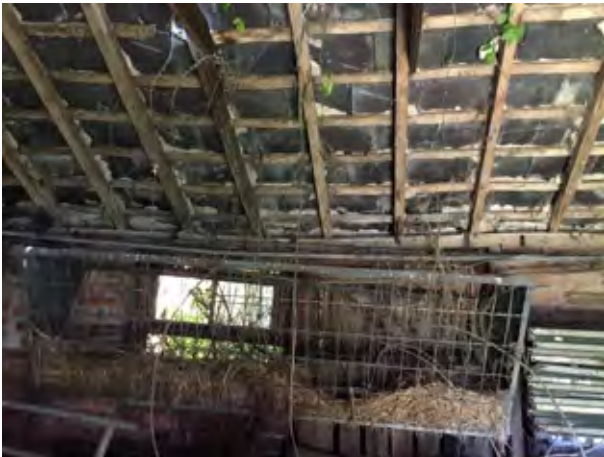
Room 1 is the largest of the rooms. The wall plate over the window openings on the rear elevation is over-deflecting and the roof has moved downward in this location. The roof is in poor condition and would benefit from replacement involving the installation of a new ridge beam. New lintels should also be provided. The rafters appeared to be over-deflecting and these may also require replacement or the installation of additional purlins.

Over-deflection of rafters and wall plate which also acts as a lintel.

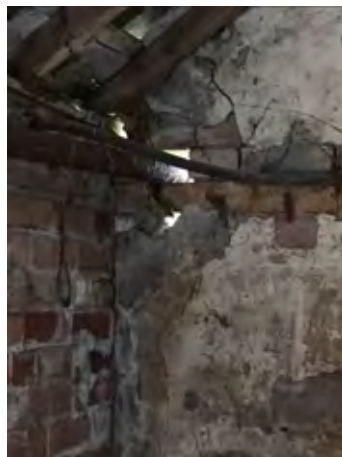
Hole through left hand side gable wall.

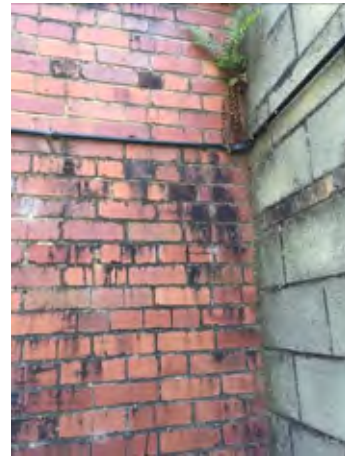
No rain water gutter was visible towards the right hand side of the elevation and towards the left, the gutters were broken in places. Black staining was noted towards the right hand side of the elevation and this is likely to be due to the lack of adequate above ground drainage. New above ground drainage should be provided as part of the proposed scheme of repairs. Externally towards the left hand side of the elevation an open drain extended along the elevation externally. The drain was approximately 1.0 m deep.

Water staining to front elevation brickwork.

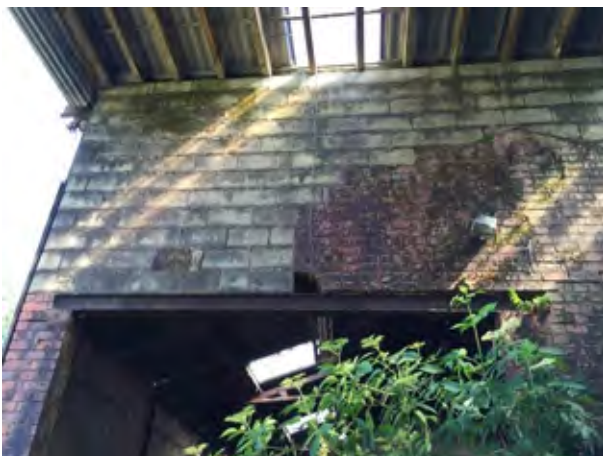
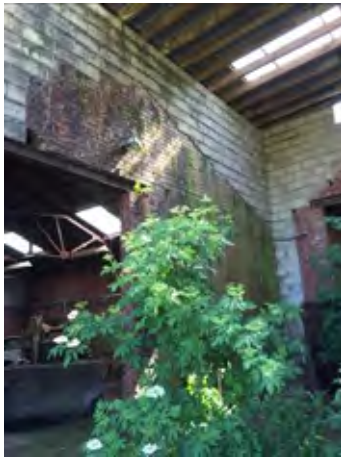
The steel beams provided to form the opening between the barn and the adjacent taller barn has corroded causing the masonry adjacent to the steelwork to crack. We recommend that the steelwork is cleaned and provided with a suitable corrosion protection product is applicable, or the steelwork should be replaced. The cracked masonry should be repointed.

Large opening from through the right hand side gable wall. Blockwork constructed over original gable profile to increase height of adjacent barn.

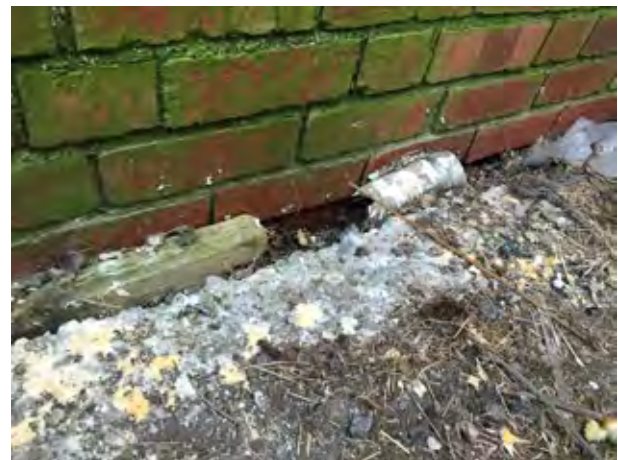
There appears to have been some movement of the gable wall in the outwards direction at the base of the wall. This should be investigated further, but appears to be a historic defect which may not require any further repair works.

Movement of brickwork outwards at low level.

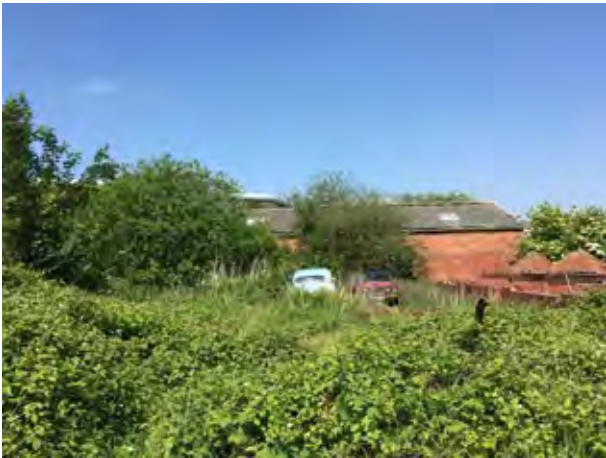
Rear elevation hidden by trees and vegetation.

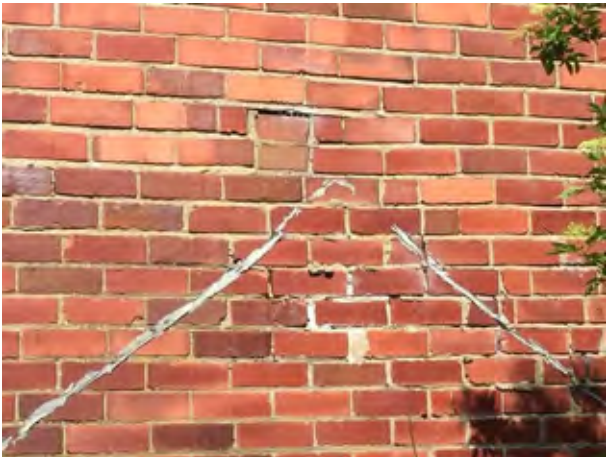
Masonry moved inwards where previous roof structure abutted the elevation.

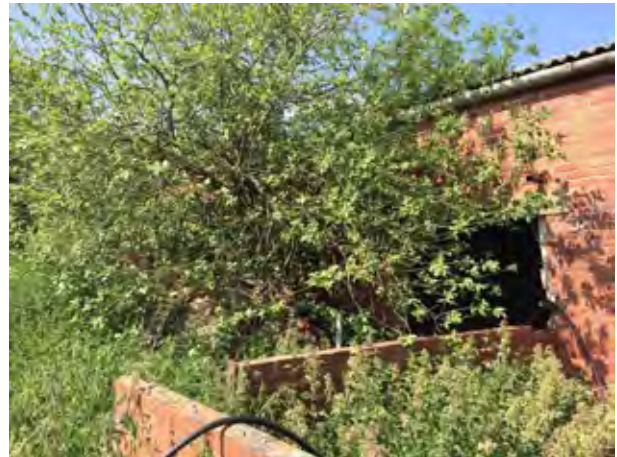
Trees built close up to the rear elevation.

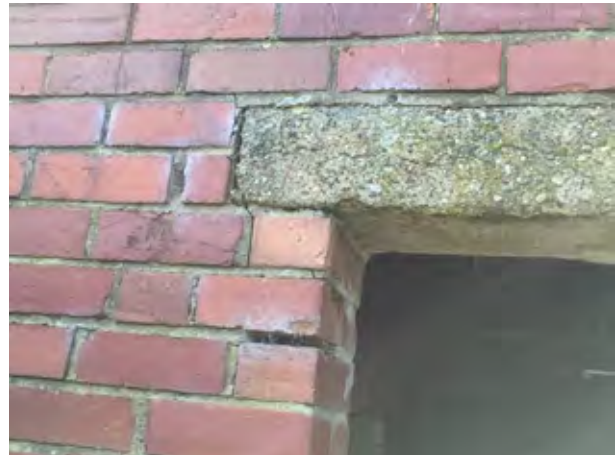
The external elevation was 215 mm thick solid brickwork. An opening had been provided towards the rear elevation. This had a concrete lintel over. Some movement was noted at the bearing of the opening.

Movement of brickwork to bearing for lintel.

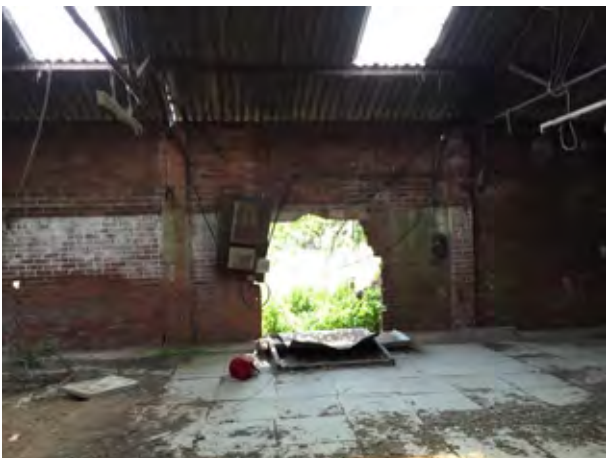
Large opening formed through rear wall.

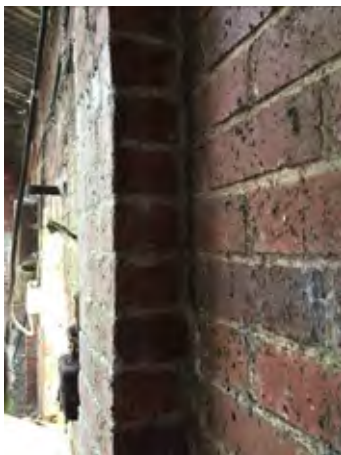
Brick pier on rear wall.

We would recommend that an additional leaf of blockwork is built against the rear wall to enhance the stability of the rear wall for the full length of the barn. The piers currently stabilise the wall, but the proposed additional support would also improve the thermal characteristics of the barn.

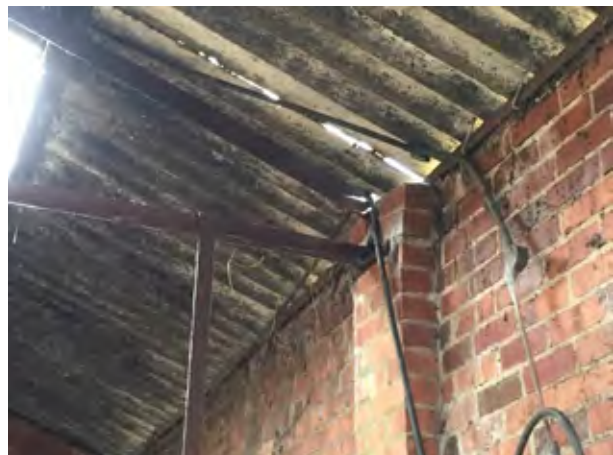
Trusses supported by brick piers. Brickwork lifted.

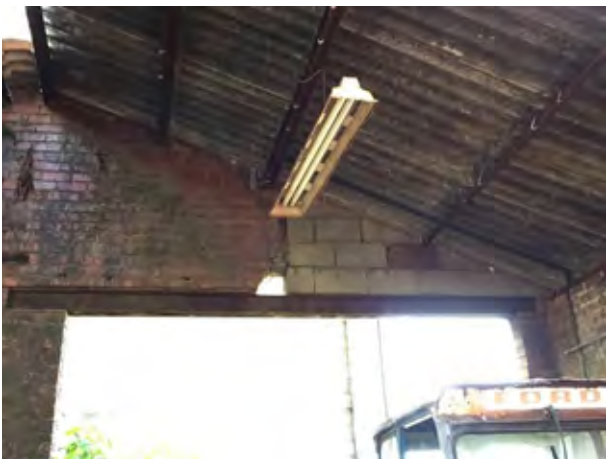
The gable wall / right hand side elevation had a large opening formed through the wall towards the front elevation. Steel beams had been used to support the masonry above the opening. The masonry above was part original brickwork and part newer blockwork used to increase the height of the adjacent, attached barn. The steelwork appeared to be corroding and a section of the masonry above was missing.

Steelwork installed to form large opening/

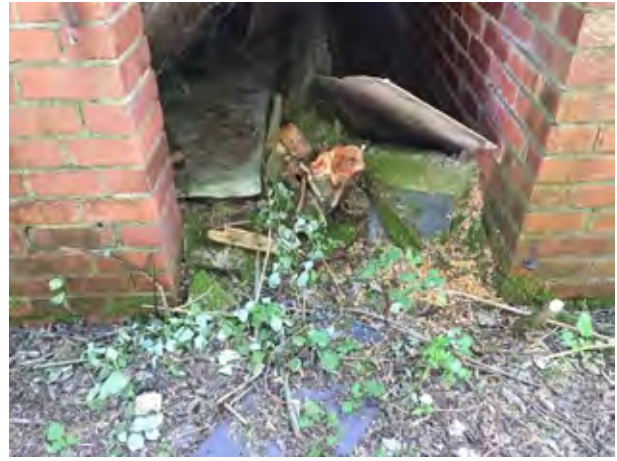
In some locations vegetation / shrubs were growing tight up to the face of the front elevation or within one of the doorways; however, there were no obvious signs of structural damage due to the location of the shrubs. The vegetation should be removed; this includes removal of the roots.

Tree growing within the doorway.

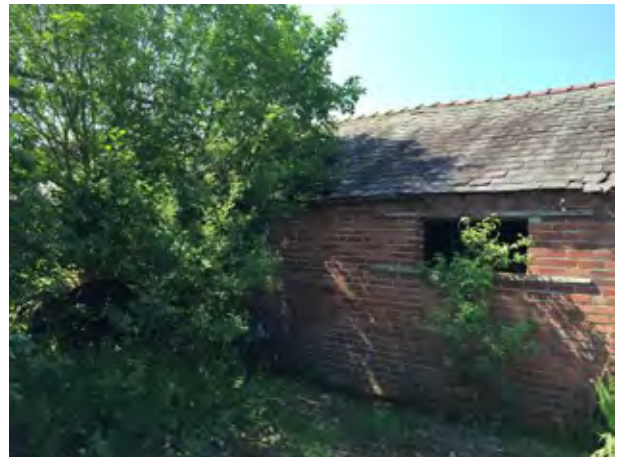
Also as noted on the front elevation, the roof ridge line and roof slopes were undulating. This is likely to be due to roof spread and / or inadequate or rotting timber roof members. The previously noted there are no ties across the roof and no ridge beam.

Undulating roof to rear elevation.

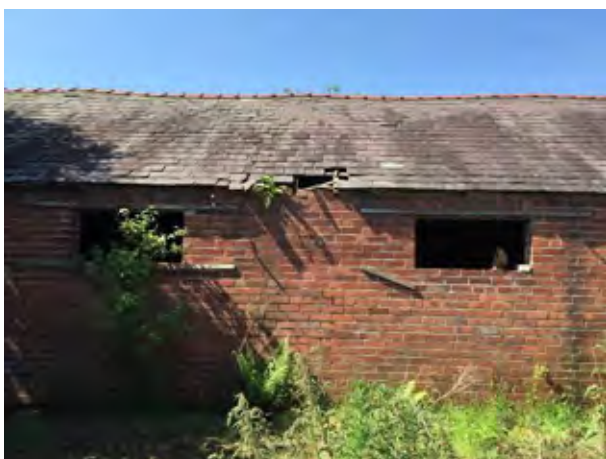
At least three location, holes were noted through the roof covering. The hole should be repaired as part of the scheme of repairs. Vegetation, also contributing to the defects noted to the roof, should also be removed.

Undulating roof. Holes through roof at eaves level.

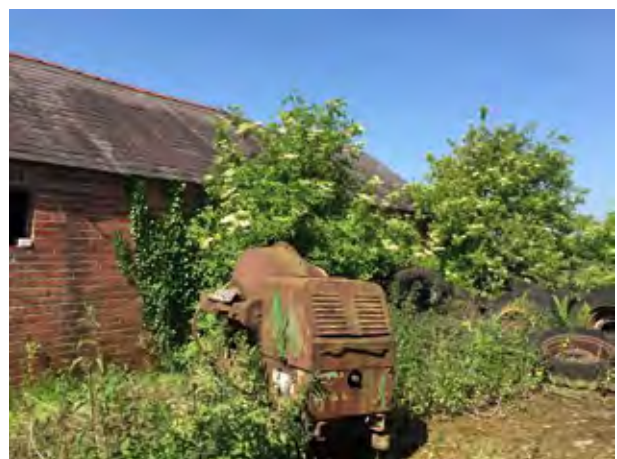
Vegetation masking the rear elevation.

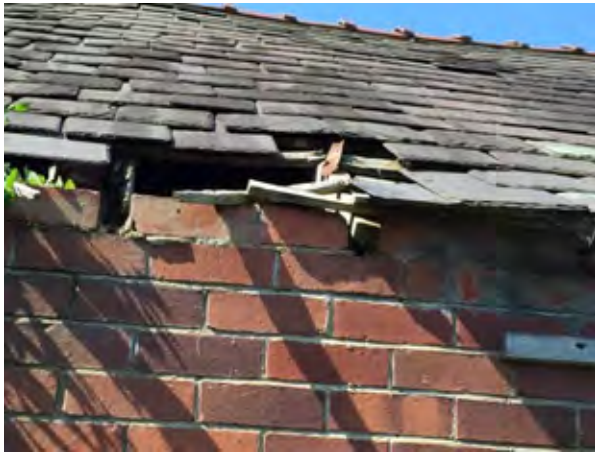
Holes through the roof at eaves level. Rafter ends rotting.

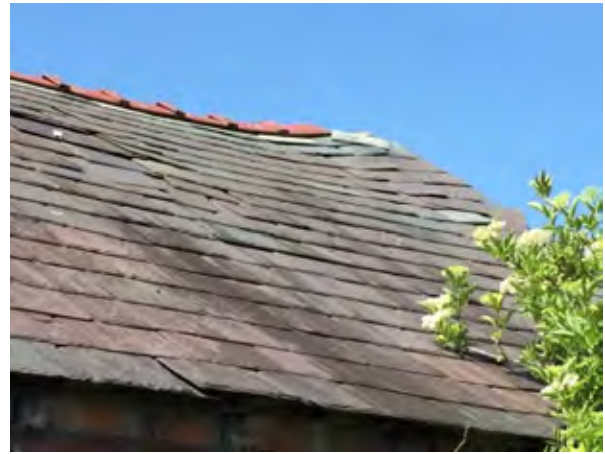
Undulating roof slopes noted.

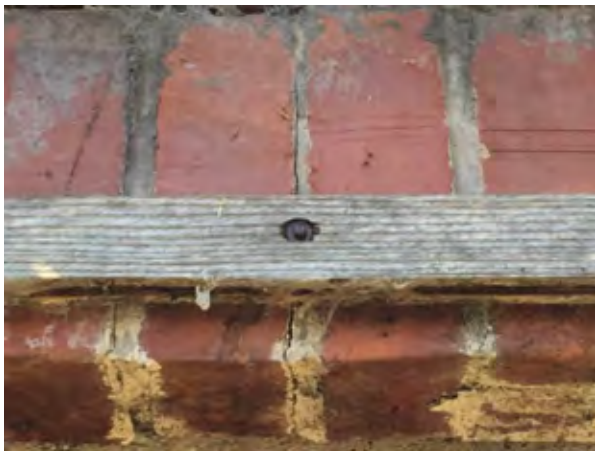
A fixing through the timber has caused the standing soldier lintel brickwork to crack.

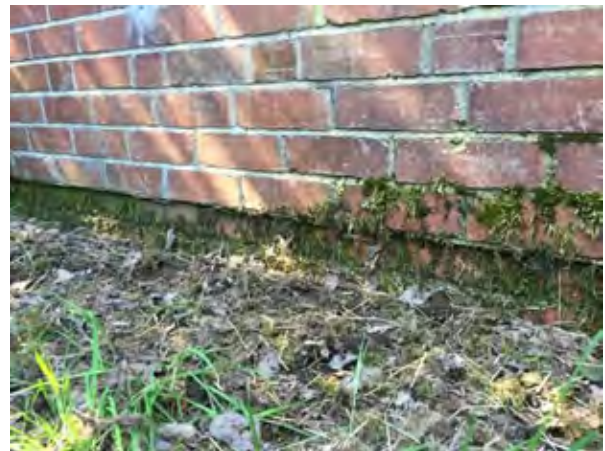
Moss growth was noted at low level. We assume a damp proof course will be installed. There is a possibility that damp has occurred to the elevation where the tires were stored. We could not check the wall as the tires formed an obstacle to that location.

Moss growth at low level indicating damp ingress. The brick elevation has moved outwards at low level.

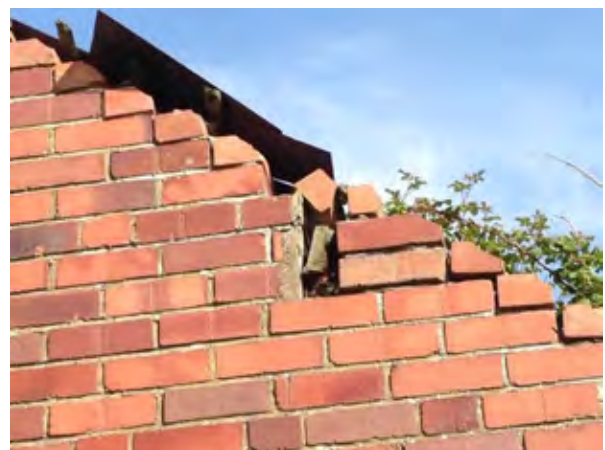
The timber purlin ends were visible. Towards the right hand side the purlin end had rotted and the verges had collapsed. The top two courses of brickwork appeared to be loose and should be re-set. Some timber replacement will be necessary and the roof repaired. The verges will require repointing.

Damage to brickwork and rotten roof timbers visible. Verge mortar missing.

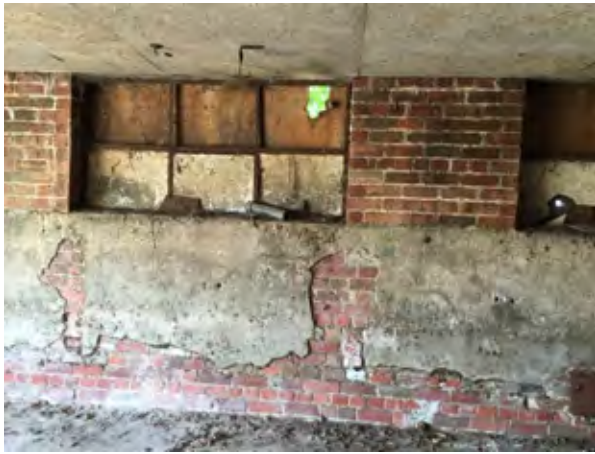
Steel window frames supporting elevations.  
Render dislodging.

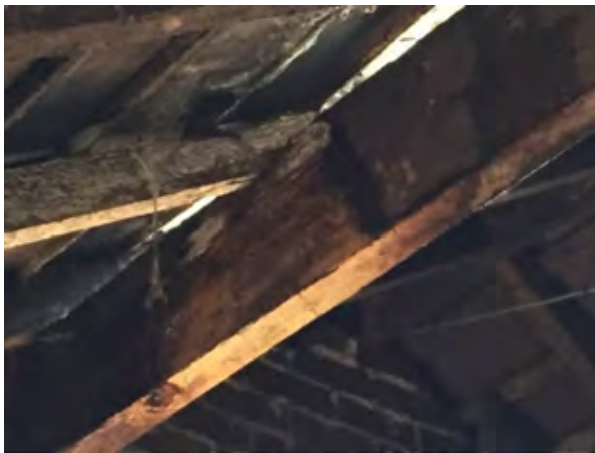
Water staining to timbers.

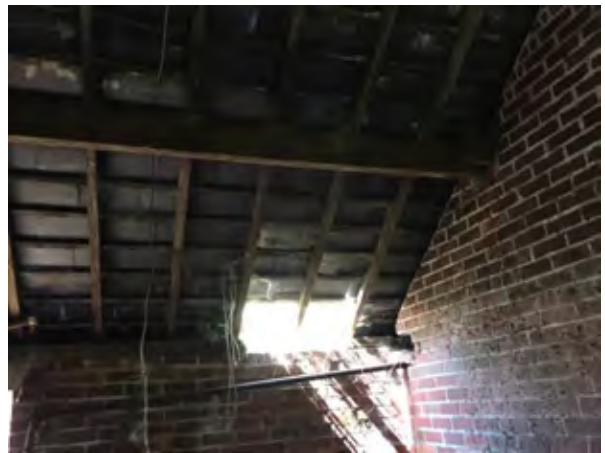
Holes through the roof.

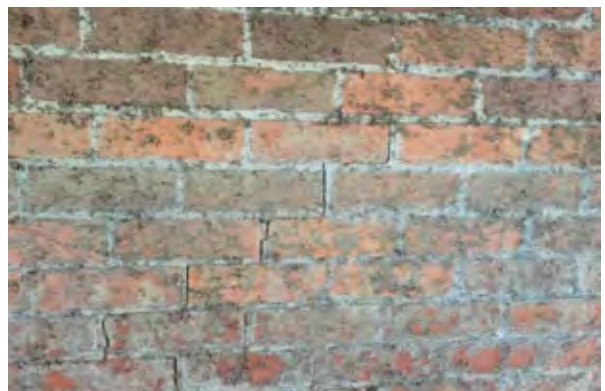
Cracking to cross wall.

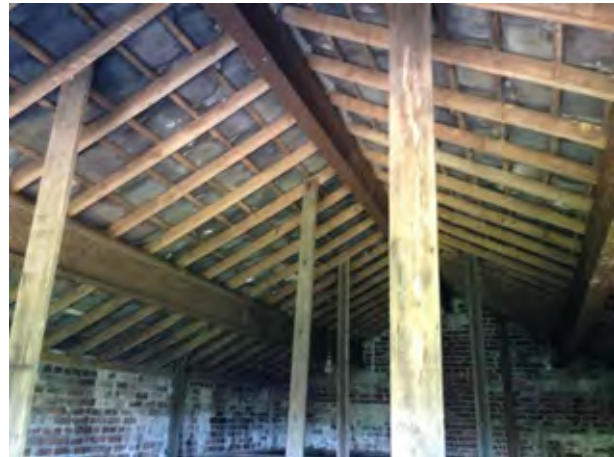
Steel ridge beams and purlins.

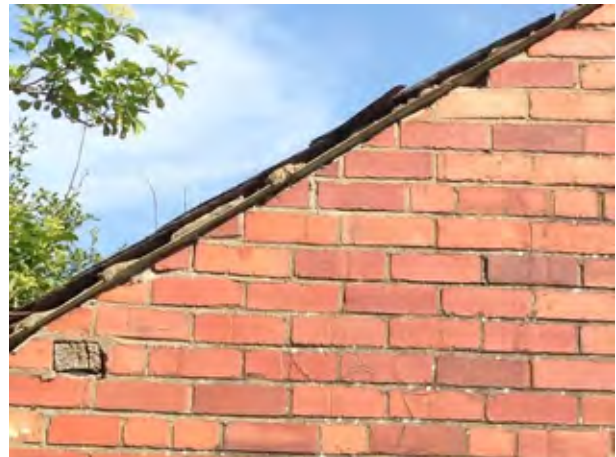
The mortar to the verges had dislodged and requires repointing.

Mortar dislodged from verges.

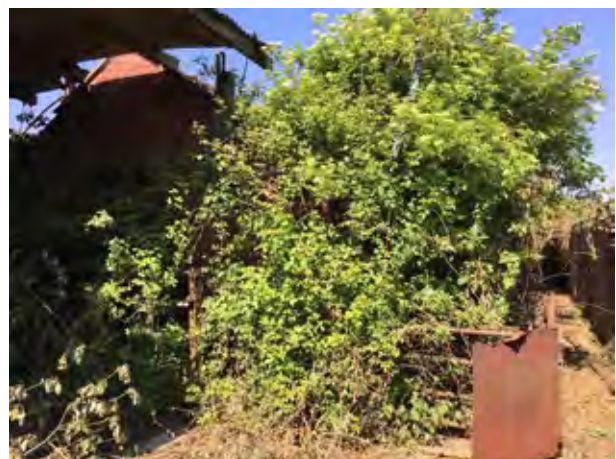
The majority of the elevation is hidden by vegetation which would mask any defects.

Majority of the elevation is hidden by vegetation.
