Our Ref: 01016/Rep 01  
Date: 10<sup>th</sup> July 2015

## **STRUCTURAL INSPECTION AND LETTER REPORT – GAMFORD FARM, ROSSETT**

We thank you for instructing Woodbank Consulting Engineers Ltd (Woodbank) to carry out a visual survey of the barns and main property at Gamford Farm, Rossett, which are to form part of a planning application.

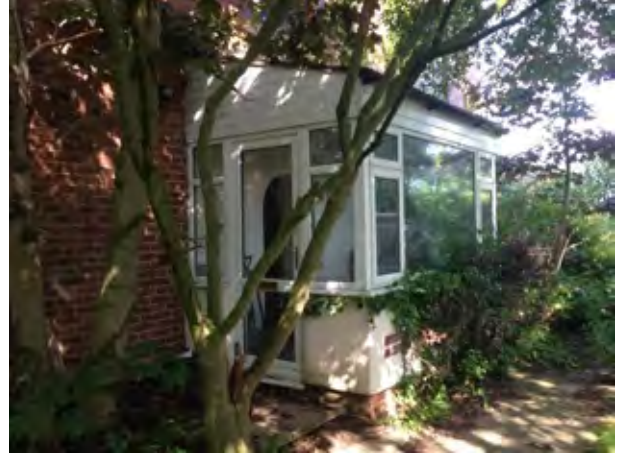
Porch structure. Trees close to front elevation.

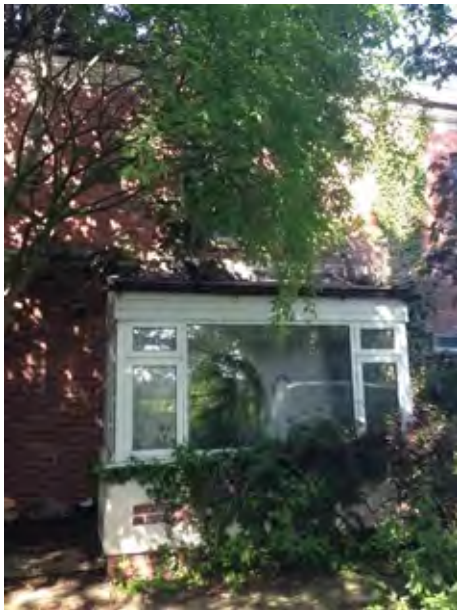
Porch structure partially covered by vegetation.

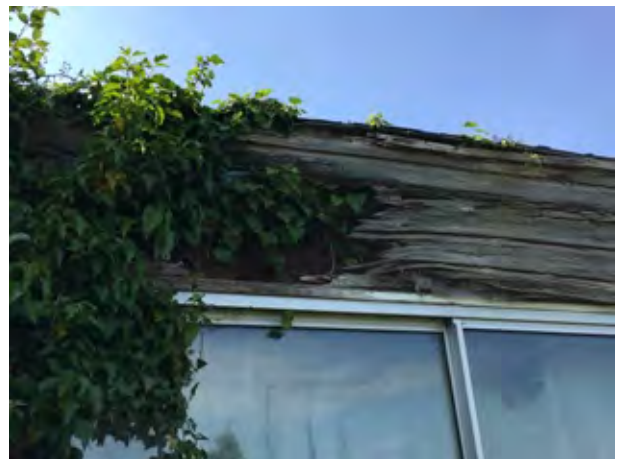
Rotting timber fascia to side extension.

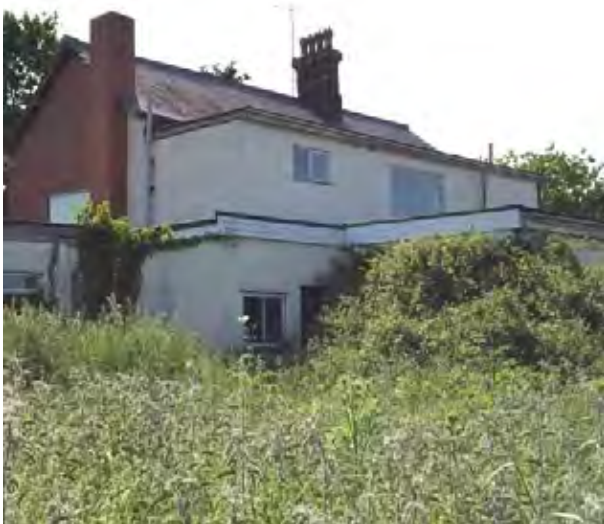
Rear elevation generally.

A small area of the rear of the original house was visible from the left hand side. This revealed that the condition of the masonry was generally satisfactory, but the roof edge was in poor condition. Slates and roof timbers were missing and rotten.

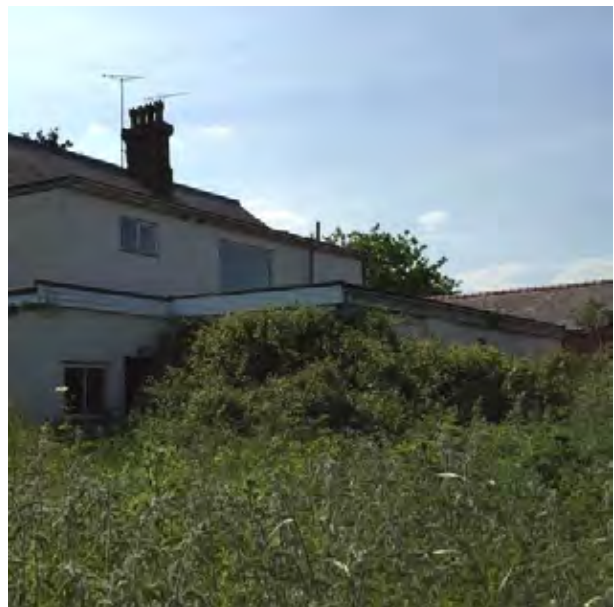
Rear elevation of rear extensions. Vegetation covering elevations.

Vegetation was growing in the rain water gutters and should be cleared.

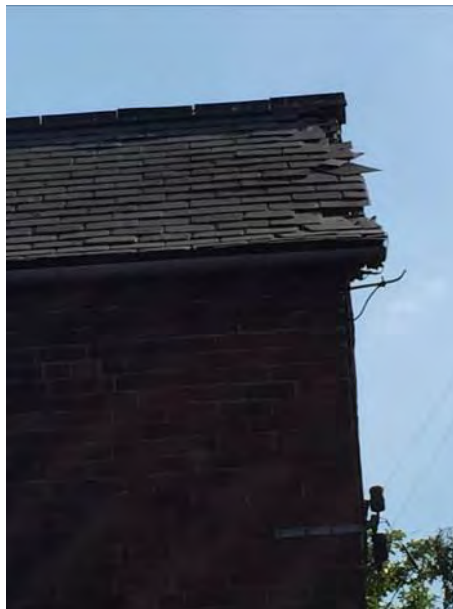
Condition of verge considered to be poor.

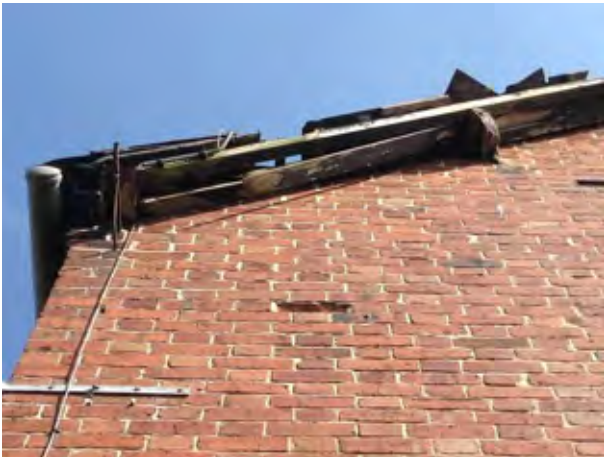
Timbers and fascia boards to eaves are rotten and the slates are missing or damaged.

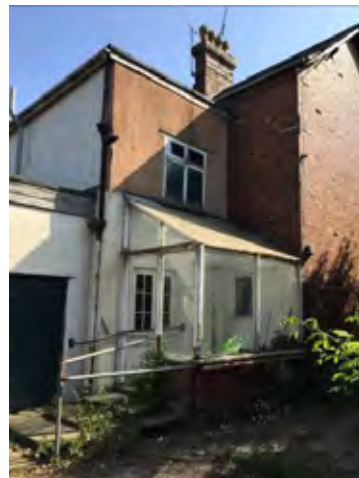
Rear porch on left hand side elevation.

A brick and timber framed porch had been constructed at ground floor level adjacent to the elevation. The majority of the timbers were severely rotten with some frames rotten through the full cross section of the timber. Some of the bricks had spalled due to freeze thaw action. The porch should re-built as a repairs is unlikely to be cost effective.

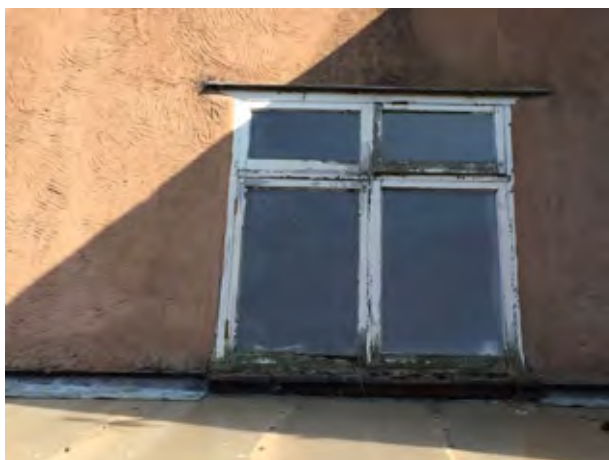
First floor timber window frame rotting.

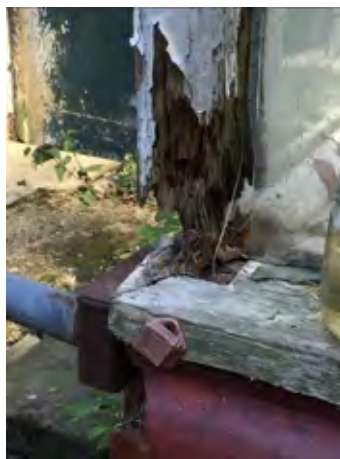
Rotting timber fascia to side extension.
