**Report No.:** SW3087

**Nature of Work:** Refurbishment Survey

7-9 Grosvenor Road  
Wrexham  
LL11 1BU

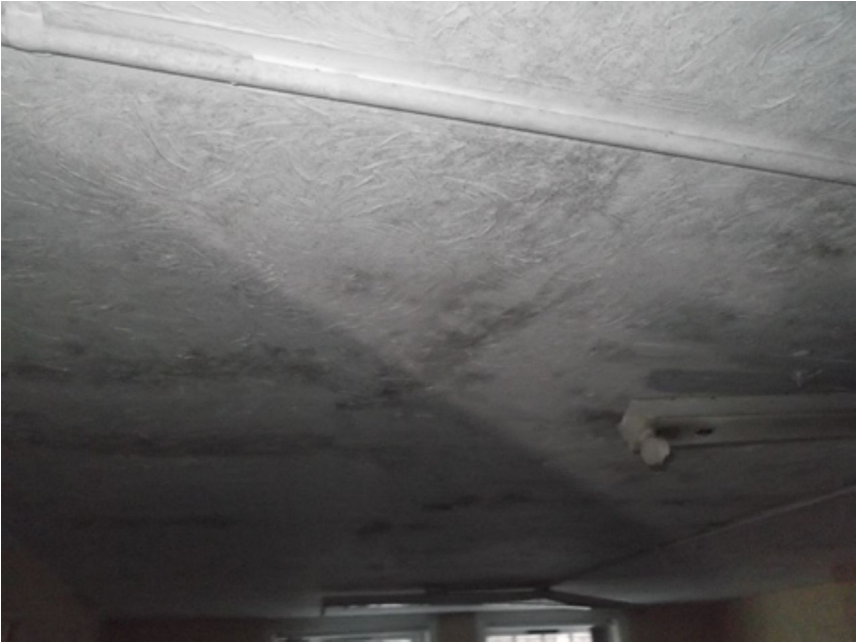
| Item Number: | 04 | Sample Number: | 411/112 | |

| Item: | Textured coating to ceiling | | | |
| Asbestos Content: | No asbestos detected Identified | | | |

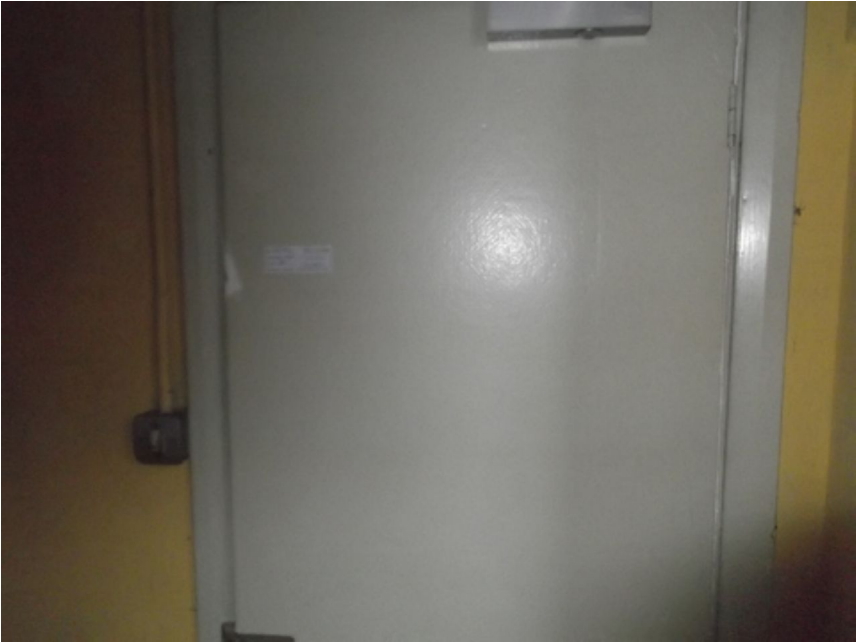
| Item Number: | 07 | Sample Number: | 411/115 | | |

| Item: | Insulating board door panel | | | | |
| Asbestos Content: | No asbestos detected Identified | | | | |

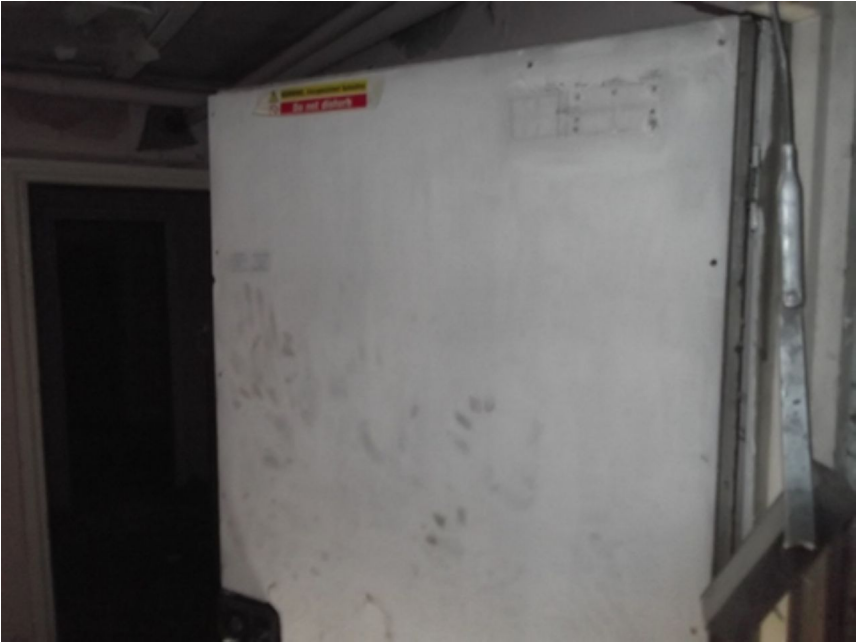
| Item Number: | 08 | Sample Number: | 411/116 | |

| Item: | Insulating board door panel | | | |
| Asbestos Content: | No asbestos detected Identified | | | |
| Comments: | Item can be found to the rear of the door. The door closer is on the floor and the item can be found on the screws still connected. | | | |

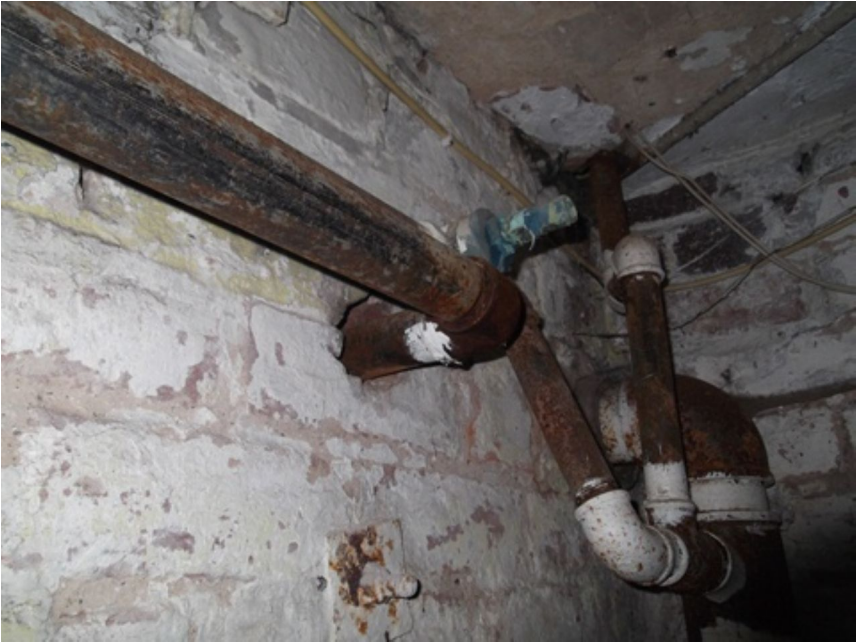
| Item Number: | 10 | Sample Number: | 411/118 | |

| Item: | Textile joint sealant | | | |
| Asbestos Content: | No asbestos detected Identified | | | |
| Comments: | Item can be found on joints which appear to have been encapsulated. | | | |

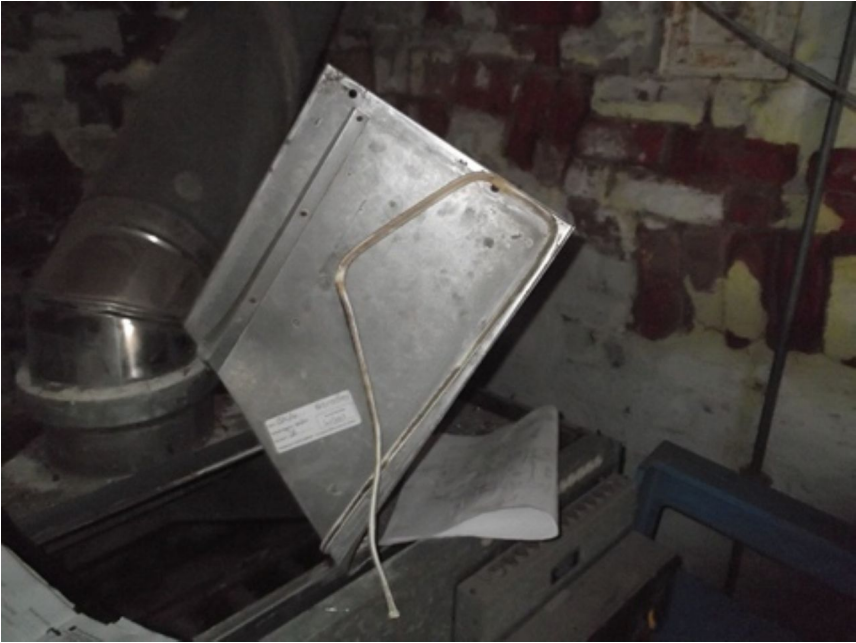
| Item Number: | 11 | Sample Number: | 411/119 | | |

| Item: | Textile rope seal | | | | |
| Asbestos Content: | No asbestos detected Identified | | | | |

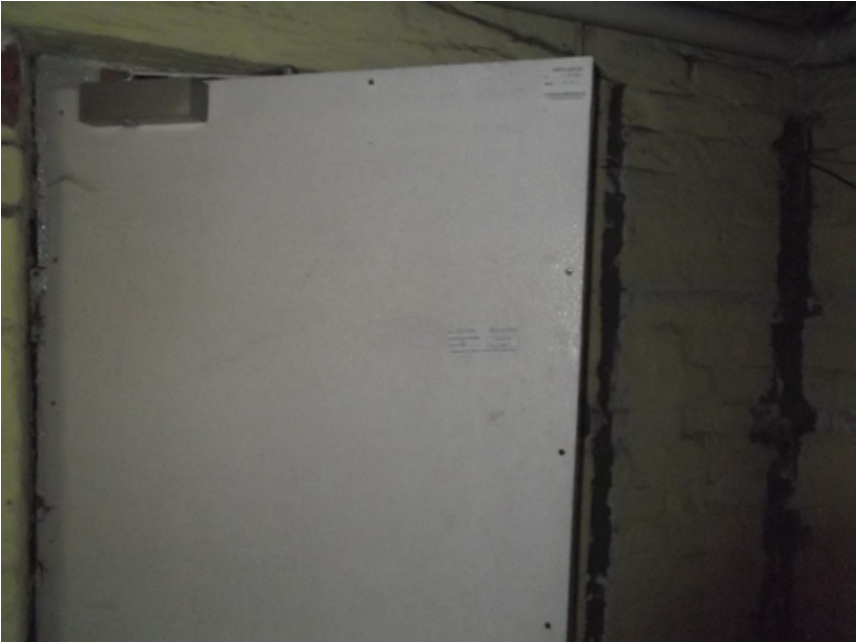
| Item Number: | 12 | Sample Number: | 411/120 | |

| Item: | Insulating board door panel | | | |
| Asbestos Content: | No asbestos detected Identified | | | |

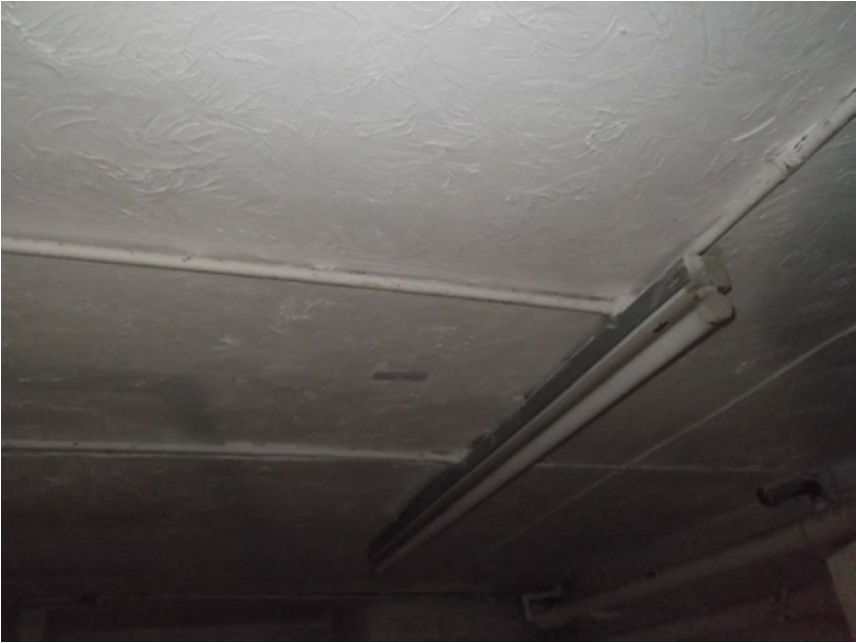
| Item Number: | 14 | Sample Number: | 411/122 | |

| Item: | Textured coating to ceiling | | | |
| Asbestos Content: | No asbestos detected Identified | | | |

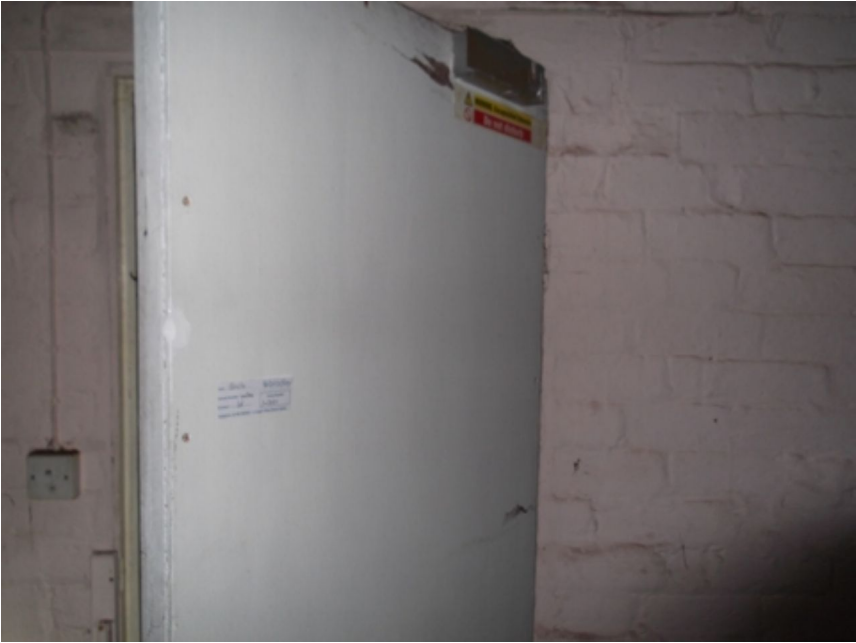
| Item Number: | 16 | Sample Number: | 411/124 | |

| Item: | Insulating board door panel | | | |
| Asbestos Content: | No asbestos detected Identified | | | |

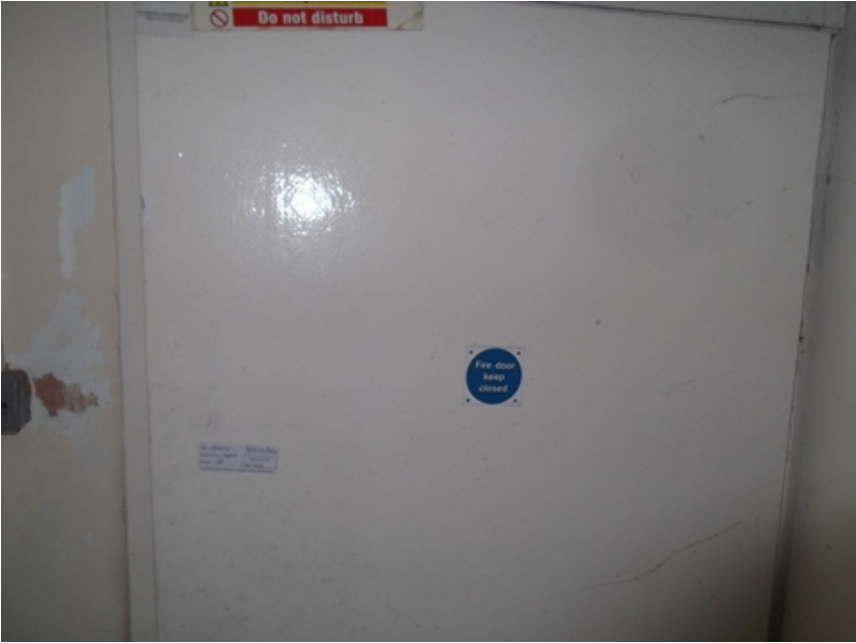
| Item Number: | 17 | Sample Number: | 411/125 | |

| Item: | Insulating board door panel | | | |
| Asbestos Content: | No asbestos detected Identified | | | |

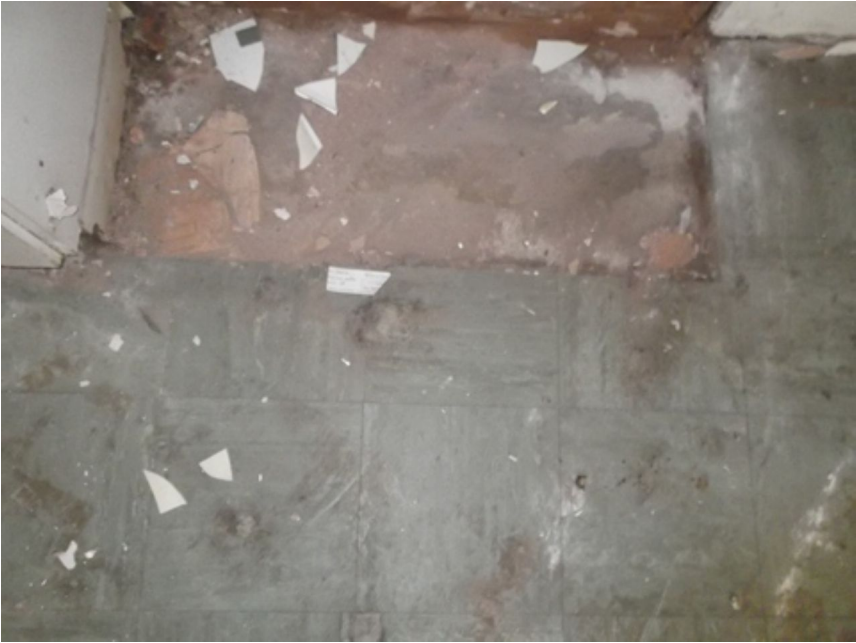
| Item Number: | 18 | Sample Number: | 411/126 | |

| Item: | Thermoplastic floor tiles | | | |
| Asbestos Content: | No asbestos detected Identified | | | |

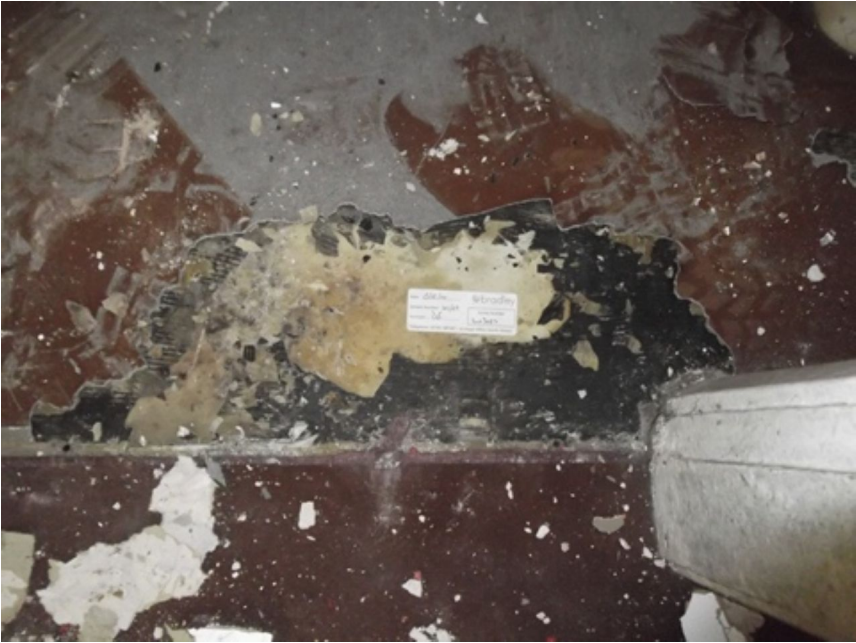
| Item Number: | 19 | Sample Number: | 411/127 | |

| Item: | Bitumen resin / adhesive | | | |
| Asbestos Content: | No asbestos detected Identified | | | |
| Comments: | Item can be found under modern vinyl. | | | |

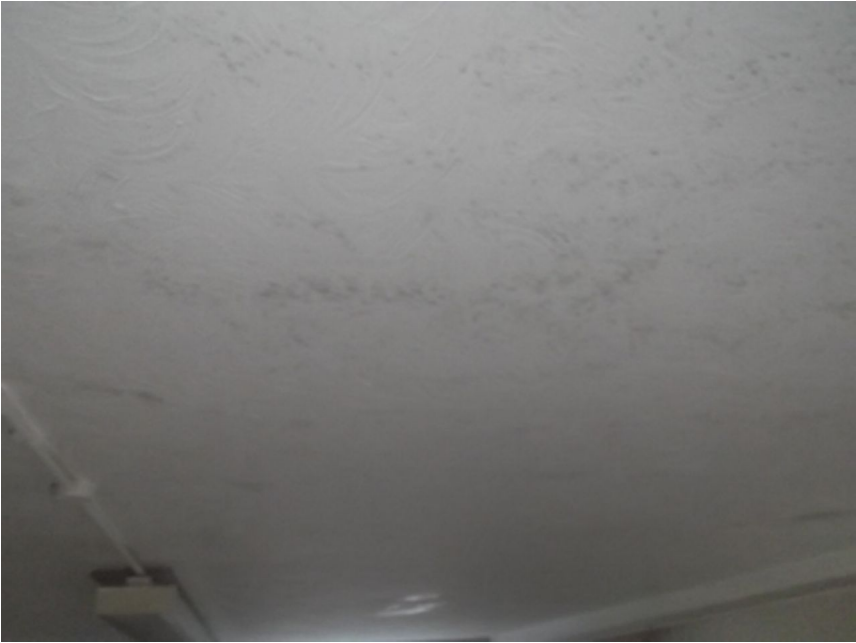
| Item Number: | 20 | Sample Number: | 411/128 | | |

| Item: | Textured coating to ceiling | | | | |
| Asbestos Content: | No asbestos detected Identified | | | | |

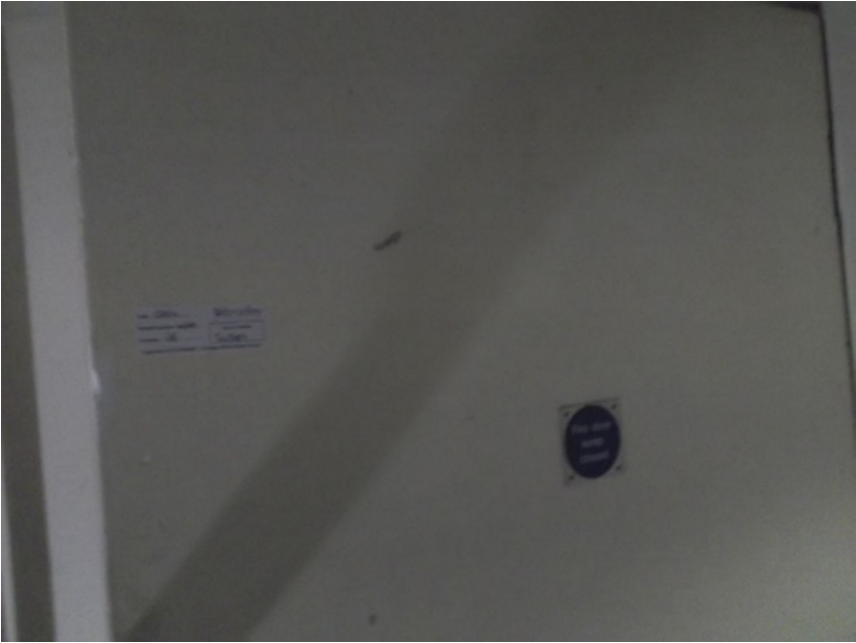
| Item Number: | 21 | Sample Number: | 411/129 | |

| Item: | Insulating board door panel | | | |
| Asbestos Content: | No asbestos detected Identified | | | |

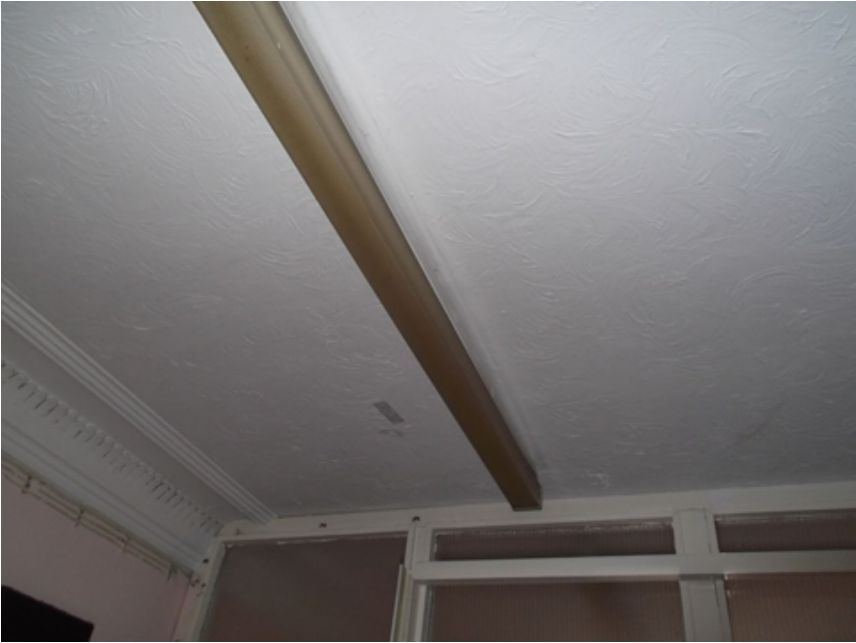
| Item Number: | 31 | Sample Number: | 411/138 | |

| Item: | Textured coating to ceiling | | | |
| Asbestos Content: | No asbestos detected Identified | | | |

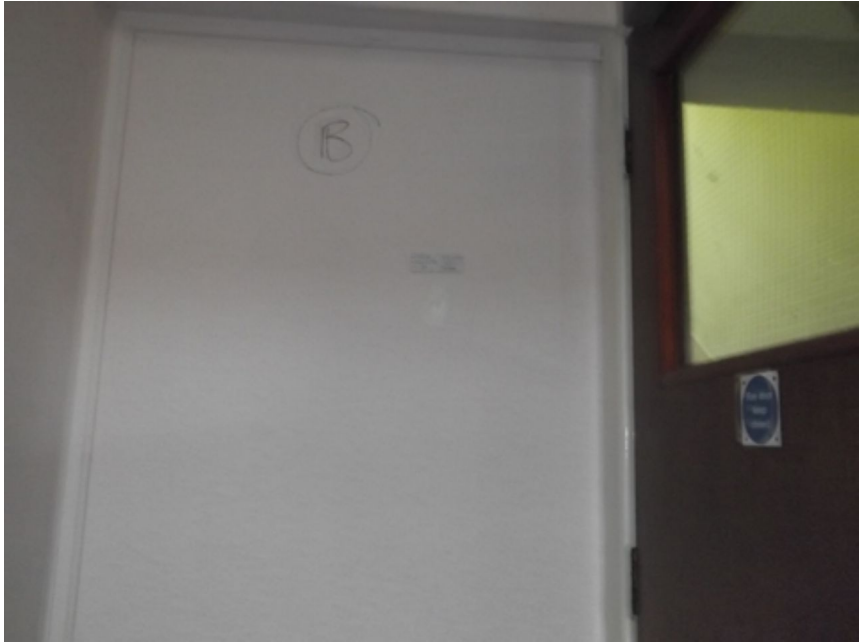
| Item Number: | 39 | Sample Number: | 411/145 | | |

| Item: | Insulating board to wall | | | | |
| Asbestos Content: | No asbestos detected Identified | | | | |

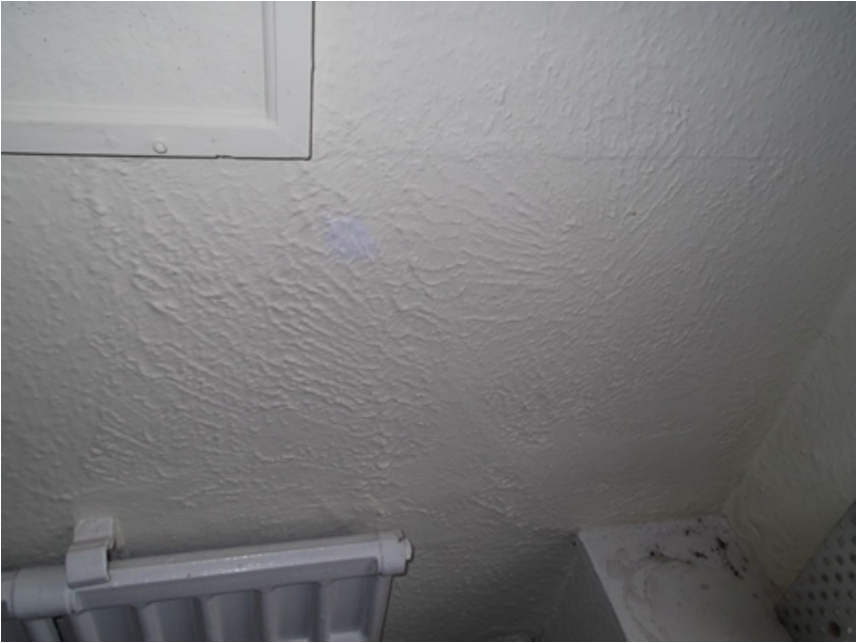
| Item Number: | 42 | Sample Number: | 411/148 | | |

| Item: | Textured coating to walls | | | | |
| Asbestos Content: | No asbestos detected Identified | | | | |

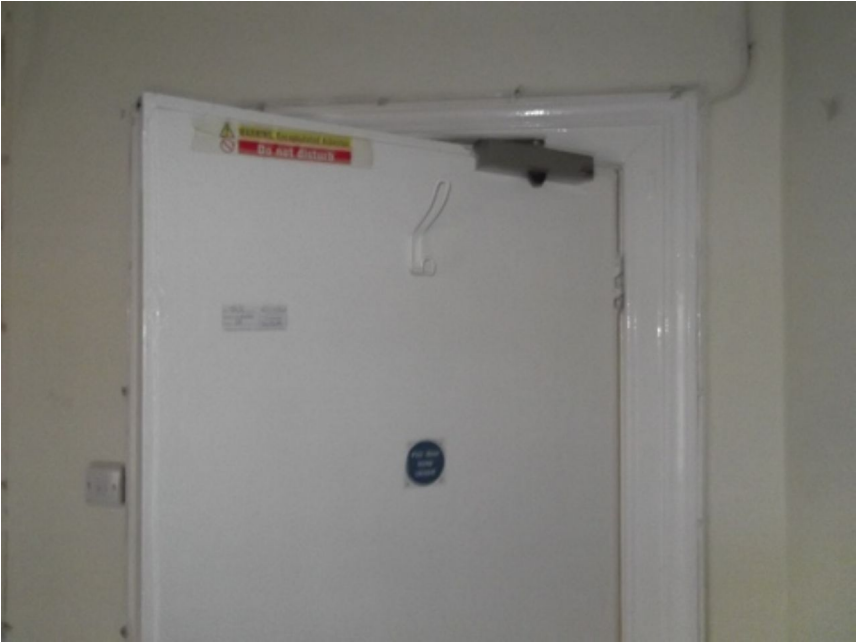
| Item Number: | 45 | Sample Number: | 411/150 | |

| Item: | Insulating board panel | | | |
| Asbestos Content: | No asbestos detected Identified | | | |

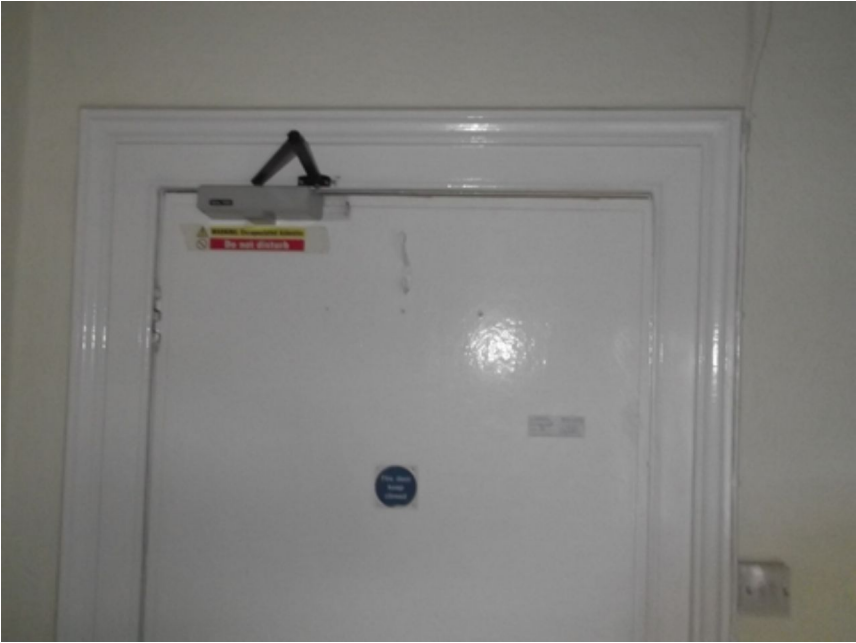
| Item Number: | 47 | Sample Number: | 411/151 | |

| Item: | Insulating board panel | | | |
| Asbestos Content: | No asbestos detected Identified | | | |

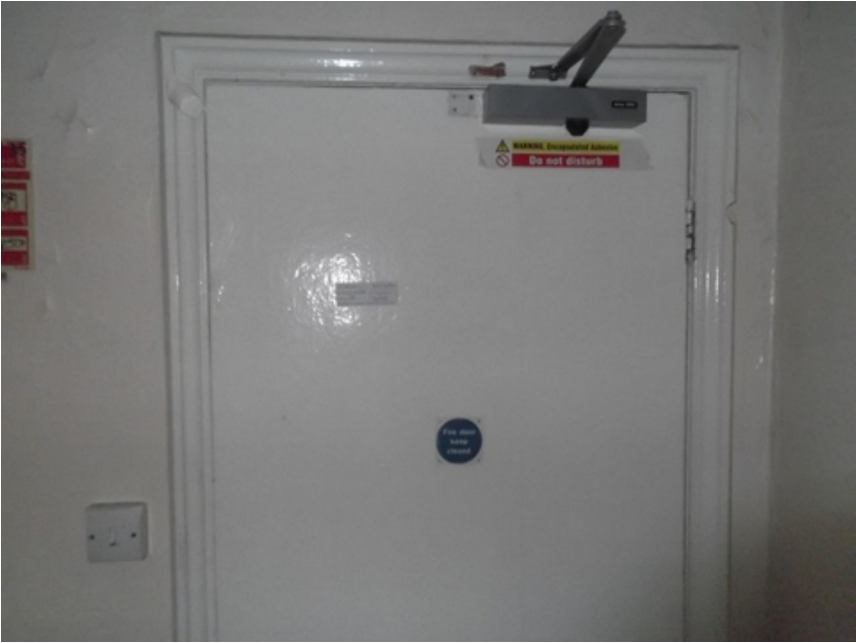
| Item Number: | 49 | Sample Number: | 411/152 | |

| Item: | Insulating board panel | | | |
| Asbestos Content: | No asbestos detected Identified | | | |

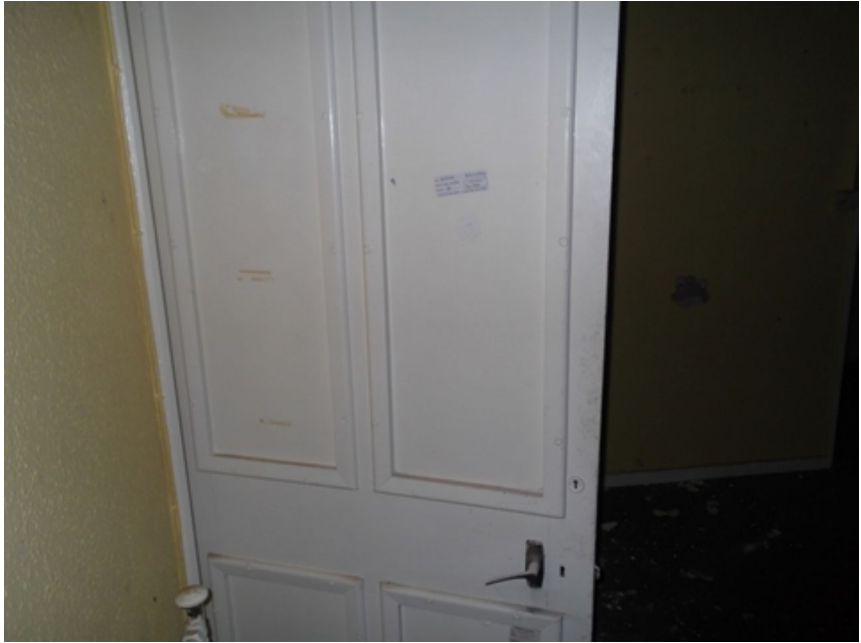
| Item Number: | 53 | Sample Number: | 411/154 | |

| Item: | Insulating board panels | | | |
| Asbestos Content: | No asbestos detected Identified | | | |
