# Conversion of Outbuilding at Moss Bank Farm, Borras Head, Wrexham

## Structural Appraisal Report

February 2020

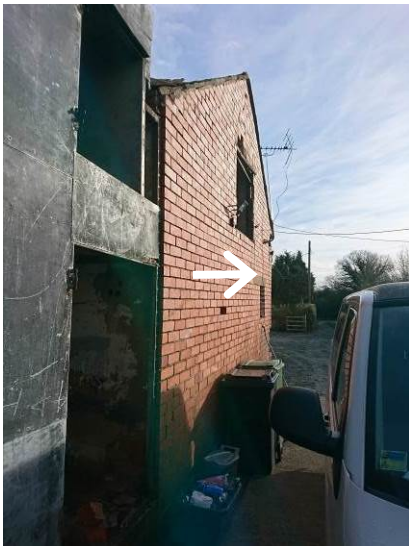
No significant cracking was apparent to the elevation. Missing brickwork was apparent at low and high levels on the two storey gable adjacent to the front elevation (see Photo 9). A small area of missing brickwork was also apparent above the window opening with several loose units noted locally. This is probably as a result of distortion to the timber lintel and is reflected internally. The lintel to room five has been dislodged along with the brickwork above. A small area of brickwork at low level adjacent to the door opening has been

Photos 9 – Missing brickwork at low level.

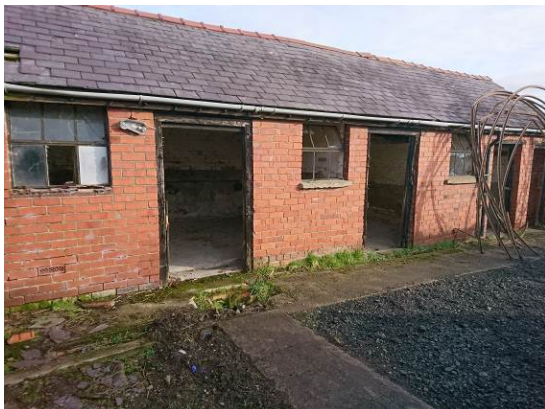
The elevation comprises brickwork to full height with several window and door openings apparent (see Photo 10). The roof over is finished with slates. A series of brick buttresses are provided along the single storey elevation. The lower part of the two storey section has a render finish with the upper part obscured by a steel framed building.

No significant cracking was apparent to the elevation. An area of loose brickwork was apparent at eaves level at the left hand end due to vegetation growth. The timber lintel to the adjacent window opening is severely rotted at one end due to vegetation growth and water penetration. A significant outwards lean was apparent in the centre of the elevation within the upper reaches of the elevation. This has resulted from roof spread and appeared to be a fairly longstanding defect. Debonded render finishes were apparent at the intersection of the single and two storey sections. Severe staining to the elevation is also apparent locally which has resulted from missing guttering and drainage. Vegetation and severely eroded pointing were apparent to the buttresses (see Photo 11). This is due to water cascading over the brickwork from the roof over. Eroded brick units were also apparent to the buttress closest to the two storey section. It is apparent that the buttresses are later additions to try to stabilise the external wall. This would appear to have been partially successful. Eroded brick units were apparent at low level throughout and to several of the buttresses. Erosion of pointing up to 10mm depth is apparent throughout with areas up to 50mm depth apparent in the buttresses. The remainder of the pointing was noted as hard. The lintels to all of the openings have suffered deterioration and should be replaced.

Photo 10 – Rear Elevation.

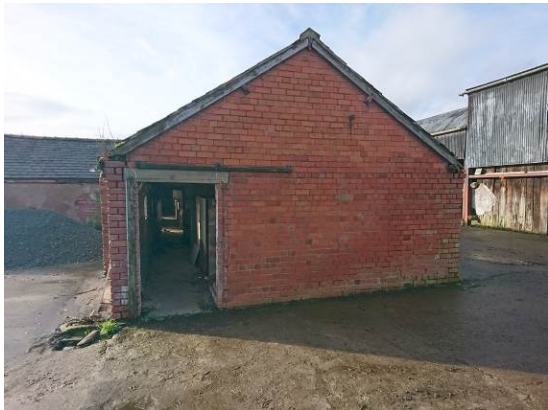
The elevation comprises brickwork to full height with several window and door openings apparent (see Photos 12 and 13). The elevation to the short leg has render finishes over the majority of the area. The roof over the short leg is finished with slates.

No significant cracking was apparent to the elevation. The render finishes are cracked and have debonded from the elevation exposing areas of the brickwork below. A significant inwards bulge was apparent below the window opening to room five and to the rear of room four (see Photo 14). The exact cause the defect is not readily apparent, however localised reconstruction will be required. Loose and distorted brickwork is apparent at the intersection with the main leg. This would appear to have resulted from slight settlement and a complete loss of pointing to bed joints. Loose brickwork is apparent above the opening into room one resulting from vegetation growth from the wall plate. Eroded brick units were apparent at low level throughout and to an area at the right hand end of the elevation. Erosion of pointing up to 10mm depth is apparent throughout with areas up to 25mm depth apparent in isolated areas. The remainder of the pointing was noted as hard. The lintels to all of the openings have suffered deterioration and should be replaced. The fascia at the left hand end of the elevation is charred which is indicative of fire damage (see Photo 15). Some charring is also apparent to the lintel and rafters locally, however no structural damage is apparent.

Photo 12 – Right Hand Side Elevation – short leg.

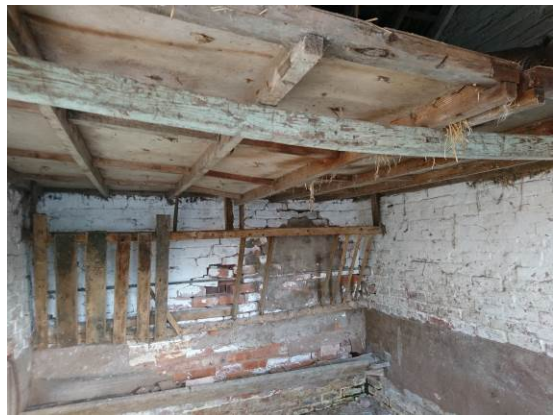
The mezzanine floor over has been constructed from small timbers which are widely spaced. The joists supporting the floor show significant distortions due to long term creep in over-loaded timbers (see Photo 22).

Photo 22 – General view of mezzanine timbers
