# CPAT Report No. 1771

## 4-6 Regent Street, Wrexham

### Building Survey

Client name: I Harding  
 CPAT Project No: 2508  
 Project Name: 4-6 Regent Street, Wrexham  
 Grid Reference: SJ 3340 5037  
 County/LPA: Wrexham  
 Planning Application: P/2020/0672  
 CPAT Report No: 1771  
 HER Enquiry No: N/A  
 Event PRN: 140355  
 Report status: Final

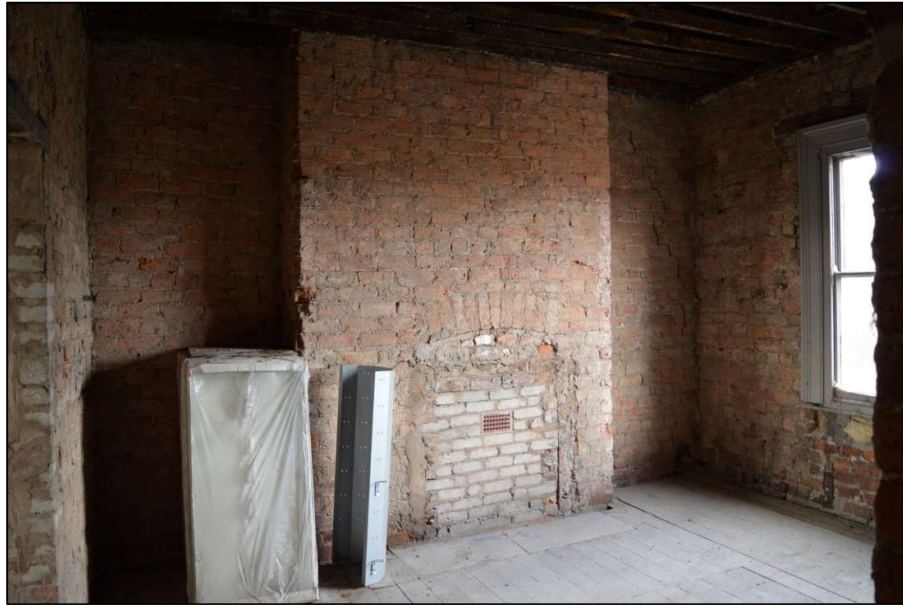
*Fig 4: Blocked fireplace with hearth stones in Room 1 on second floor (CPAT 4853-0003)*

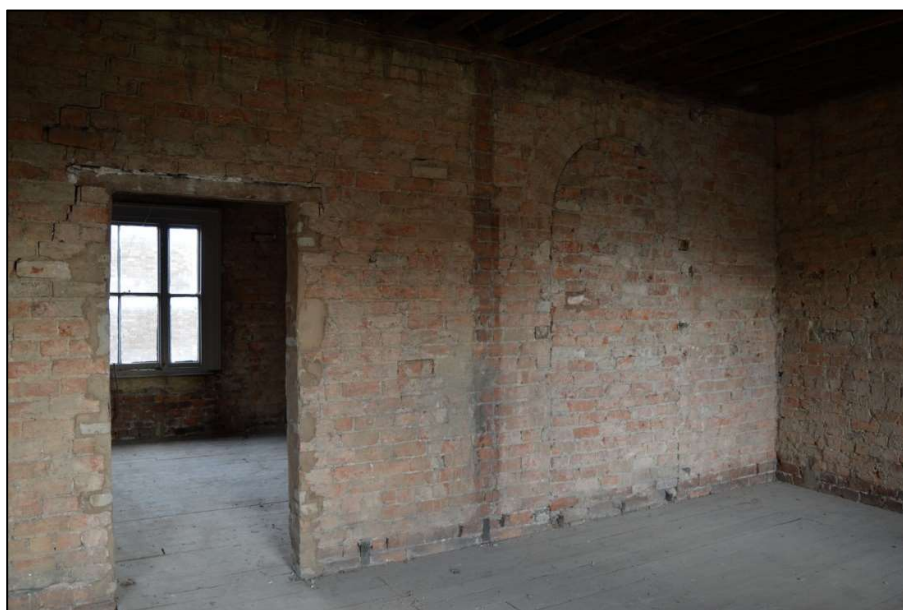
*Fig 9: Blocked arched doorway and ?later doorway in Room 2 on second floor (CPAT 4853-0008)*

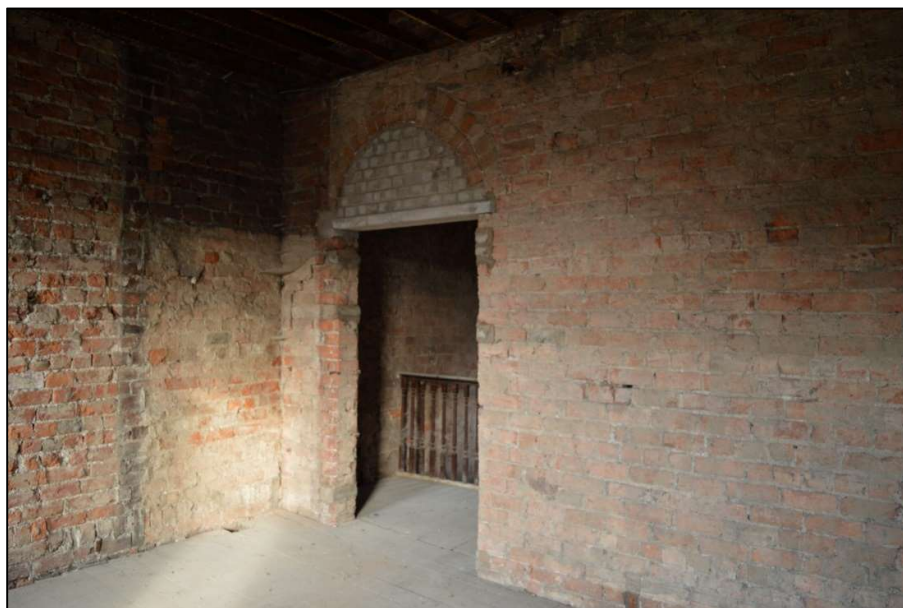
*Fig 13: Partly blocked arched doorway in Room 3 on second floor (CPAT 4853-0012)*

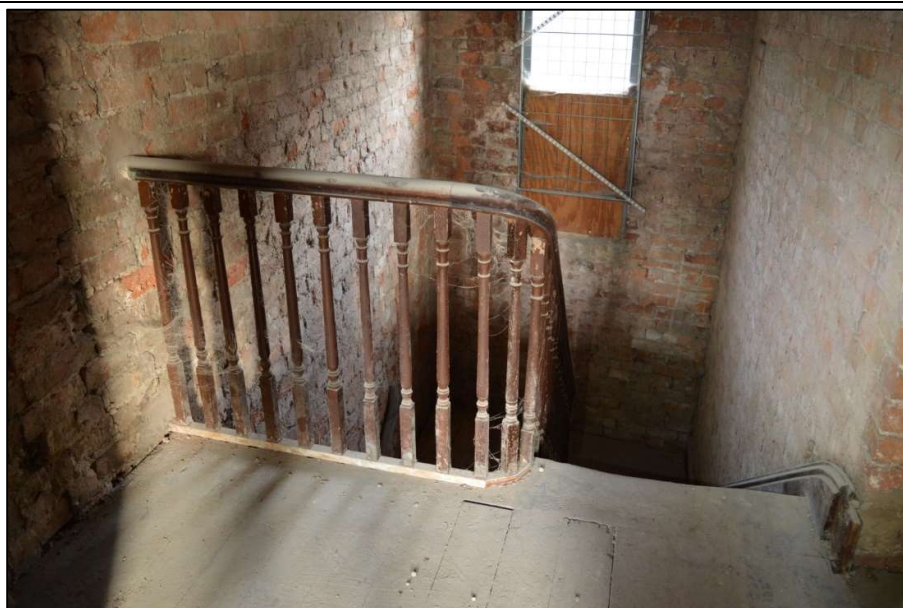
- 3.3. An internal east/west wall divided the building into front and rear halves and a brick stack in each half carried the chimneys from ground floor level, also serving to define the separation of both the front and rear halves into two unequal-sized rooms. A stair was provided at the north-west (Fig 16) and north-east corners, though the former is of a different design and its defining wall is not very well tied into the north wall of the building (Fig 20) which suggests it was either an afterthought or a later insertion. The north-east stair (Figs 36, 57) is clearly original and has a spiral appearance with landings supported by brick arches (Fig 67) that would have allowed more light into the building.

*Fig 16: Top of western stair on second floor (CPAT 4853-0015)*

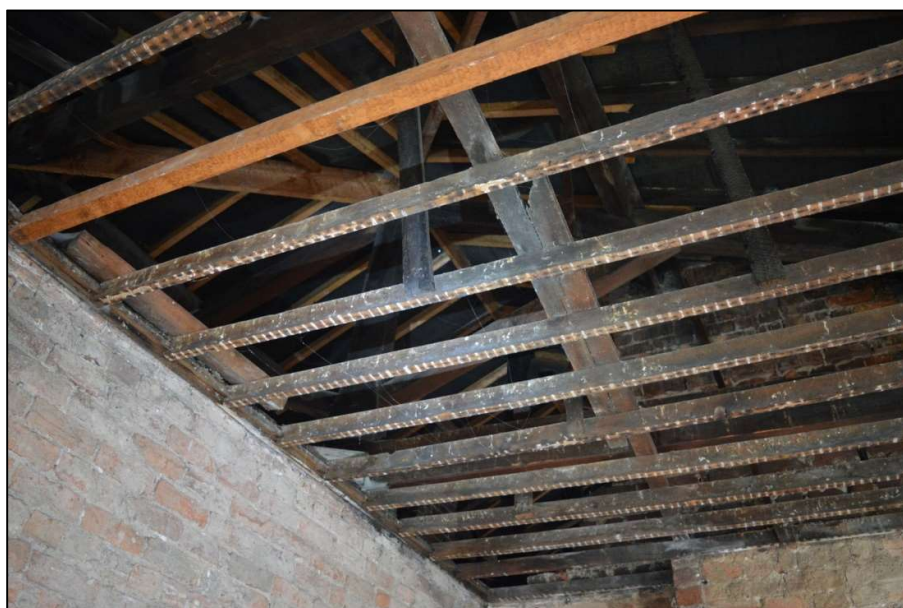
- 3.13. The roof space could not be accessed at the time of the visit, but owing to the removal of the ceiling material the roof structure could be observed through the joists (Figs 17-19, 70, 71). The roof had a hipped design with its long axis running approximately east/west and was supported on four timber roof trusses each aligned north/south and linked by purlins.

*Fig 17: Ceiling timbers with Truss 4 behind in roof space (CPAT 4853-0016)*

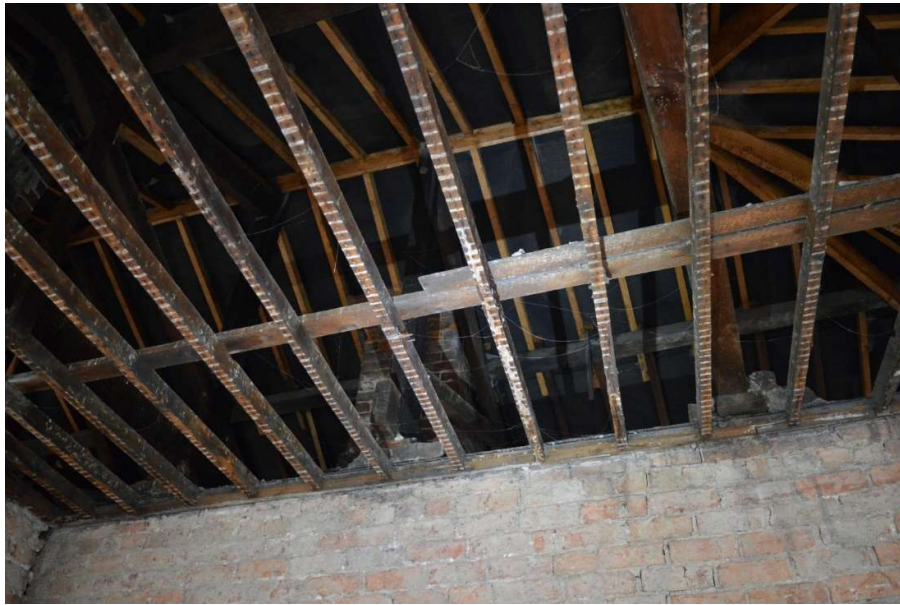
*Fig 18: Ceiling timbers with Trusses 1-3 behind in roof space (CPAT 4853-0017)*

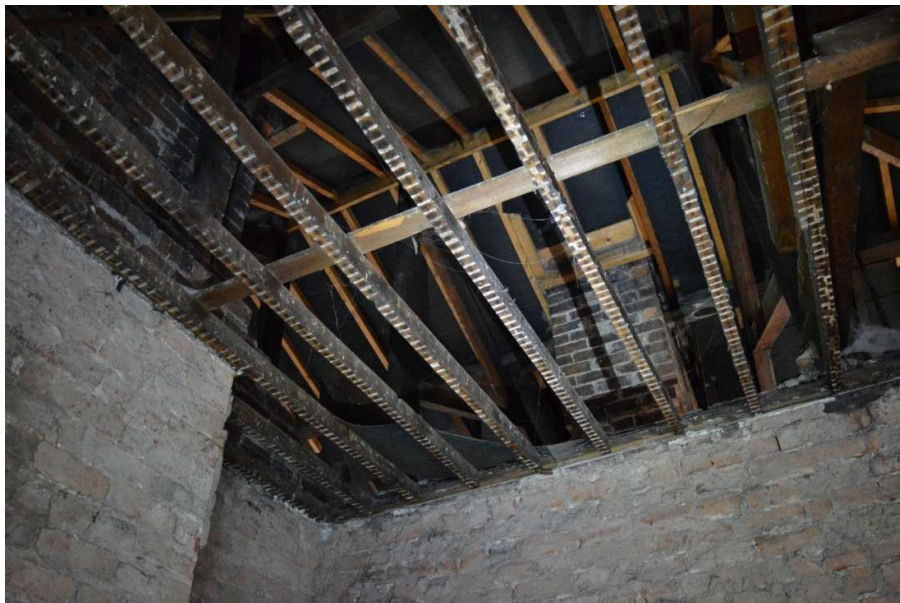
*Fig 19: Ceiling timbers with Trusses 3 and 4 behind in roof space (CPAT 4853-0018)*

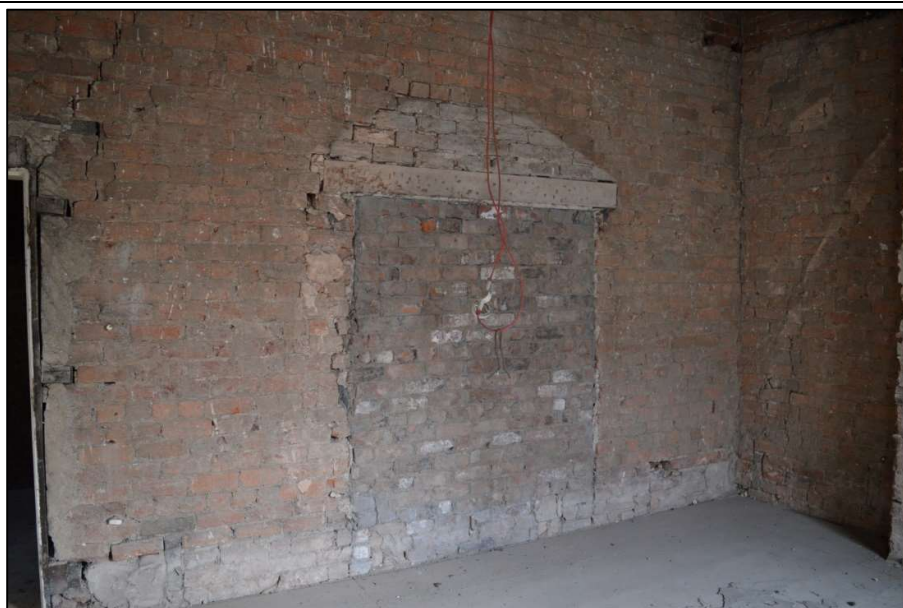
- 3.9. Room 6 was unusual in that its east wall had a marked curve (Fig 40), which suggested a special function but could not be explained by the surviving structure. Originally, rooms 5 and 6 and rooms 7 and 8 were linked but the respective doorways (Figs 34 and 26, respectively) had been blocked, probably at different times in the building's history. This implies that the original layout had been redesigned on a number of occasions. It seems likely, therefore, that some of the other doorways were later insertions but it was not possible to confirm this suspicion.

*Fig 26: Blocked doorway in Room 7 on first floor. (CPAT 4853-0025)*

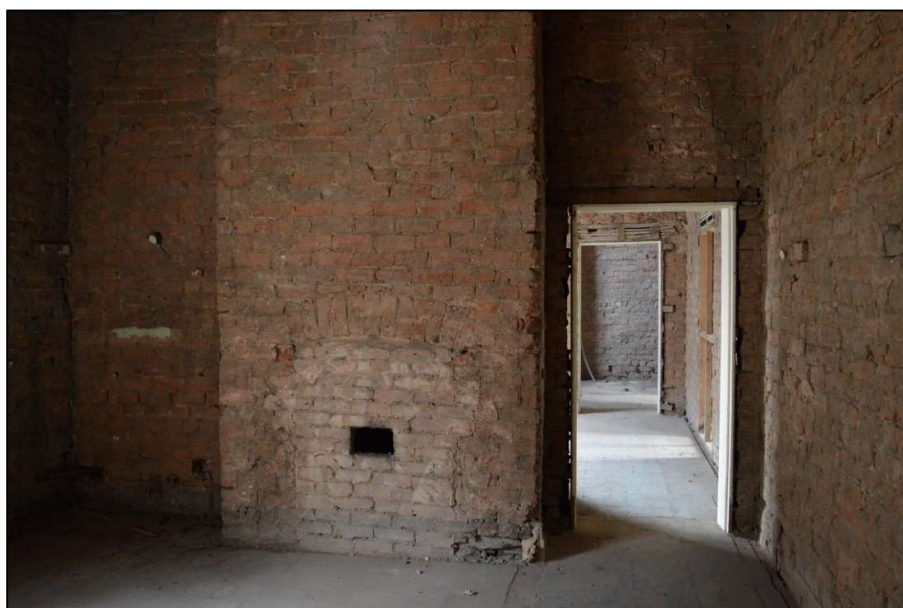
- 3.8. The rooms to the rear (5 and 8) and the east and west stairs were linked by a series of doorways, effectively forming a corridor between the two stairs (Fig 27). The two front rooms (6 and 7) were not linked and access was only from the east and west stairs, respectively. There were four fireplaces at this level, one to each room, though all had been blocked in relatively recent times.

*Fig 27: Blocked fireplace in Room 8 on first floor and route to east stair (CPAT 4853-0026)*

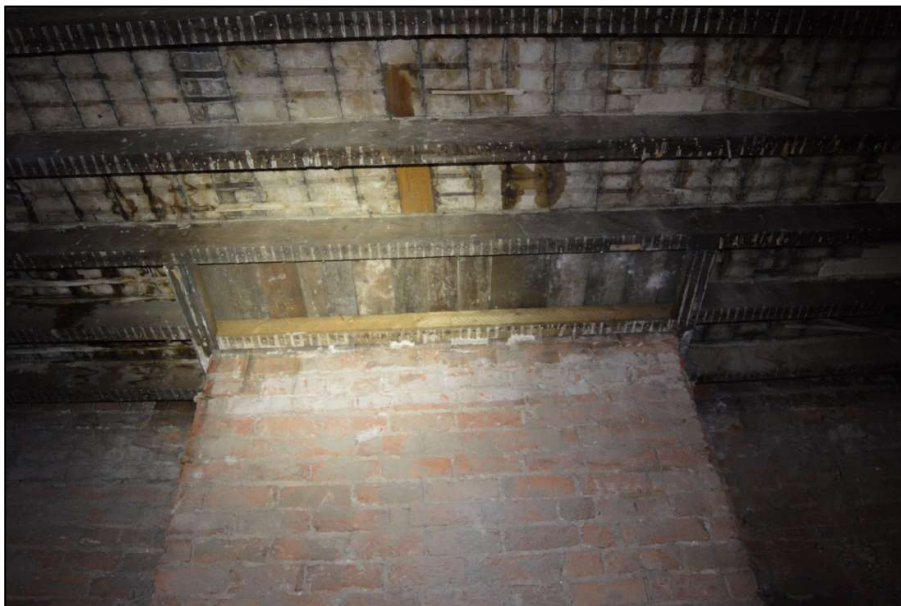
*Fig 31: Top of chimney breast in Room 8 on first floor showing supporting timber for the hearth stone  
(CPAT 4853-0030)*

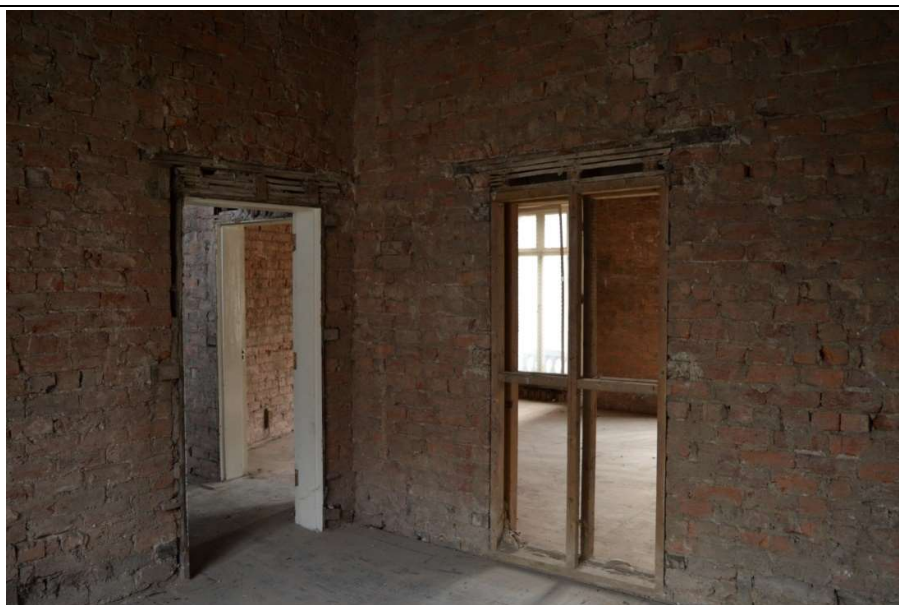
*Fig 34: Blocked doorway in Room 5 on first floor (to right). Also shows doorway to east stair (CPAT 4853-0033)*

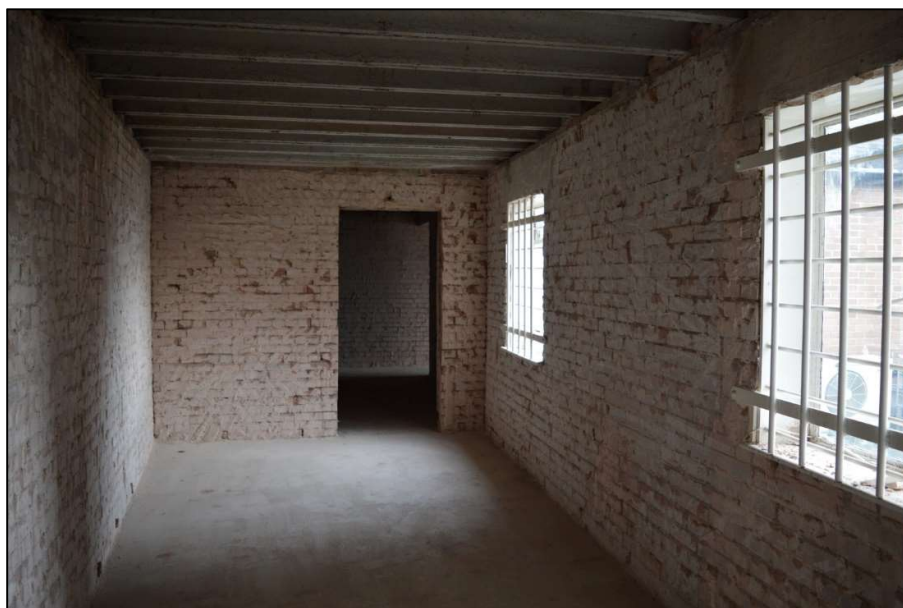
- 3.7. The removal of the interior of the ground floor meant that the east and west stairs started at first floor level though there was a small step down in the west stair to provide access to a modern extension to the rear of the building. This comprised a corridor (Fig 42); an additional room (Fig 43); and linking these, a small room where a stair (Fig 44) provided access from the ground floor. The bottom of the east stair had been similarly cut away (see Fig 54) and a stairway inserted at first floor level which provided access to the rear of the property at ground floor level.

*Fig 42: Modern extension connecting to rear of first floor from west stair (CPAT 4853-0041)*

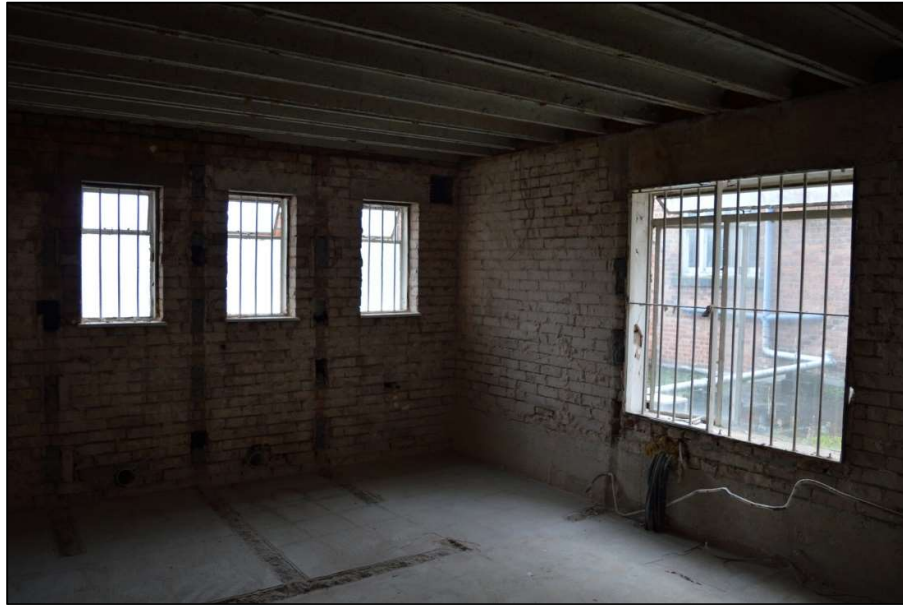
*Fig 43: Rear part of modern first floor extension (CPAT 4853-0042)*

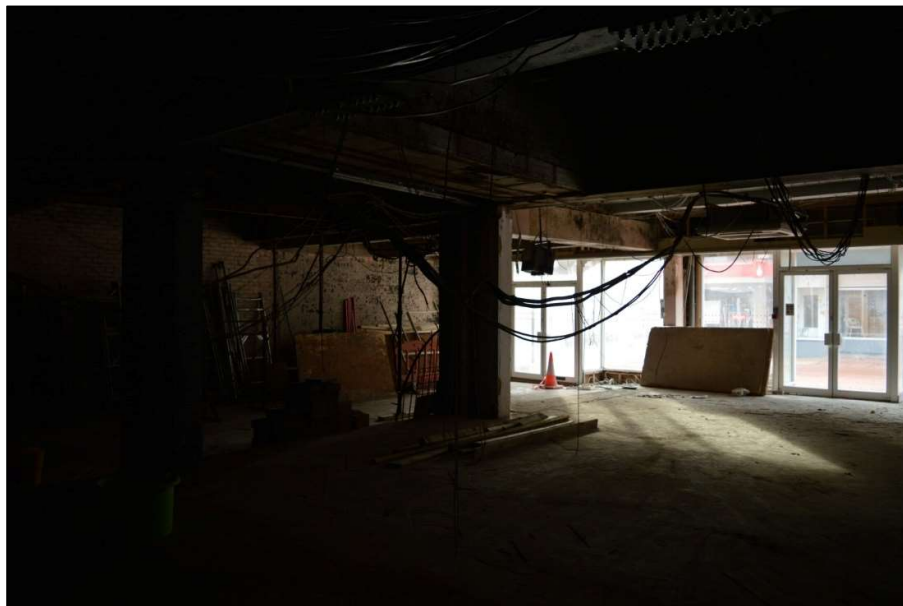
*Fig 46: General view of ground floor (CPAT 4853-0045)*

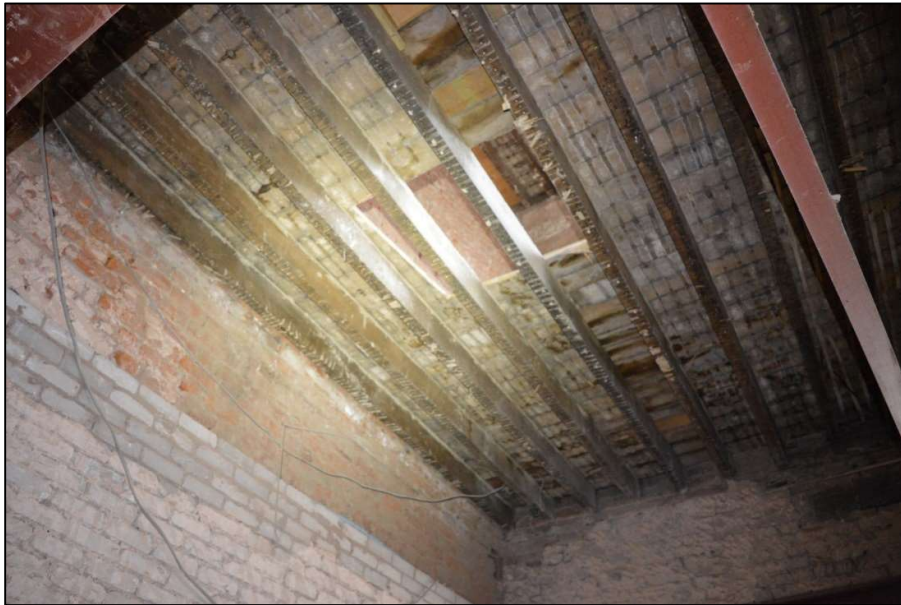
*Fig 48: First floor supporting joists from below. Also shows original east wall (to left) of ground floor with modern brick facing of its lower part and the surviving upper part of the south wall (to right) of the original building (CPAT 4853-0047)*

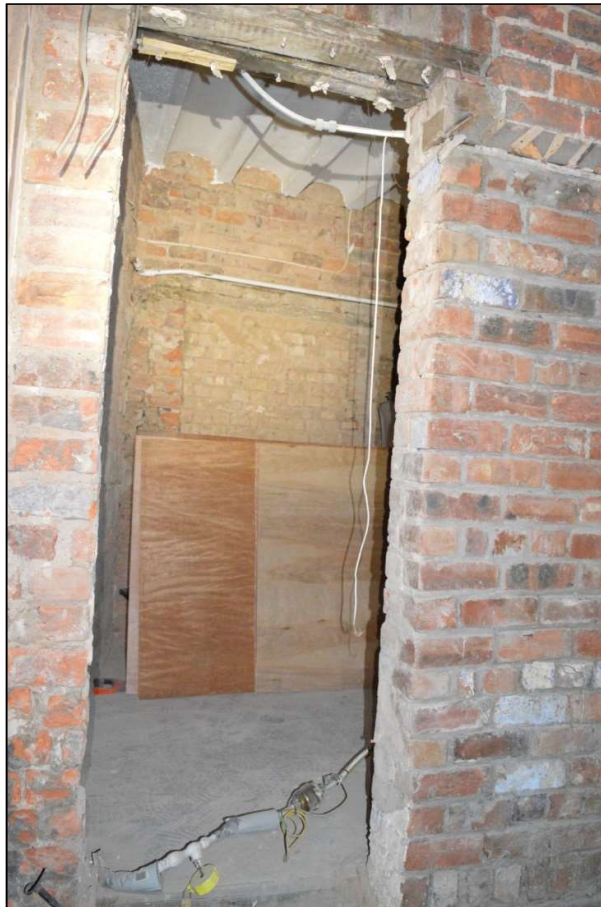
*Fig 56: Doorway to rear of original building where the brick seems to be re-used. The blocked doorway in the wall behind might indicate there was an earlier yard wall to the rear of the original building (CPAT 4853-0055)*

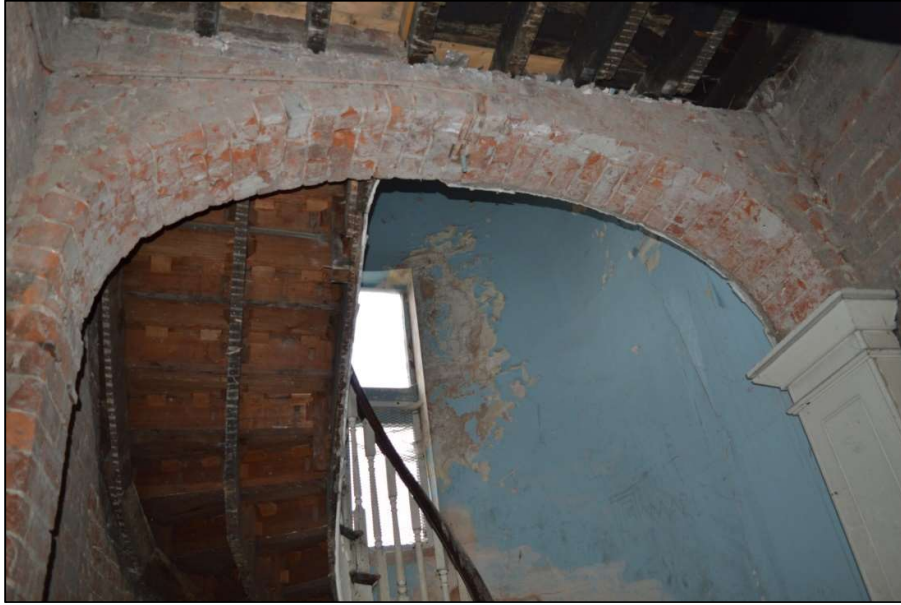
*Fig 67: The arch above the first floor landing of the east stair (CPAT 4853-0066)*

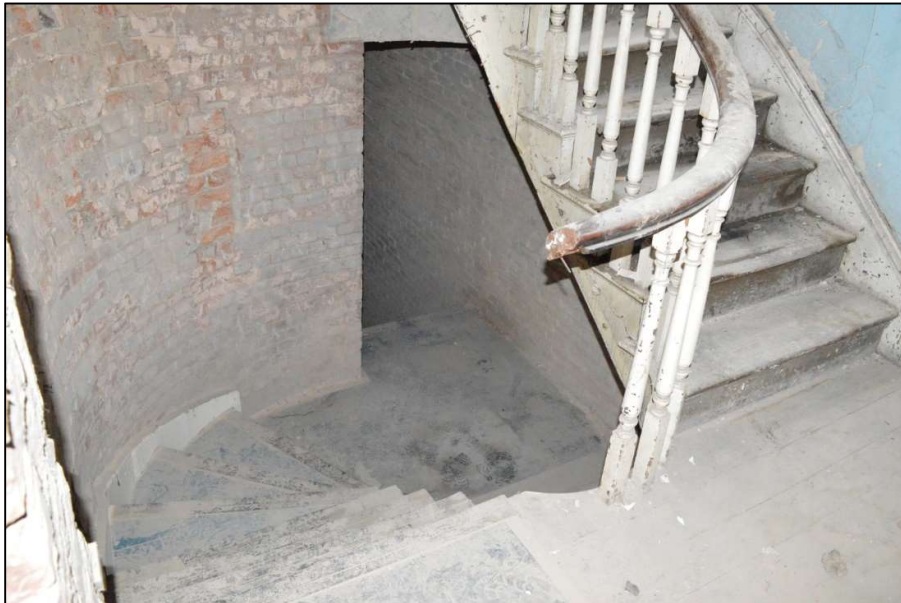
*Fig 68: Looking down the east stair from the first floor landing. Shows where the east stair was truncated by the modern insertion of steps down (centre) to the rear of the building (CPAT 4853-0066)*

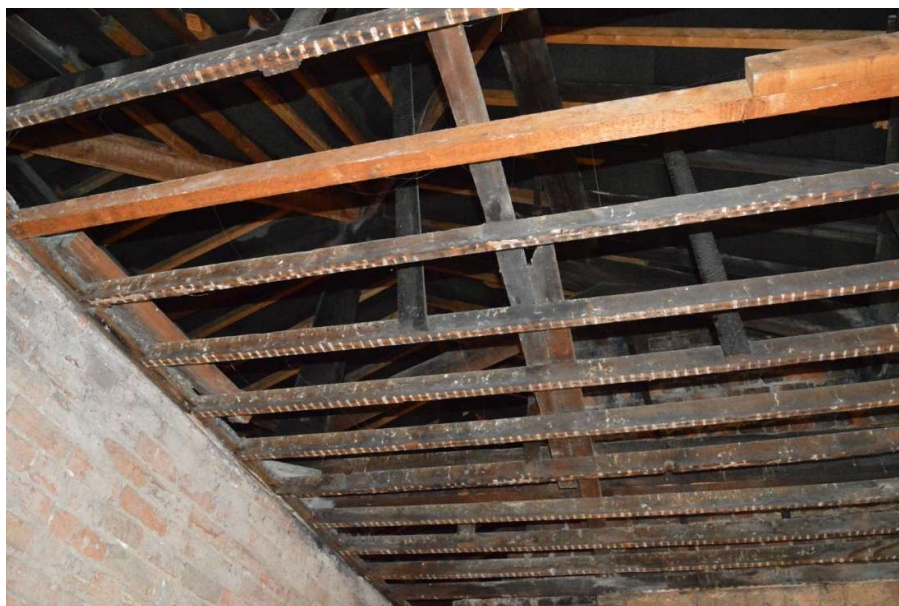
*Fig 70: Ceiling timbers with Truss 4 behind in roof space (CPAT 4853-0069)*

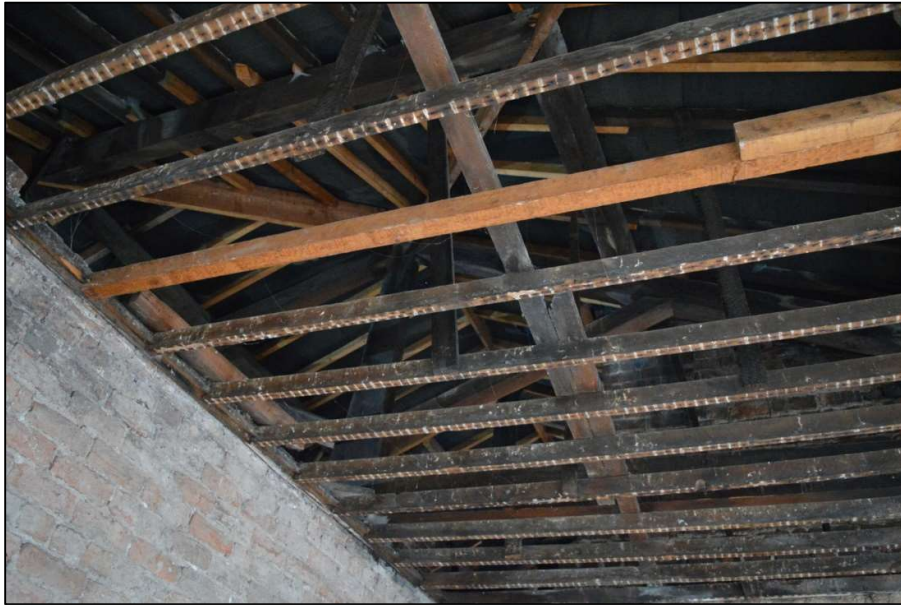
*Fig 71: Ceiling timbers with Truss 4 behind in roof space (CPAT 4853-0070)*

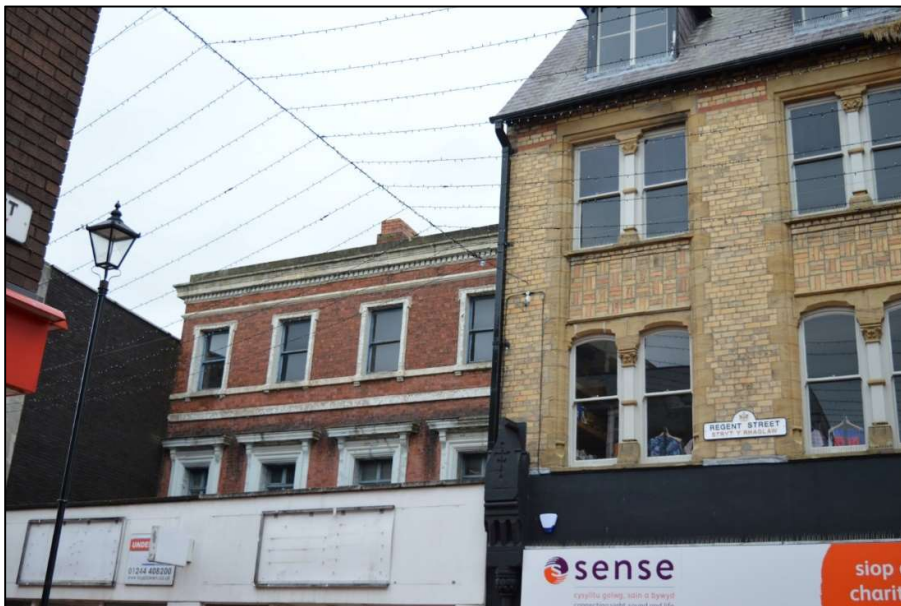
- 3.2. The original building at the core of 4-6 Regent Street was built of brick and on three floors with a hipped roof. The south side of the building (Fig 72) was designed to provide a more impressive appearance, with a parapet at both roof and first floor level and decorative stone window surrounds and string courses adding to the overall appearance. This side faces onto Regent Street but was set back from the frontage, which implies it predates those buildings to either side and was originally free-standing; the roof design may support this suggestion. To the rear the building is of simpler functional appearance, with no ornament (Fig 75).

*Fig 72: The view of the remaining part of the original building from Regent Street CPAT 4853-0071)*

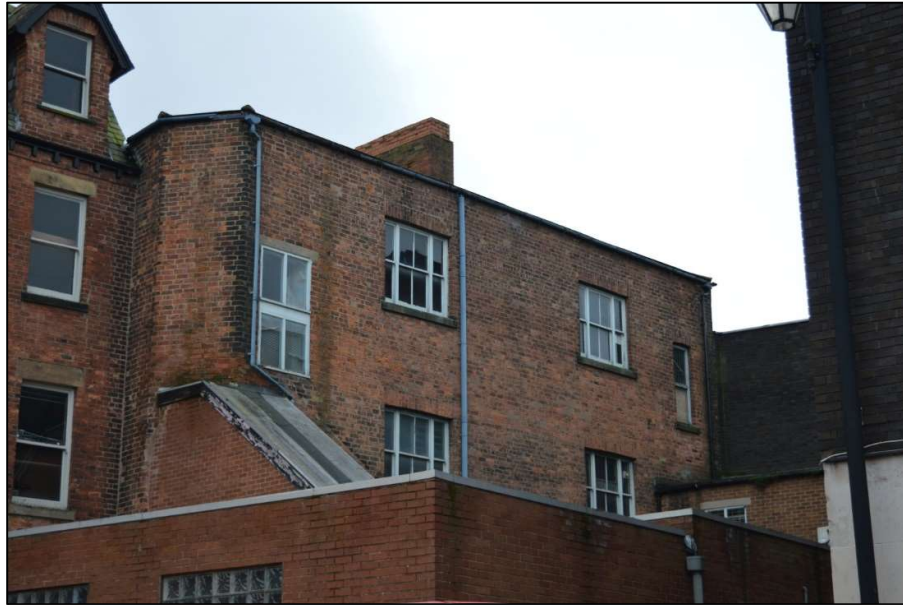
*Fig 75: The rear view of the first and second floors of the original building from Argyle Street. The sloping structure to lower left is where modern steps down to the rear of the building were inserted into the east stair at first floor level (CPAT 4853-0074)*

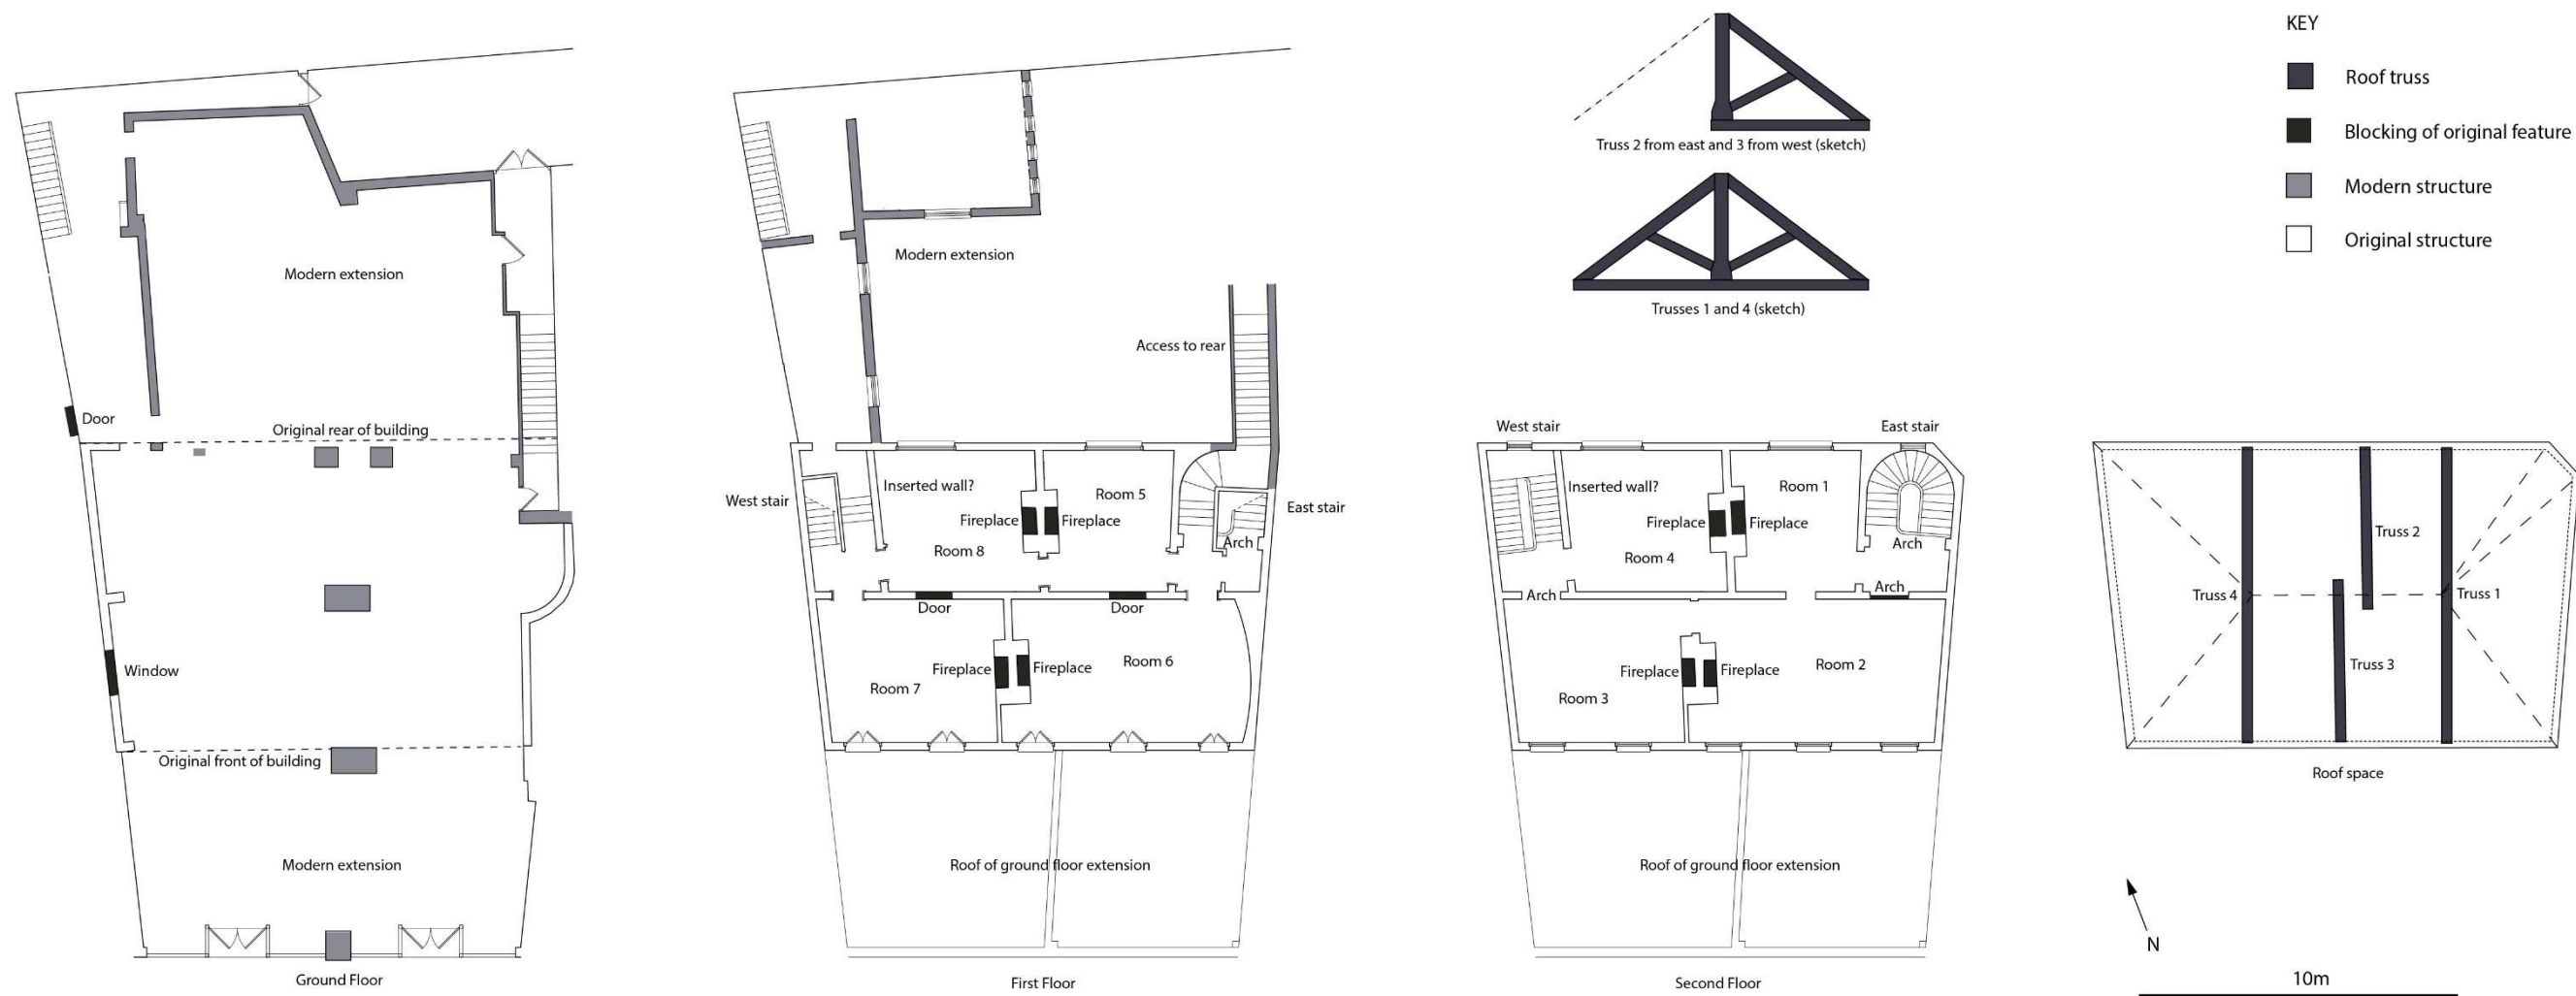
Fig. 76: Plan of the floors in the property, showing architectural detail revealed. Room numbers refer to those in the text of the report
