## Project

**Project Name:** 14154 EURO GARAGE WREXHAM  
**Project Description:** CCTV Drainage Inspection Report  
**Project Date:** 09/04/2021  
**Inspection Standard:** MSCC5 Sewers & Drainage GB (SRM5 Scoring)

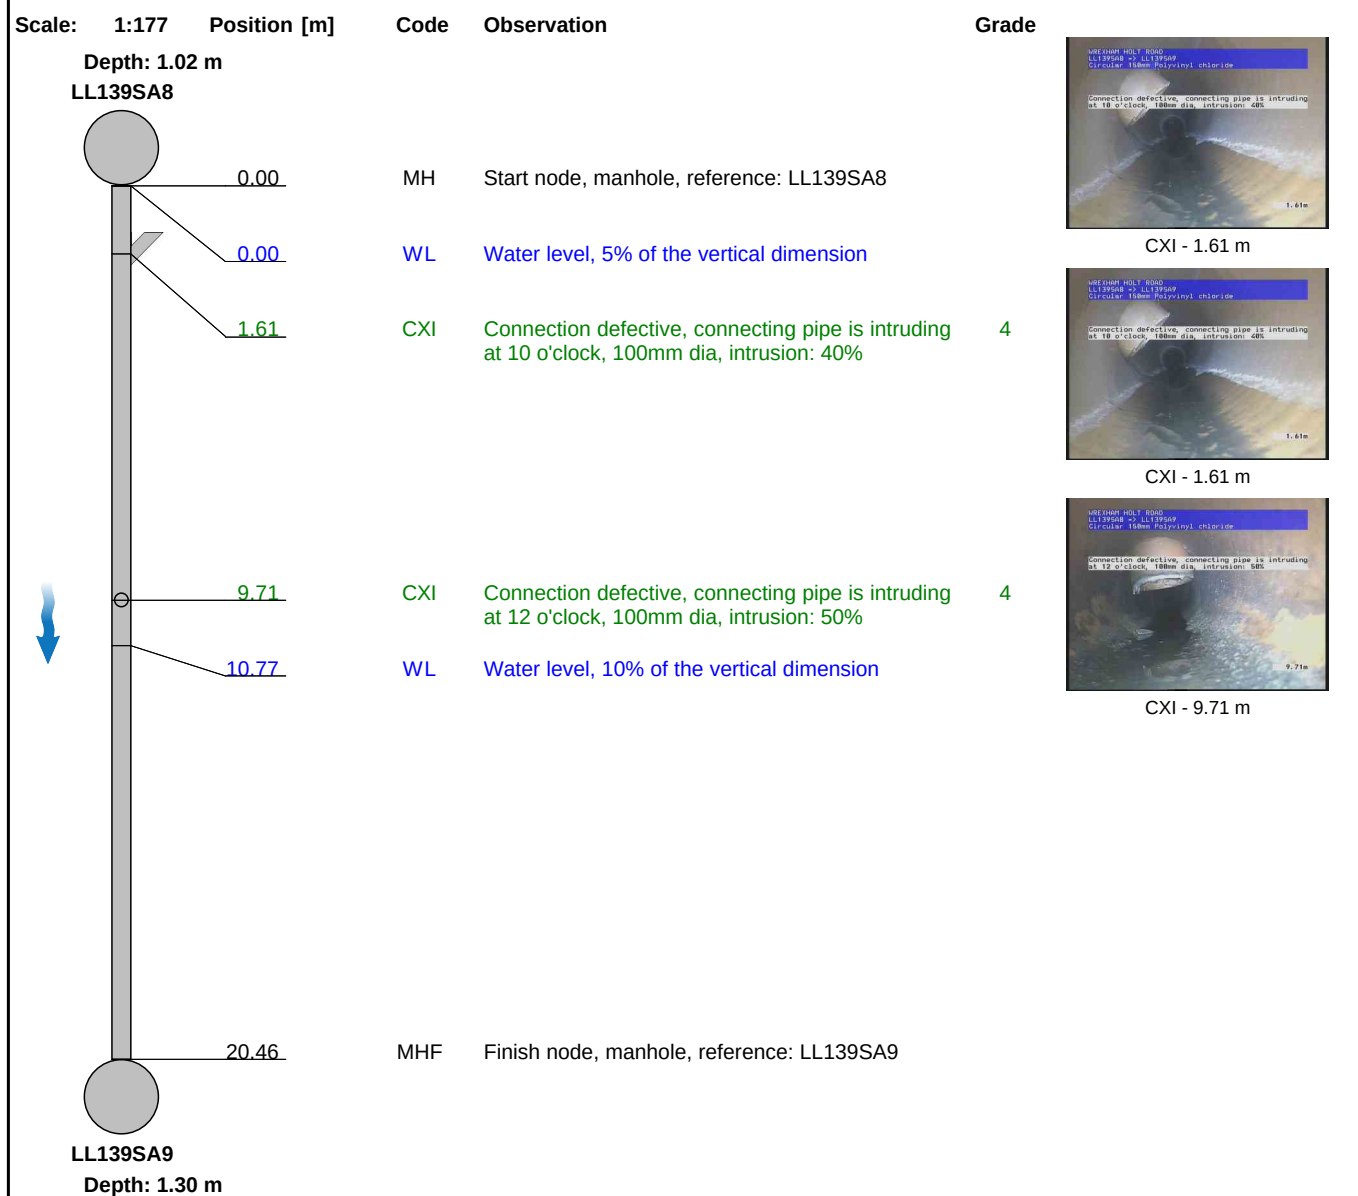
CLICK TO OPEN THIS SECTION

1, 00:00:43, 1.61 m  
Connection defective, connecting pipe is intruding at 10 o'clock, 100mm dia, intrusion: 40%

2, 00:00:43, 1.61 m  
Connection defective, connecting pipe is intruding at 10 o'clock, 100mm dia, intrusion: 40%

3, 00:01:47, 9.71 m  
Connection defective, connecting pipe is intruding at 12 o'clock, 100mm dia, intrusion: 50%

| <b>Recommendations:</b> | ROBOTIC CUT | | | | |
