DATE: April 2021

## **BS5837: 2012 TREE REPORT**

**Yew Tree Cottage, Sun Lane, Bowling Bark, Wrexham**  
**For Chris Bryan**

AUTHOR: MARK CHESTER

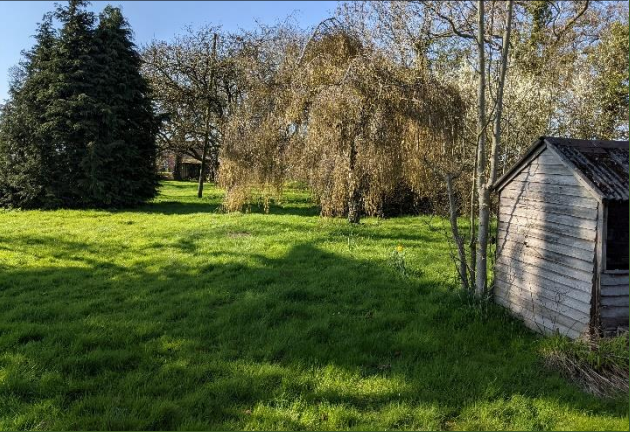
| <b>Image 1:</b> The road frontage looking west. | <b>Image 2:</b> Looking in to the site, with T1 centrally and T2 to the left. | <b>Image 3:</b> Looking to the wider property, to the west. |

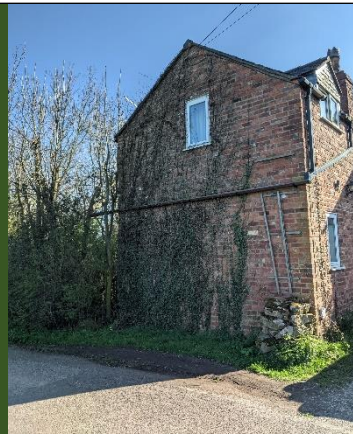
**Image 8:** The exterior of the property, with the hedgerow to the left.

| H1 | Hedge | M | 12 | 0 | 2 | 2 | 2 | 2 | M | 10-20 | C2 | | M | This is an overgrown hedge in need to new planting. | Yes | Fell and replace within planting scheme | | |
