Our Ref: 7565TWNW210121L

21 January 2021

**Re: Ground Assessments at “Lagoon Site”, Parc Brymbo, Wrexham.**

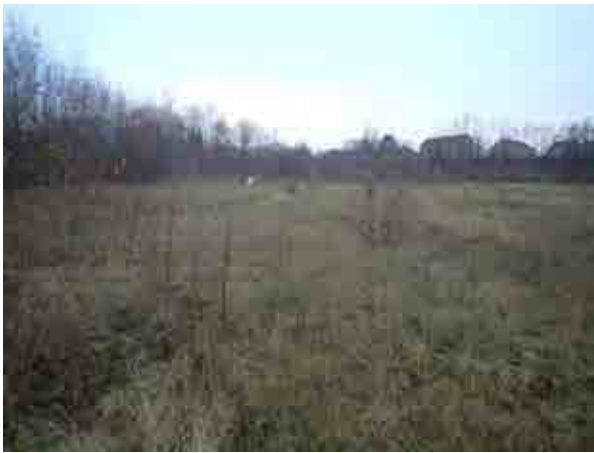
*Photograph 1: View of the site, with the tree-lined embankment in the background.*

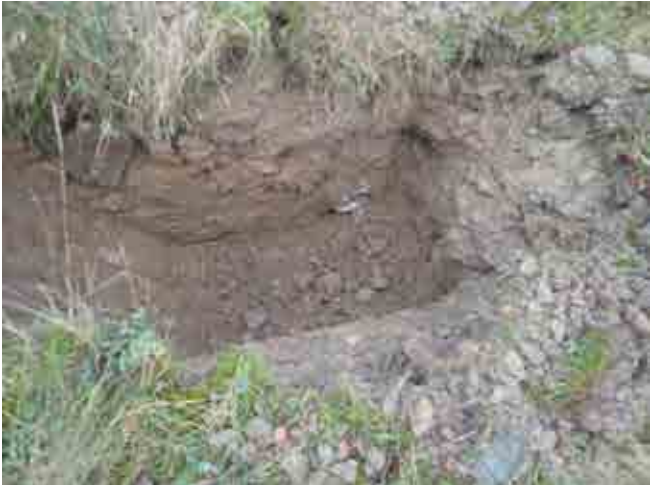
| 0.30 | JV | | | | <div> <div></div> <div>(1.10)</div> <div>1.10</div> </div> | MADEGROUND. Brown, slightly clayey, very sandy, angular to sub-angular, fine to coarse GRAVEL and COBBLE of various lithologies, predominantly sandstone, rare brick and concrete. *Assumed as medium dense to dense. | | | |
| | | | | | | <b>Remarks</b><br><br>Location CAT scanned prior to excavation.<br>Sides stable during excavation.<br>Surface water seepage only during excavation.<br>*Based upon trenchside stability characteristics.<br>Please note that discolouration of photographs may occur when viewed on screen as a PDF, or when printed as a hard copy.<br>Trial pit backfilled with arisings upon completion. | | | |

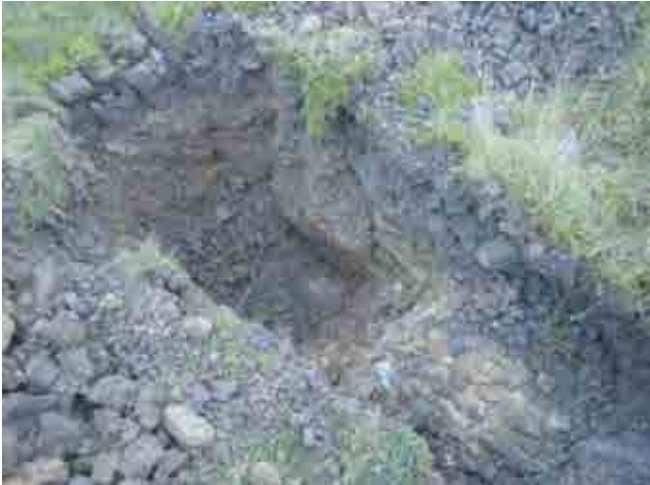
| 0.40 | JV | | | | (1.10) | MADEGROUND. Brown, slightly clayey, very sandy, angular to sub-angular, fine to coarse GRAVEL and COBBLE of various lithologies, predominantly sandstone, rare brick and coal. *Assumed as medium dense to dense. | | | |
| | | | | | | <b>Remarks</b><br><br>Location CAT scanned prior to excavation.<br>Sides stable during excavation.<br>Surface water seepage only during excavation.<br>*Based upon trenchside stability characteristics.<br>Please note that discolouration of photographs may occur when viewed on screen as a PDF, or when printed as a hard copy.<br>Trial pit backfilled with arisings upon completion. | | | |

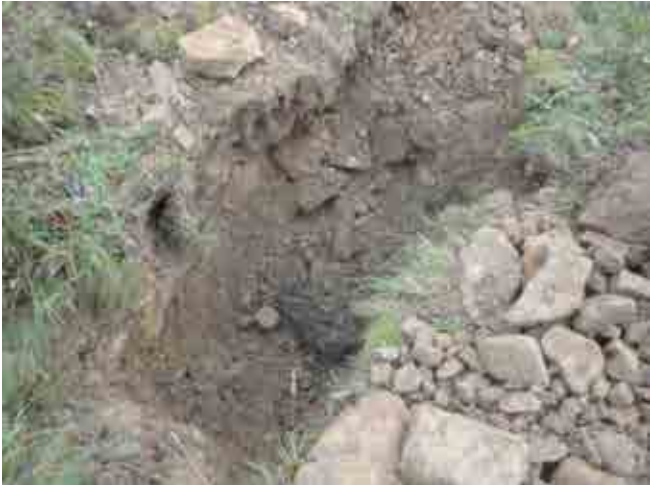
| | | | | | (1.05) | MADEGROUND. Brown, clayey, very sandy, angular to sub-angular, fine to coarse GRAVEL and COBBLE of predominantly sandstone, rare brick and coal. Low boulder content. *Assumed as medium dense to dense. | | | |
| | | | | | | <b>Remarks</b><br><br>Location CAT scanned prior to excavation.<br>Sides stable during excavation. Spalling only.<br>No groundwater encountered during excavation.<br>*Based upon trenchside stability characteristics.<br>Please note that discolouration of photographs may occur when viewed on screen as a PDF, or when printed as a hard copy.<br>Trial pit backfilled with arisings upon completion. | | | |

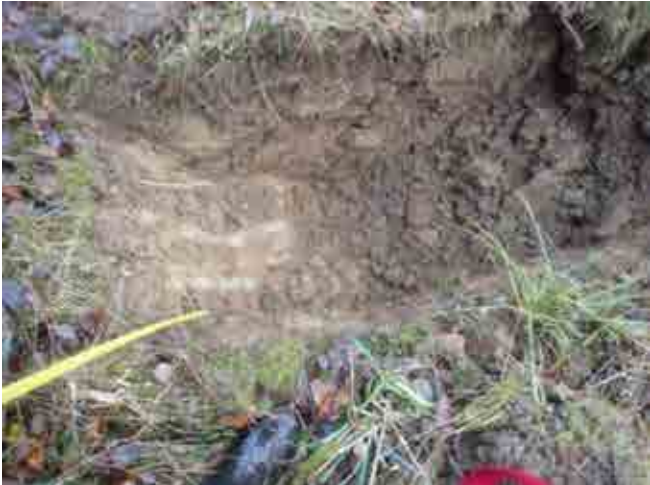
| <div> <div>Coopers (Chester) Ltd</div> <div>tel: 01244 684 910</div> <div>web: www.coopers.co.uk</div> <div>email: admin@coopers.co.uk</div> </div> | | | | <b>Site</b><br>PARC BRYMBO, WREXHAM - LAGOON SITE | | | <b>Trial Pit Number</b><br>TP06 | | |
|---|---|---|---|---|---|---|---|---|--|
| 0.80 | B | | | | 1.10 | MADEGROUND. Brown, slightly clayey, very sandy, angular to sub-angular, fine to coarse GRAVEL and COBBLE of predominantly sandstone, rare brick coal and rare fused material. *Assumed as medium dense to dense. | | | |
| | | | | | | <b>Remarks</b><br><br>Location CAT scanned prior to excavation.<br>Sides stable during excavation. Spalling only.<br>No groundwater encountered during excavation.<br>*Based upon trenchside stability characteristics.<br>Please note that discolouration of photographs may occur when viewed on screen as a PDF, or when printed as a hard copy.<br>Trial pit backfilled with arisings upon completion. | | | |

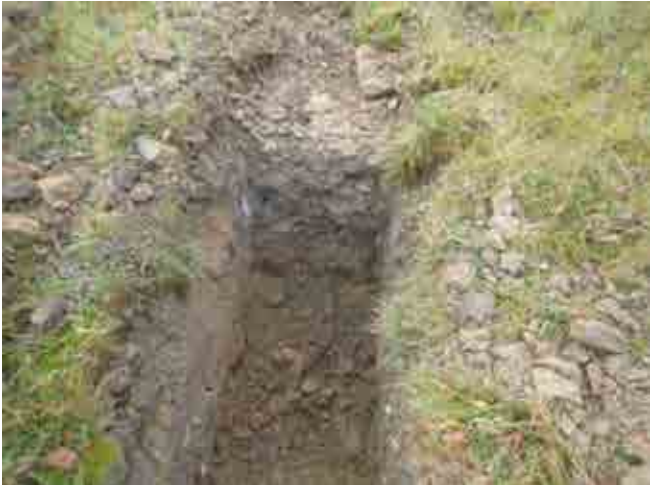
| | | | | | | <b>Remarks</b><br><br>Location CAT scanned prior to excavation.<br>Sides stable during excavation.<br>No groundwater encountered during excavation.<br>*Based upon trenchside stability characteristics.<br>Please note that discolouration of photographs may occur when viewed on screen as a PDF, or when printed as a hard copy.<br>Trial pit backfilled with arisings upon completion. | | | |

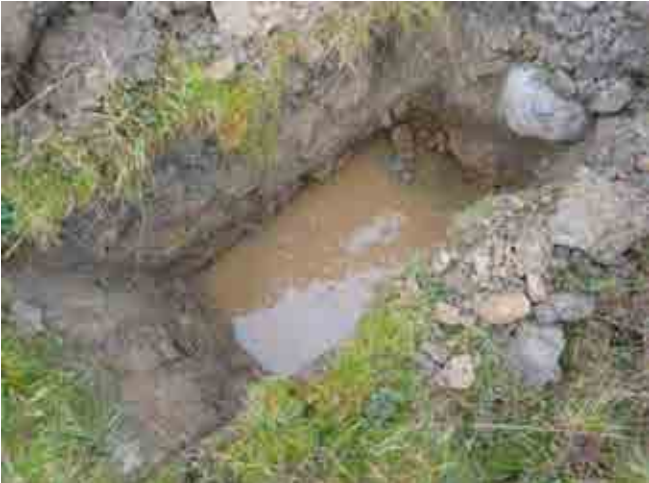
| 1.00 | B | | Seepage during excavation(1) at 1.00m. | | 0.90 | MADEGROUND. Brown, slightly clayey, very sandy, angular to sub-angular, fine to coarse GRAVEL and COBBLE of various lithologies including sandstone, coal and brick. *Assumed as medium dense to dense. | | | ∇1 |
| | | | | | <b>Remarks</b><br><br>Location CAT scanned prior to excavation.<br>Sides stable during excavation.<br>Seepage at 1.00m during excavation. Sheen on surface.<br>*Based upon trenchside stability characteristics.<br>Please note that discolouration of photographs may occur when viewed on screen as a PDF, or when printed as a hard copy.<br>Trial pit backfilled with arisings upon completion. | | | | |

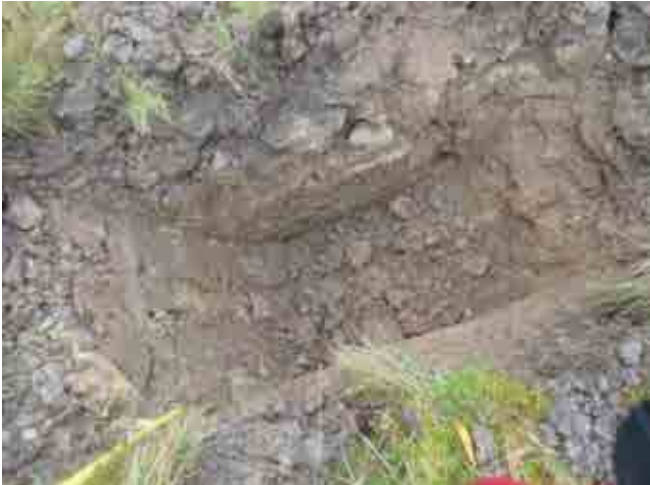
| | | | | | (1.15) | MADEGROUND. Brown, slightly clayey, very sandy, angular to sub-angular, fine to coarse GRAVEL and COBBLE. Sand is fine to coarse. Gravel is predominantly sandstone. *Assumed as medium dense to dense. | | | |
| | | | | | | <b>Remarks</b><br><br>Location CAT scanned prior to excavation.<br>Sides stable during excavation.<br>Seepage at 1.00m during excavation. Sheen on surface.<br>*Based upon trenchside stability characteristics.<br>Please note that discolouration of photographs may occur when viewed on screen as a PDF, or when printed as a hard copy.<br>Trial pit backfilled with arisings upon completion. | | | |

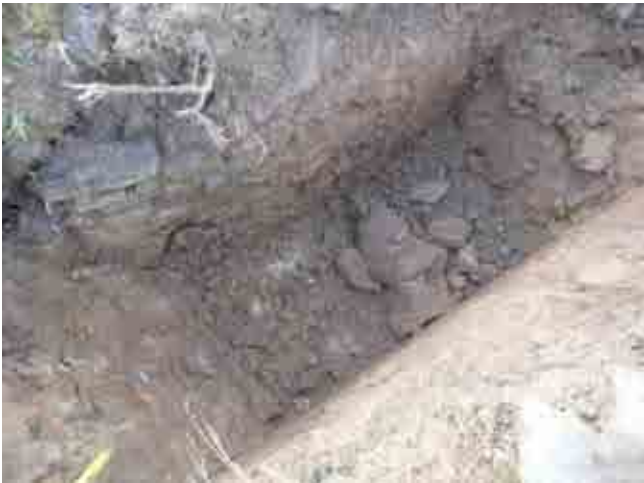
| 0.80 | B | | | | 1.00 | MADEGROUND. Brown, slightly clayey, very sandy, angular to sub-angular, fine to coarse GRAVEL and COBBLE of predominantly sandstone with rare brick and coal.<br>*Assumed as medium dense to dense. | | | |
| | | | | | | <b>Remarks</b><br><br>Location CAT scanned prior to excavation.<br>Sides stable during excavation. Spalling only.<br>No groundwater encountered during excavation.<br>*Based upon trenchside stability characteristics.<br>Please note that discolouration of photographs may occur when viewed on screen as a PDF, or when printed as a hard copy.<br>Trial pit backfilled with arisings upon completion. | | | |

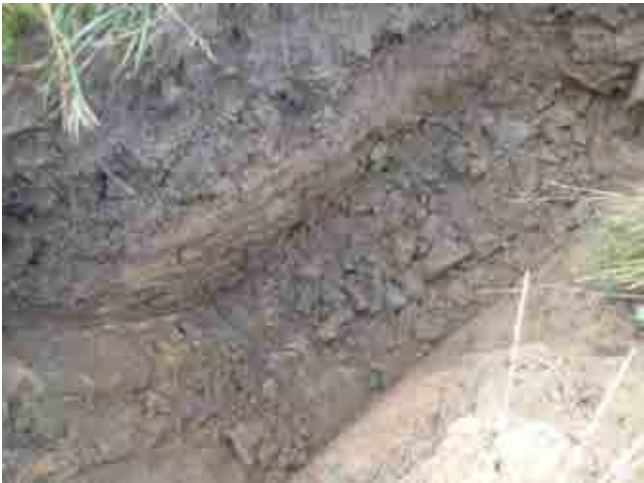
| 0.90 | B | | | | 0.65<br>(0.65) | MADEGROUND. Brown, slightly clayey, very sandy, angular to sub-angular, fine to coarse GRAVEL and COBBLE of sandstone. *Assumed as medium dense to dense. | | | |
| | | | | | | <b>Remarks</b><br><br>Location CAT scanned prior to excavation.<br>Sides stable during excavation.<br>No groundwater encountered during excavation.<br>*Based upon trenchside stability characteristics.<br>Please note that discolouration of photographs may occur when viewed on screen as a PDF, or when printed as a hard copy.<br>Trial pit backfilled with arisings upon completion. | | | |

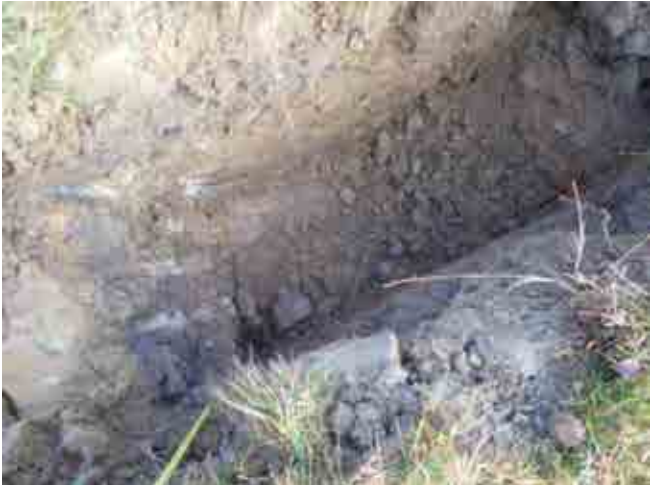
| | | | | | (1.15) | MADEGROUND. Brown, slightly clayey, very sandy, angular to sub-angular, fine to coarse GRAVEL and COBBLE. Sand is fine to coarse. Gravel is predominantly sandstone with rare brick, ceramic, metal wire and coal. *Assumed as medium dense to dense. | | | |
| | | | | | <b>Remarks</b><br><br>Location CAT scanned prior to excavation.<br>Sides stable during excavation.<br>No groundwater encountered during excavation.<br>*Based upon trenchside stability characteristics.<br>Please note that discolouration of photographs may occur when viewed on screen as a PDF, or when printed as a hard copy.<br>Trial pit backfilled with arisings upon completion. | | | | |

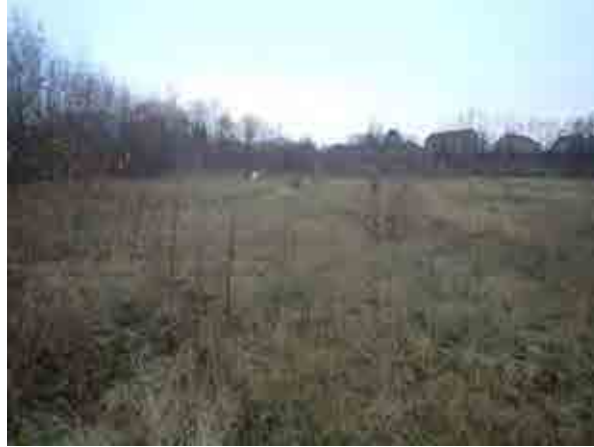
- 1.2 The triangular shaped parcel of land is situated adjacent to residential housing to the south, west and north, with sports pitches to the east. At the time of Coopers walkover on 2 December 2020 the site consisted of 1 No. field with tree-lined embankments (refer to photograph 1) on the southern and western boundaries. The field consisted of scrubland with patches of no vegetation growth, with scattered self-seeded trees and strewn with scattered sandstone boulders left over from the remediation phase of the site.

*Photograph 1: View of the site, with the tree-lined embankment in the background.*

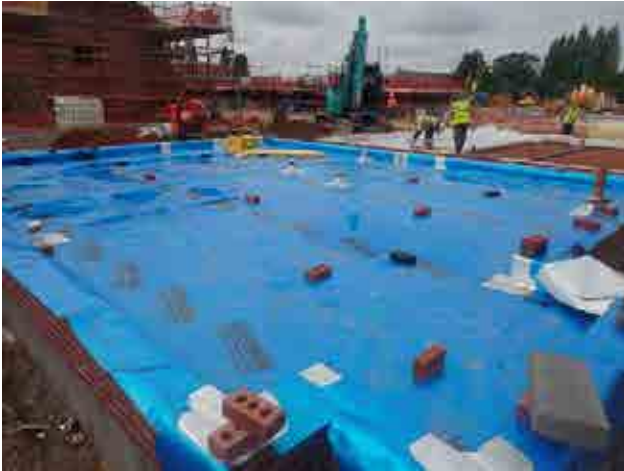
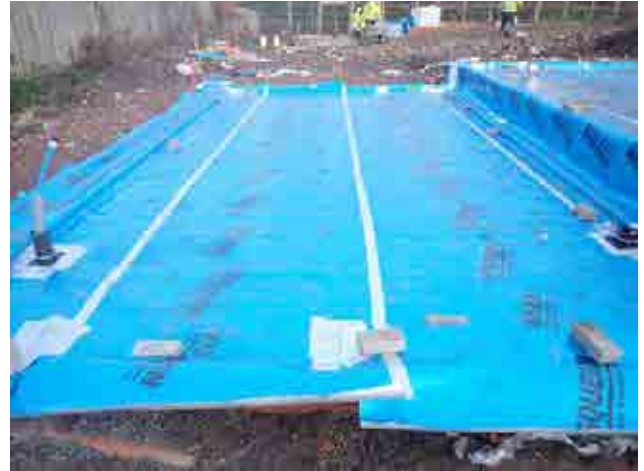
Photograph 2 and 3: Check general condition of gas membranes with photographs showing the plot in context.

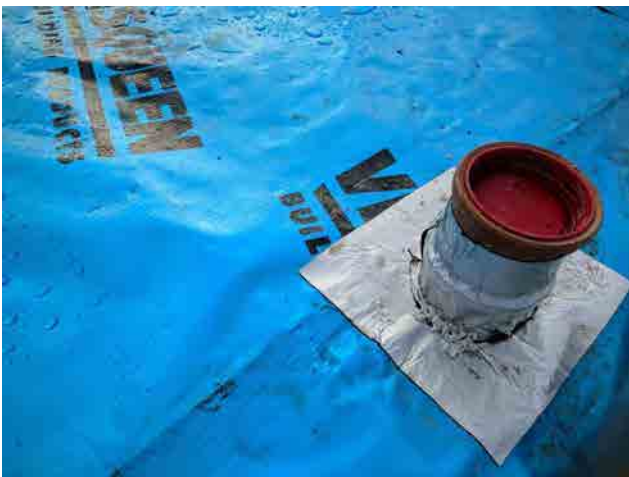
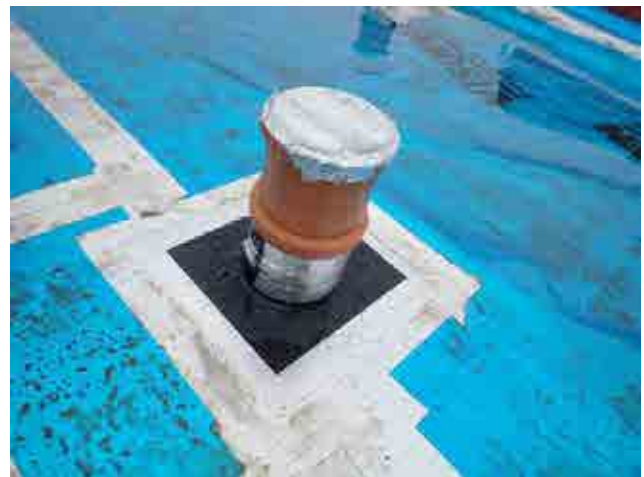
Photograph 4 and 5: Check top hat is sealed to membrane and pipework with tapes, and Jubilee clip, or detail strip installation.

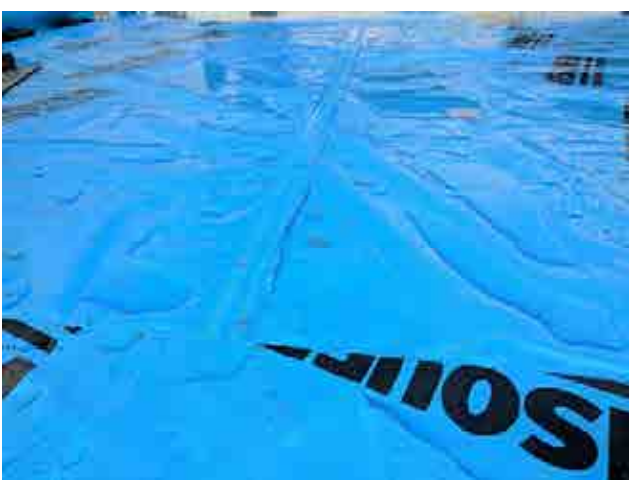
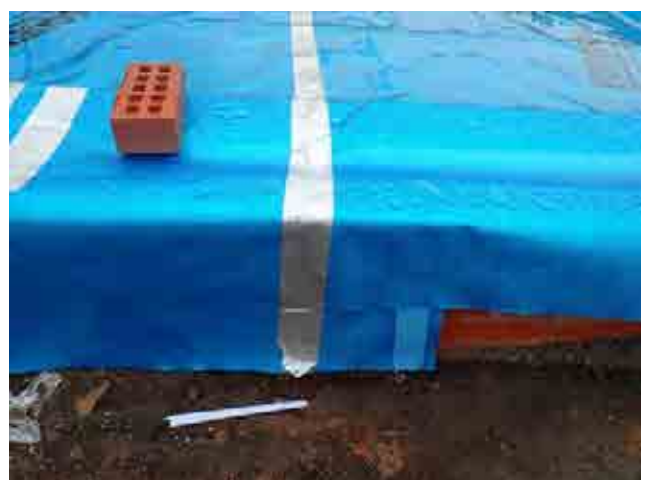
Photograph 6 and 7: Check >150mm overlaps of membranes and proprietary tapes placed and sealed or heat welded jointing with photographs taken.

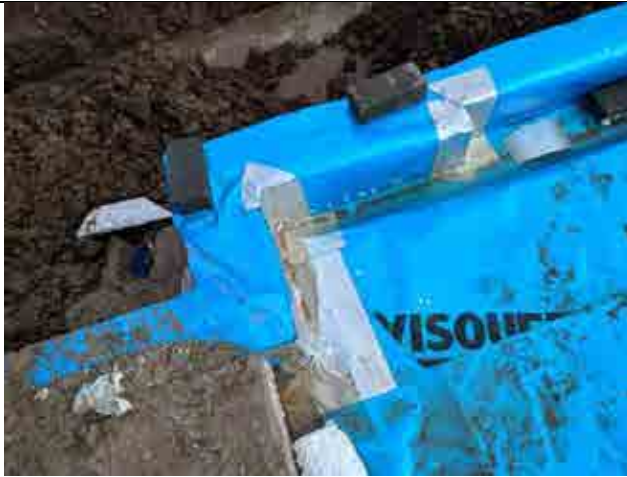
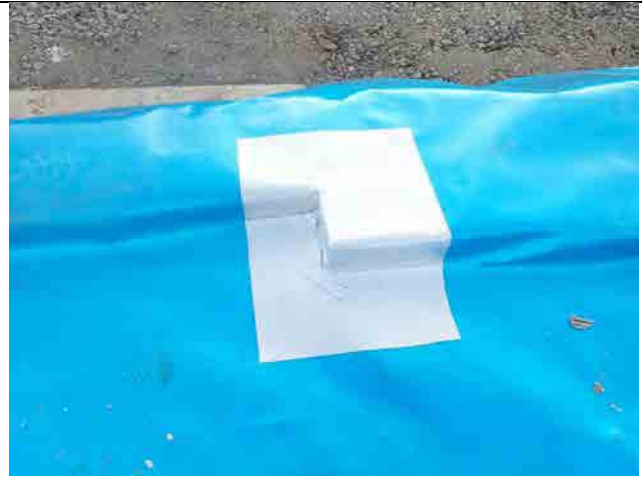
Photographs 8 and 9: Formed corner sections correctly taped

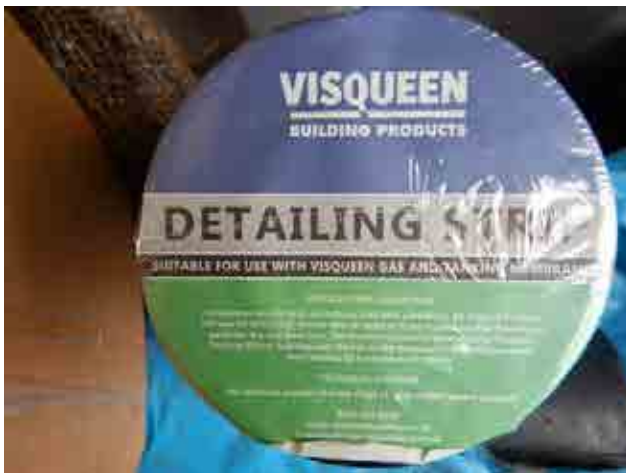
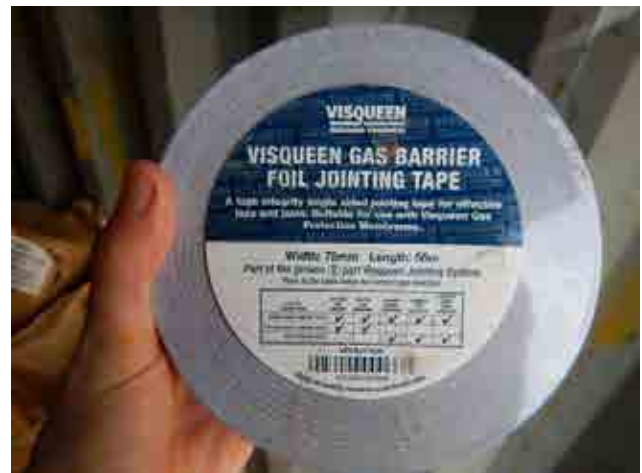
Photographs 10 and 11: Confirm ancillary products utilised in the gas membrane installation.

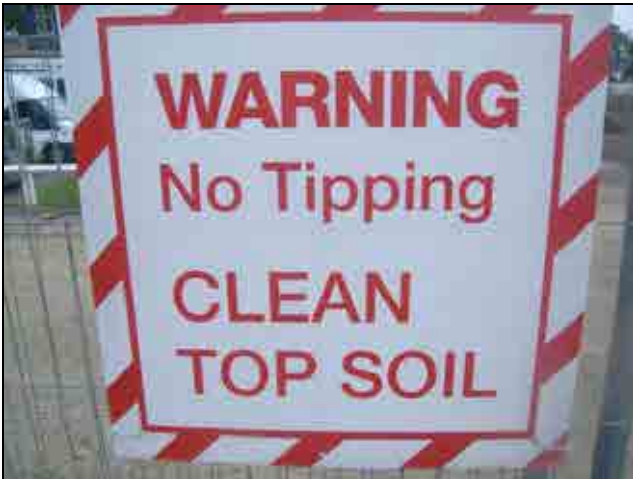
*Photograph 12: Example of good stockpile management with warning signs to demonstrate areas of inert topsoil.*

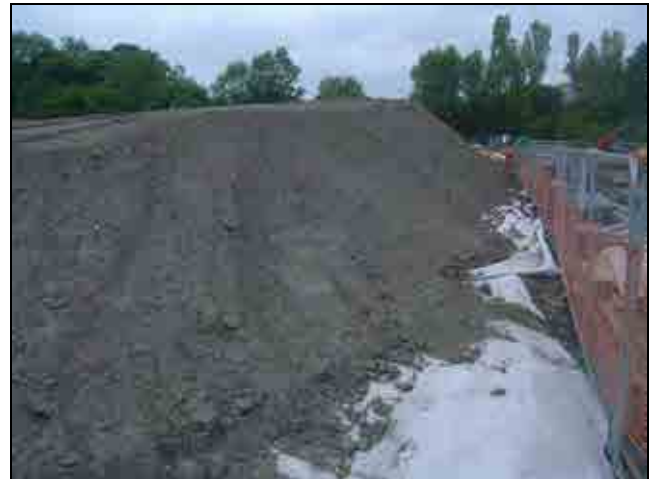
*Photograph 13: Example of good stockpile management with soils placed on geotextile with fences to prevent accidental cross-mixing.*

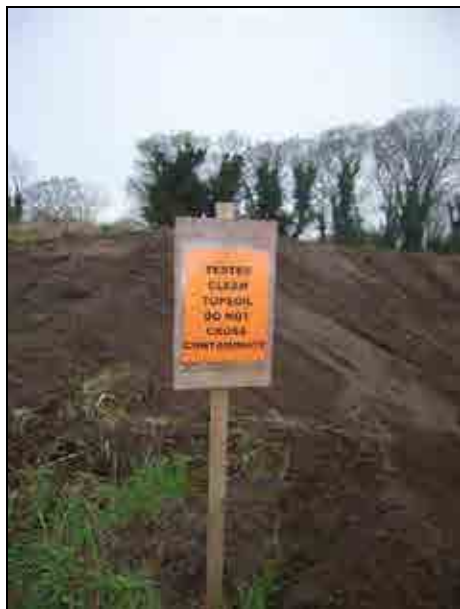
*Photograph 14: Example of good stockpile management with warning signs to demonstrate areas of inert topsoil.*

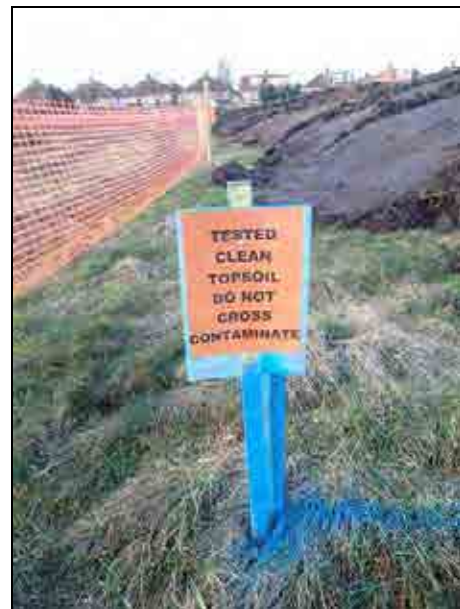
*Photograph 15: Example of good stockpile management with warning signs and fencing to prevent accidental cross-mixing.*

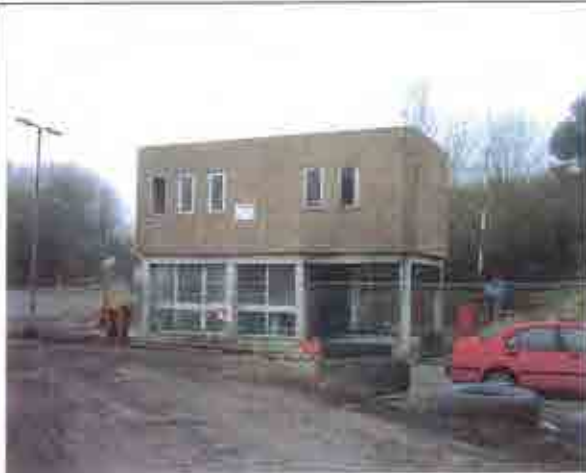
Original security building at No 2 Gate access – demolished in 2005

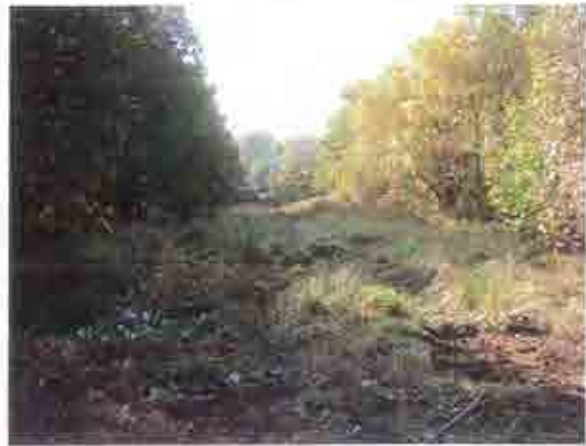
Northwestern strip prior to creation of reclamation site access road (2003)

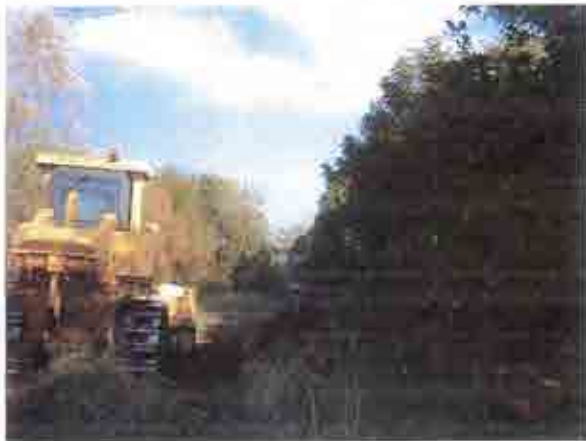
Stripping of topsoil to create reclamation site access road (2003)

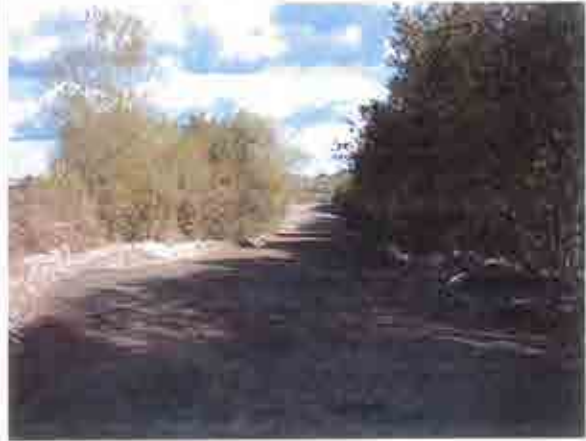
Reclamation site access road along northwestern strip

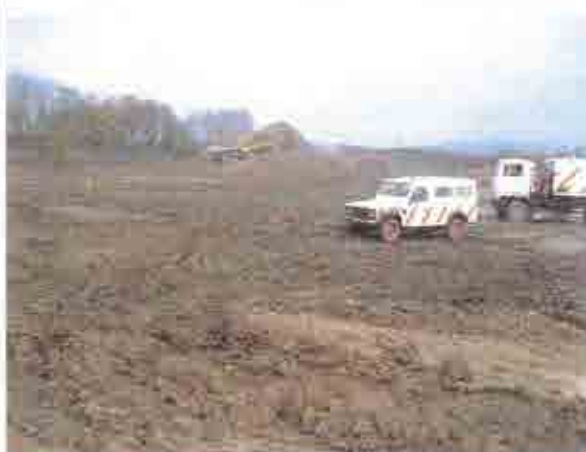
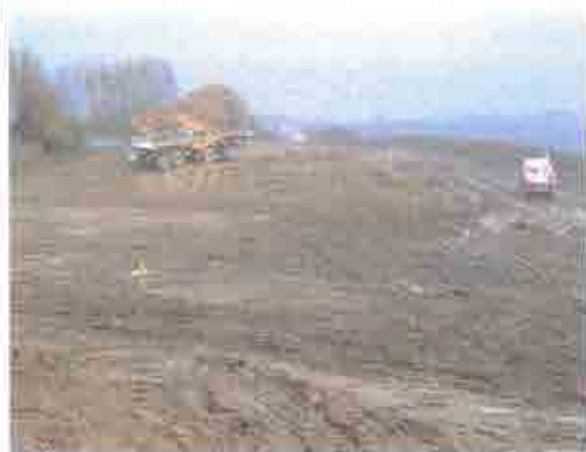
side of the site. BDL advised that during the excavation of the lagoons (to a maximum depth of 4m below the surrounding ground) the ground conditions were noted to comprise natural soils or possible re-worked Ty Cerryg overburden with no indications of steelworks slag, waste deposits or other deleterious materials.

Excavation of lagoon area (November 2003)

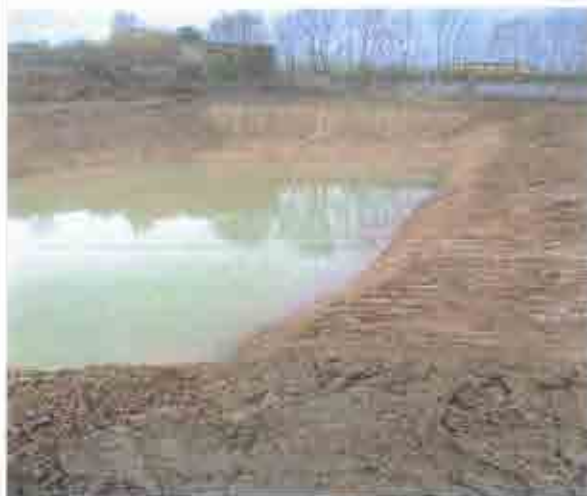
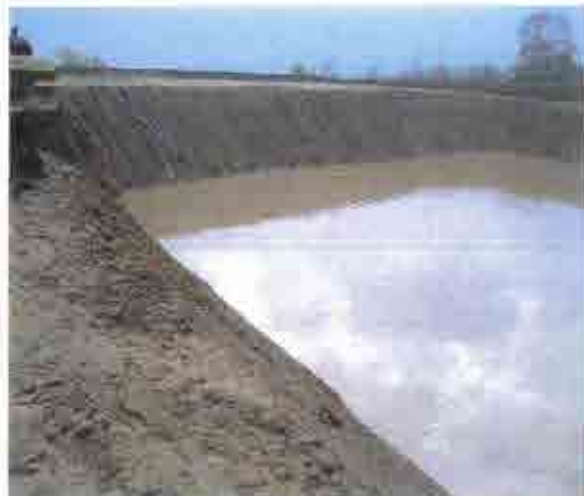
Lagoons (November 2003)

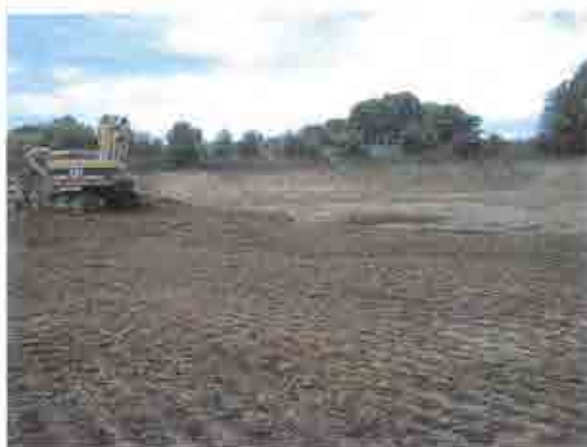
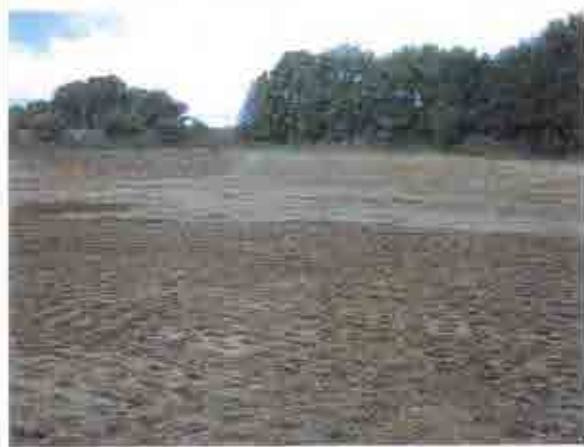
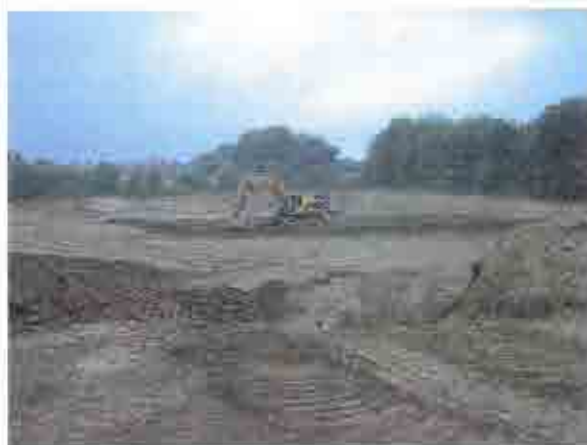
On-going re-compaction of materials in LRDM  
(July – October 2007)

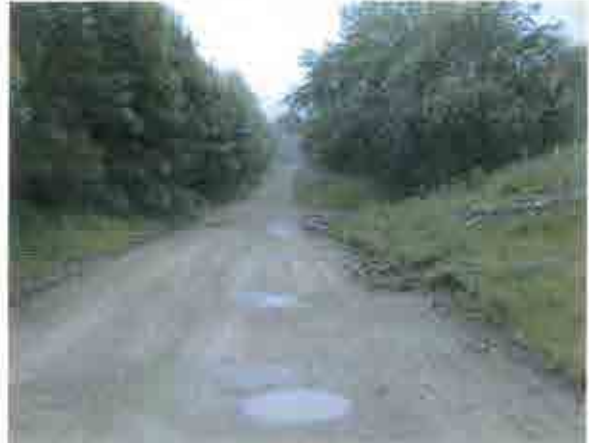
Cycleway along northwestern strip following  
placement of topsoils along western edge to  
narrow road (May 2007)

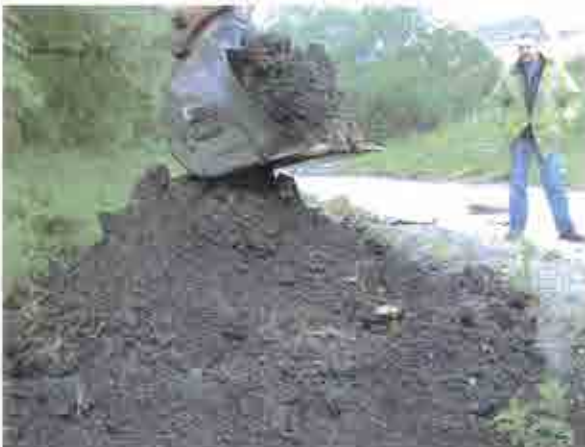
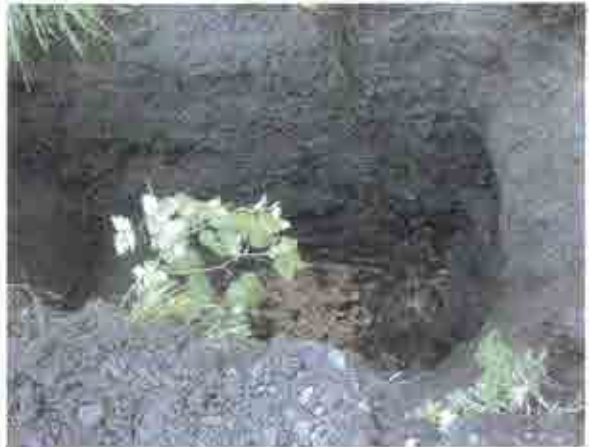
Trial pit 300507TP1 on northwestern strip

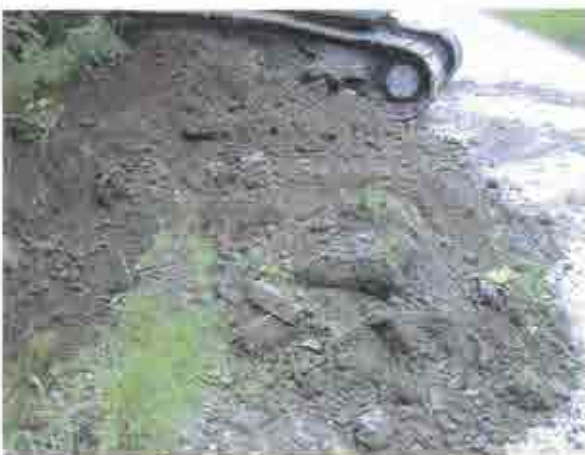
Trial pit 300507TP2 on northwestern strip

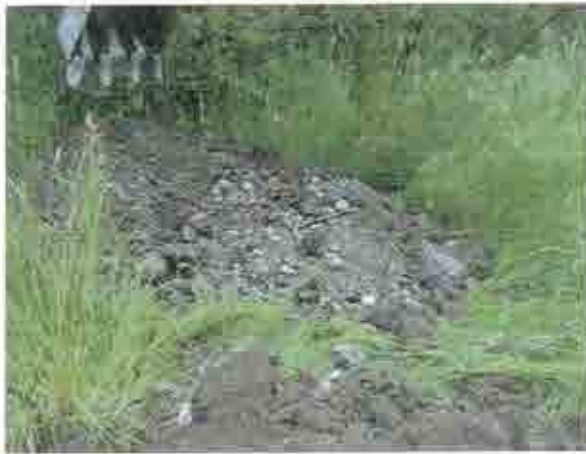
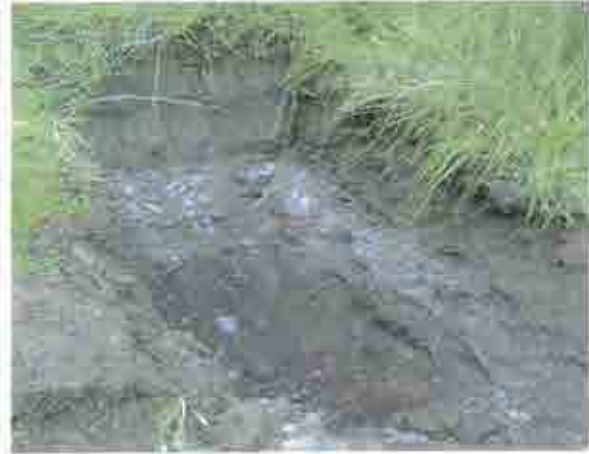
Trial pit 300507TP4 on northwestern strip  
LRDM
