# Structural Report

Coed Derwen  
Erbistock  
Wrexham  
LL13 0DN

CLIENT  
Etonbrook Limited

DOCUMENT NUMBER  
AJF-21081-R01

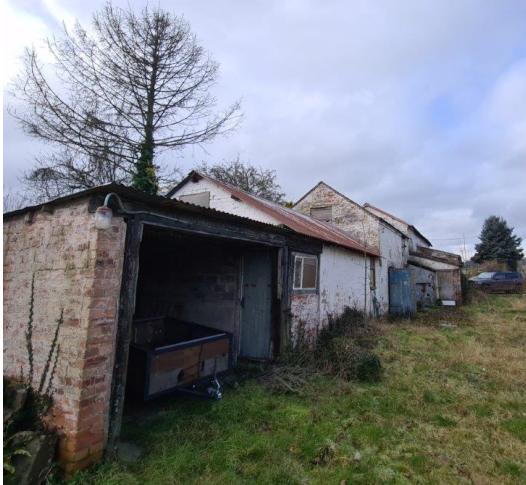
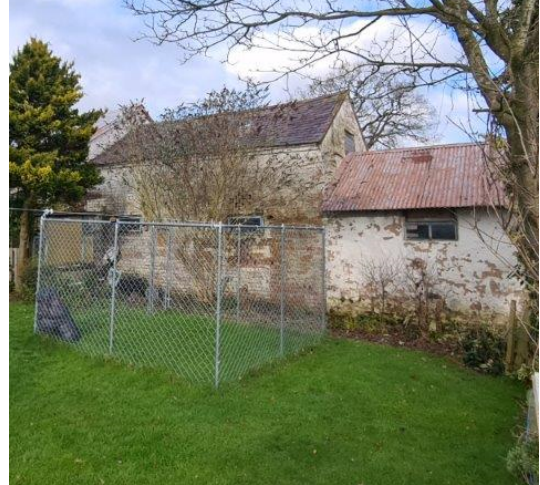
- 2.1. The site is located in a rural setting to the West of Overton on the South side of the Lane.
- 2.2. The farm comprises a single-storey dwelling, two-storey barn building, and various agricultural outbuildings. **This report considers the two-storey barn building only.**
- 2.3. The barn comprises various lean-to structures of varying constructions.

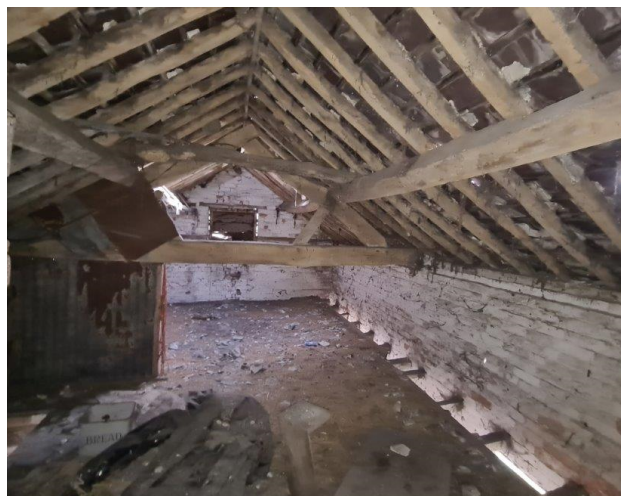
- 2.4. The main barn building is a mixture of stone and brickwork walls. There is a concrete ground bearing slab located below the external ground level.
- 2.5. First floors are split over two levels and are suspended timber construction supported by masonry walls and various timber beams.
- 2.6. The roof structure comprises a mixture of sheet metal cladding and slate tiles supported by timber purlins and trusses.
