# **STRUCTURAL CONDITION SURVEY**

## **ROSE HILL LODGE,**

## **WREXHAM**

**Date**  
**June 2020**

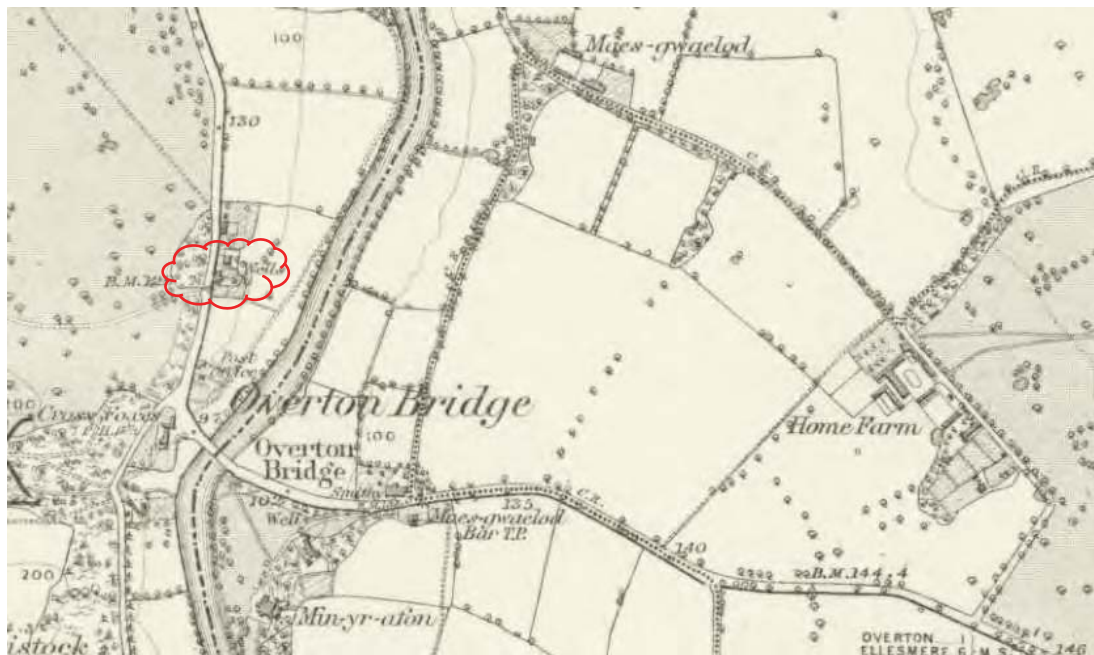
Figure 1 - Historical Mapping of Local Area 1879

- 3.1. A search of the historical mapping for the area local to the property has been undertaken and has indicated that the original construction of the property pre-dates the earliest historical mapping made available, which dates 1879. The configuration of the property has remained relatively unchanged from its original layout in 1879 with exception to the extension to the rear of the property in 2011. Reference is made to Figure 1 below.
