**REPORT**

**ALTHREY WOODHOUSE  
OVERTON ROAD  
BANGOR ON DEE  
LL13 0DA**

**M WASON & R J A PEARCE MRICS  
4 Lime Terrace  
Lime Street  
Coleham  
Shrewsbury  
SY3 7EE**

**Date of Inspection: 7<sup>th</sup> November 2019**

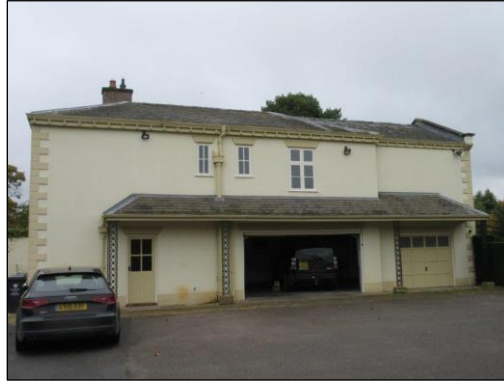
The property is of standard construction for the period. The main roof is pitched and clad with slate and clay ridge tiles.

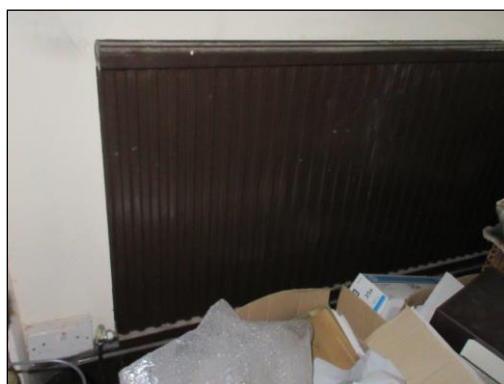
There are three radiators present throughout the entirety of the property these are of considerable age. The heating and hot water system requires complete replacement.
