## AGENT'S HOUSE, BRYMBO

# PRELIMINARY BAT ROOST ASSESSMENT AND EMERGENCE SURVEY

Report Ref EE.672.LB

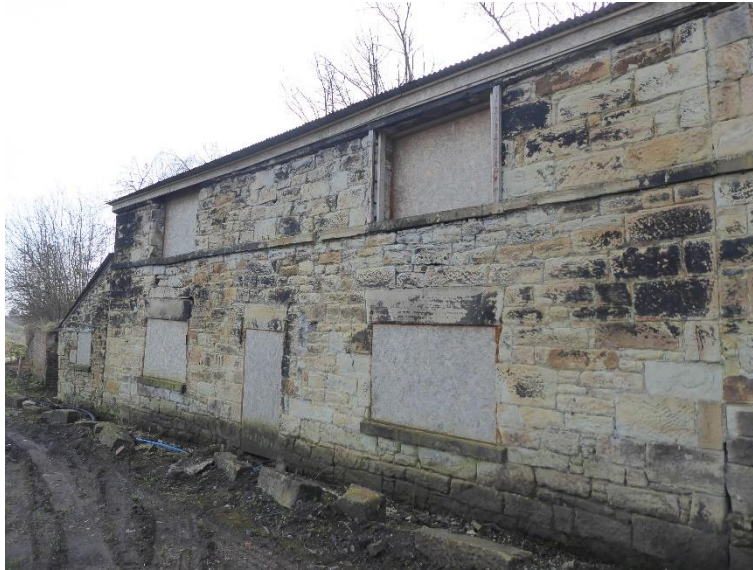
- 4.1.2 The house was constructed of un-rendered stone, had a corrugated metal sheet roof and both corrugated metal and chipboard fascias. To the front of the house were seven windows and a doorway, which were boarded up with chipboard and sealed with expanding foam (Photo 4.1). To the rear were two small windows, which were also boarded up (Photo 4.2). There was a large wooden doorway on the western end of the house and a door into the lean-to on the eastern end of the house.

***PHOTO 4.1 NORTHERN SIDE OF THE HOUSE***

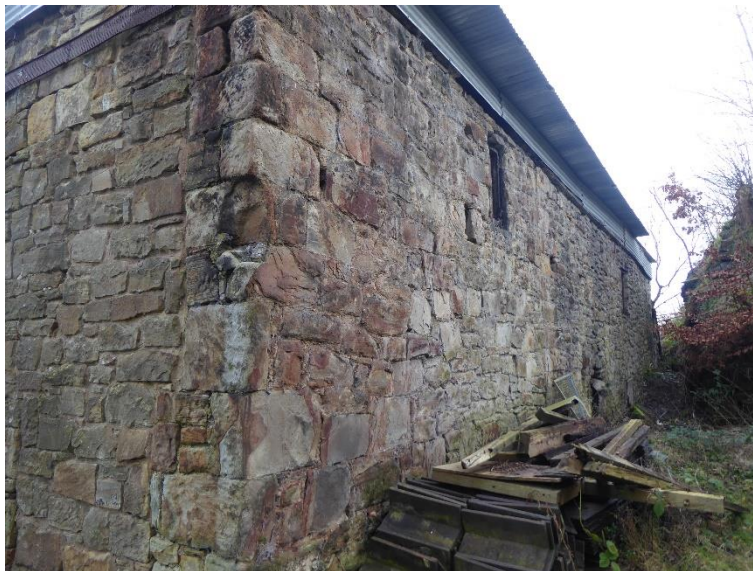
***PHOTO 4.2 SOUTHERN SIDE OF THE HOUSE***

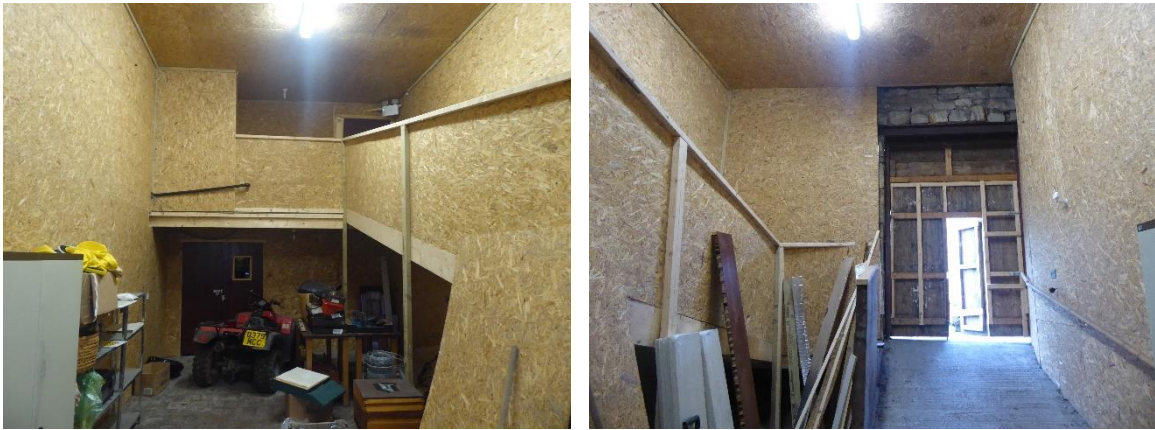
- 4.2.1 Internally, the walls and ceiling were lined with chipboard, creating a large double storey height room, which was used for storage (Photo 4.3 & Photo 4.4). This was accessed through the large wooden door on the western side of the building (Photo 4.4). Two rooms had been created on the eastern side of the building, one on the ground floor and another on the first floor, reached by a wooden ramp (Photo 4.5).

**PHOTO 4.3 & 4.4. WALLS LINED WITH CHIP BOARD TO CREATE A LARGE DOUBLE STOREY HEIGHT ROOM**

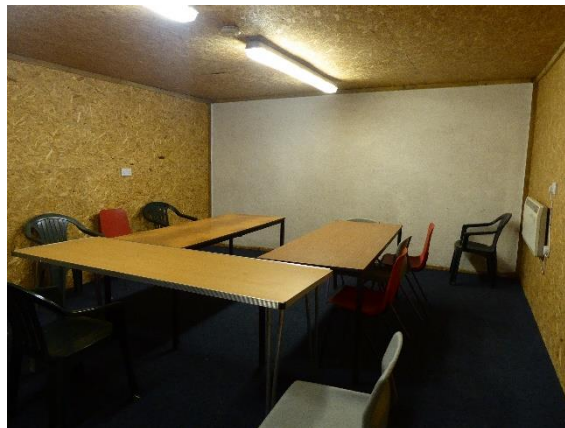
**PHOTO 4.5. FIRST FLOOR ROOM**
