# Arboricultural Report

## Safety and Condition Survey

**The Woodlands  
Worthenbury  
Wrexham  
LL13 0AW**

Date: 3<sup>rd</sup> April 2018

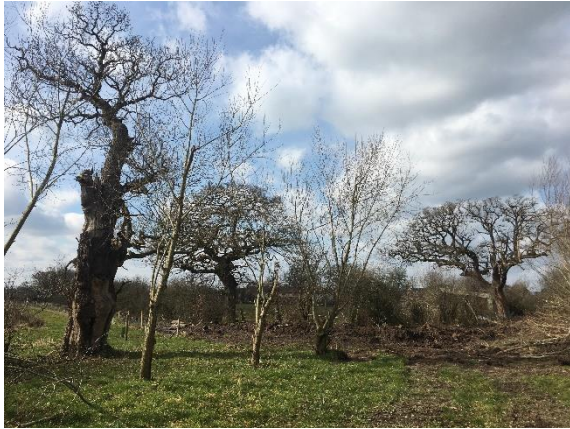
Photograph of T1, T2, T3

| Ref | Age | Species | Height (m) | Diameter at breast height DBH (mm) | Radial crown spread (m) | Condition | Observations | Recommendations | Priority |
|---|---|---|---|---|---|---|---|---|---|
| T1 | M | Oak | 15.8 | ~ 1000 | 8.5 | C/D | Extensive basal decay extending up to the scaffold union at circa 4m.<br>Extensive dieback (re-trenching) evident throughout the crown. | Reduce to a habitat stick of circa 6m in height using coronet cuts where practicable to maintain / create habitat potential for bats etc. | Moderate (6-12M) |
