## RSA Designer Response

### ROAD SAFETY AUDIT STAGE 1/2

| <b>Project Title</b> | Llay S278 |

# **STRAIGHT MILE, GRESFORD ROAD AND CROWN CROSSROADS, LLAY PROPOSED SECTION 278 HIGHWAY WORKS**

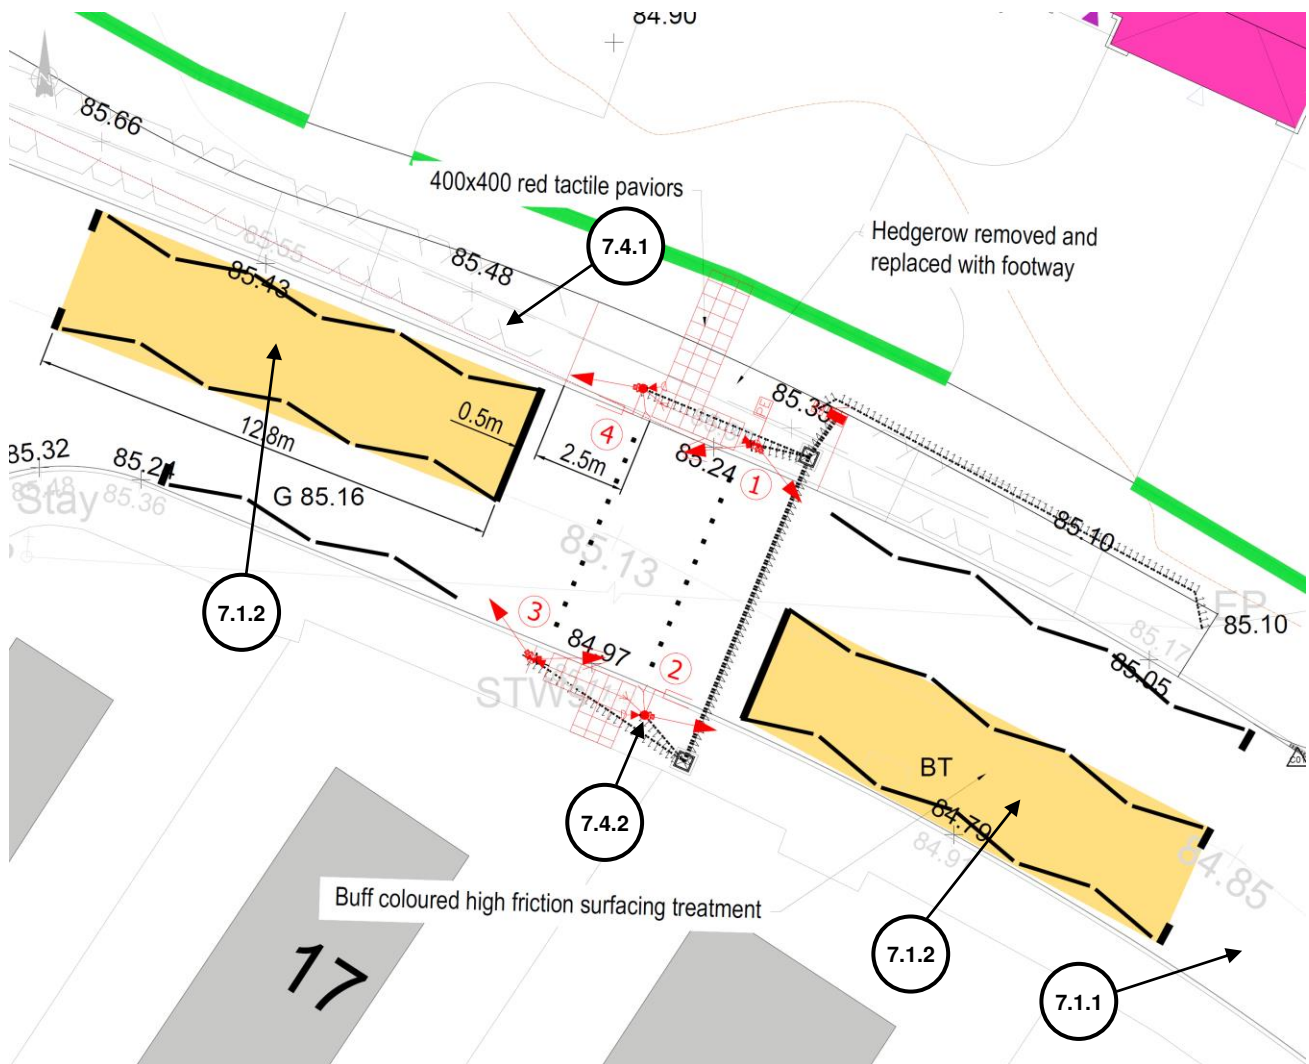
### 12.1 STRAIGHT MILE

| Problem Identified (Paragraph No) | Problem Accepted (YES/NO) | Recommendation Accepted (YES/NO/PART) | Response/Action (describe) |
|---|---|---|---|
| <p>6.3.1 Location: Straight Mile at proposed junction</p> <p><b>Problem</b></p> <p>Summary: Possible narrow lane widths through junction</p> <p>The drawing provided for audit does not show the proposed lane widths on Straight Mile through the proposed junction. If adequate lane widths are not provided for vehicles travelling through the junction or turning right, then there may be an increased risk of side swipe collisions or head-on collisions if vehicles are overhanging into the opposing traffic lanes.</p> <p><b>Recommendation</b></p> <p>The lane widths should be checked to ensure they are wide enough to allow all vehicles travelling through the junction adequate space without overhanging into opposing lanes, and modifications made to the design if wider lanes are required.</p> | N | Y | <p>The through lane widths on Straight Mile are as existing at 3.3m.</p> <p>The right turn lane width is 3.5m.</p> <p>Dimensions to be added to relevant drawing(s).</p> <p>No design modifications required.</p> |

| Problem Identified (Paragraph No) | Problem Accepted (YES/NO) | Recommendation Accepted (YES/NO/PART) | Response/Action (describe) |
|---|---|---|---|
| <p>6.3.2 Location: Straight Mile at proposed junction</p> <p><b>Problem</b></p> <p>Summary: Possible reduced junction intervisibility due to existing vertical road alignment on Straight Mile</p> <p>It was observed during the site visit that the proposed junction is located to the west of an existing blind summit on Straight Mile. This may result in the visibility splay to the east of the junction being reduced due to the blind summit. A reduction in intervisibility at the proposed junction may increase the risk of collisions between those turning out of the access road and those travelling along Straight Mile. Additionally, this may also increase the risk of rear end shunt collisions on Straight Mile due to westbound drivers unaware of vehicles braking for the junction just over the blind summit.</p> <p><b>Recommendation</b></p> <p>The appropriate junction intervisibility splays in both the horizontal and vertical planes should be checked to ensure suitable intervisibility is provided between the proposed access and those travelling along Straight Mile. Amendments to the junction location should be carried out if appropriate intervisibility cannot be provided at its current location.</p> | N | P | <p>The location of the junction on Straight Mile is situated on a stretch of road that falls continuously from west to east for greater than 120 metres in each direction (as indicated by the road levels on drg. 9501).</p> <p>Intervisibility splays, both horizontally and vertically, comply with the requirements for a 40mph speed limit.</p> <p>No design modifications required.</p> |
