## **STRUCTURAL APPRAISAL**

### **THE DYMOCK ARMS PENLEY**

**SEPTEMBER 14, 2019**

## **THE DYMOCK ARMS UPDATED REPORT SEPTEMBER 2019**

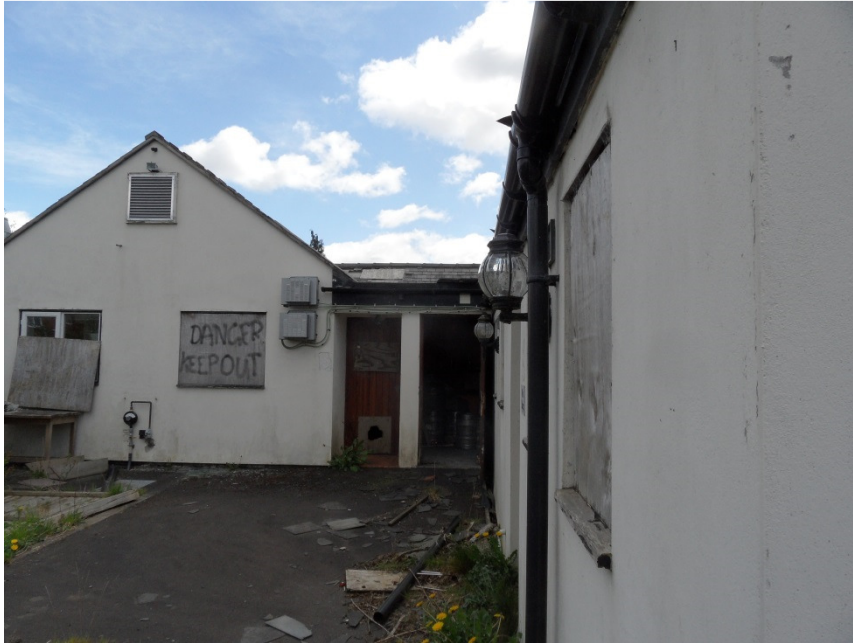
- 5.1 This is split into two portions again with that to the left hand side set back comprising a gable elevation of single storey construction with two windows set within and a vent aperture at the ridge position
