5th June 2019

Ref: K0871/pw

**WILLIAMS FARM: WREXHAM INDUSTRIAL ESTATE:  
REVIEW OF DRAINAGE MEASURES**

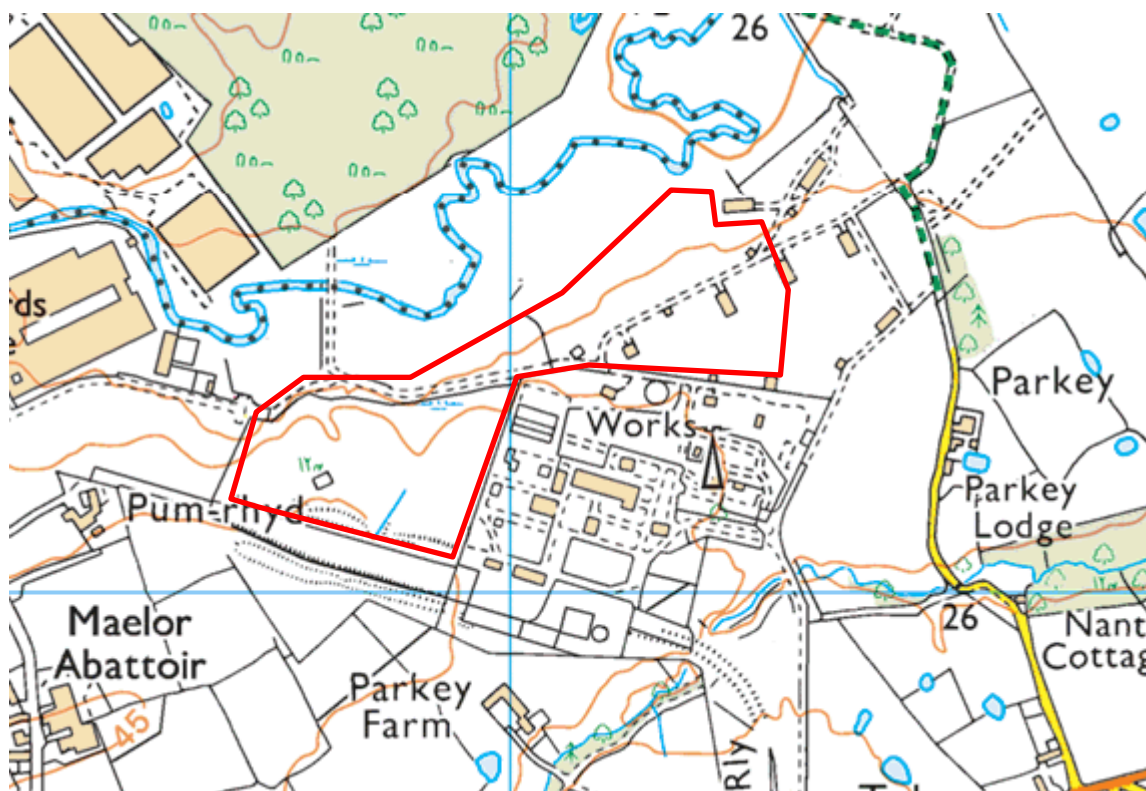
**Figure 1: Topography of Site**

The topography of the Site is shown in Figure 1; this shows that the solar farm is located on northerly facing slopes that drain towards the River Clywedog. The contours show that the highest point on the southern boundary is at around 40 mAOD, whilst the lowest point on the north western boundary is between 20 and 25 mAOD.

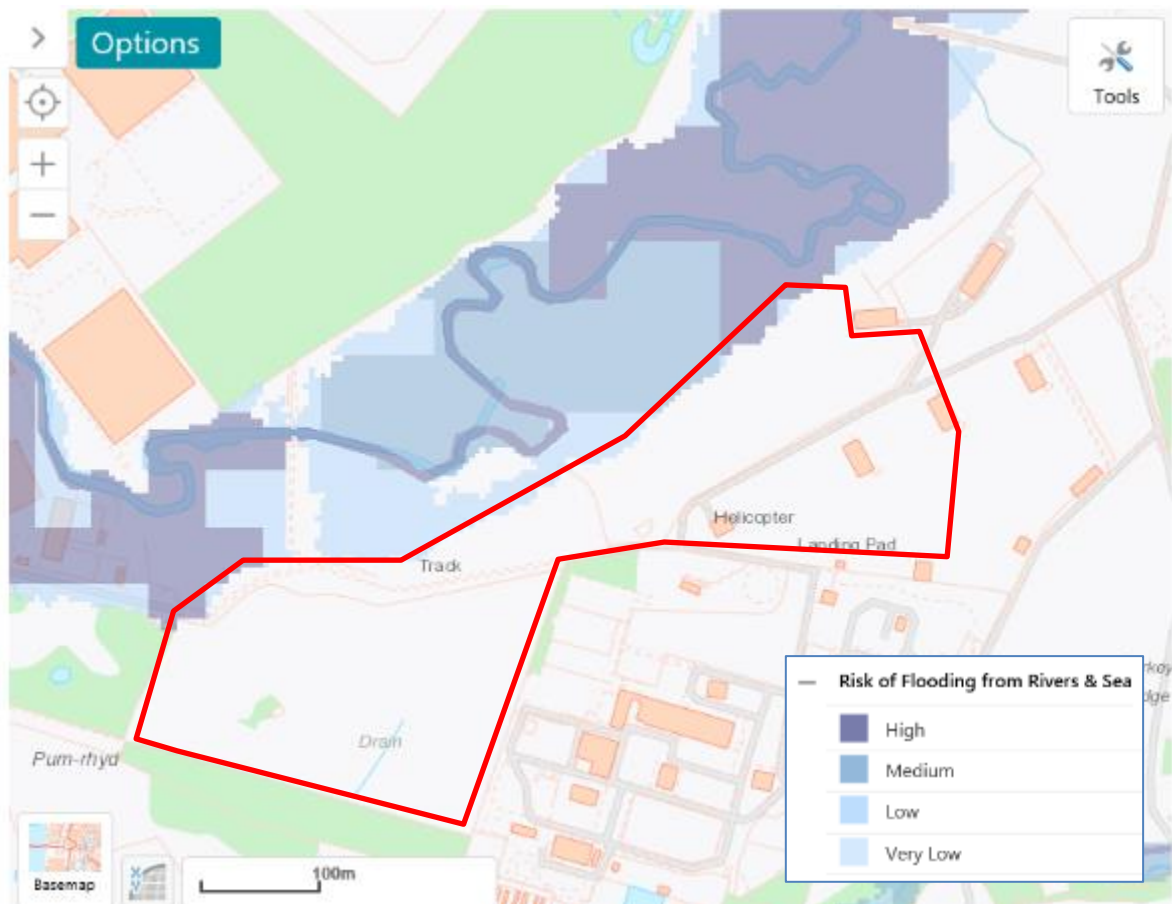
**Figure 3: Fluvial Flood Risk (NRW Web Site )**

Extracts from the NRW (Natural Resources Wales) Web Site are given in Figure 3 for Fluvial Flood Risk and Figure 4 for Surface Water Flood Risk. This shows that the Site lies almost entirely within Fluvial Flood Zone 1, with an annual exceedance probability (AEP) of flooding of lower than 0.1% (very low category). There is minor encroachment into flood zones along the north western boundary, but this is of no practical consequence. The majority of the Site is at very low risk of surface water flooding being unshaded in Figure 4. The exception is a small area on the north western margin where there is a high risk.

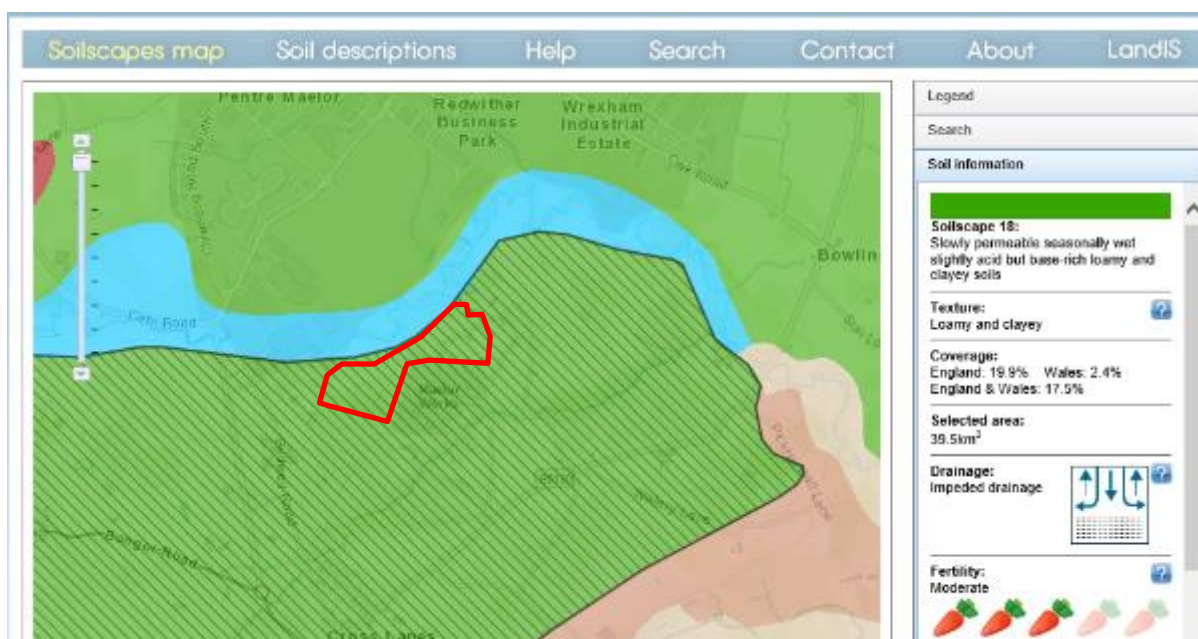
**Figure 5: Soil Properties (NSRI Soilscape Website) - approximate boundary shown in red**

The soil properties for the Site are illustrated in Figure 5 from the NSRI Soilscape web site. This shows that the soils are “slowly permeable and seasonally wet”. This is relevant to the viability of swales since it gives a strong indication that infiltration swales would be unlikely to be an effective drainage measure. This consistent with infiltration testing that was reported in the SWMP.
