## SALEM CHAPEL

# BAT INSPECTION AND EMERGENCE SURVEY

## UPDATED NOVEMBER 2018

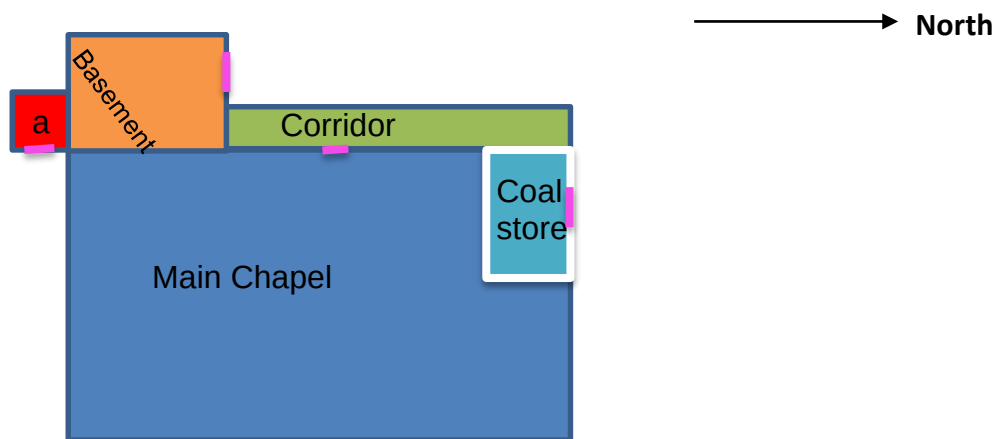
**Figure 16 – a diagram to illustrate the layout of the Chapel**

In the basement of the house many more droppings were found on the floor, these appeared to be Lesser horseshoe droppings. A Lesser horseshoe bat was then discovered in the porch area of the basement (figure 4), which was hanging up, this then flew into the corridor, there was a high concentration of bat droppings in this porch area. Two bats were observed flying whilst we were in the basement. One was later seen hanging up above the stairs to the coal bunker area and another underneath the pulpit. Figure 1 illustrates the layout of the Chapel. The pink lines illustrate the windows and door as described above.

When the loft space was accessed only two bats were visible from the loft hatch (to the south of the building) suggesting most of the bats were present in the northern area of the roof.
