## **Appendix F – Metro Rod Wincan Report**

## CCTV SURVEY REPORT

| Site Address: | Ipsen Biopharm, Ash Road North, Wrexham, LL13 9UF |

Project Name Opus Ipsen Biopharm 396204

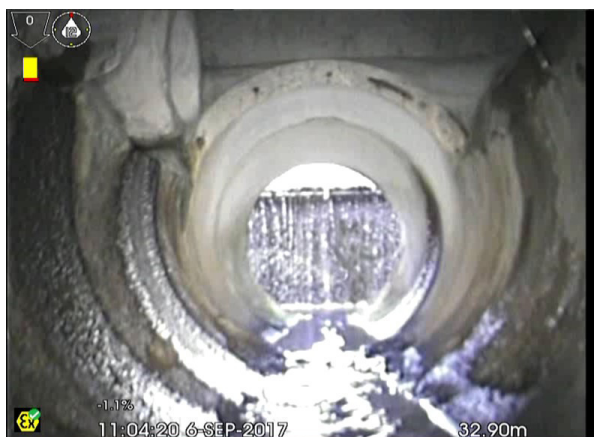
C3\_H.wallX\_cae23a6f-c0cc-48f1-a634-35f3af4b8d59\_20170912\_083506\_942.jpg, 00:01:40, 8.99m  
Attached deposits, encrustation from 5 o'clock to 7 o'clock, 5% cross-sectional area loss
