# Conversion of Outbuildings, Charity Farm, Haighton La, Bangor-on-Dee, Wrexham

## Structural Appraisal Report

June 2017

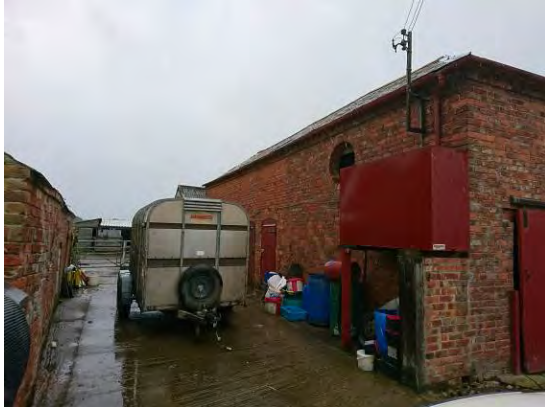
Photo 1 – Outbuilding Front Elevation.

The elevations comprise brickwork to full height. The lintels to window and door openings are a mixture of brick arches, timber sections and concrete units. Roof finishes comprise slate throughout with clay ridge tiles and pointed verges. Windows comprise single glazing in steel frames with a timber leaves and frames provided to the door openings (see Photos 1 – 5). A large opening on the front elevation has been infilled in the past to form two smaller door openings.

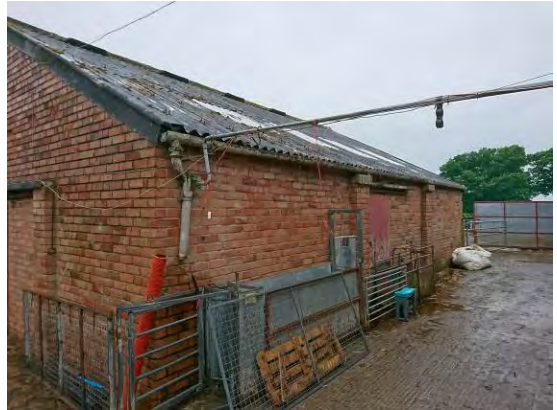
Photo 15 – Shippon Right Hand Side Elevation.

The elevations comprise brickwork to full height. The lintels and cills to high level window openings comprise precast concrete units. Lintels to low level openings comprise insitu concrete beams with short external overhangs. Roof finishes comprise asbestos cement sheeting. Windows comprise single glazing in steel frames, doors comprise timber leaves supported by top runners (see Photos 14 – 17).

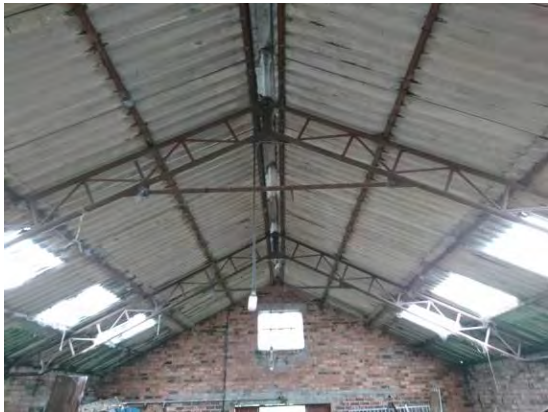
Photo 18 – Typical view of roof construction.

The interior of the shippon comprises a single open room. The floor comprises a stepped concrete ground bearing slab. Walls generally comprise bare brickwork with areas of cement render at low level. An insitu concrete ring beam is provided above the door openings on the front and rear elevations. The roof over comprises asbestos cement sheeting supported off tubular purlins spanning between fabricated steel truss frames (see Photo 18).
