**LAND OFF PONT ADAM CRESCENT  
RUABON, WREXHAM**

**PRELIMINARY BAT SURVEY REPORT**

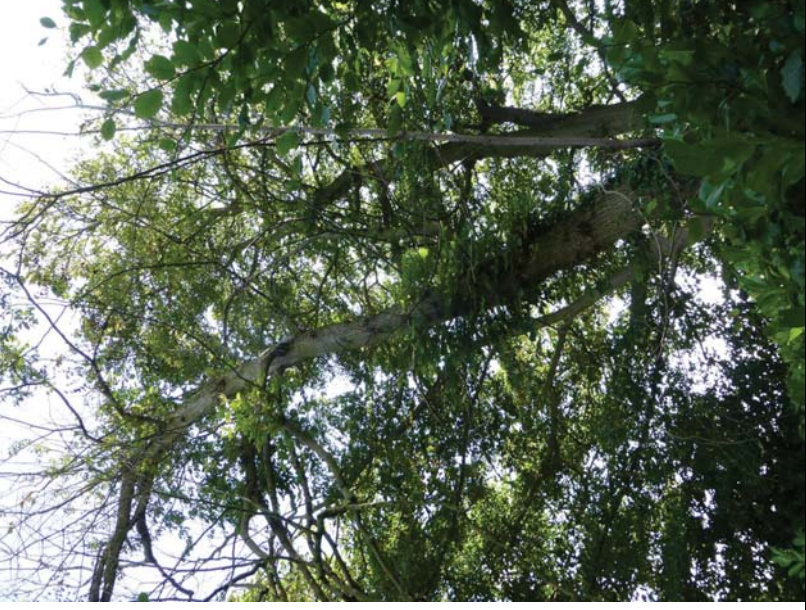
| T13 | <i>Betula pubescens</i> | <p>A mature silver birch tree, located on the adjacent property. The tree has a large rambling rose hanging from it, which rather obscures the trunk. The tree has some ivy cover, but has no apparent holes or broken branches.</p> | 3 | |

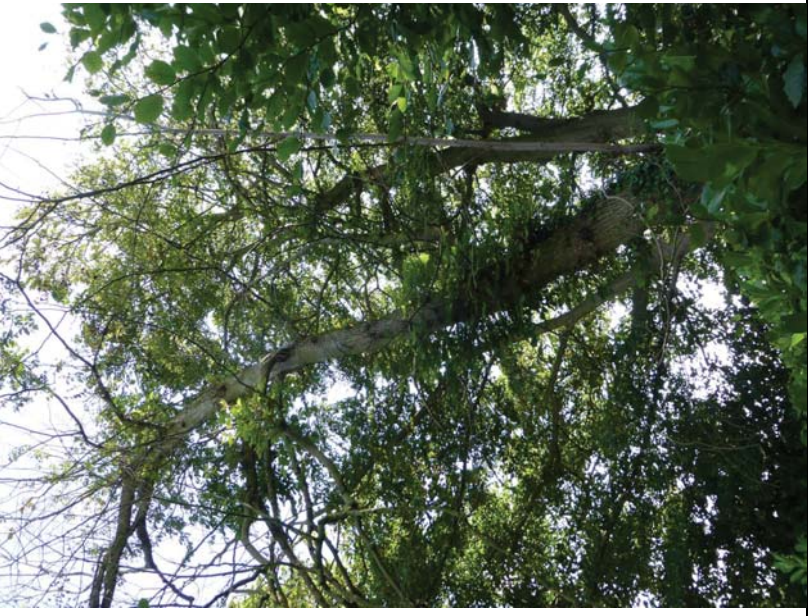
T16

Multi stemmed beech tree with missing branches and at least one hole. Difficult to inspect because it is located on the adjacent property. A small hole can be seen at a height of approximately 4m. The hole was obscured by a branch and could not be fully assessed.

2

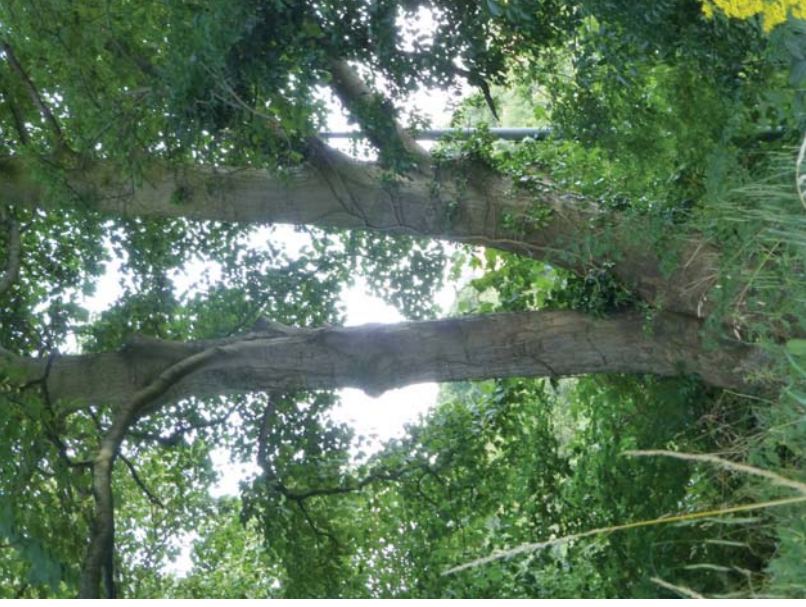
| T17 | <i>Acer pseudoplatanus</i> | <p>Two conjoined sycamore trees, or two co-dominant stems of the same tree. Located at the top of a steep bank. The roots are exposed as a result of people climbing up the bank to take a short cut to Pont Adam Crescent. A few lower branches are missing, but there are no obvious holes in the tree. The base of one missing branch is pointing upwards and probably holds water in the winter. May need to be inspected if the tree is felled.</p> | 3 | |

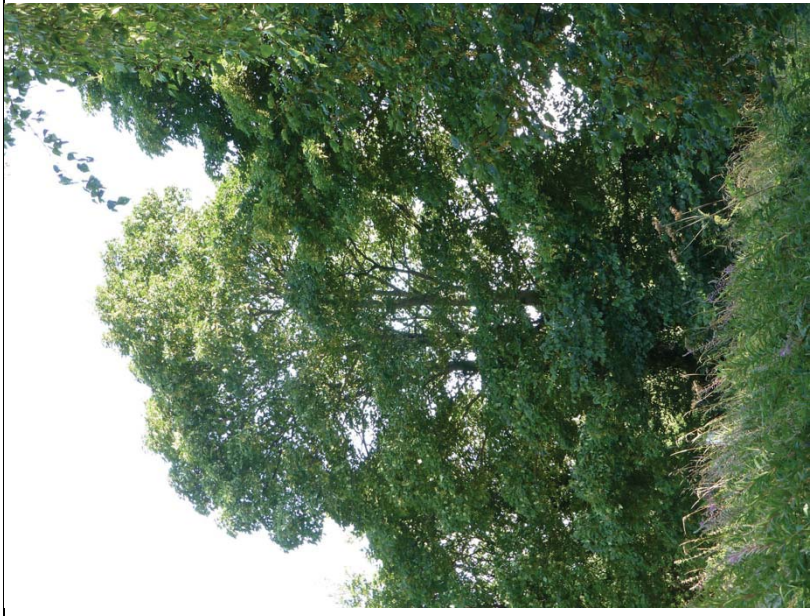
T18

Young sycamore tree with ivy on the trunk. No broken branches or holes were apparent.

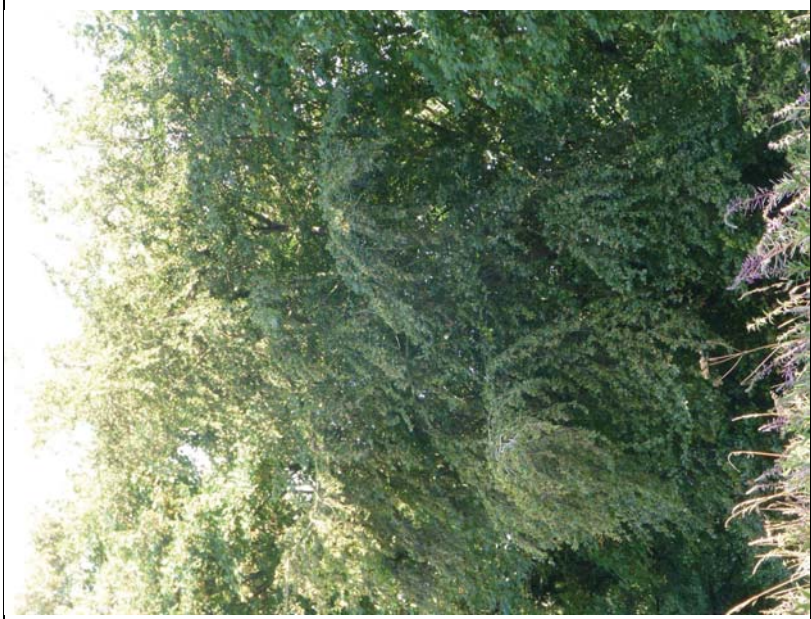
| T19 | <i>Fagus sylvatica</i> | Young beech tree, without any obvious bat potential. There are no broken limbs and no holes in the trunk. Ivy has just started to colonise the tree, but only extends for 3-4m up the trunk. | 3 | |

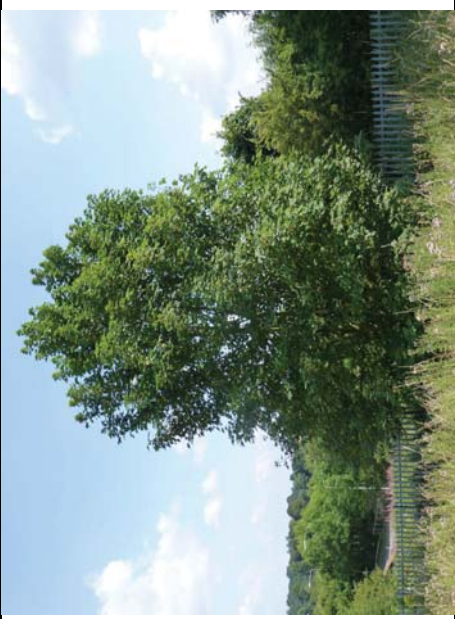
| T20 | <i>Acer pseudoplatanus</i> | Coppiced sycamore tree, without any bat potential. | 3 | |

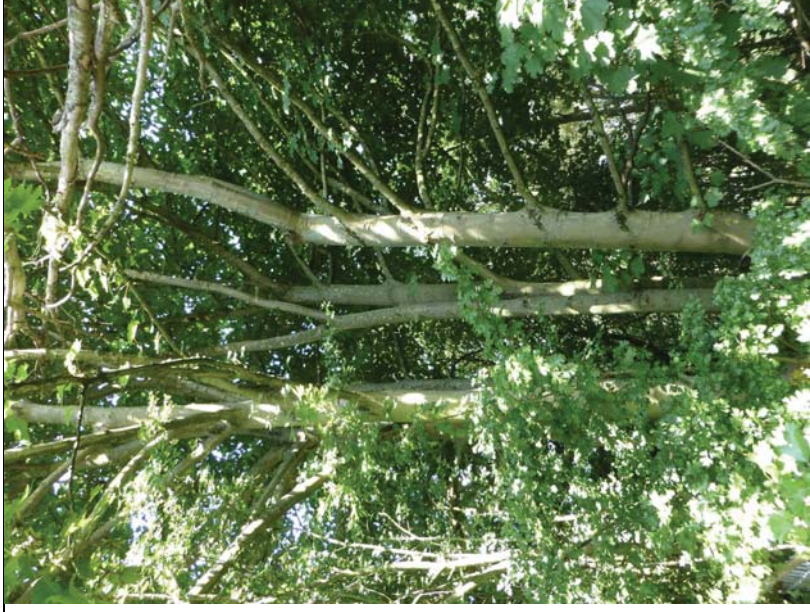
T21

Coppiced sycamore tree with seven stems. No bat potential. These are healthy, although one upper branch has died. This may have left a cavity, but it is upward facing and probably fills with water in the winter. The tree is growing on railway property.

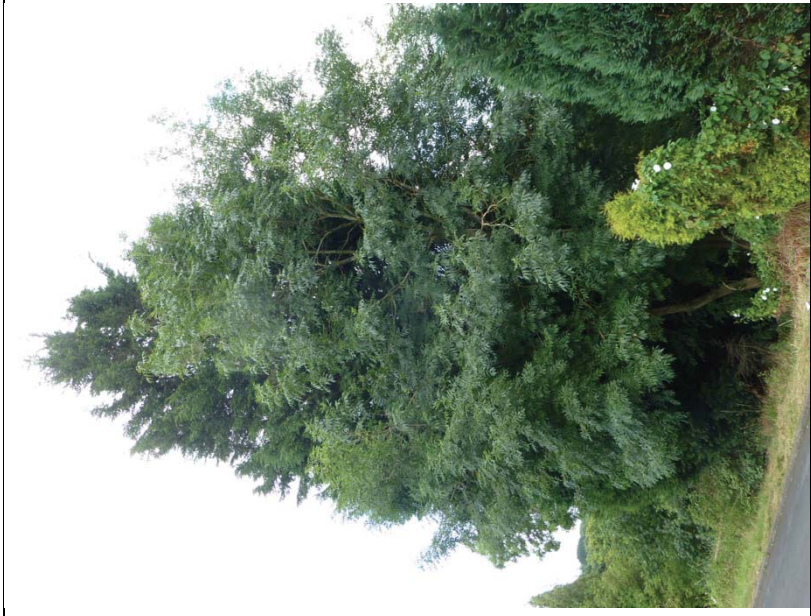
| T22 | <i>Fraxinus excelsior</i> | Coppiced ash tree, with no bat potential. | 3 | |

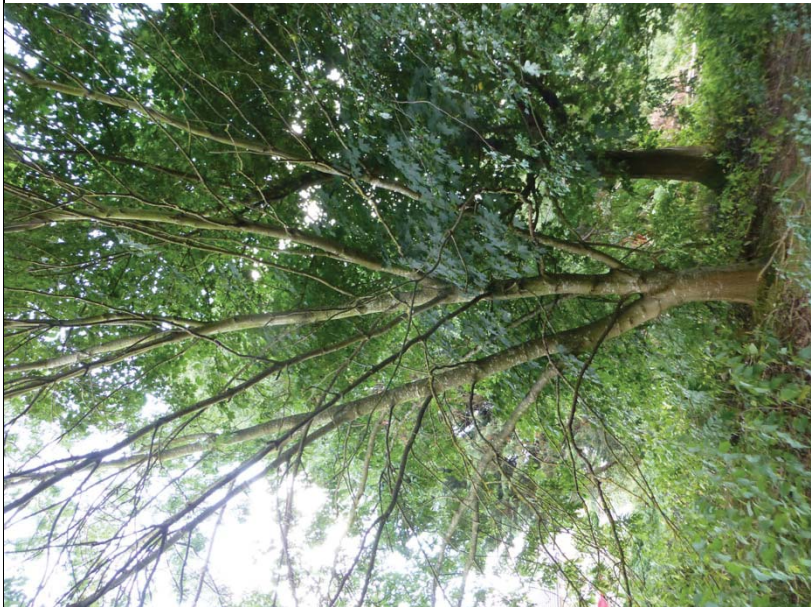
| T26 | <i>Fraxinus excelsior</i> | A young ash tree, which is branched at a height of approximately 1m above the ground. There are no missing branches or holes in the tree. No bat potential. | 3 | |

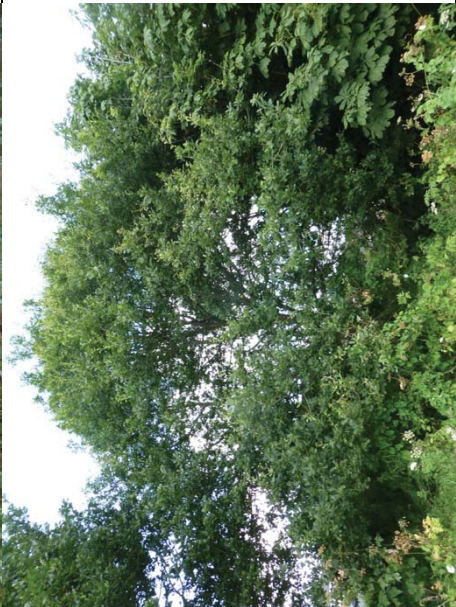
| T27 | <i>Quercus robur</i> | Young oak tree with no broken branches or holes. Tree should be retained. | 3 | |

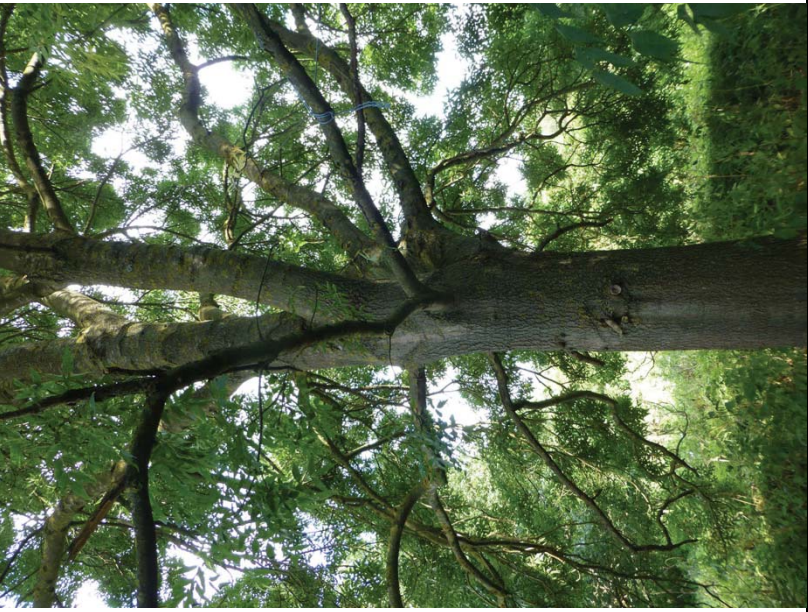
T28

Young oak tree, with no broken branches or holes. Tree should be retained.

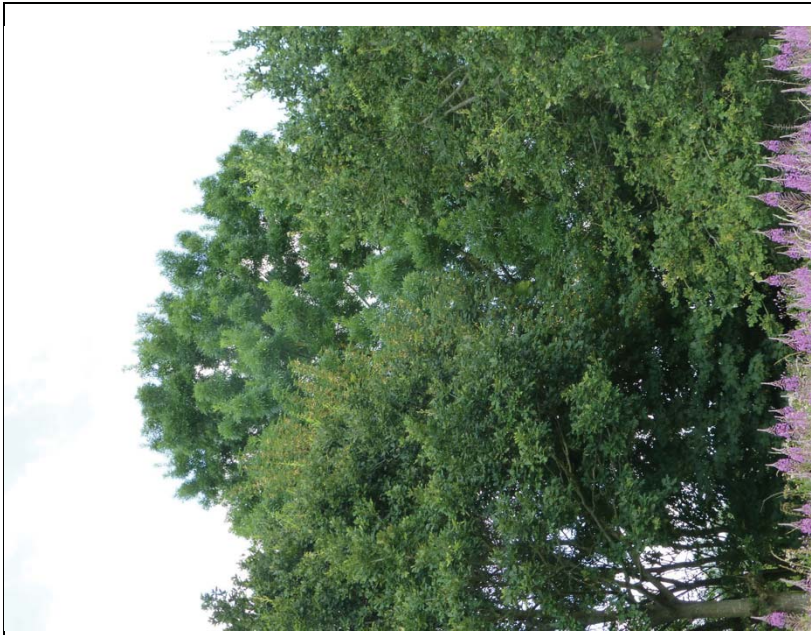
| T29 | <i>Fraxinus excelsior</i> | Healthy standard ash tree. No obvious holes and no missing branches. | 3 | |

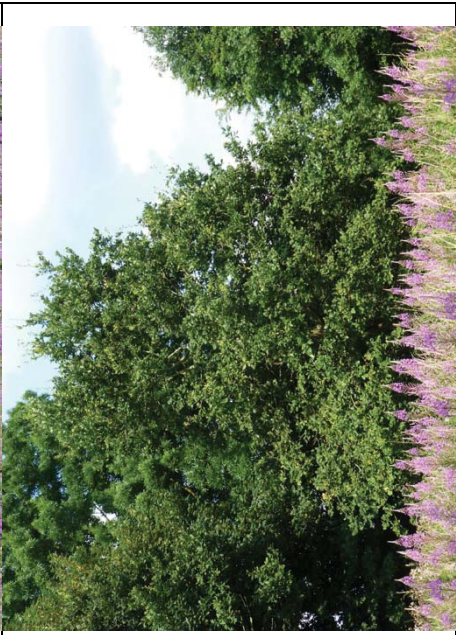
| T30 | <i>Quercus</i> species | Young standard oak with bird box attached. No bat potential. | 3 | |

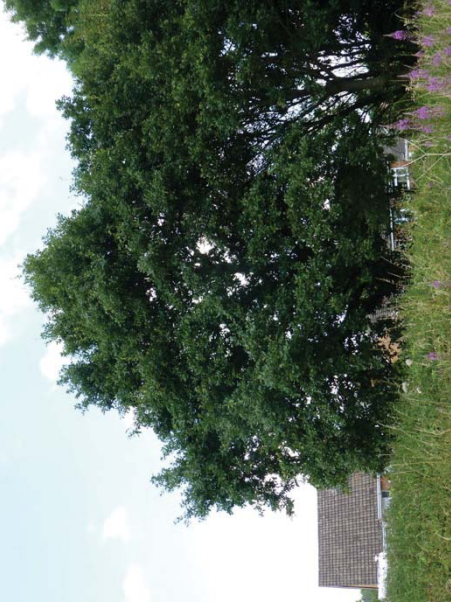
| T31 | Quercus species | Coppiced oak tree with two main stems.<br>No bat potential. Has a bird box attached. | 3 | |

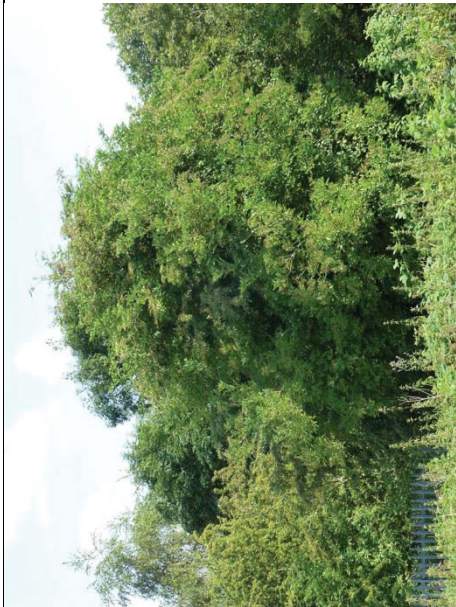
| T33 | <i>Sambucus nigra</i> | Elder tree. No bat potential. New tree and not marked on tree survey map. | 3 | |

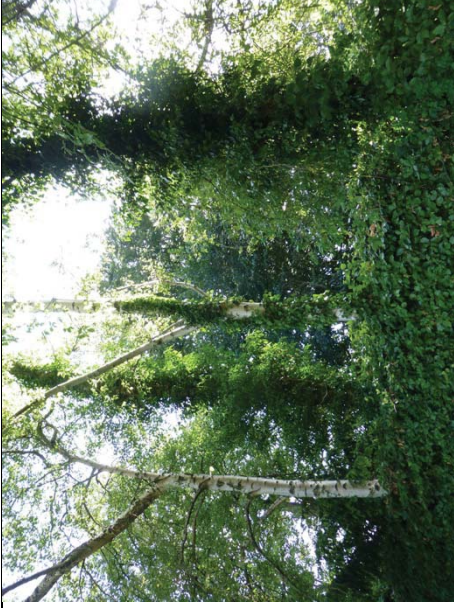
| G1 | <i>Betula pubescens</i> | <p>A group of nine birch trees originally planted as a screen against the hedge line. Two of the trees have dense ivy cover, but they are probably too small to be of any value to bats. The trees should be divided into two groups. One has four and the other five trees.</p> | 2/3 | |

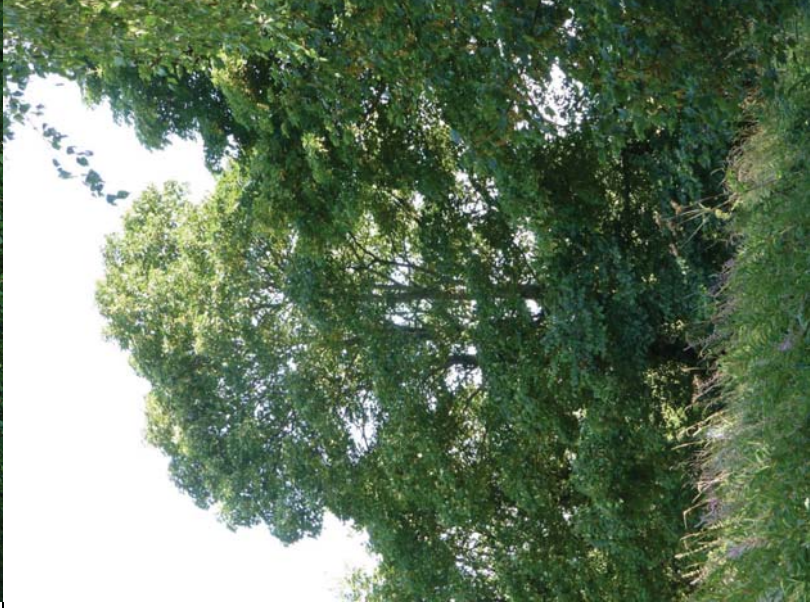
| G2 | <i>Acer pseudoplatanus</i> | <p>A group of self-sown, young sycamore trees at the top of a steep bank, forming part of the linear wooded feature. The trunks are covered by a small amount of ivy. No broken branches or holes apparent.</p> | 2/3 | |

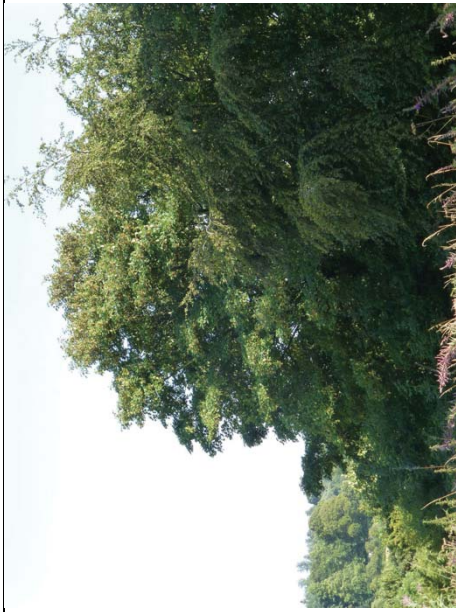
| G3 | <i>Acer pseudoplatanus</i> | A group of five young sycamore trees with a light covering of ivy on the trunks, forming part of the linear wooded feature. There was no obvious sign of holes or broken limbs. Category 2, due to ivy cover. | 2 | |

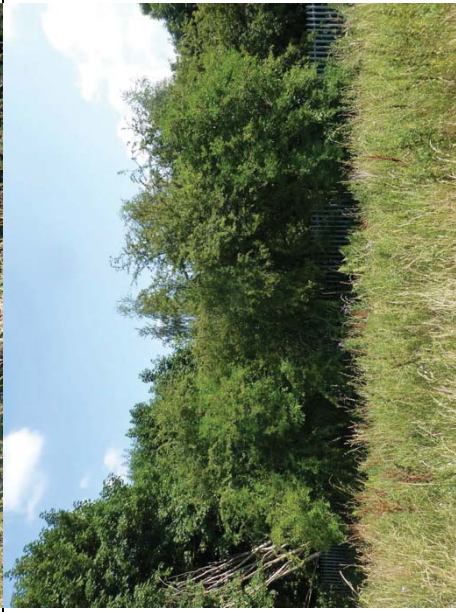
| G4 | <i>Crataegus monogyna</i><br>and <i>Sambucus nigra</i> | Group of hawthorn and elder trees growing on railway property, adjacent to the site. None of the trees has bat potential. | 3 | |

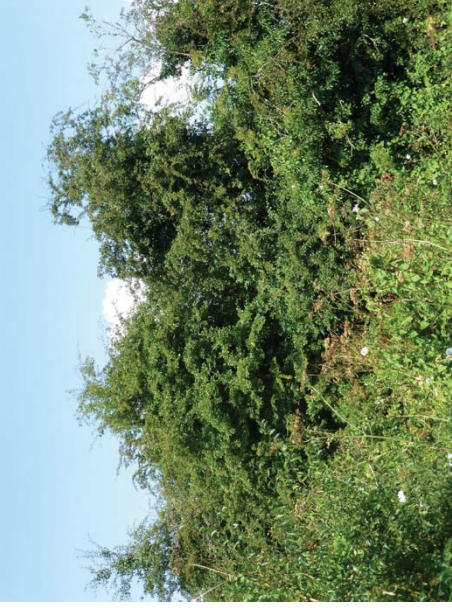
| G5 | <i>Crataegus monogyna</i> | Two groups of hedgerow hawthorn trees, with no obvious bat potential. | 3 | |

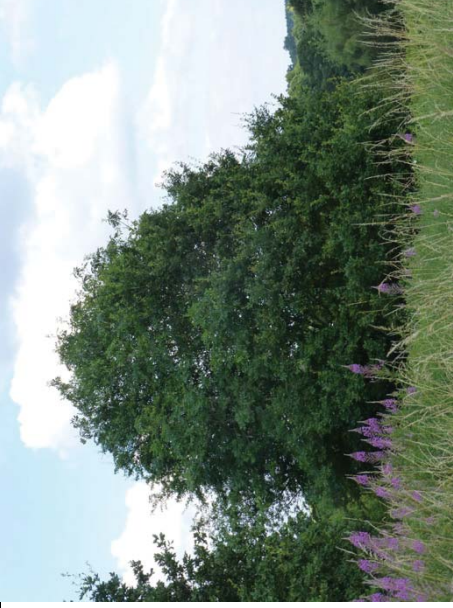
| G8 | <i>Salix caprea</i> , <i>Acer pseudoplatanus</i> and <i>Quercus</i> species. | Single goat willow, a sycamore and oak tree. No bat potential. | 3 | |
