**Condition Survey  
Ruabon Brickworks  
Haford Road  
Johnstown  
WREXHAM**

## **Condition Survey @ Johnstown, Wrexham**

**Date of survey:** Tuesday 11<sup>th</sup> August 2009  
**Weather Conditions:** Sunny and Dry  
**Undertaken By:** Robert Tait and Penny Smith

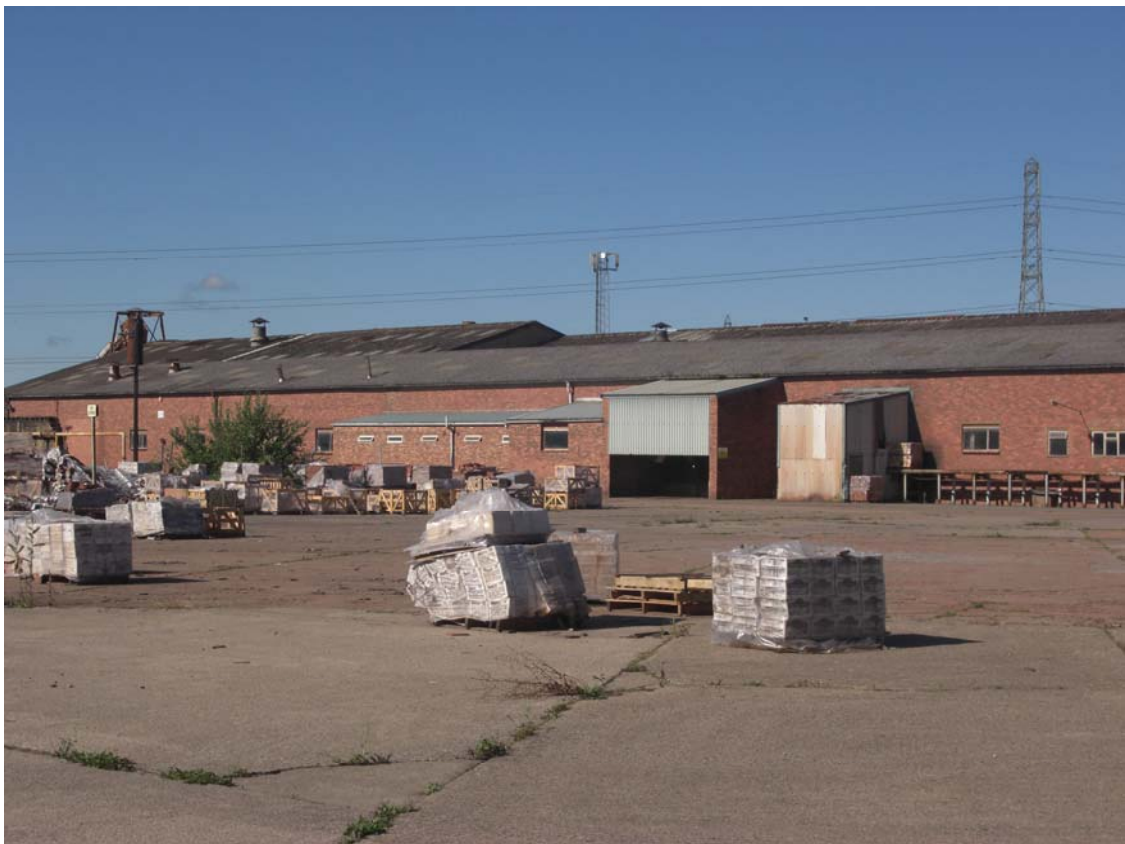
Part F View

The contemporary structures Parts E and F were in a significantly better structural condition although some isolated areas of cracking was noted in E part around SE corner.

The contemporary structures E and F are in a substantially adequate structural condition although these are essentially basic industrial buildings with floor slab arrangements highly customized for their current usage.

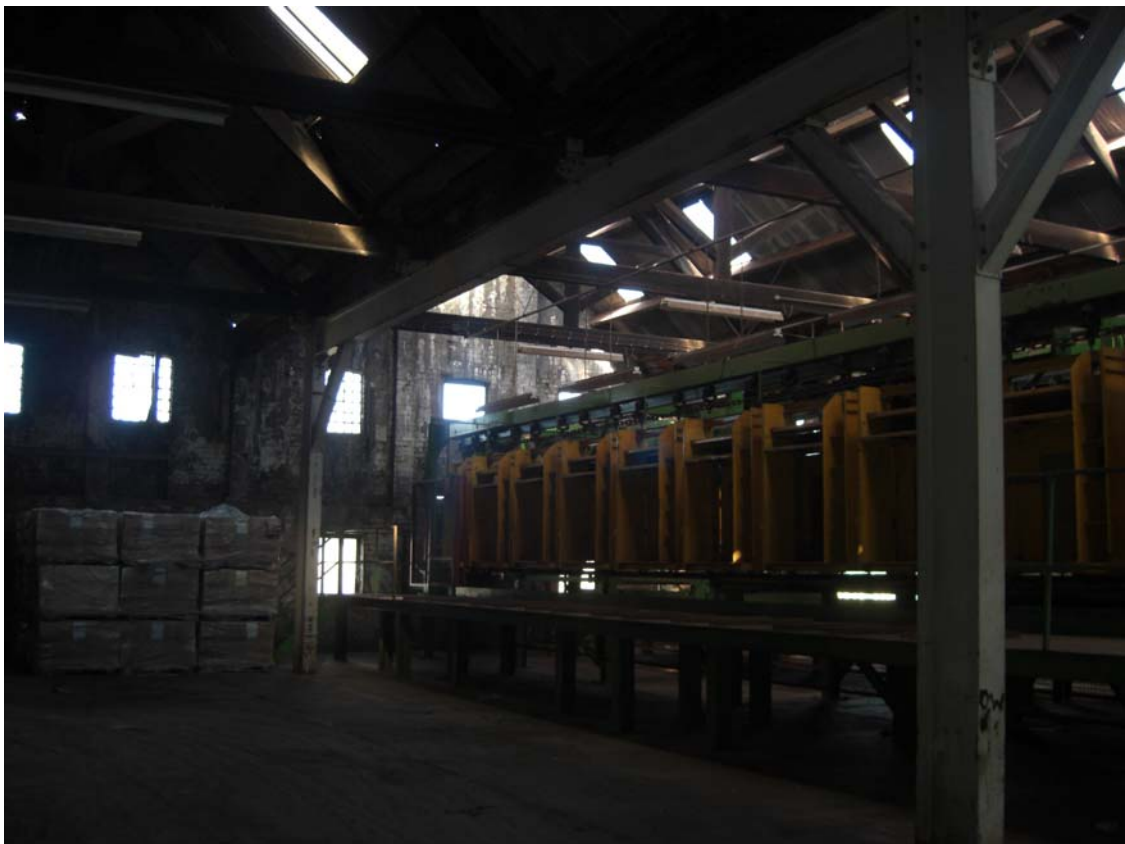
Open Internal Area Part A

Much of the structure of Part A was covered due to it's fitting out as either offices or a canteen. The open areas however were considered to be similar to parts B and C in terms of water penetration and resulting timber decay. In the finished areas significant low level damp was apparent.

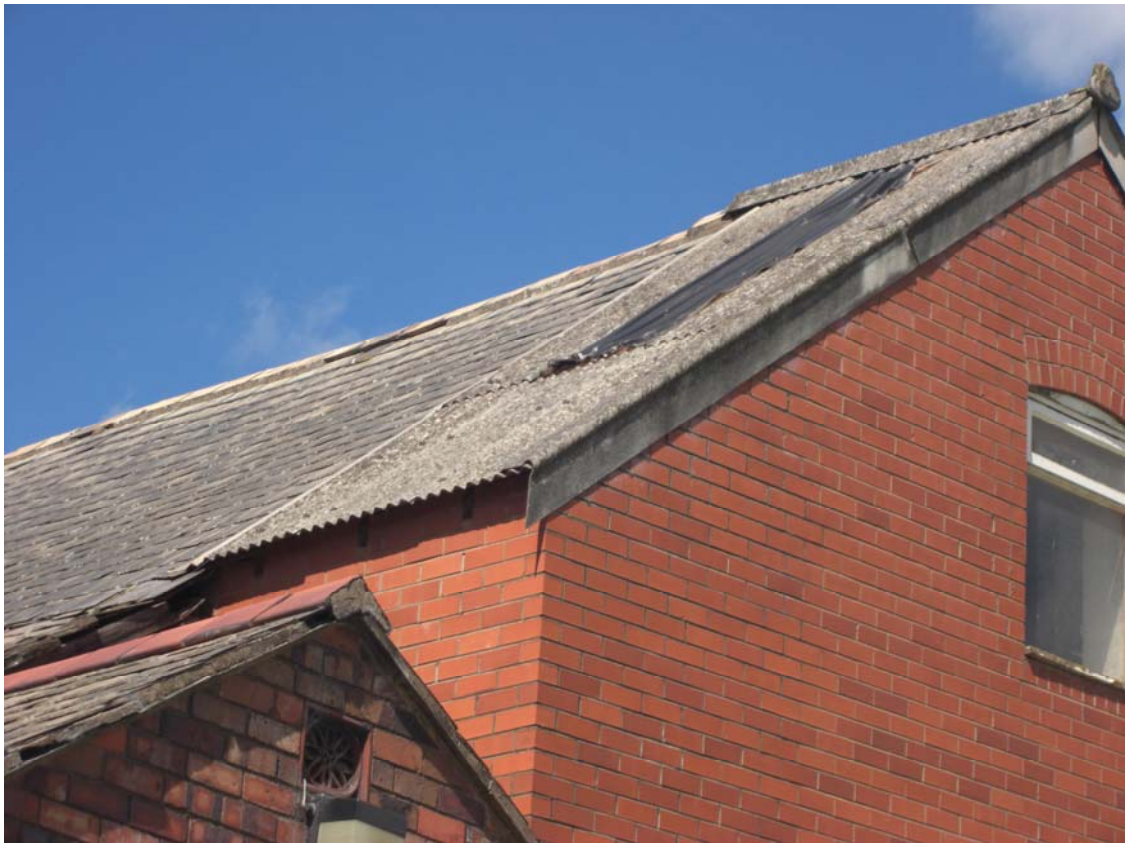
Front Extension Part C

Area C has also been extended to the East, this time over its entire length with the original front wall being replaced by steel columns. The front load bearing wall appears to be more modern and is a combined brick/ concrete block construction.

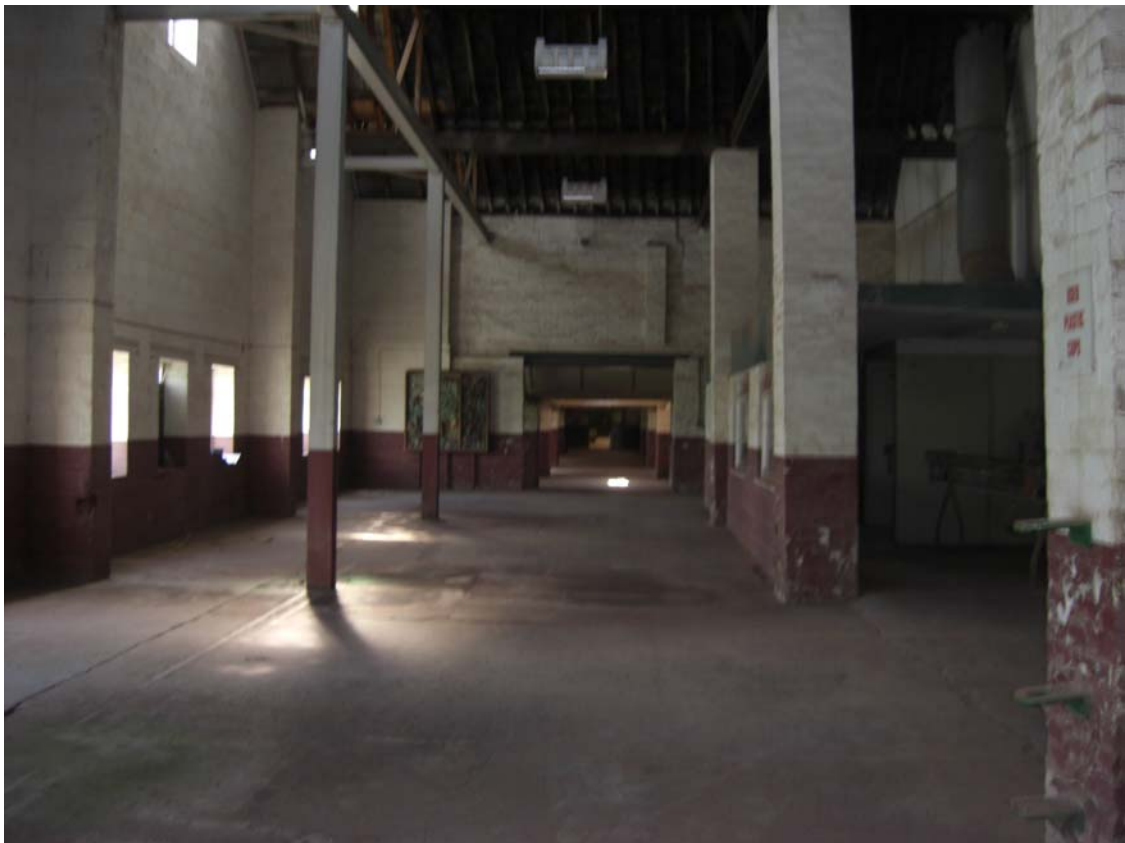
Internal Part C

Part C exhibits many of the defects noted in B although the level of maintenance may be somewhat improved. Significant water penetration still prevailed however with resulting timber decay. In addition to high level water penetration significant low level damp was also noted. Very severe out of plumb was noted to the west upper gables where a timber runway structure was attached.

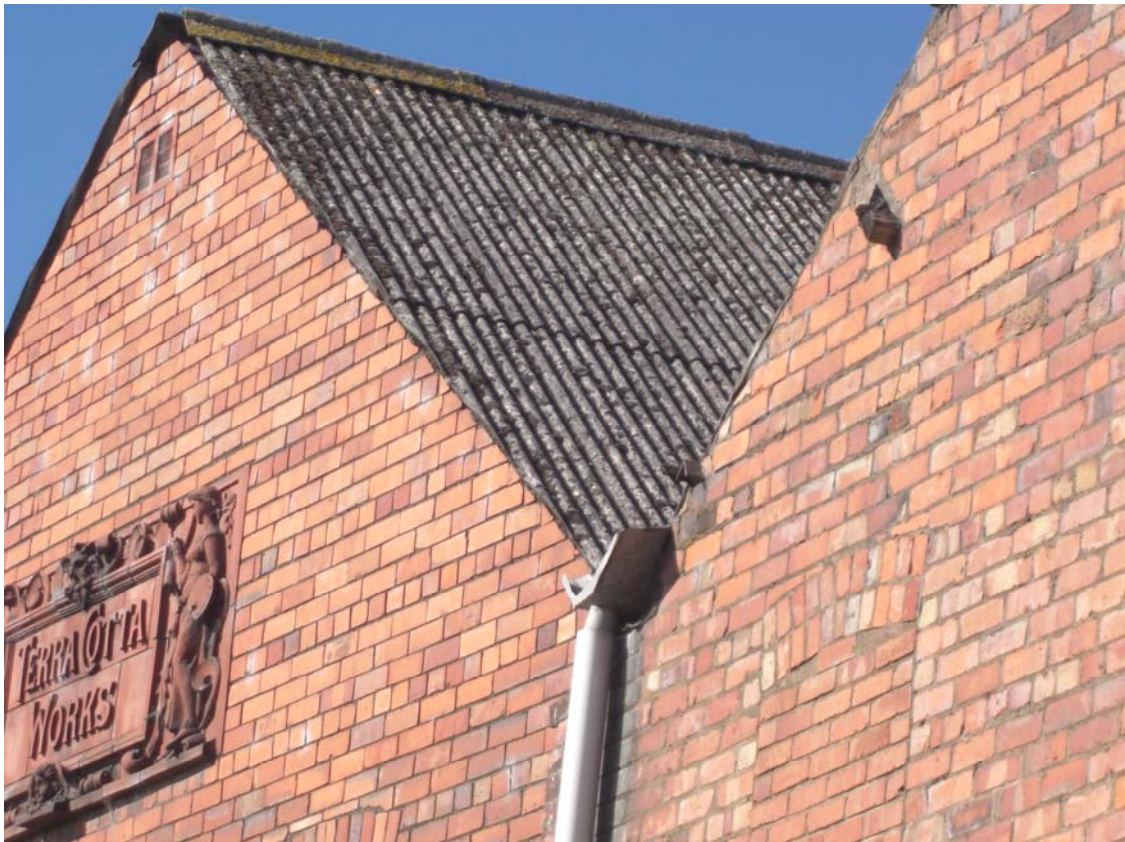
Typical Roof Tiling / Internal Gutter
