Site Investigation Report  
for land at  
Cwrt Pentwmpath,  
Llay

For: Castlemead Group Limited  
Abenbury House  
17 Wilkinson Business Park  
Clywedog Road South  
Wrexham  
LL13 9AE

21<sup>st</sup> December 2022

Site Investigation Report for land at  
Cwrt Pentwmpath, Llay

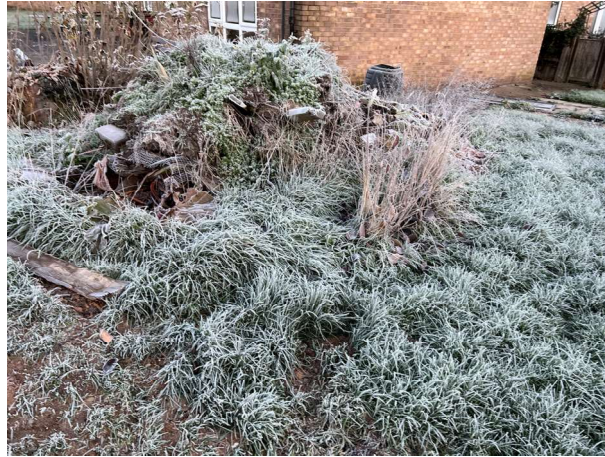
*Photograph 5: Waste heap in west of site*

The site was surrounded by board fencing along the western boundary, which followed part of the access road. The private gardens were fenced off with mesh and board fences. Rail fencing followed the access paths and access road. A waste heap, covering an area approximately 1m x 1m, including soil, wire mesh, wooden planks and concrete was located to the west of the site (see Photograph 5).

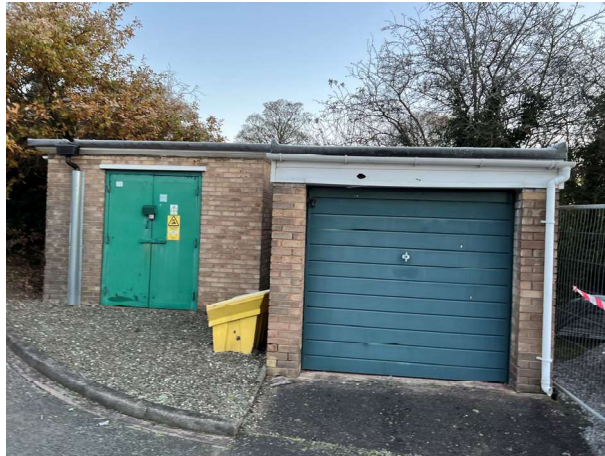
*Photograph 6: View to the north west*

An electrical sub-station was located immediately next to the garage (see Photograph 6) and backing onto the central part of eastern boundary. A coarse limestone gravel, clear of vegetation, was present around the sub-station with turf beyond the gravel surround to the northern side. No evidence of possible contamination was observed around the outside of the sub-station.

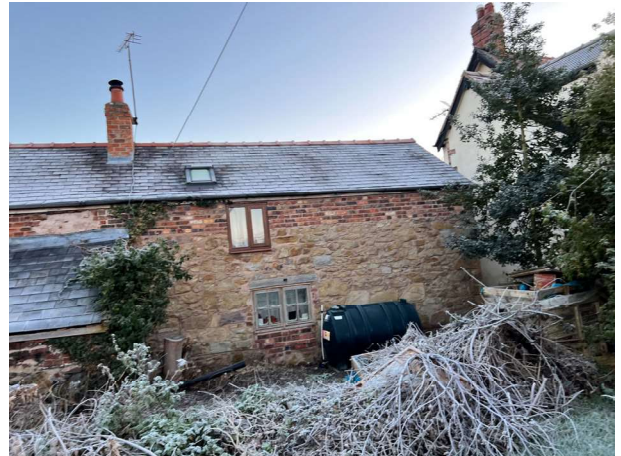
*Photograph 7: View to the south east across the current car park*

As shown in Drawing No. 7962/AP, presented in Appendix 16, the site was bounded by Eighth Avenue to the north west and a public footpath to the south west, with residential properties beyond to the north, west and south of the site. A field was located adjacent to the north east of the site. An above ground domestic kerosene fuel tank was noted adjacent to the far south east corner of the site boundary, as shown in Photograph 7.
