## **MAES Y CAPEL, COEDPOETH, Sustainable Drainage Options**

### **Introduction**

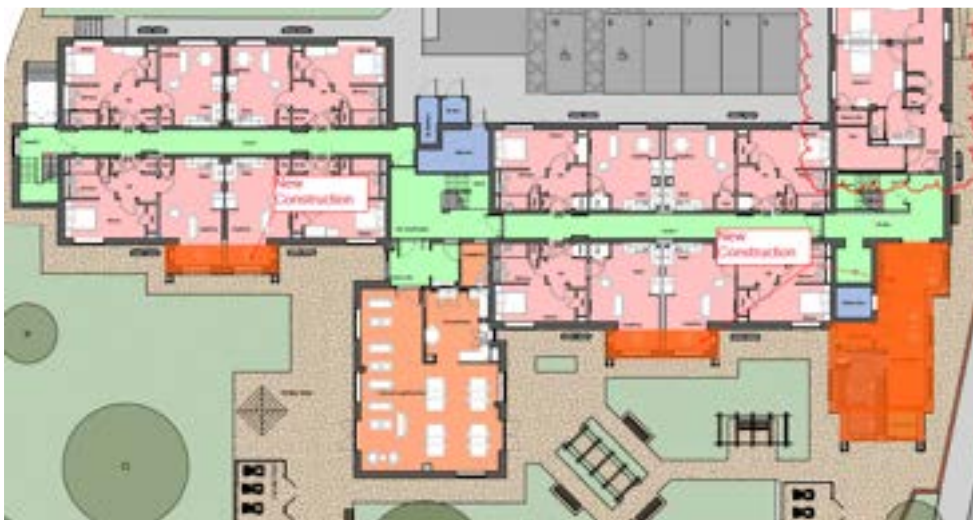
The proposed changes, recently granted planning consent for the works to Maes y Capel, Coedpoeth increase the building footprint by approximately 98m<sup>2</sup>, through the provision of two new bay windows and the addition of a new entrance/ reception area (see figure1).

Figure 1. Proposed building footprint with new areas highlighted.

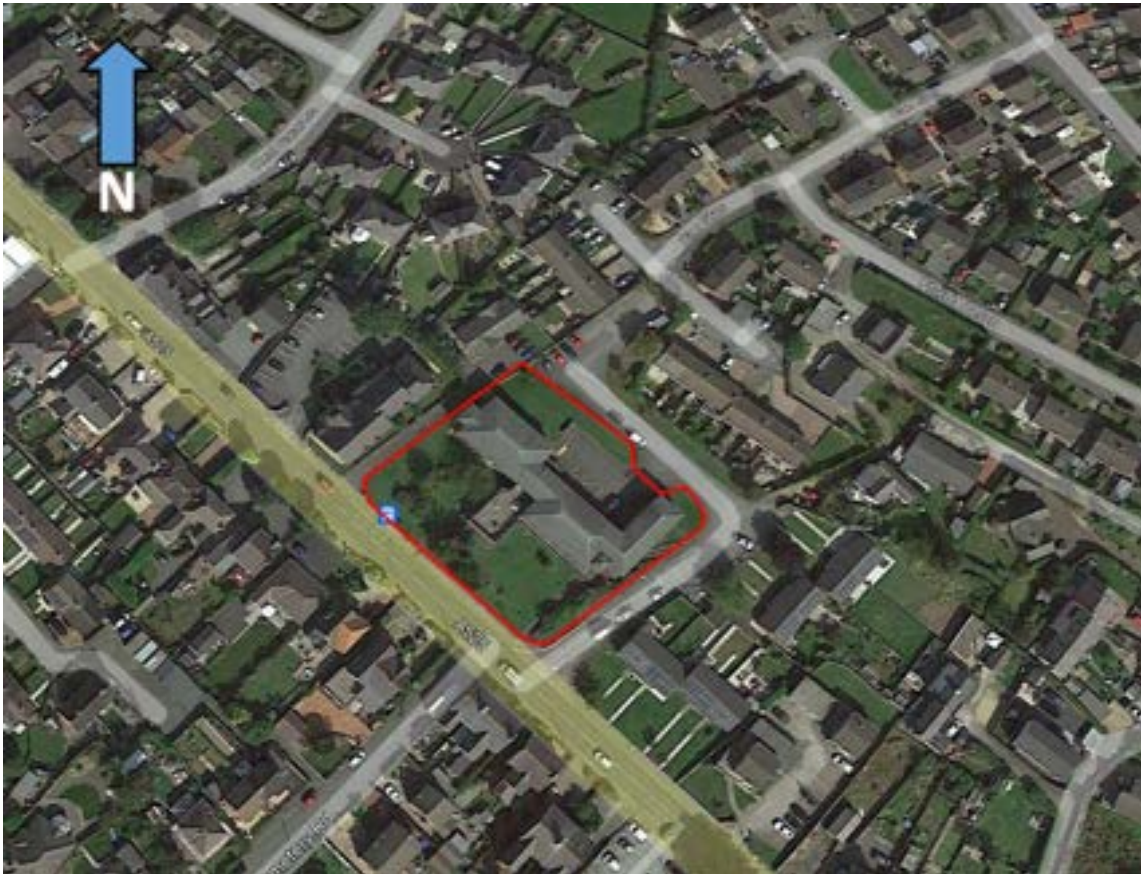
**Figure 1: Site area delineated by redline boundary**

The site is located off Greenfield Road, Coedpoeth, Wrexham, LL11 3UD, approximately 5.5km west of Wrexham town centre. The site currently comprises of an existing main building with associated infrastructure and parking and is still occupied by residents. See Figure 1 below for reference. The site is surrounded by residential housing and the A525 is located to the south of the southwest boundary.

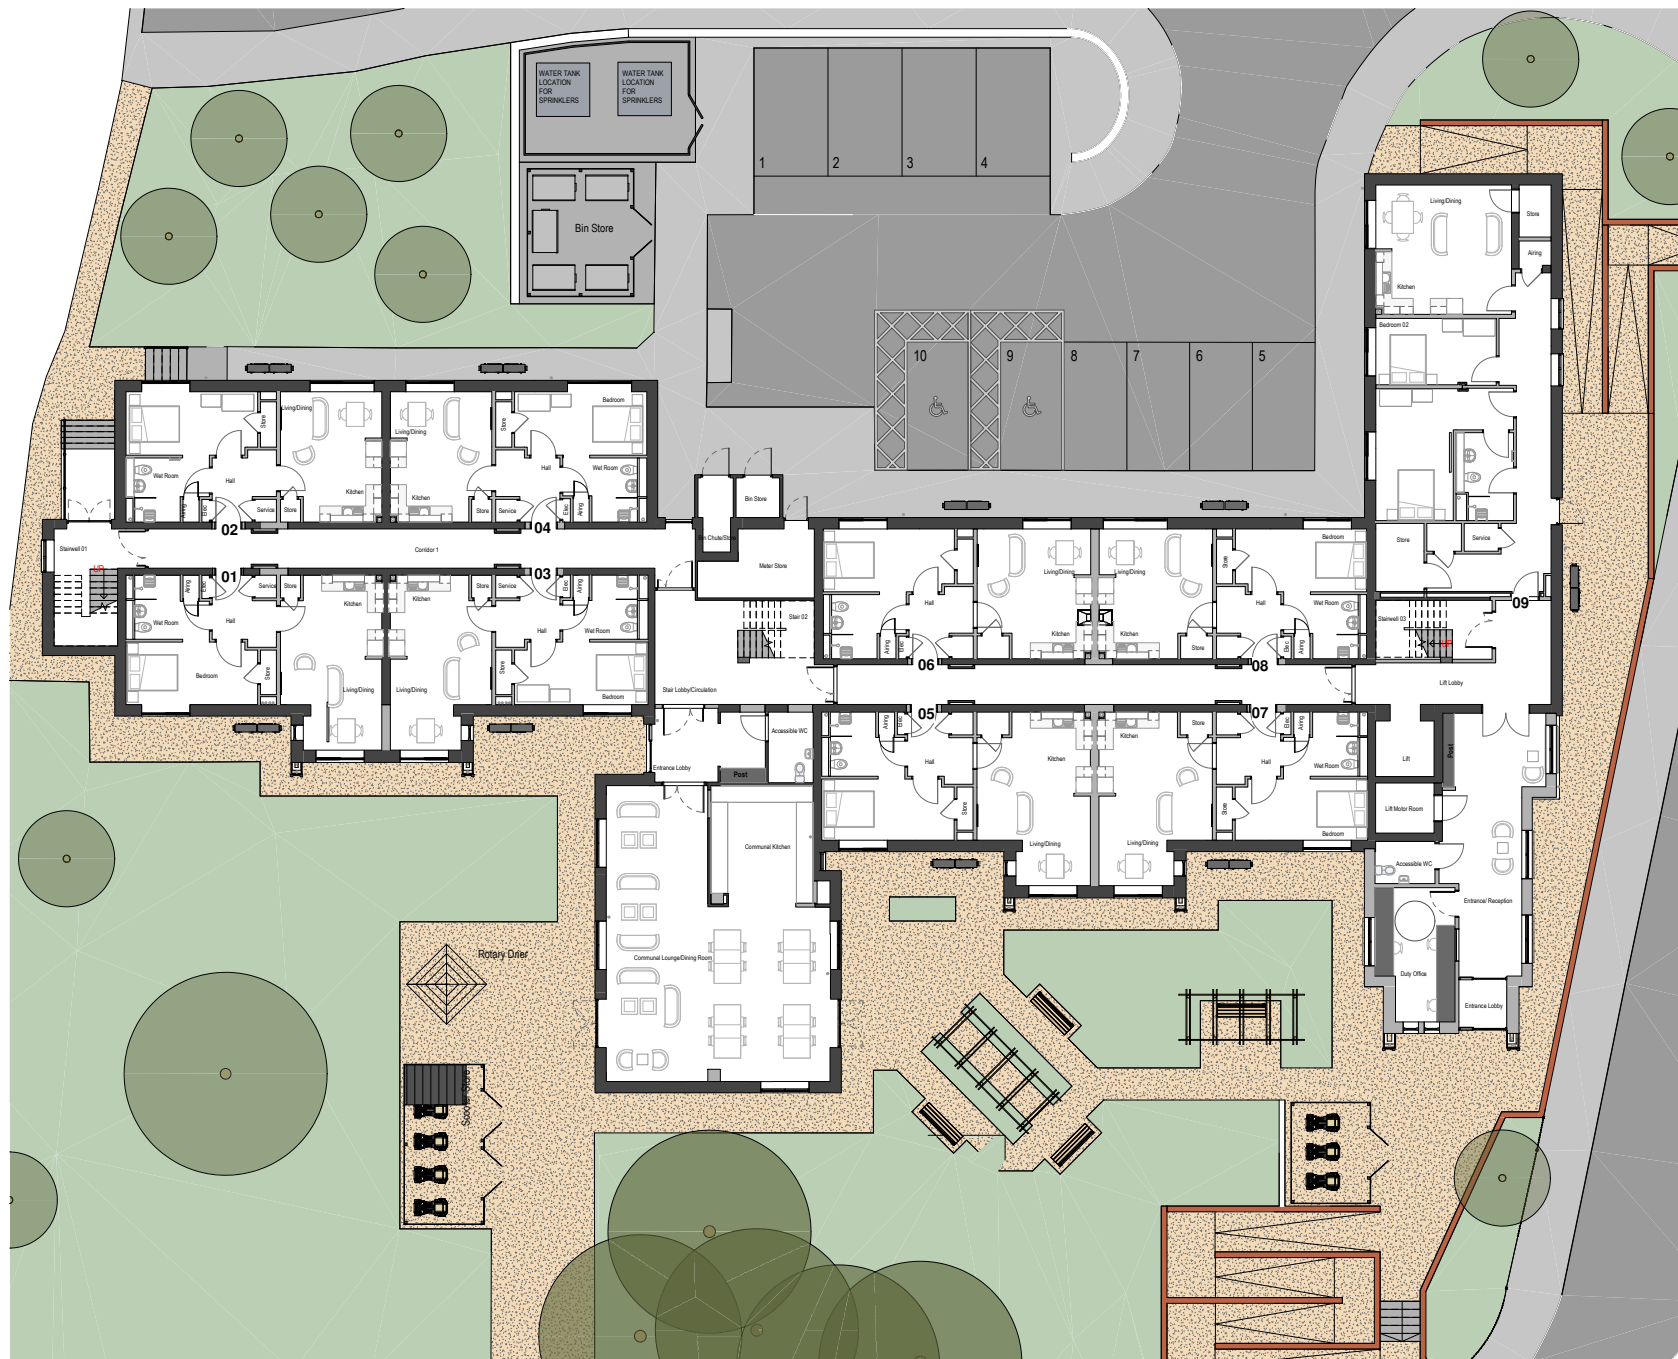
## Figure 2- Proposed Development Plan

1 | Level 00 - Ground Floor  
 1 : 100

The proposed works involve removing some internal walls and potentially introducing bay extensions and retaining ramp structures to achieve the proposed architectural layout. See Figure 2 enclosed for reference.

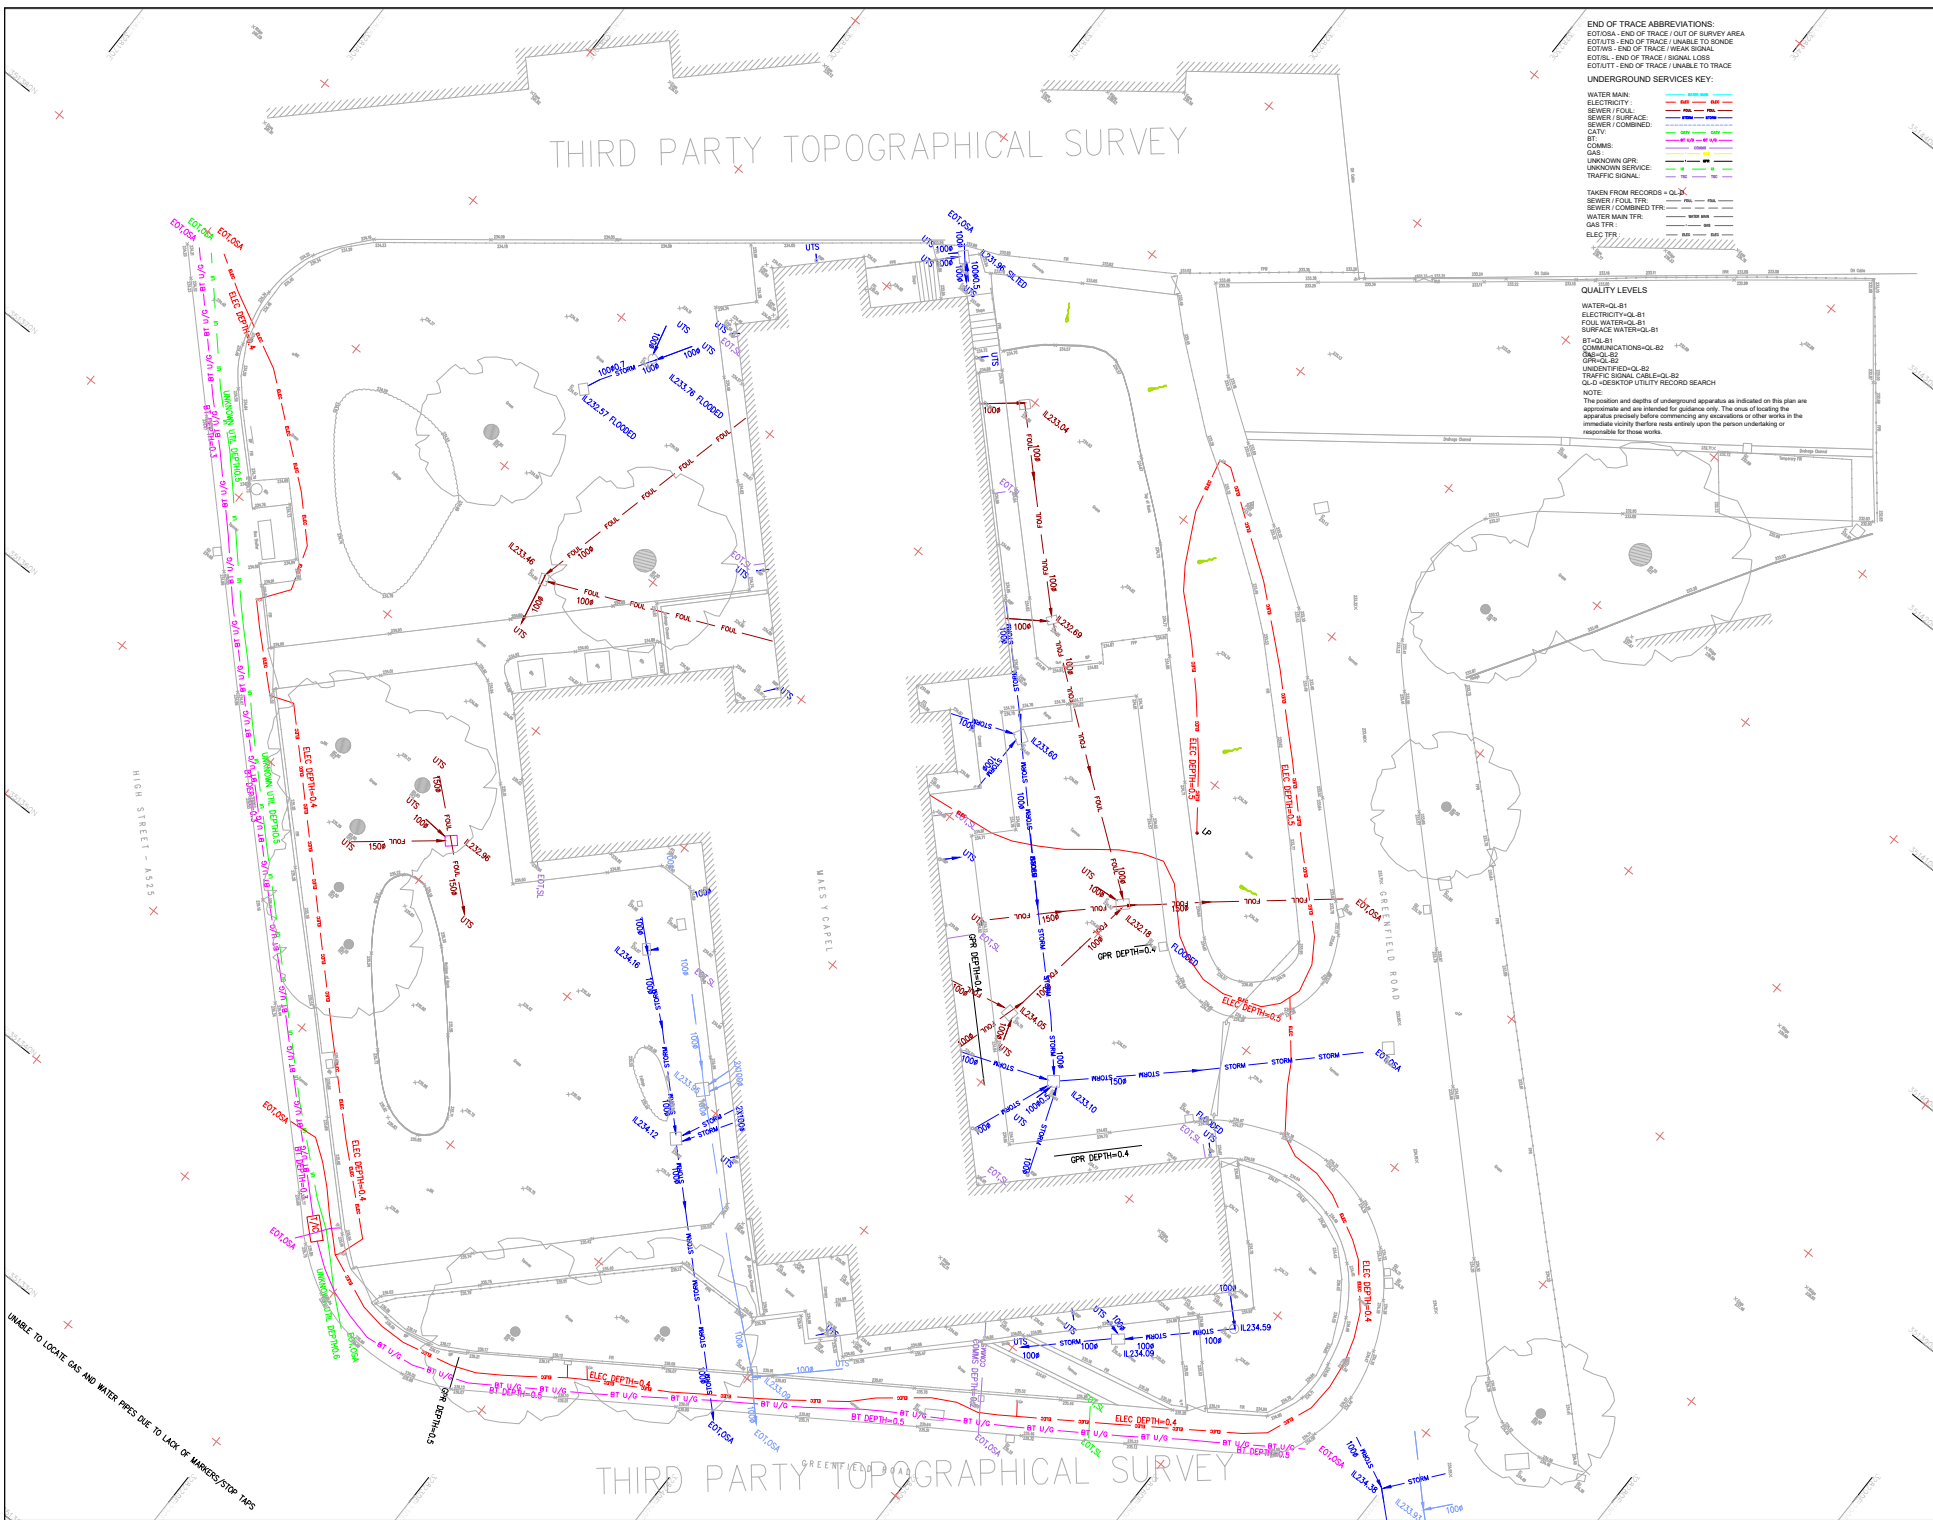
## Appendix 2- GPR Survey

- END OF TRACE ABBREVIATIONS:
- EDT05A - END OF TRACE / OUT OF SURVEY AREA
  - EDT05B - END OF TRACE / UNABLE TO SONDE
  - EDT05C - END OF TRACE / WEAK SIGNAL
  - EDT05D - END OF TRACE / SIGNAL LOSS
  - EDT05E - END OF TRACE / UNABLE TO TRACE
- UNDERGROUND SERVICES KEY:
- WATER MAIN
  - ELECTRICITY
  - SEWER / FOUL
  - SEWER / SURFACE
  - SEWER COMBINED
  - CATV
  - BT
  - COMMS
  - GAS
  - UNKNOWN GPS
  - UNKNOWN SERVICE
  - TRAFFIC SIGNAL
- TAKEN FROM RECORDS - CL 2X
- SEWER / FOUL TFR
  - SEWER COMBINED TFR
  - WATER MAIN TFR
  - GAS TFR
  - ELEC TFR
