## SALEM CHAPEL, PENTRE BROUGHTON

### MITIGATION STRATEGY

Report Ref EE.3669.22.KW

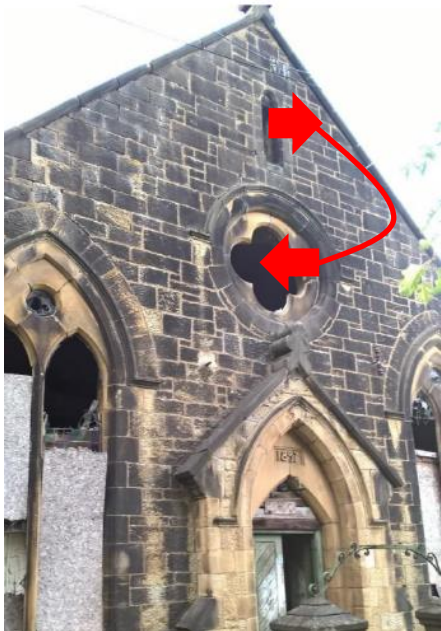
| Time | Species | Emergence Location | Photo |
|---|---|---|---|
| 20:37 | Lesser horseshoe (LHS) | From the 'slit' and re-entered through clover-window feature | |

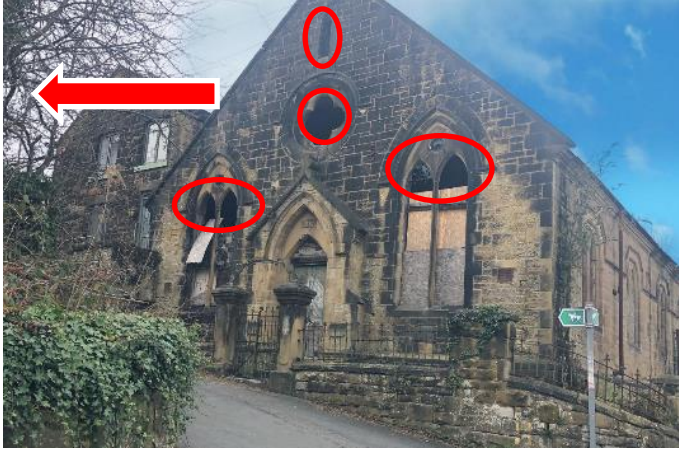
| Time | Species | Emergence Location | Photo |
|---|---|---|---|
| 20:43<br>–<br>21:07 | LHS | From the slit, clover-window and broken windows, sometimes re-entering. All flew south straight into woodland. Total emergence count was 30 bats. | |

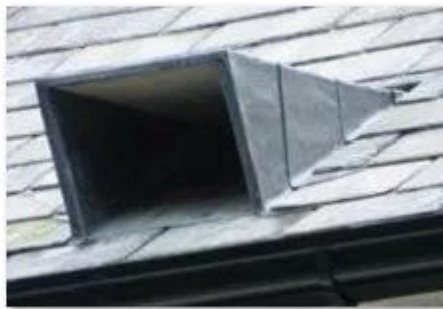
**FIGURE 3.2 – EXAMPLE OF A DORMER ENTRY POINT**

- An additional entrance point into the loft space will be created on the western elevation (Figure 3.2 for example and Figure 3.3 for location). This will comprise a dormer opening on the western roof pitch, at a minimum size of 300mm x 200mm. The access point will be baffled internally (without reducing the access point area) to limit airflow within the loft space.

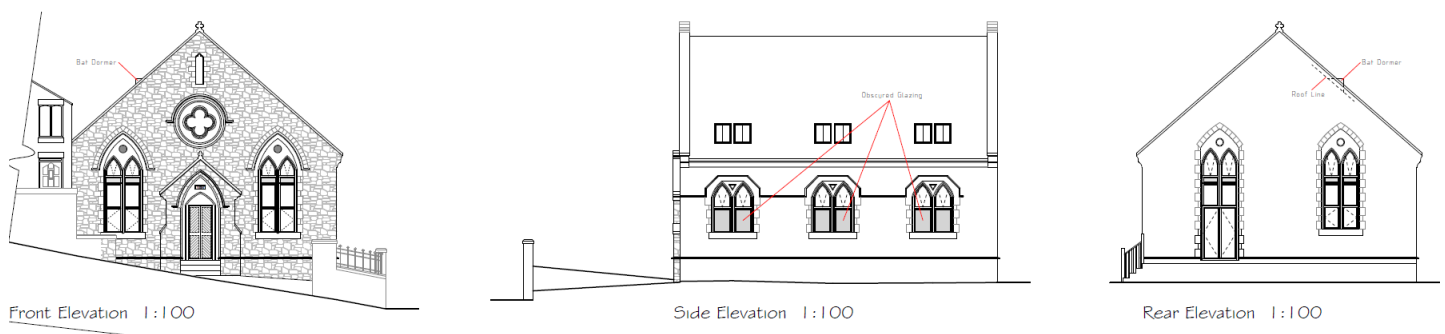
**FIGURE 3.3 – LOCATION OF BAT DORMER ENTRY POINT**

- The existing 'slit' access point on the southern gable will be replicated on the rebuild of this aspect (see Figure 3.3). Ideally the original stone work of this feature should be retained and installed within the new gable wall so the bats can continue to use their existing, familiar entrance. If it is not possible to use the existing feature, the entrance point will be replicated with a vertical slit in the stone work, at a minimum size of 200mm x 300mm. The replicated access point will be in the same position as the existing access point, just above the position of the loft floor. The access point will be baffled internally (without reducing the access point area) to limit airflow within the loft space.
