| PROJECT: | MOSS VILLA, CHAPEL LANE<br>BRONINGTON, WHITCHURCH<br>SHROPSHIRE SY3 3HR | SCALE @ A3: | 1:10 | DRAWN BY: | OH | CHKD BY: | PF |
| DRAWING: | JOINERY DETAILS<br>PROPOSED WINDOWS<br>FW01 & FW03 | DRAWING No: | SA47065 -BRY-XX - DT- A - 007 _ B | DATE: | 04.04.23 | REVISION: | |

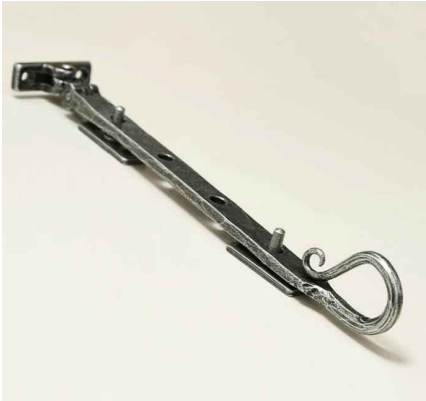
Example of Window Ironmongery  
Pewter Shepherd's Crook  
Casement Stay

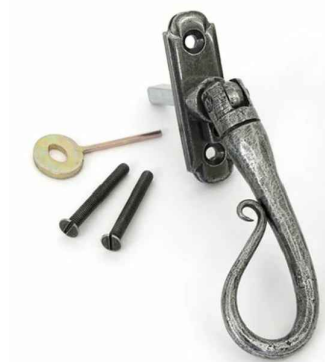
Example of Window Ironmongery  
Pewter Shepherd's Crook  
Espagnolette Window Fastener
