## PHARMACY HOUSE, 18 HIGH STREET, OVERTON

### Heritage Statement

Chambers Conservation Ltd, August 2021 – Issue 1

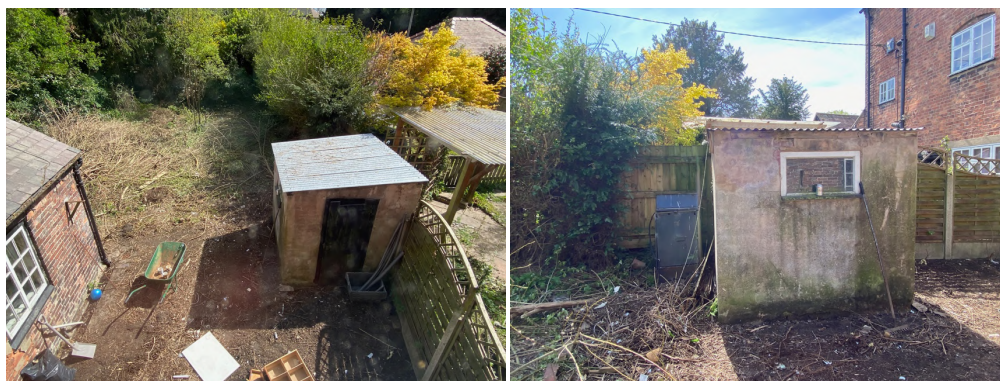
*Garden (including coal store)*

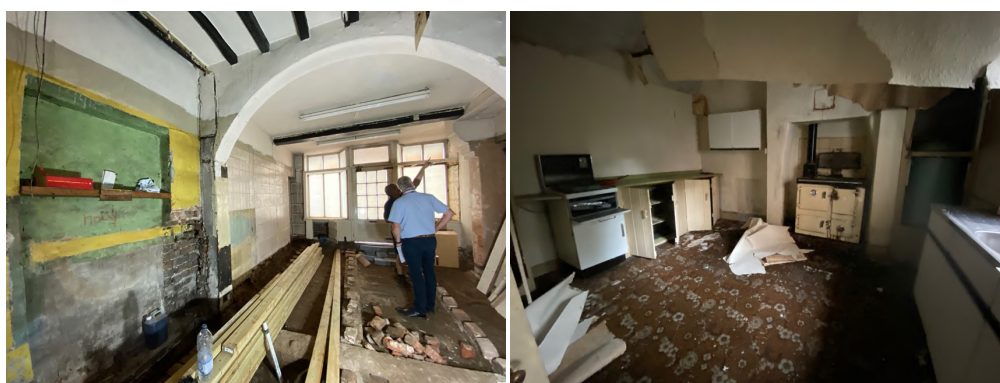
*Shop and kitchen*

The interior of the shop has suffered from both poor quality mid / late 20<sup>th</sup> century fitouts and from the effects of damp. At the time of the purchase of the building, the timber floor was collapsing and was no longer safe – it was removed with the agreement of Cadw. Walls are crudely plastered and have a very inconstant appearance. There are remnants of fairly recent fittings. The significance of the interior of the shop is therefore limited.

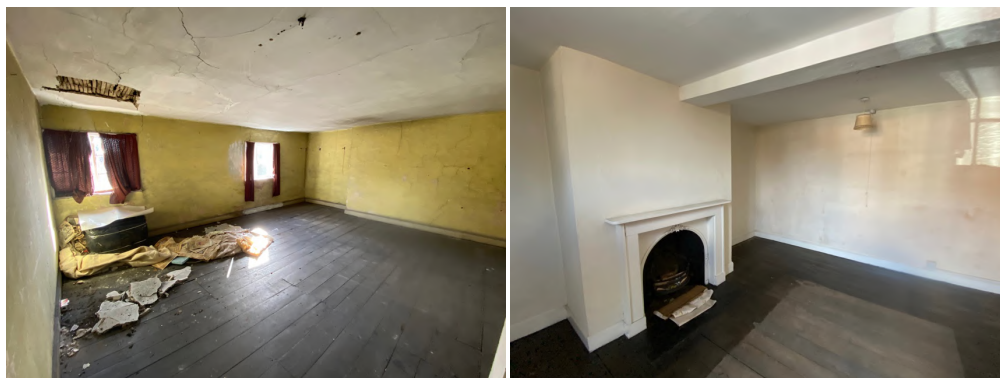
*Second floor room with failing ceiling and bedroom*

- Reinstatement of lost ceilings – this will have a positive impact as the visual character of the second-floor rooms would be reinstated. It should be noted that this ceiling (together with its neighbour in a very poor state of repair) will be reinstated in

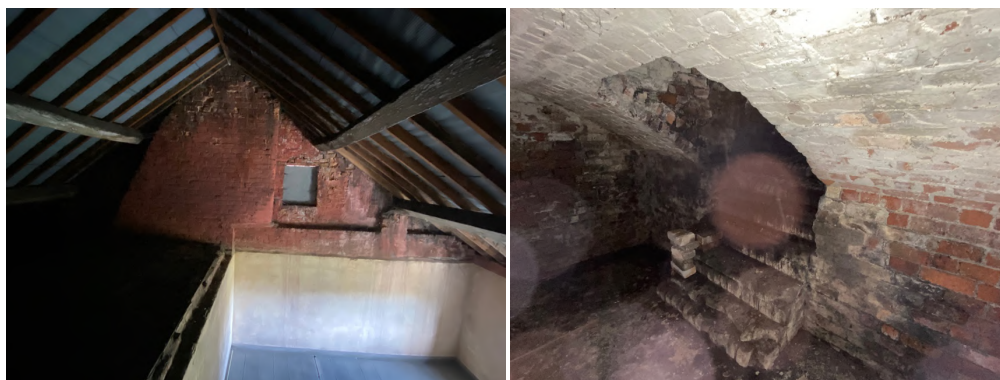
*Second floor room with lost ceiling (viewed from attic) and cellar*
