## Heritage Impact Statement - Holt Hill, Green Street, Holt, LL13 9JF

Report for C Eaton

24th January 2020

**Mel Morris Conservation**

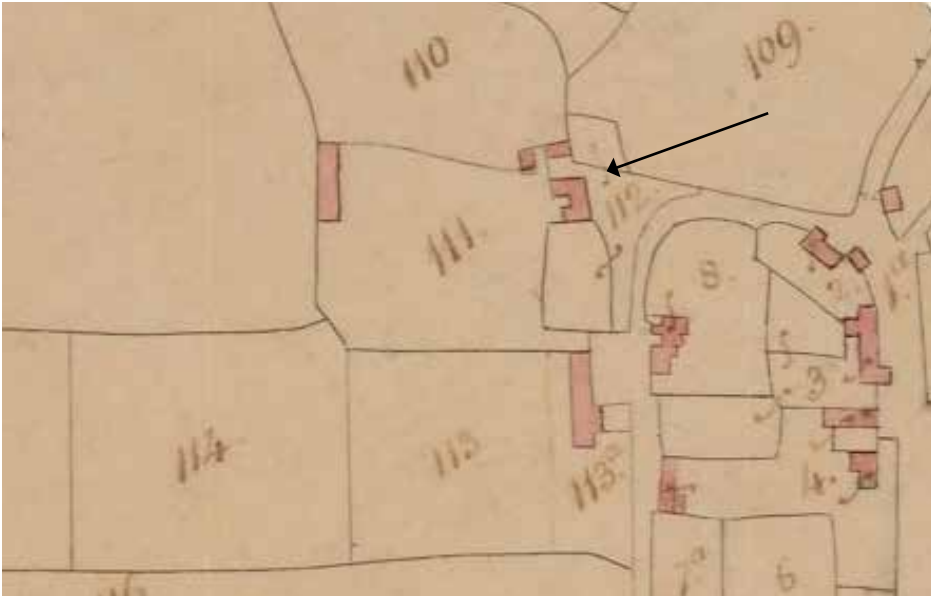
Plate 1: Extract from the 1843 Tithe map with Holt Hill identified by the arrow.

The map shows a larger floor plan to Holt Hill than currently stands, with an extended wing to the west and a short wing to the north, both running east-west. The same arrangement survives in the late 19th century and the early 20th century Ordnance Survey maps.

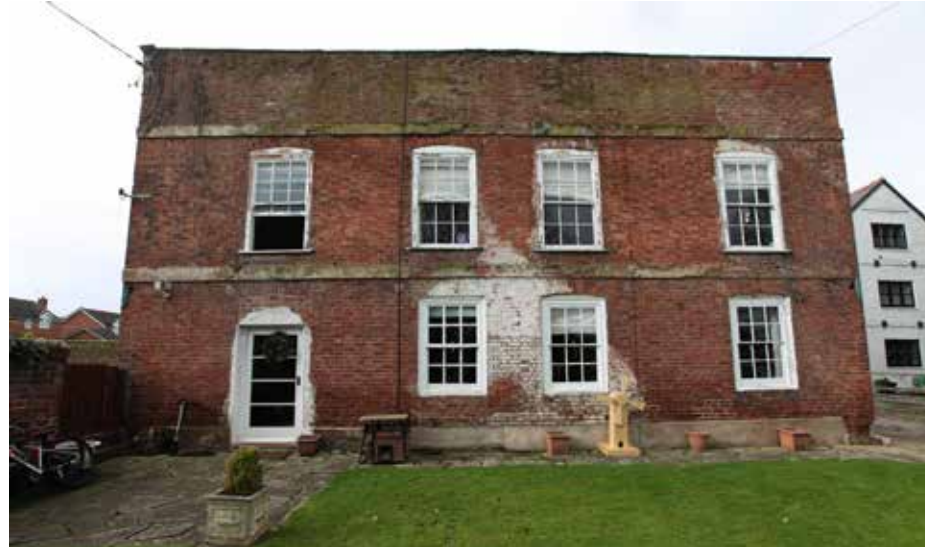
Plate 4 above: The east elevation of ca. 1720-1730 of elegant simplicity and subtle articulation in the form of brick bands was a single unified composition, adopting the principles of the golden section. The protocol for the period was to have an attic storey to provide the correct classical proportions. Here the parapet incorporated faux or blind windows, which completely removed the evidence of the former gable frontage. The recessed openings have been later filled in. We can see from this photograph that the former doorway which was blocked up in the late 20th century (second window from the left) did not sit precisely under the first floor window, the reason being that the existing internal wall to the early hall prevented this. This would not have been as obvious as it is now, being a doorway. At some point the original doorway appears to have had a canopy. The square lintel is modern.

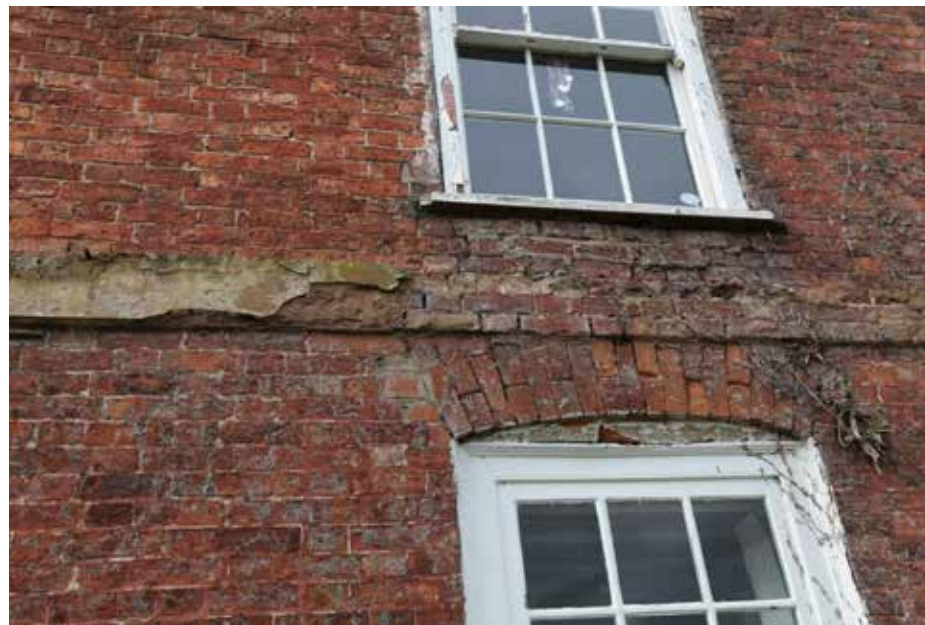
Plate 5 above: The raised bands between the floors comprised three courses of projecting brickwork and were finished in stucco. The brickwork is in very poor condition and the stucco will need to be reinstated, as originally intended. This image shows the Dining Room window with its segmental rubbed brick arch and the moulded architrave to the sash window, as originally designed. The sash window above is modern and incorporates a projecting timber cill, which is incorrect for the period. It also has 'horns' and has no architrave. To the left of the Dining Room window we can see evidence of the original 'tuck-pointed' joints which provided a high degree of refinement. This has been affected by subsequent repointing and the poor condition of the masonry, a large part of which is the result of rampant ivy.

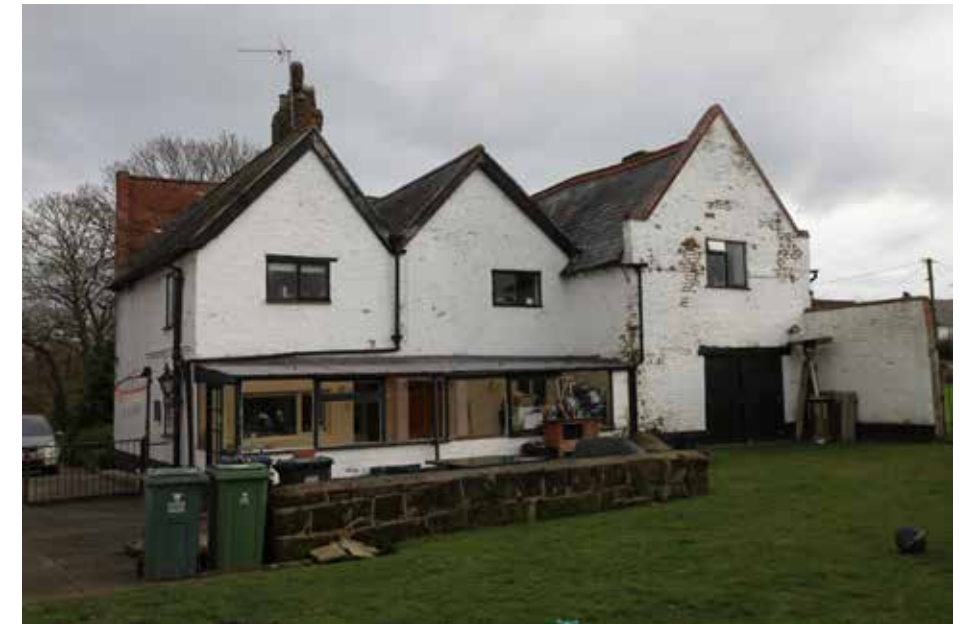
Plate 6 above: The west elevation incorporates a slightly taller wing to the south, with raised coped gable, of ca. 1690-1700 and a pair of gables to the centre and north which are coeval. These roofs were probably built immediately after the south wing.

The west elevation contains three gable wings, of uneven size, with altered windows, a raised coped brick gable to the southern wing and modern bargeboards to the central and northern ranges. The southern wing with the coped gable is the earliest. The other two first floor roofs and gables are coeval, although the ground floor structure of each range is of different phases. Each pitched roof has a similar ridge beam and the central and northern ranges each have a jointed truss above a very large jointed beam which spans both the central and northern wing. This massive beam, which has no signs of any scarf joint, is not central to the wings and reveals that this modification and the brick gables as they currently stand may be part of an intermediate phase of remodelling (i.e. before the Georgian east facade was built).

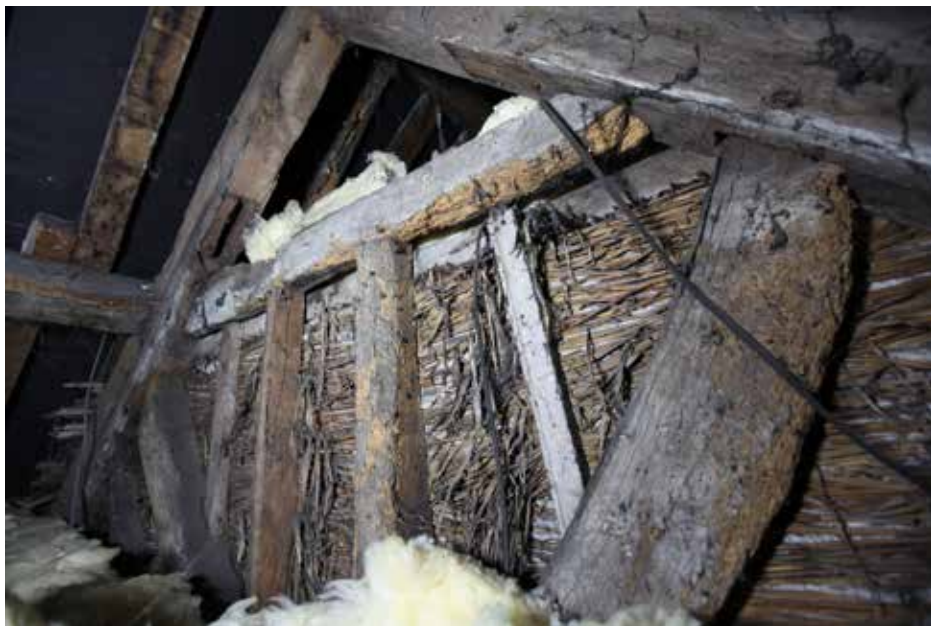
Plate 7: The central truss. The paired curved Queen struts are visible here, as is the timber studwork which incorporates reed and plaster for the raised ceiling in Bedroom 2. The mortices for an earlier, higher, collar reveal that the rafters may have been once under-drawn with reed and plaster, suggesting that the truss predates the east elevation.

The two roof trusses within the building within the central range and northern wing are off-set and not equidistant from the front (east) and rear (west) walls. They are of similar form and date and they sit over a massive oak beam. This oak beam is contemporary with the trusses, which are jointed and pegged into the beam. It was intended to span the central and northern ranges and to unify the internal functions of these ranges around the first floor landing and upper hall. The roof structure throughout the central and northern ranges is of trenched double-purlin form, with a large square oak ridge purlin supported on Queen strut trusses and brickwork. The central truss is altered with open mortices in the same opposing location suggesting some modification. This truss within the central range also appears to have been 'beefed-up' with an additional principal rafter added to the southern principal, which is supporting the higher purlin. This would suggest that the truss has been modified at a time of re-roofing. The roof structure to the southern 'wing' is of single-purlin construction of ca. 1690-1700 and the purlins sit on an internal brick gable wall. The collars / ceiling joists to this range are later additions, which is why an internal oak lintel which served the west-facing gable window is visible within the roof space.

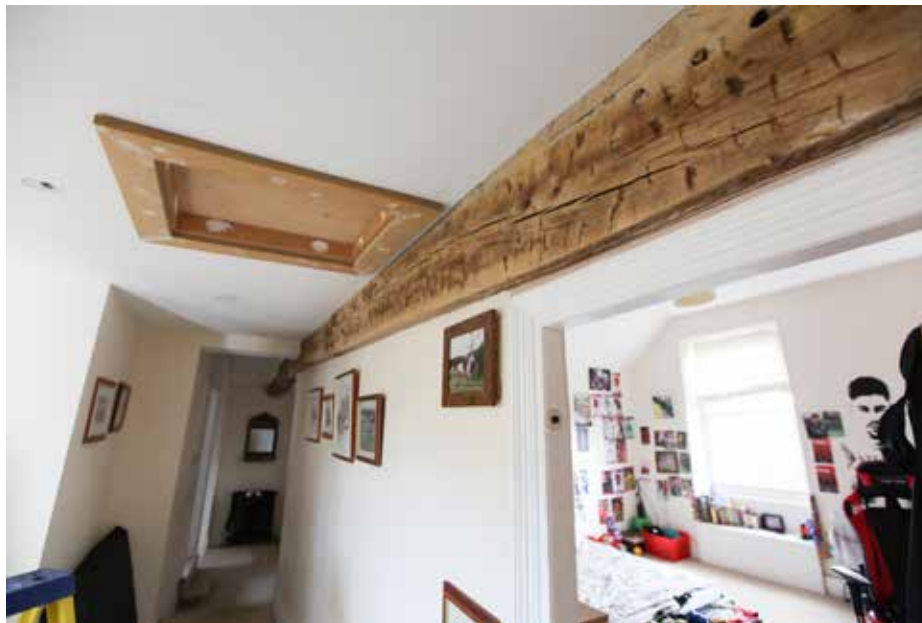
Plate 8: The oak beam which spans the central and northern ranges supports the two trusses. The pegged joints can be seen over this doorway.

The Lounge (former hall) also has another odd feature, which is a low transverse beam with stop-chamfers at one end. These stop chamfers are of pyramidal or nailhead form, which is a rare detail (cf. 1651 Glos; 1592 Glos; 1615 Angl - Hall, 37 and 59). The beam has been inserted in order to support a brick wall above at first floor level but when it was inserted is open to conjecture. It may have been during the Georgian remodelling or before then, in order to support the new roof structure and trusses. The beam itself is certainly much older than the 18th century and may have come from another part of the house, or from somewhere else entirely. The brick wall which the beam is supporting continues in the alignment of a very long oak beam which spans both the hall wing and the kitchen wing to its north, which is explained elsewhere (see plate 8). What appears to have taken place is that the central hall was remodelled to increase its depth in

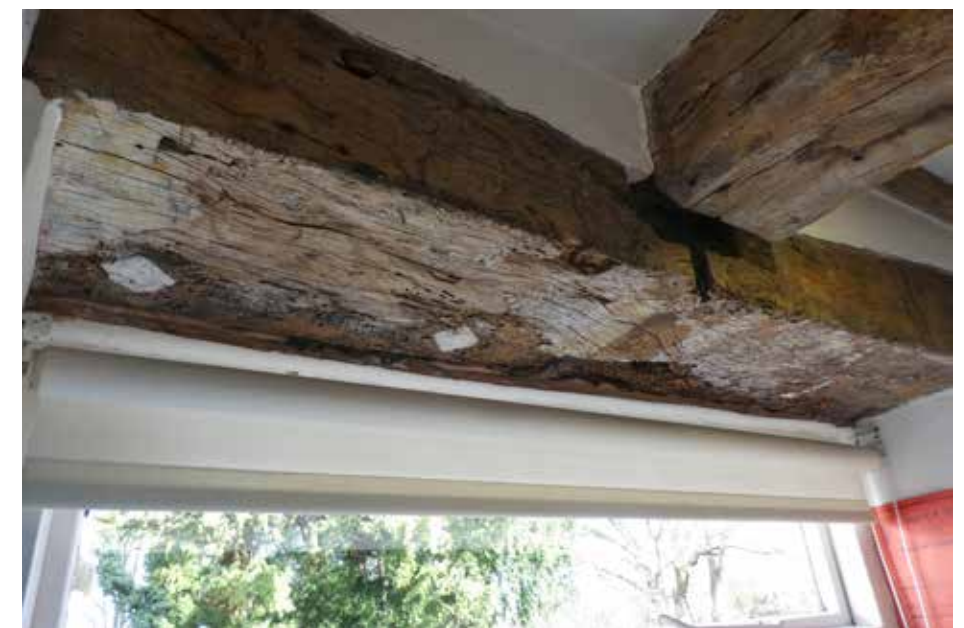
Plate 11: The presence of a diamond mullioned oak window, which would have been unglazed and perhaps shuttered, within the present kitchen, is indicative of a 'dairy'. The evidence for this is in the original oak lintel which incorporates diamond-shaped sockets for the oak 'mullions'. The main spine beam is sitting on this lintel and there are no signs that this is an alteration.

The northern wing has a slightly narrower form and the reason for this is related to the original service function of this 'wing'. The present Kitchen has a low ceiling and it also has dateable features, such as the remains of a diamond-mullioned window to the north (see plate 11, with four blocked sockets – wooden diamond mullioned windows provided good ventilation for dairies – Flintshire, Smith, 660) and a single projecting horizontal brick band with dentil moulding of projecting headers to the north. It also has a straight joint on the north elevation, where it was either free-standing or may have abutted an earlier timber-framed kitchen bay. The lack of

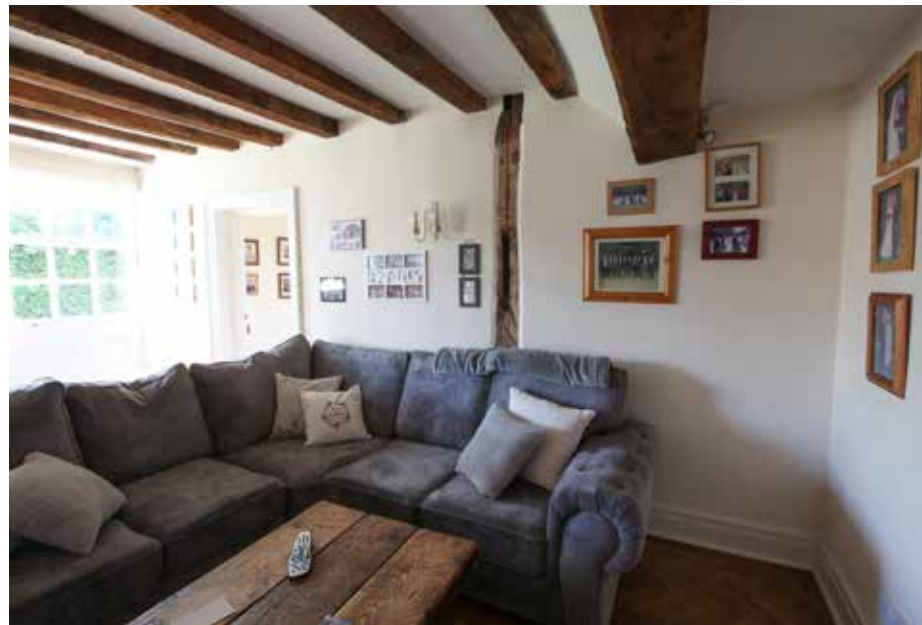
Plate 12: Former Hall, now the Lounge. The joists are of large section with a long span. Also visible is the oak post in the wall and the stop-chamfered transverse beam inserted to support a brick wall above.

The earliest evidence of a house on this site is within the central bay of the building, the former hall, which retains a timber post in the southern wall and transverse oak joists which are set at approximately 600mm centres. These joists are of very substantial section although square, not chamfered. The post contains a large socket, the remains of pegs and a chamfered profile to the parlour, which may be part of a door frame. It is likely that the wall within which it is embedded is still timber-framed, encased in plaster. The 'racked' door frame to the parlour door is also a probable indication of hidden timber-frame. There is no evidence that this oak post has been moved here from elsewhere and its location is precisely equidistant from the front (east-facing) and rear (west-facing) elevations, which suggests that it was perhaps one of a pair and divided the original 'hall' into two equal-sized bays on plan. The alternative hypothesis is that this post was one of a pair framing an external door within a south-facing elevation, pre-dating the southern wing. There is no evidence of a matching post to the opposite wall which, if this was one of a pair of opposing posts, would have been displaced when the present chimney breast was inserted, which serves both the present Lounge and the Dining Room. The joists do not contain any mouldings which might assist with dating, and it is possible that they were heightened at the time of the Georgian remodelling, but the presence of a timber-framed house on this site correlates with the documentary record and we can hazard a guess that the timber-frame is the remains of an early 17th century timber-frame, or even late 16th century, as a building was described on this site in 1620. Even dendrochronology is not necessarily

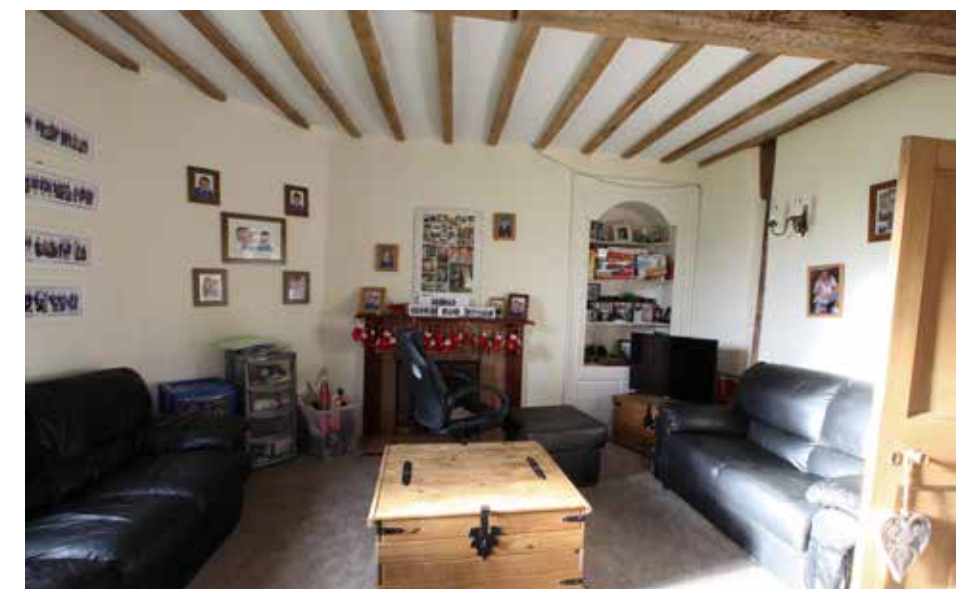
Plate 13: Parlour with brick angle for the corner fireplace to the left, a later hearth to the centre, with modern surround, and an arched corner cupboard to the right of ca. 1730, for displaying best china. The ceiling was originally underdrawn with plaster.

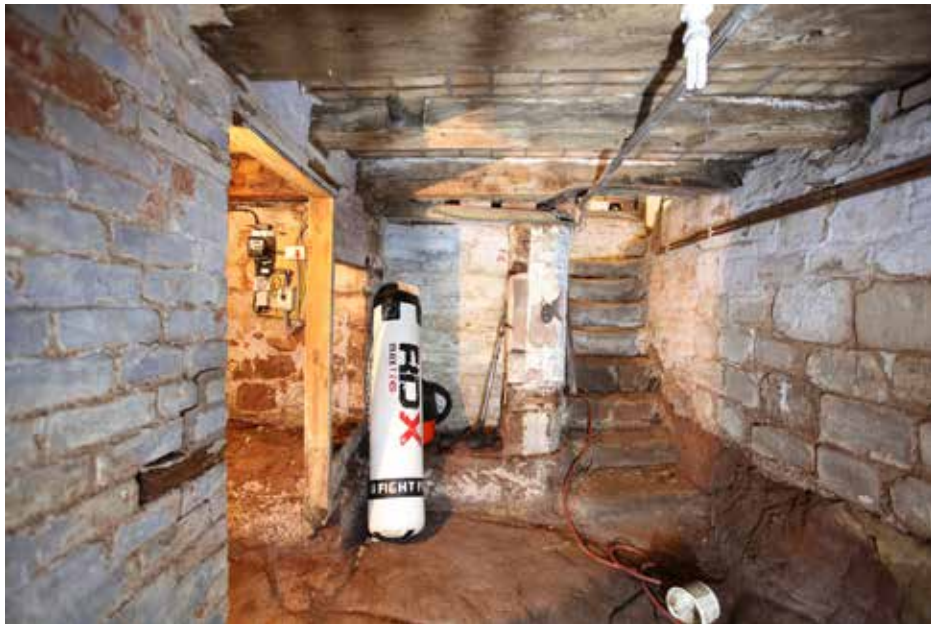
Plate 14: The cellar dates from ca. 1680-1700. The entrance was modified ca. 1730 in order to get access from the staircase hall. The original access to the cellar may have been central (see panel of brickwork to the left of the stone pier). Note the massive oak joists, which are re-used parts of a timber-framed building.

wings. The gable elevation had a different form, as there are straight joints in the gable brickwork and the remains of a timber lintel within the attic space, just above the ceiling joists, which indicates a higher gable window. The Parlour sits over a cellar. This is a conventional arrangement for the late 17th and early 18th century. The cellar and parlour were created at the same time ca. 1680-1700, or thereabouts. The cellar is largely coursed stone masonry but the bedrock has also been cut out. Some sections of brickwork around the cellar entrance steps may reflect remodelling to create an access off the rear hall in ca. 1730. The corner fireplace to the parlour is supported in part on massive angled oak beams and later inserted metal straps. The ceiling joists in the cellar contain some massive re-used beams from a timber-frame building, probably re-used from this site. They have been incorporated as floor joists and overlaid with boards. At a later date, in the 19th century a brick dividing wall and brick wine bins were added. The Parlour continued in this use for a long period. This was the best room in the house, which is why it has the decorative cupboard for displaying china. The presence of a corner chimney breast and fireplace on an angle, intended to simply heat the occupants rather than for cooking, is very typical of a parlour of ca. 1680-1700, when this was a short-lived fashion. It meant that the fireplace surround could be quite refined in design. It also continued into the room above, which was also heated as the best chamber.

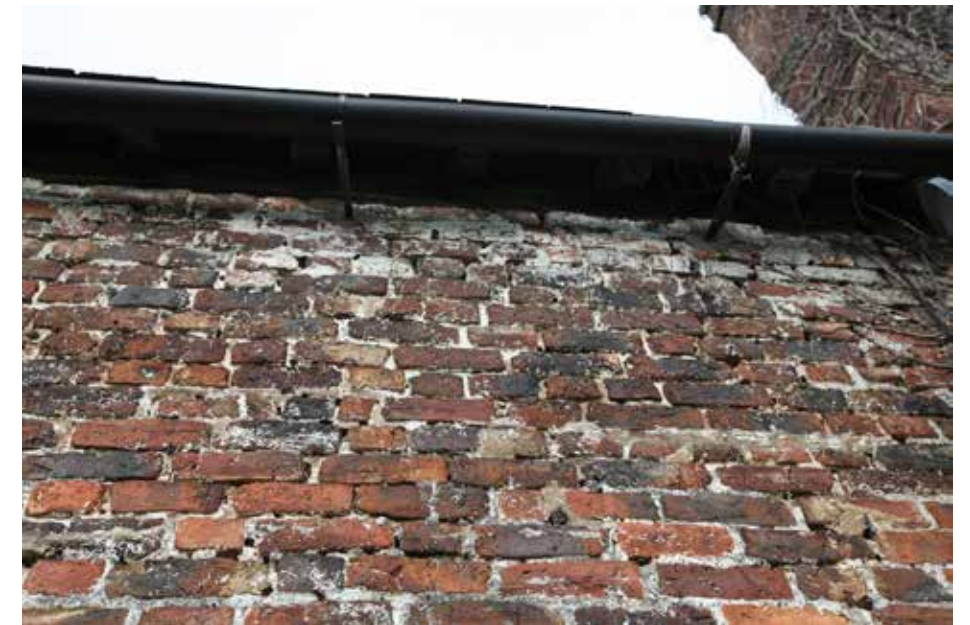
Plate 15 above: Brickwork of ca. 1680-1700, formerly limewashed.

The second phase of brickwork is found in the southern wing (south and west elevations) which is of two bays, comprising a Parlour and a second room on plan. The character of this brickwork is of random bond, with a high firing temperature and some plum and reddish-black brickwork showing signs of flaring. The higher firing temperature which has led to this finish has meant that the brickwork in this range has fared much better than the later brickwork. The south elevation has been lime-washed at some point and this has been recently removed but the painted finish to the west gable remains. The only distinct detail in this phase of brickwork is a two-course raised brick band to the west gable which is a detail found in the late 17th century. It is likely that another band lower down this elevation was removed at some time.

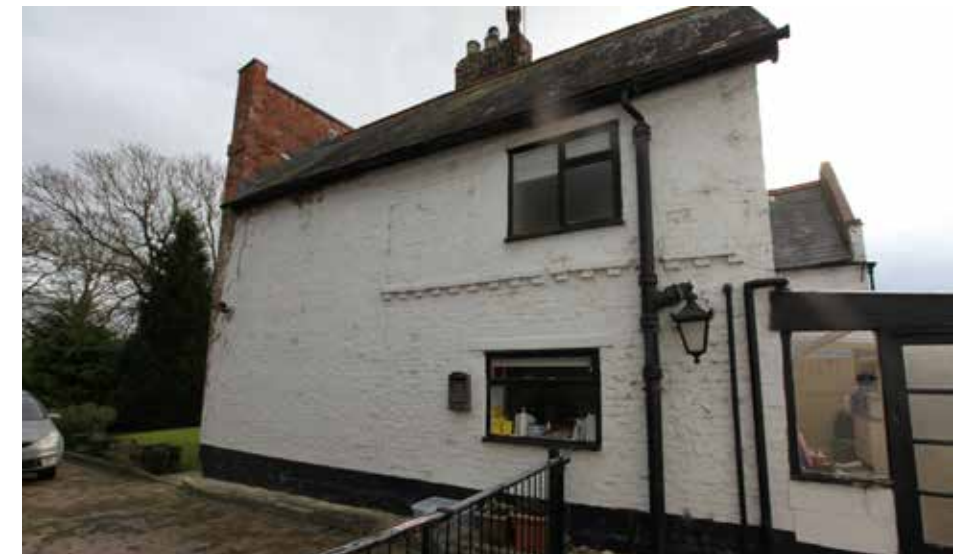
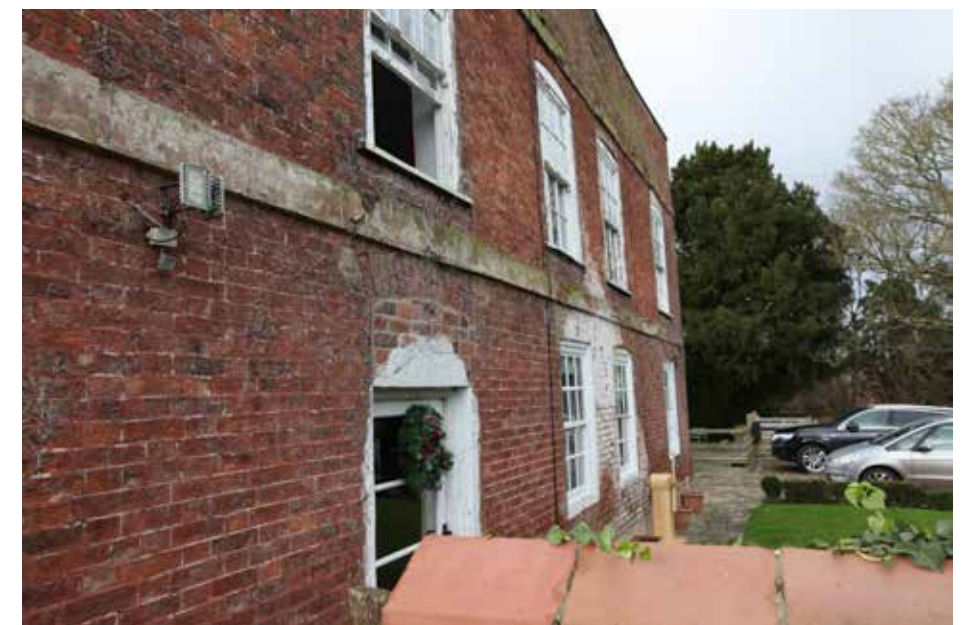
Plate 16 above: Brickwork of the late 17th century to the 'dairy', with dentilled band  
Plate 17 below: Flemish bond brickwork with 'tuck pointing' of lime putty of ca. 1730.

The east-facing elevation is faced in Flemish-bond brickwork. The joints are large with areas of original 'tuck-pointing' in order to give a more refined impression. This brickwork incorporates segmental rubbed brick arches to the sash windows. This was a fashion in the first half of the 18th century (between 1710 and 1730 – Lynch, 50) but quickly became old-fashioned when flat gauged brick arches were the norm. Elsewhere the brickwork is largely over-painted in multiple layers of limewash and modern paints and the bond is not easily distinguished.

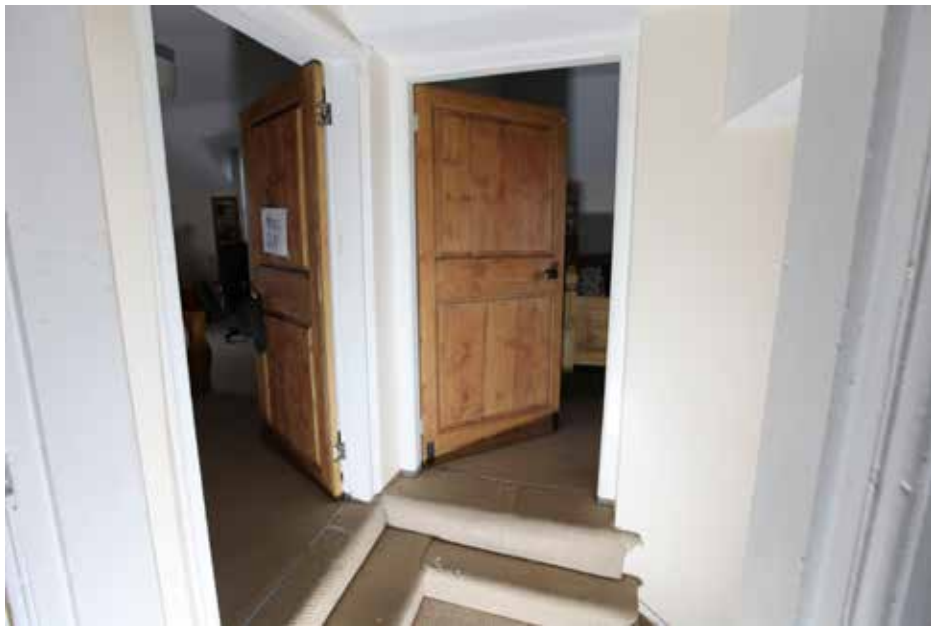
Plate 18 above: Inserted 18th century doors within original 18th century openings at the head of the staircase. The doorway to the right has a stop-chamfered frame.

There are four early to mid 18th century doors of a two-panel design at first floor level which the current owner has informed us were installed by the previous owner. These have all been stripped of their original paint finish (probably dipped) and all have planted HL hinges which have been fixed with modern screws. The door frames to these doors have a variety of mouldings, some of 18th century form, that to Bedroom 4 has a stop-chamfered frame, rather than a moulded architrave, which suggests perhaps a secondary or more utilitarian purpose to that space. The evidence at both ground and first floor level is that the internal doors are in the same locations as set out in the early 18th century.

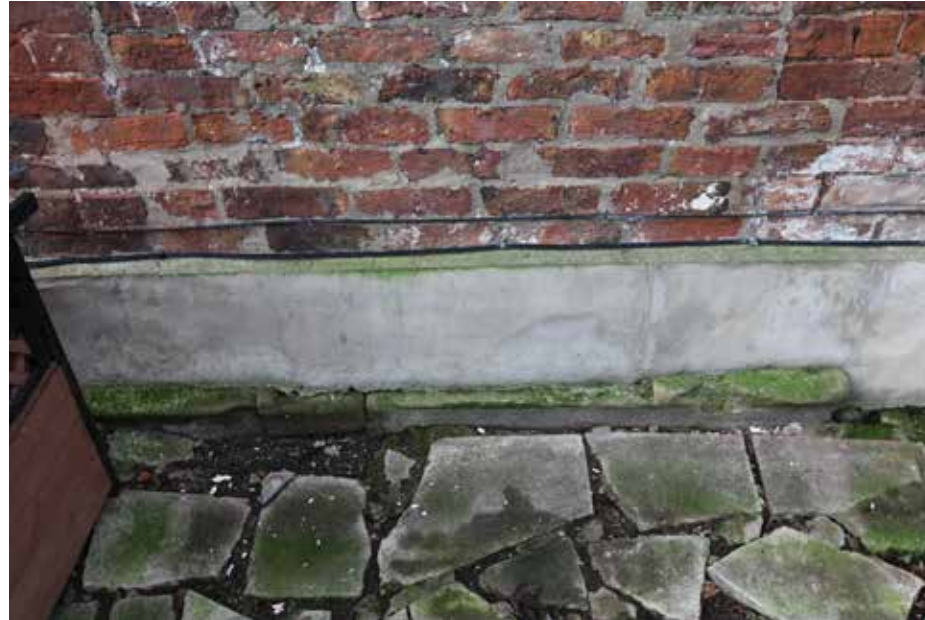
Plate 19 above: Stone moulded doorstep threshold and straight joints to the original front door.

Plate 20 below: Pegged oak door frame (early 18th century) to the original rear door. The inserted door and sub-frame is modern.

The front door to the front (east-facing elevation) was relocated in recent times when it was moved from the Hall to the Parlour. The remains of the door threshold can still be seen as well as the modified brickwork. This original opening would have had a fanlight. The neatly inserted panelled

apron and low-level lining to the present sash window must have been located here from the adjoining room, the parlour, which now contains a modern fully-glazed door: which is highly unsympathetic. The rear door which enters the rear staircase hall has an 18th century door frame with pegged joints. This is in-situ and provides evidence of the original layout at this point, although the door and subsidiary frame are replacements (described under Coflein as 6-panel raised and fielded).

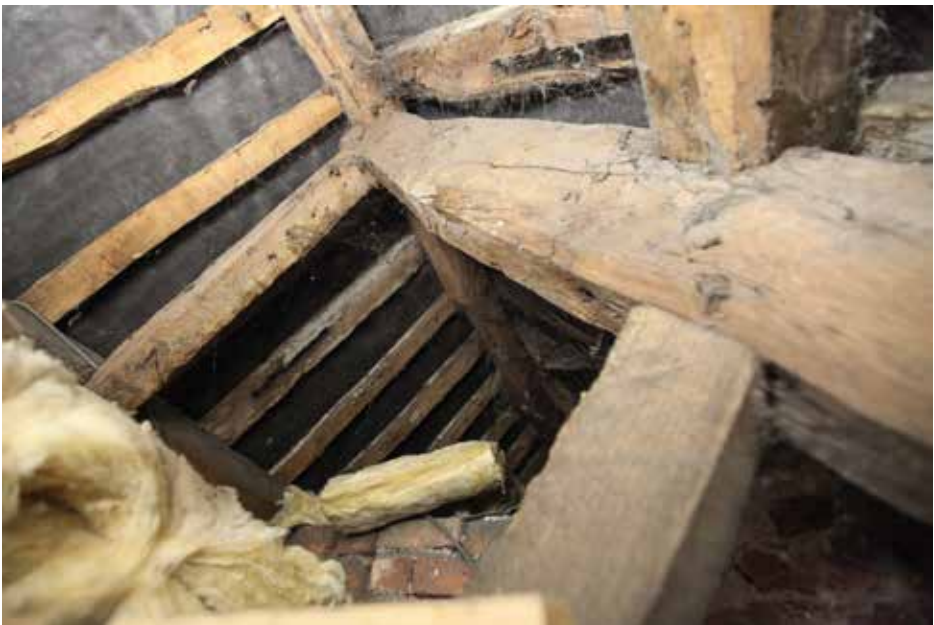
Plate 21 above: Queen strut truss to the northern range.

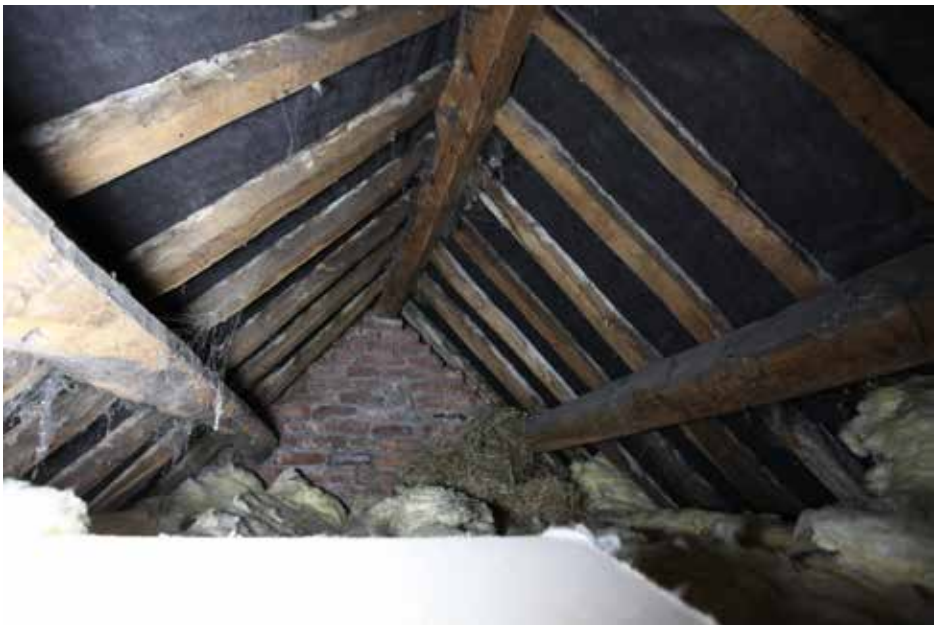
Plate 23 above: West brick gable to the northern range, with purlins.

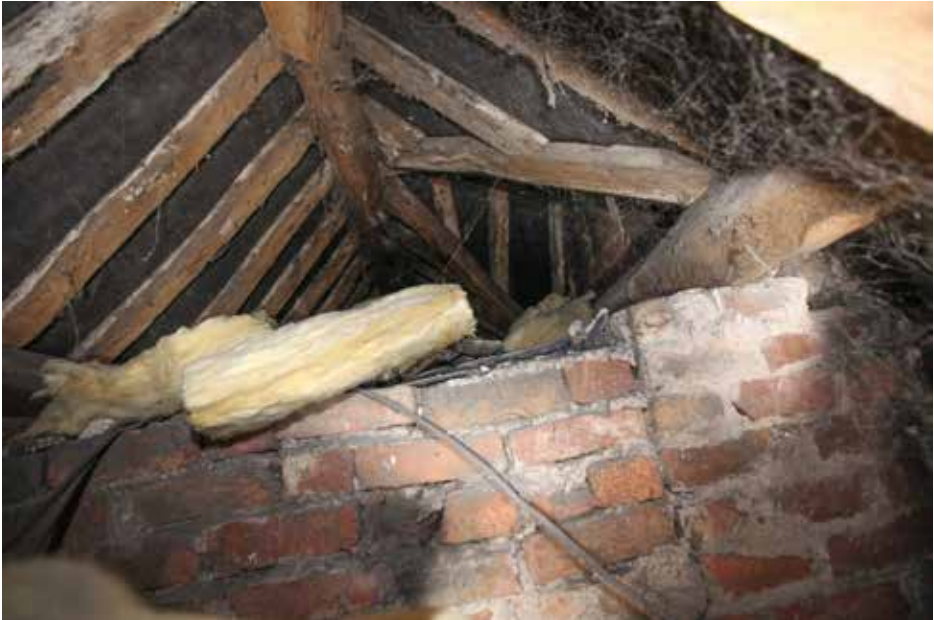
Plate 22 above: 18th century brickwork of two phases to the northern range. The raked valley rafters visible relate to the brick chimney.

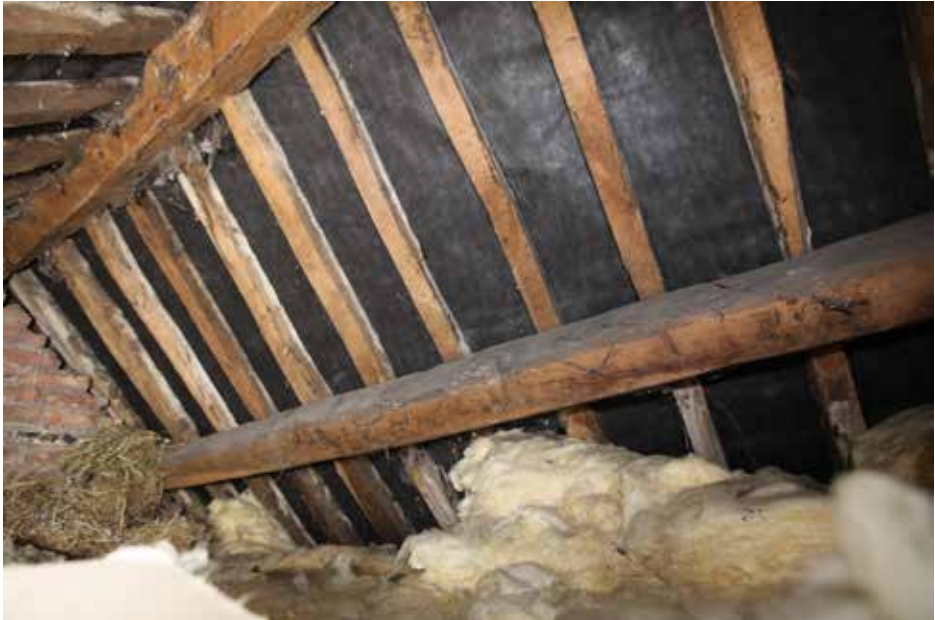
Plate 24 above: Purlin and massive ridge beam to the northern range.

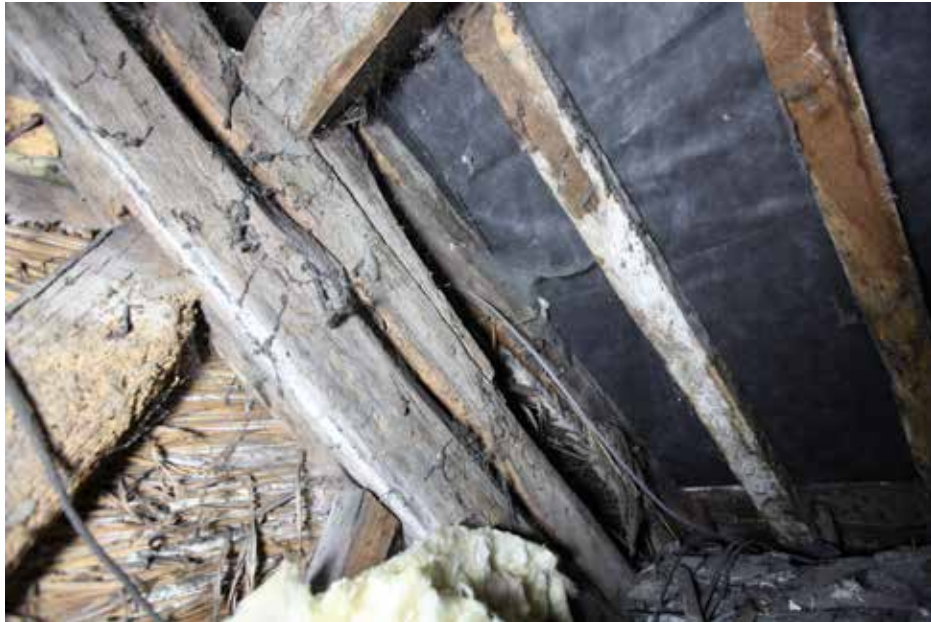
Plate 25 above: central range Queen strut truss with secondary principal rafter.

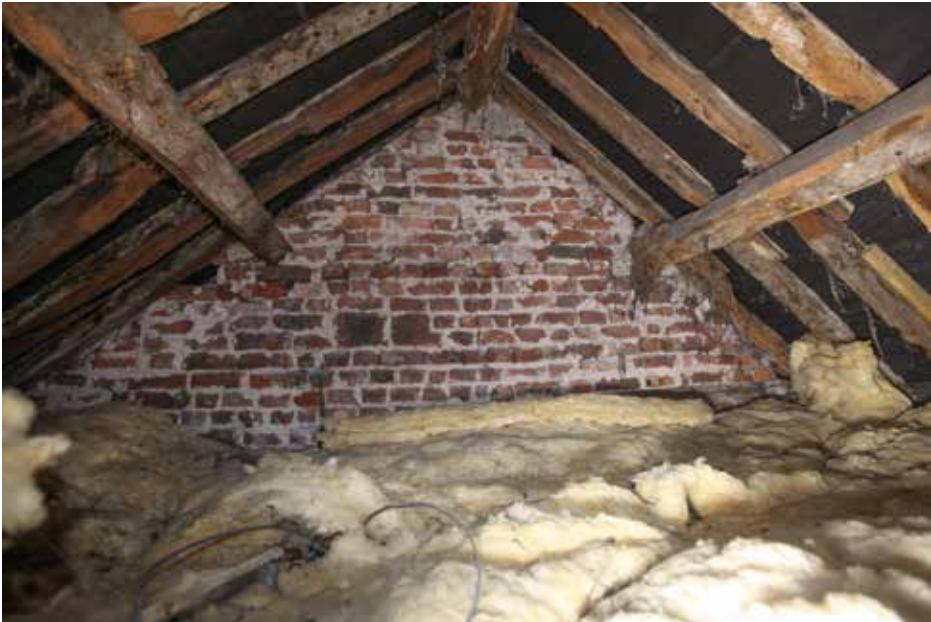
Plate 27 above: Central range - west brick gable with purlins.

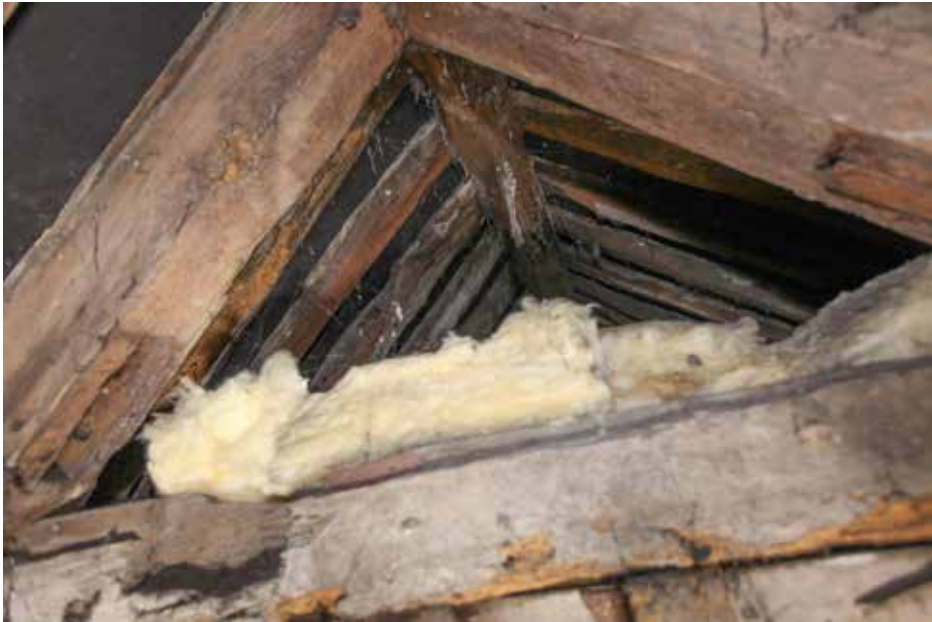
Plate 29 above: central range roof to the east showing the ridge beam and rafters

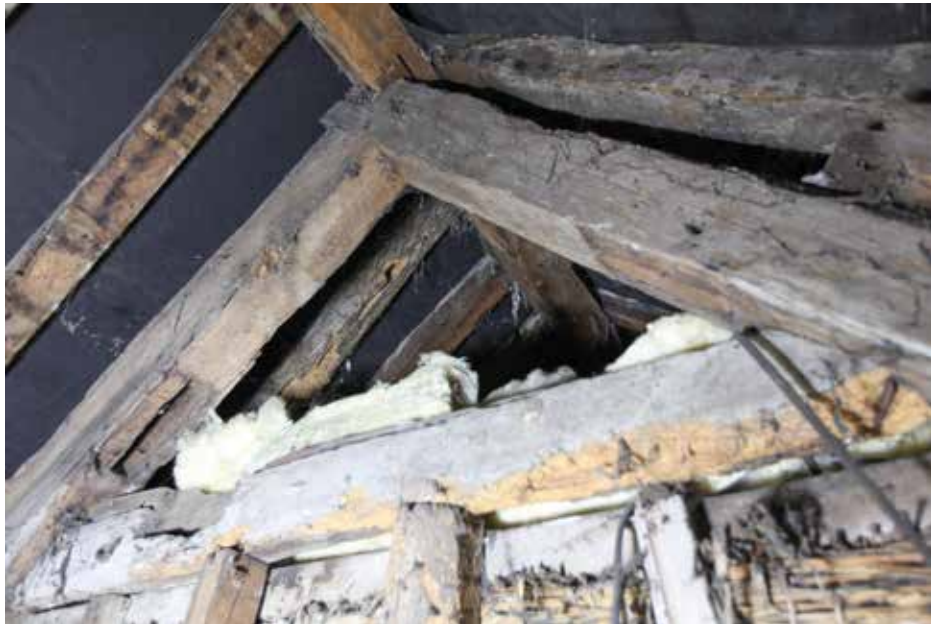
Plate 26 above: Central range Queen strut truss with additional principal rafter; increasing the pitch of the roof and inserted oak studwork to carry reed and plaster for the plastered ceiling below.

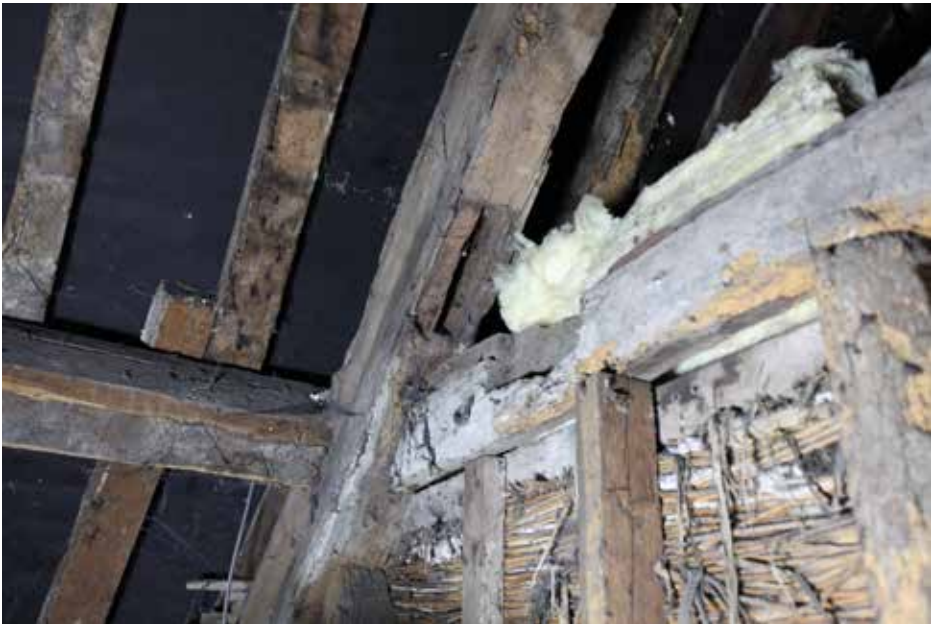
Plate 28 above: Detail of the central range truss showing the mortice in the principal rafter of the earlier raised collar.

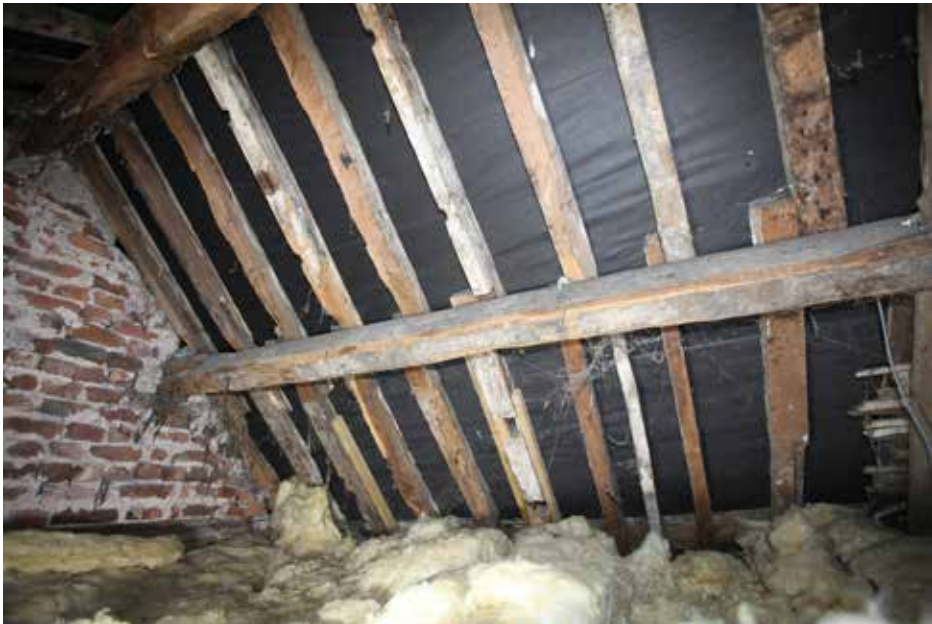
Plate 30 above: Central range purlin and rafters.

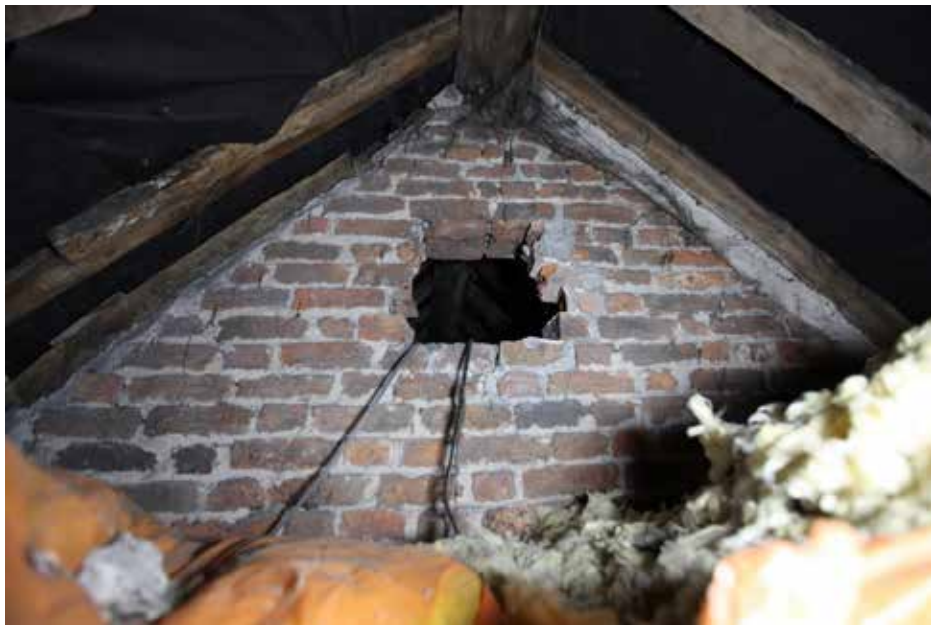
Plate 31 above: Brick internal gable to centre of southern wing.  
 Plate 32 below: detail of roof structure above the parlour and best bedroom.

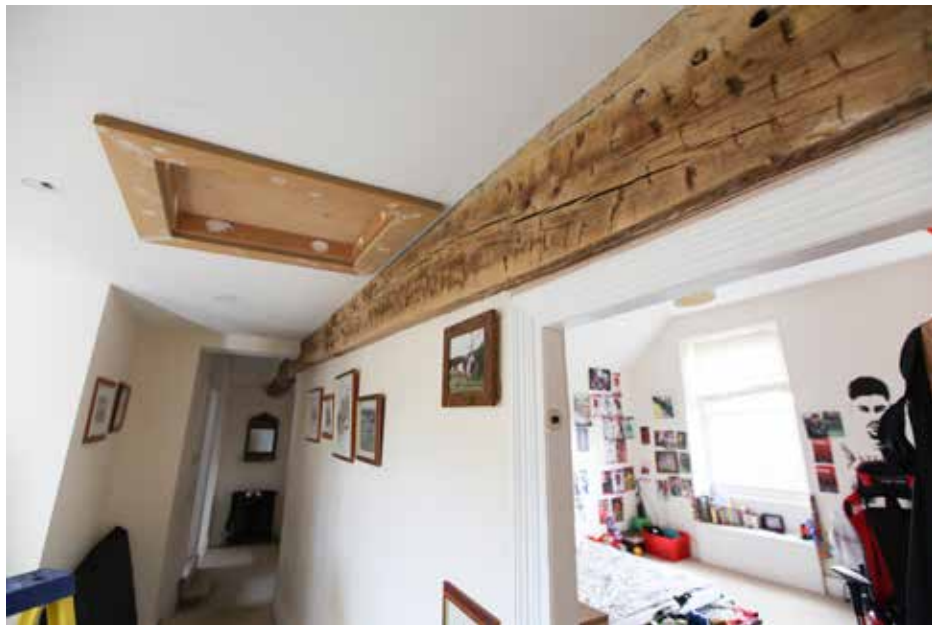
Plate 34 above: Long beam of ca. 1700 supporting pair of Queen strut trusses.  
 Plate 35 below: Bedroom 2 with raised soffit to ceiling of ca. 1730.

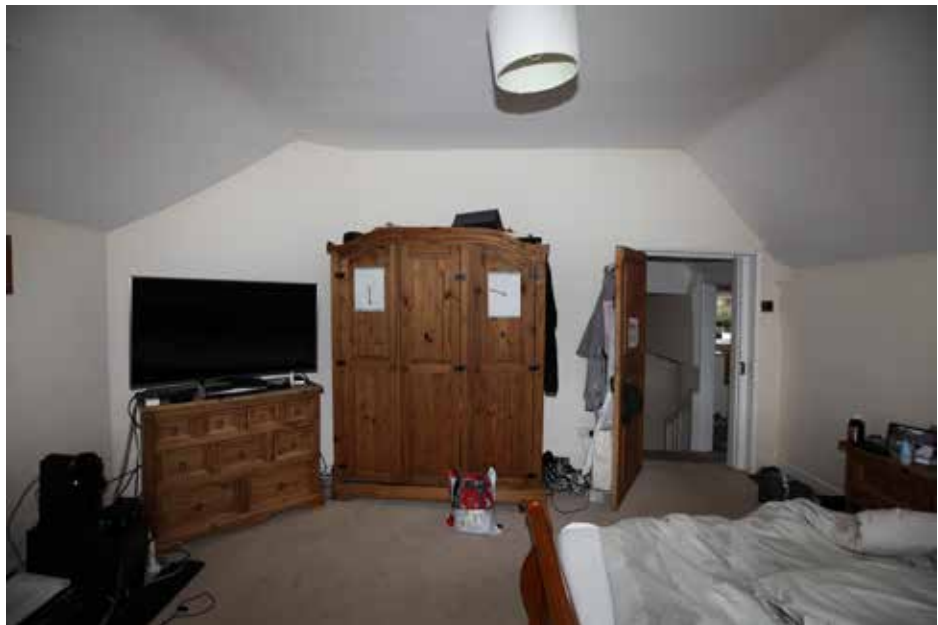
Plate 37 above: Master bedroom with corner fireplace to the left and original doorway of ca. 1690 to the right. The ceiling has been altered but may be C17.

The loss of brickwork of c.1690 between Bedroom 1 and Bedroom 4 will cause minor harm. The loss of the original doorway into Bedroom 1, the best bedroom, can be mitigated by retention of the door frame, as evidence.

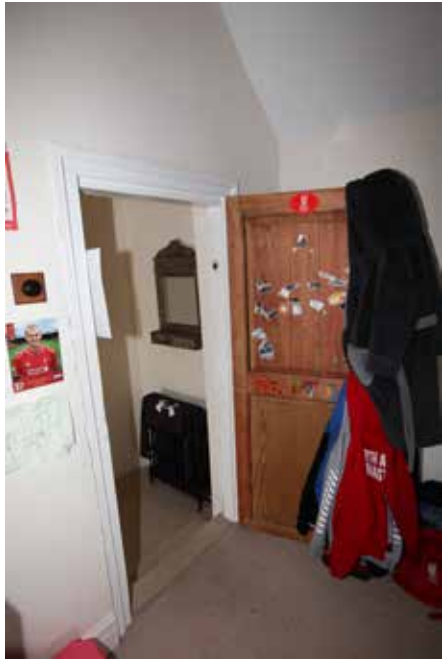
Plate 40 above: 2-panel C18 door to bedroom 3, ex-situ. The frame is 18th century.

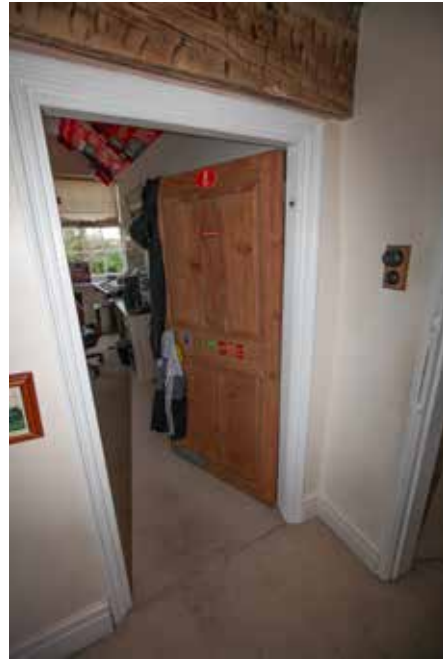
Plate 41 above: 2-panel C18 door, ex-situ, to bedroom 2. The doorway opening is 18th century.

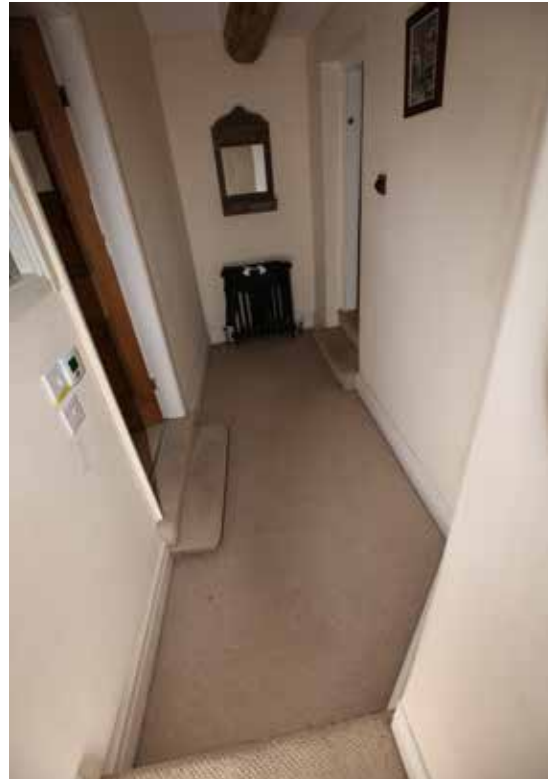
Plate 43 left: Step down to the landing over the former dairy. The floor then steps up into Bedroom 3, part of the c.1730 remodelling.

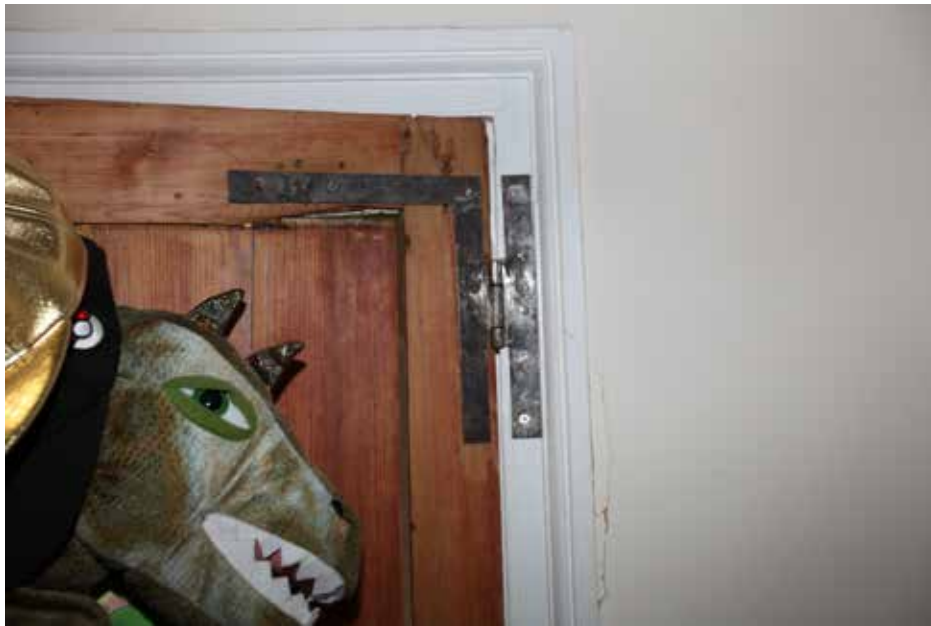
Plate 42 above: HL hinges have been screwed onto all of the 2-panel doors at first floor level. These are ex-situ but re-used 18th century hinges.
