## Heritage Impact Statement - Holt Hill, Green Street, Holt, LL13 9JF

Report for C Eaton

24th January 2020

**Mel Morris Conservation**

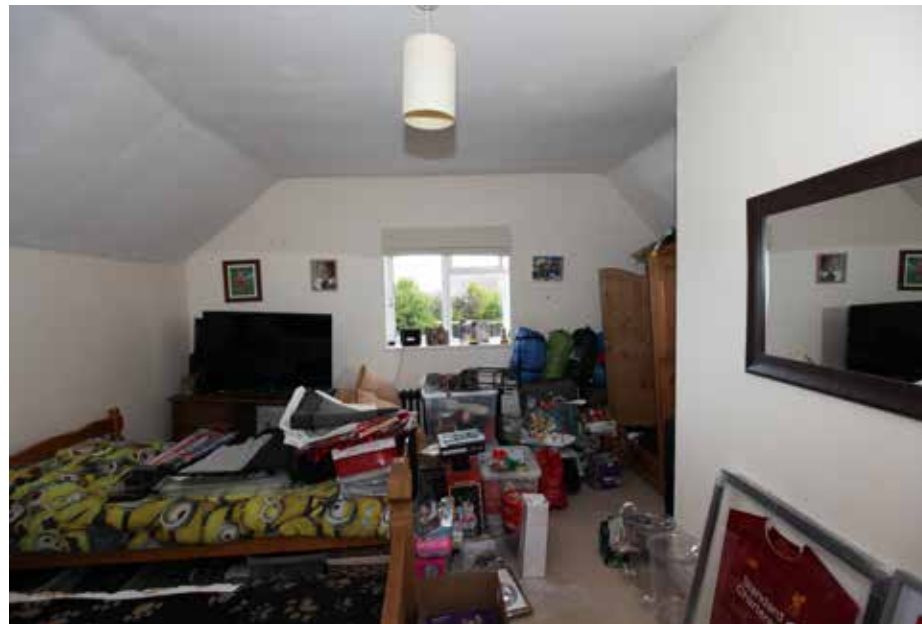
Plate 44 above: Rear bedroom 4, with inserted brick wall to the right, which forms the core of the later inserted staircase. The window on the west wall is a modern replacement.

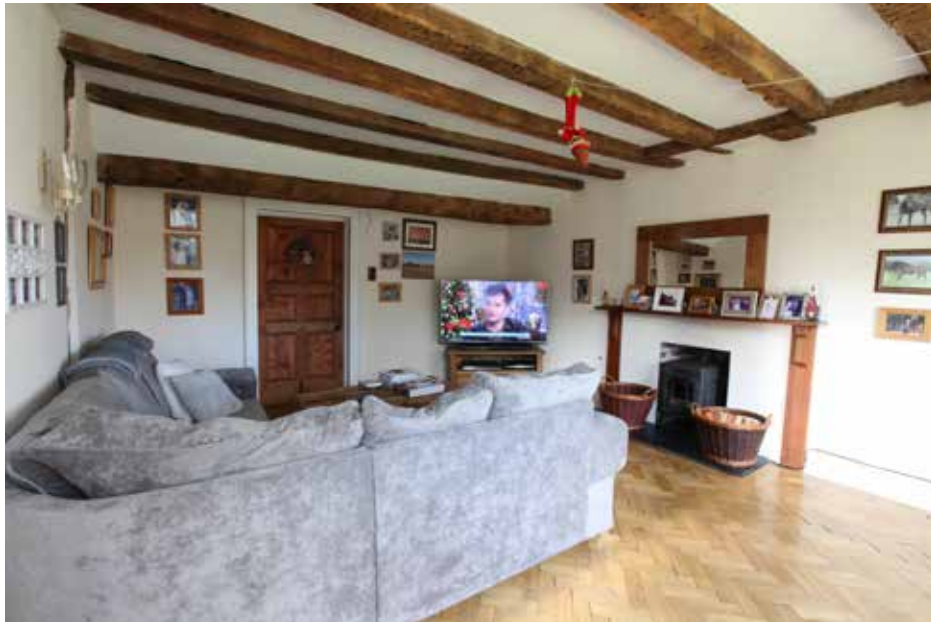
Plate 49 above: View of former hall, with early joists, modern fireplace and trimmed joists around former chimney breast.

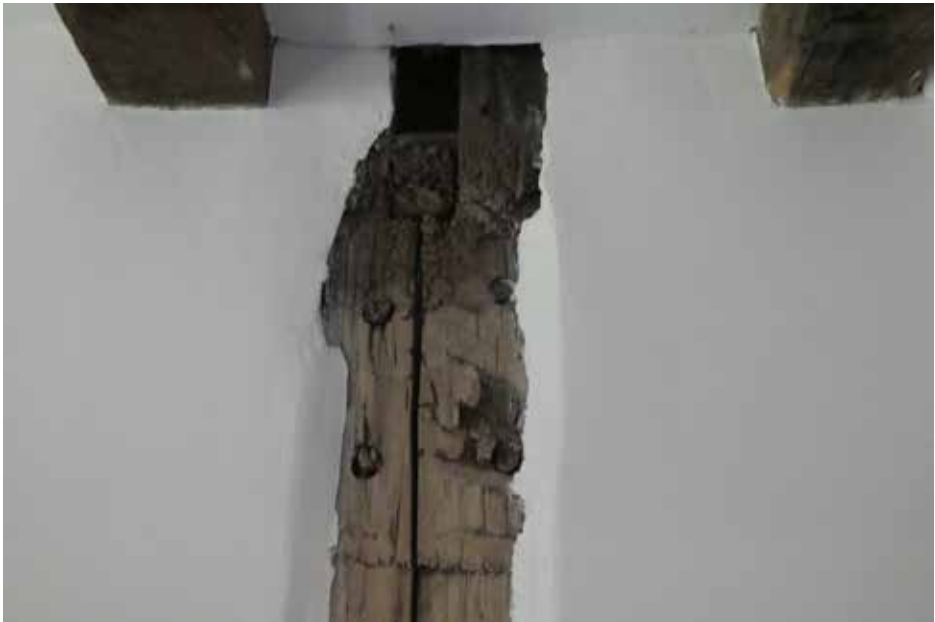
Plate 55 below: Detail of oak chamfered beam.

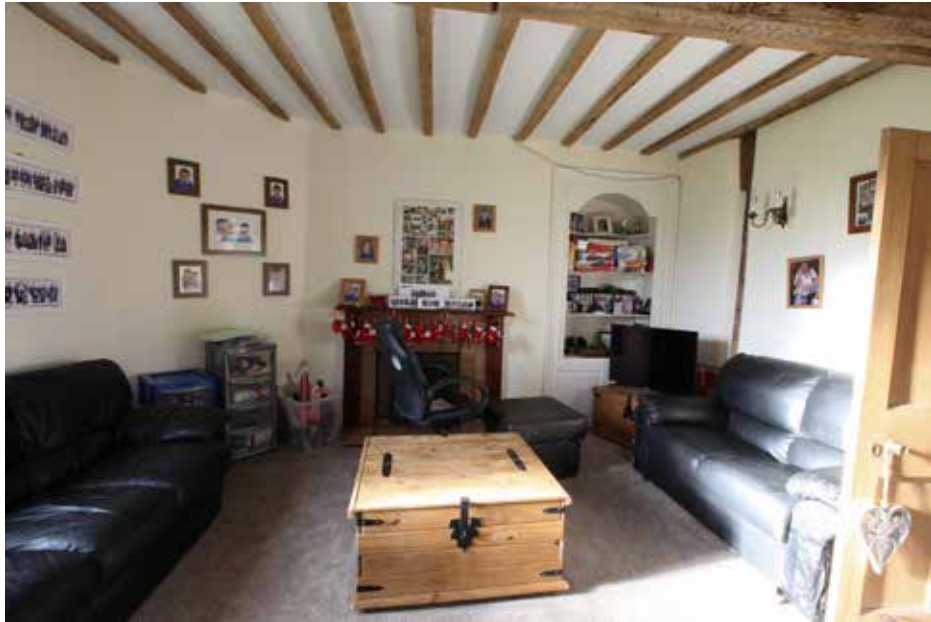
Plate 56 above: View of the parlour, with corner fireplace to the left (blocked-up), later fireplace to the centre and arched cupboard of c.1730 to the right.

The Parlour contains a modern fireplace surround to the west wall, which incorporates a horizontal flue in the garage, and to the right of this an 18th century arched cupboard recess, with contemporary joinery for displaying silver and china, with arched timber head, stepped architrave, scalloped edge display shelves and low-level raised and fielded panelled cupboards. This is in-situ and would have been related to a 17th or 18th century fireplace surround. The cupboard may have occupied the location of a

former doorway into the rear bay (now garage) but this was removed ca. 1730. The original hearth to this room still survives in the form of a corner chimney breast, but the fireplace was removed when a fireplace was added to the internal west wall, although when this was altered is not known. It uses the same flue.

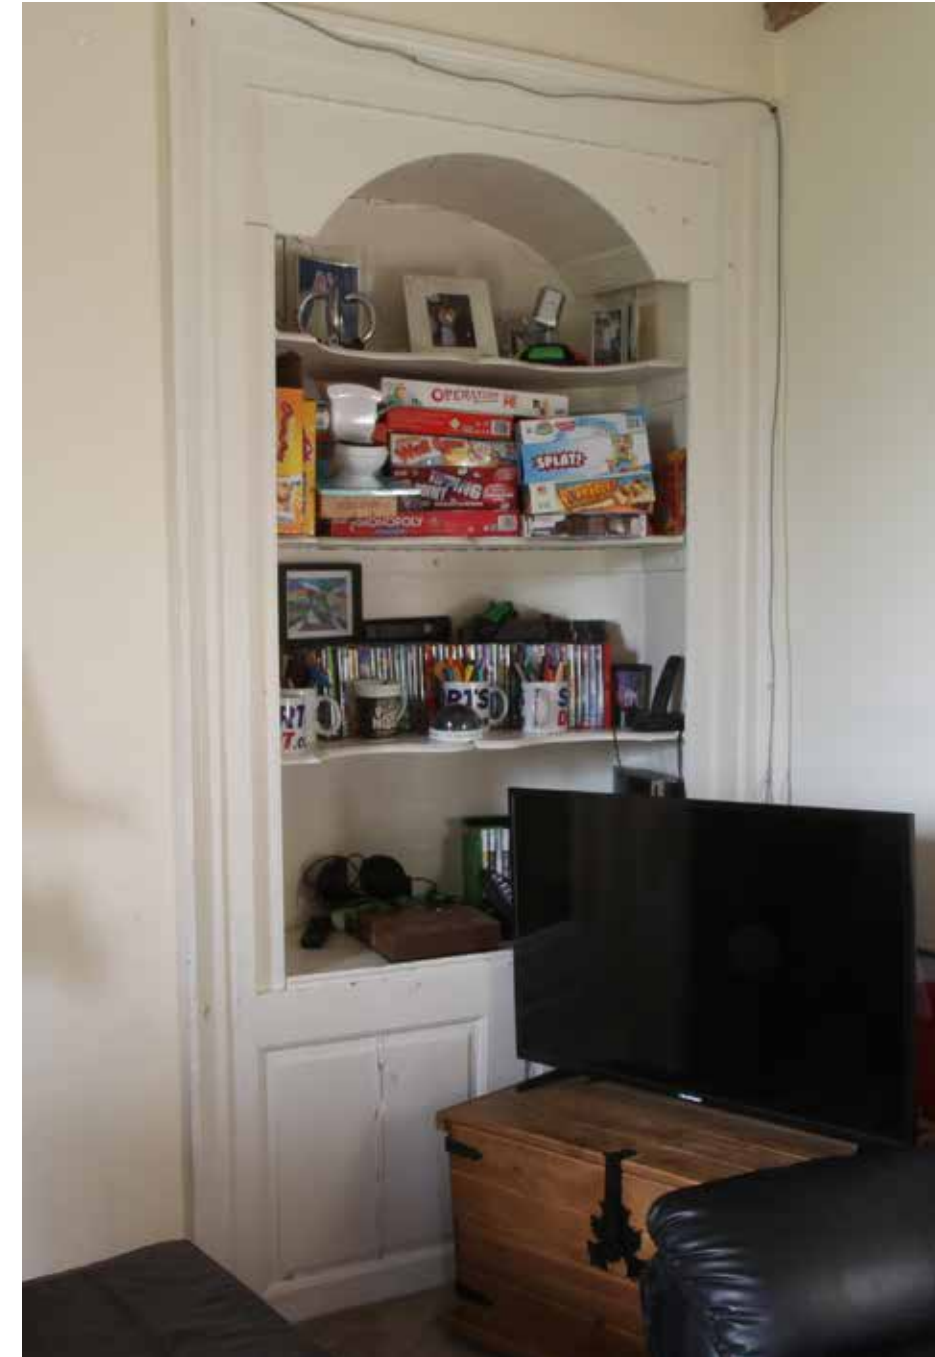
Plate 59 above: Arched china cupboard with stepped architrave, decorative scalloped display shelves, curved back and raised and fielded panelled base, ca. 1730.

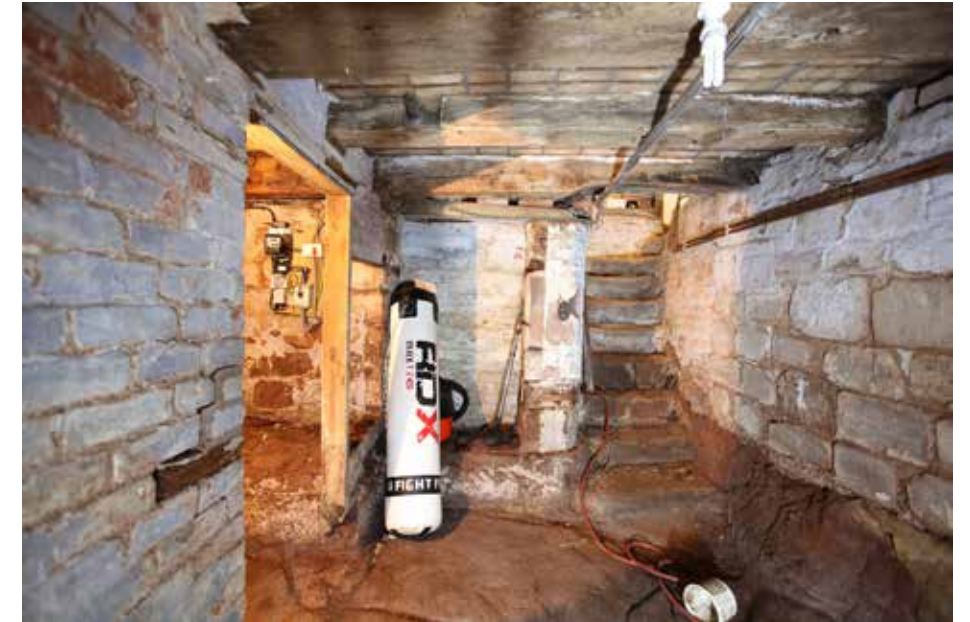
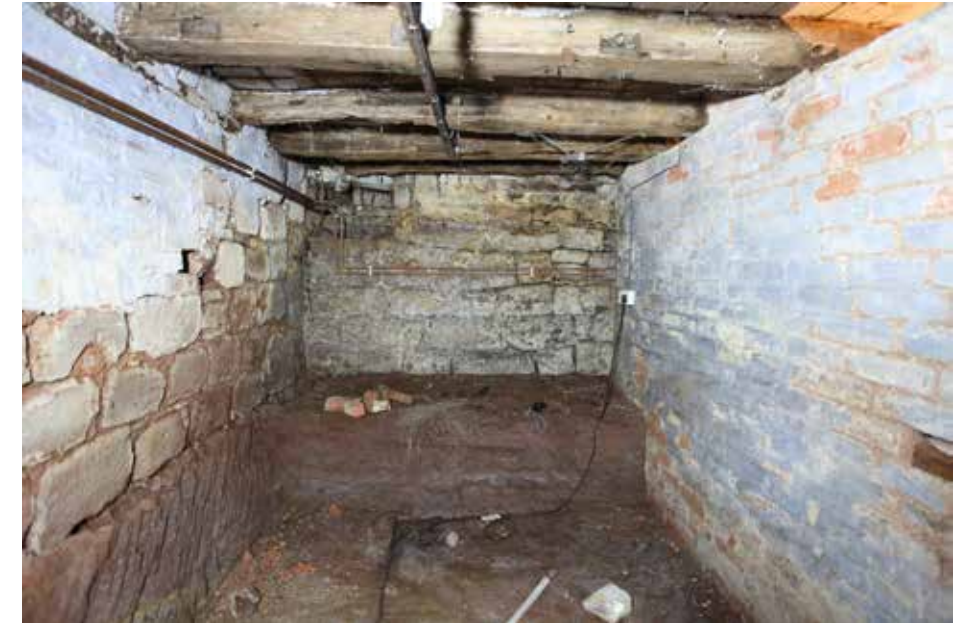
Plate 60 above and Plate 61 below: Cellar with stone masonry of ca. 1680, re-used joists (probably 16th century)

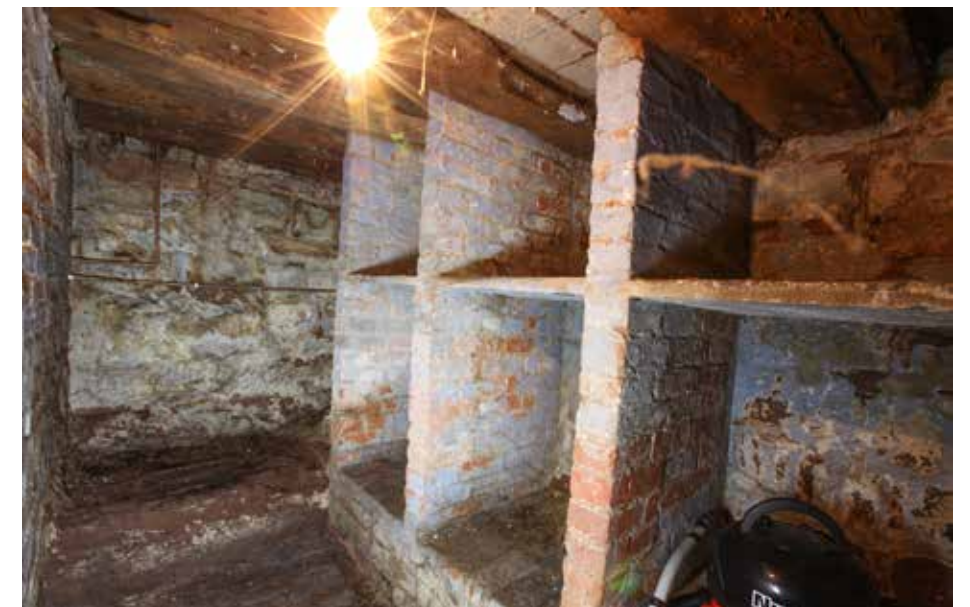
Plate 62 below: Cellar with brick 19th century wine bins

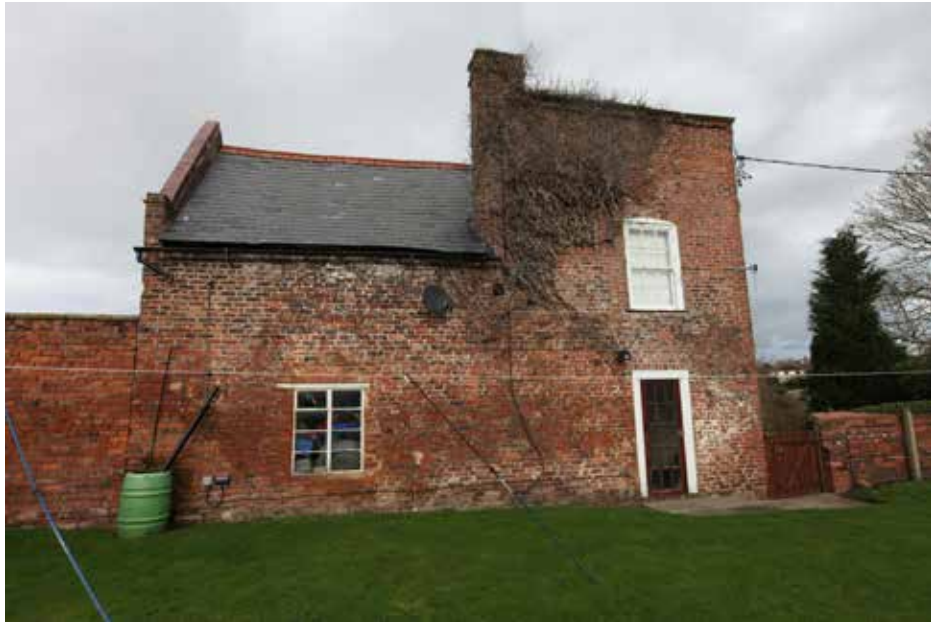
Plate 63 above: Southern wing of c. 1680-1700, with raised parapet, remodelled stack and inserted sash window to east.

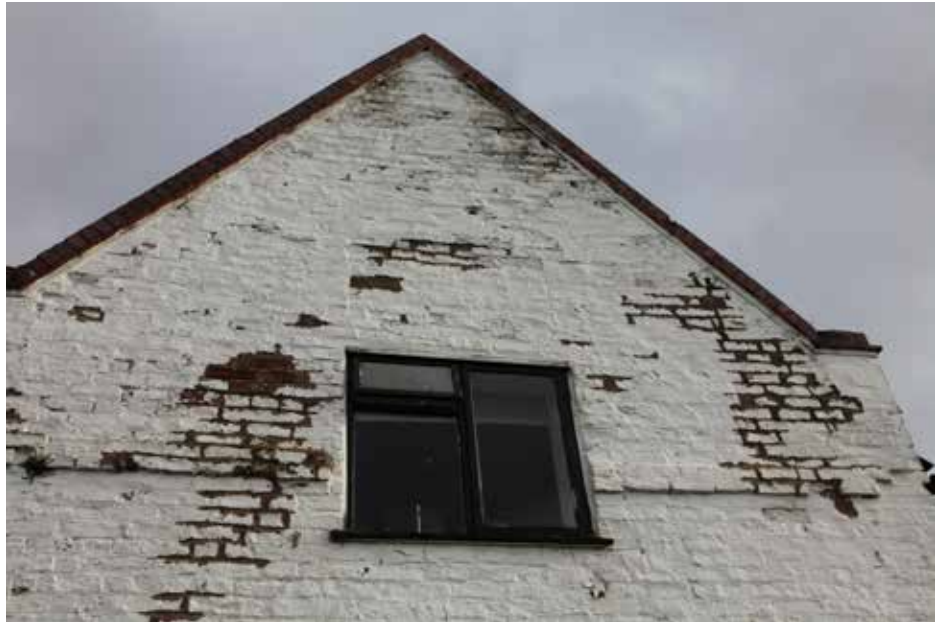
Plate 65 above: Brick gable to west end of southern wing of ca. 1680-1700, with raised brick band and remodelled window.

The second phase of brickwork is found in the southern wing (south and west elevations) which is of two bays, comprising a Parlour and a second room on plan. The character of this brickwork is of random bond, with a high firing temperature and some plum and reddish-black brickwork showing signs of flaring. The higher firing temperature which has led to this finish has meant that the brickwork in this range has fared much better than the later brickwork. The south elevation has been lime-washed at some point and this has been recently removed but the painted finish to the west gable remains. The only distinct detail in this phase of brickwork is a two-course raised brick band to the west gable which is a detail found in the late 17th century. It is likely that another band lower down this elevation was removed at some time.

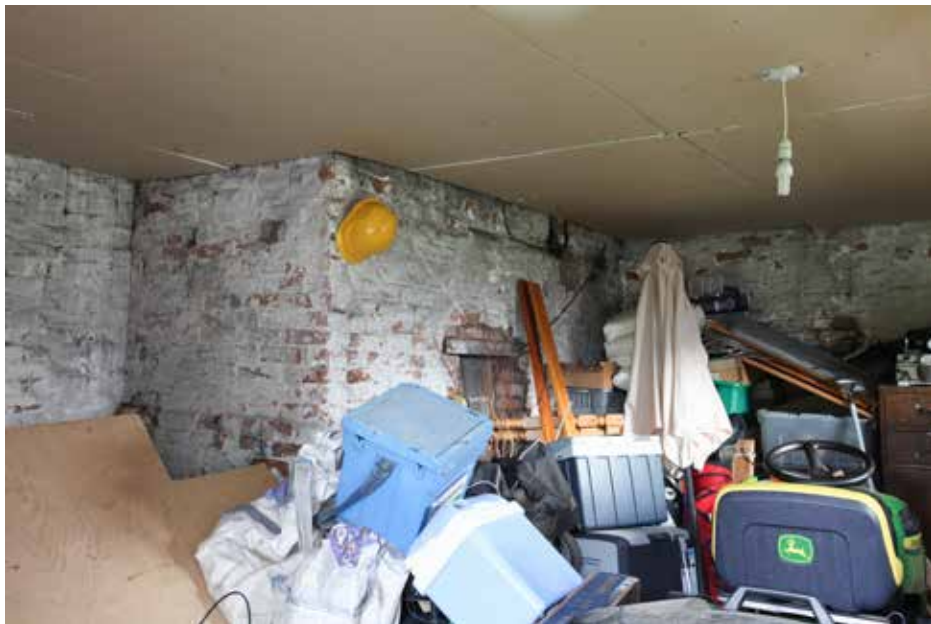
Plate 64 above: Brick masonry for staircase of ca. 1730 inserted into southern wing.

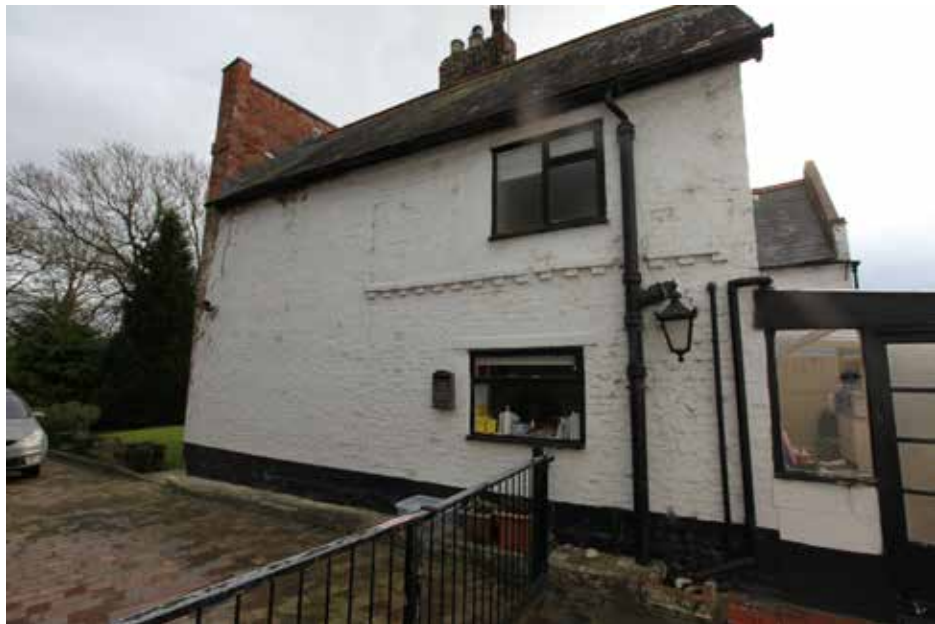
Plate 66 above: Brickwork to dairy wing, with decorative dentilled brick band and original opening to dairy window at ground floor level. Modern window to first floor.

any evidence of a masonry stack to this space, and the presence of a crude diamond lattice suggests it was probably used as a dairy. The beams within this room have no dateable mouldings but the transverse beam is substantial. Brick banding is also found over a long period, from the 17th century to the late 18th century. It is suggested that this bay was built in the late 17th century as a low two-storey structure (ca. 1680). This explains why there is a lower floor level to this part of the house at first floor level. The eaves to this dairy were raised when this and the adjoining range were part rebuilt at first floor level.

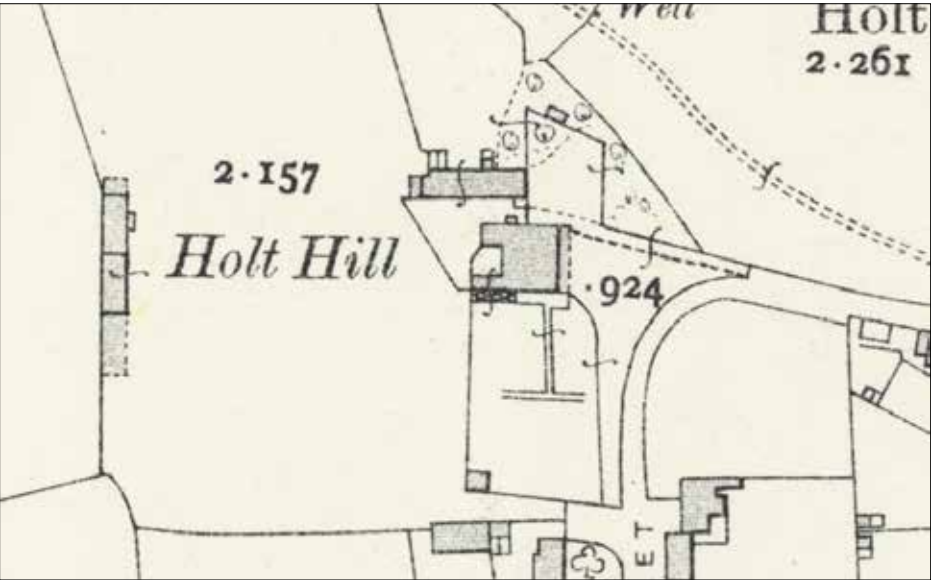
Plate 68 above and Plate 69 left: 1911 Ordnance Survey map, with to the left an overlay of the two maps.

The purple overlay is the existing 2019 plan and this demonstrates that a large wing was located in line with the northern wing, which has since been demolished. This wing existed as long ago as at least 1834 and as recently as 1964 (OS map)..

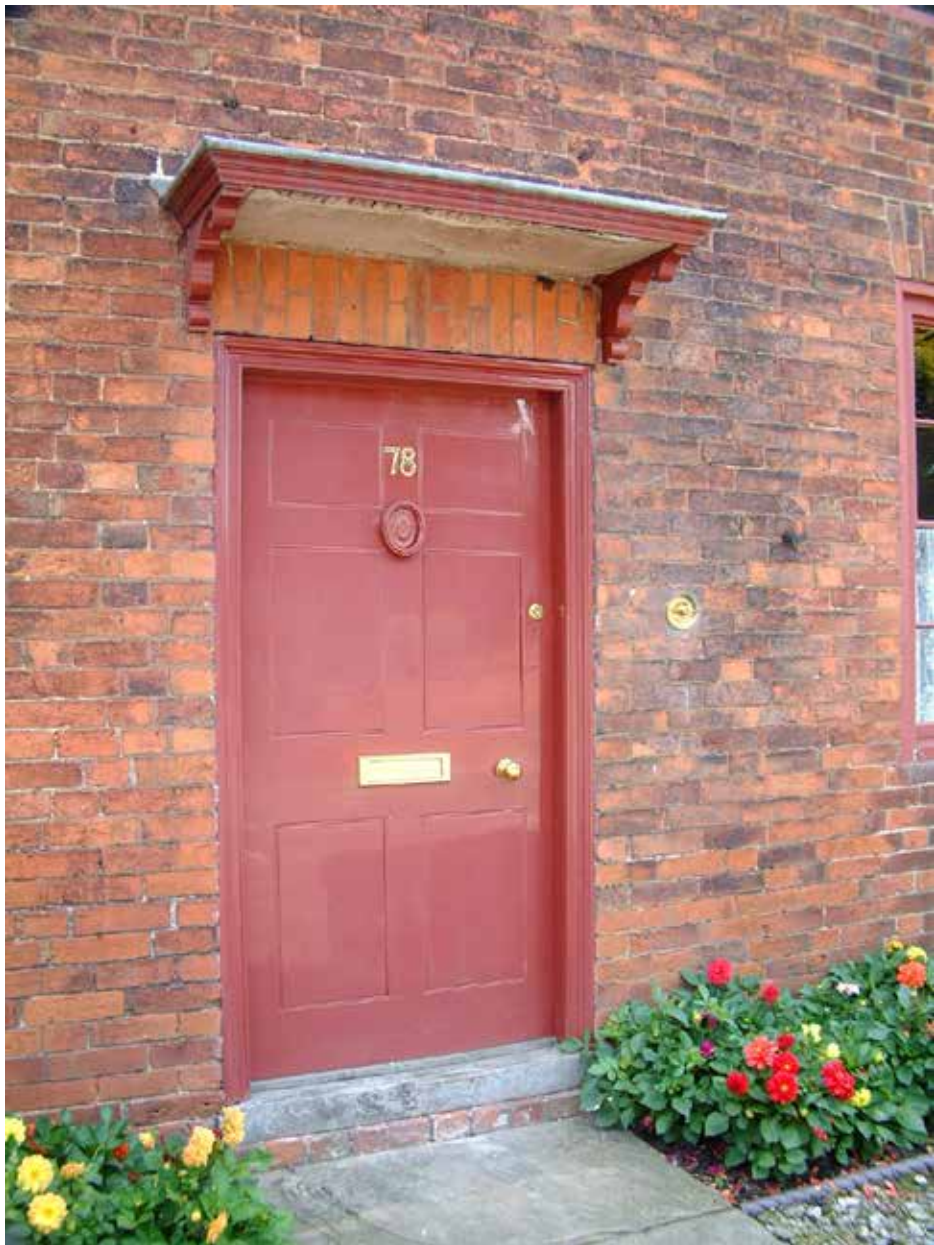
Plate 71 above: Example of Georgian door with classical door canopy, as proposed.

This canopy provides a degree of protection from rain for visitors, whilst being entirely low-key and sympathetic to the listed building. It is recommended that the detailed design is a condition of LBC with drawings at 1:10 and 1:5. The adjoining room will require the sash window to be reinstated and the panelled lining which is currently in the former doorway to be moved back to the Parlour. The relocation of this raised and fielded panelled lining and all alterations to restore the window to the Parlour should also be a condition of LBC.

The proposed alteration to the front elevation of the listed building is to restore the original front entrance door. There is positive evidence of this location in the form of the door threshold and straight joints and the fact that it entered the 'Hall'. As with all early Georgian buildings of the 1730s, the front door would have been a classical design, based on a 6-panel door, with raised and fielded panels. This is almost without exception. The proposal reinstates a traditional solid panelled hardwood door in line with the style shown on page 20. Full drawn details of this door will be needed at a scale of 1:10. In addition to the new door a fanlight will be required to be reinstated, as would have been originally designed. The proposal is to also provide a simple but classical door canopy based on similar examples we have found for 18th century buildings (see example below).
