## Geo-Environmental Report

Marston's lodge Plas Coch Road, Wrexham, LL11 2BW  
For  
Marston's Group plc

| Ref: | CRM.427.008. GE.R.001.C |

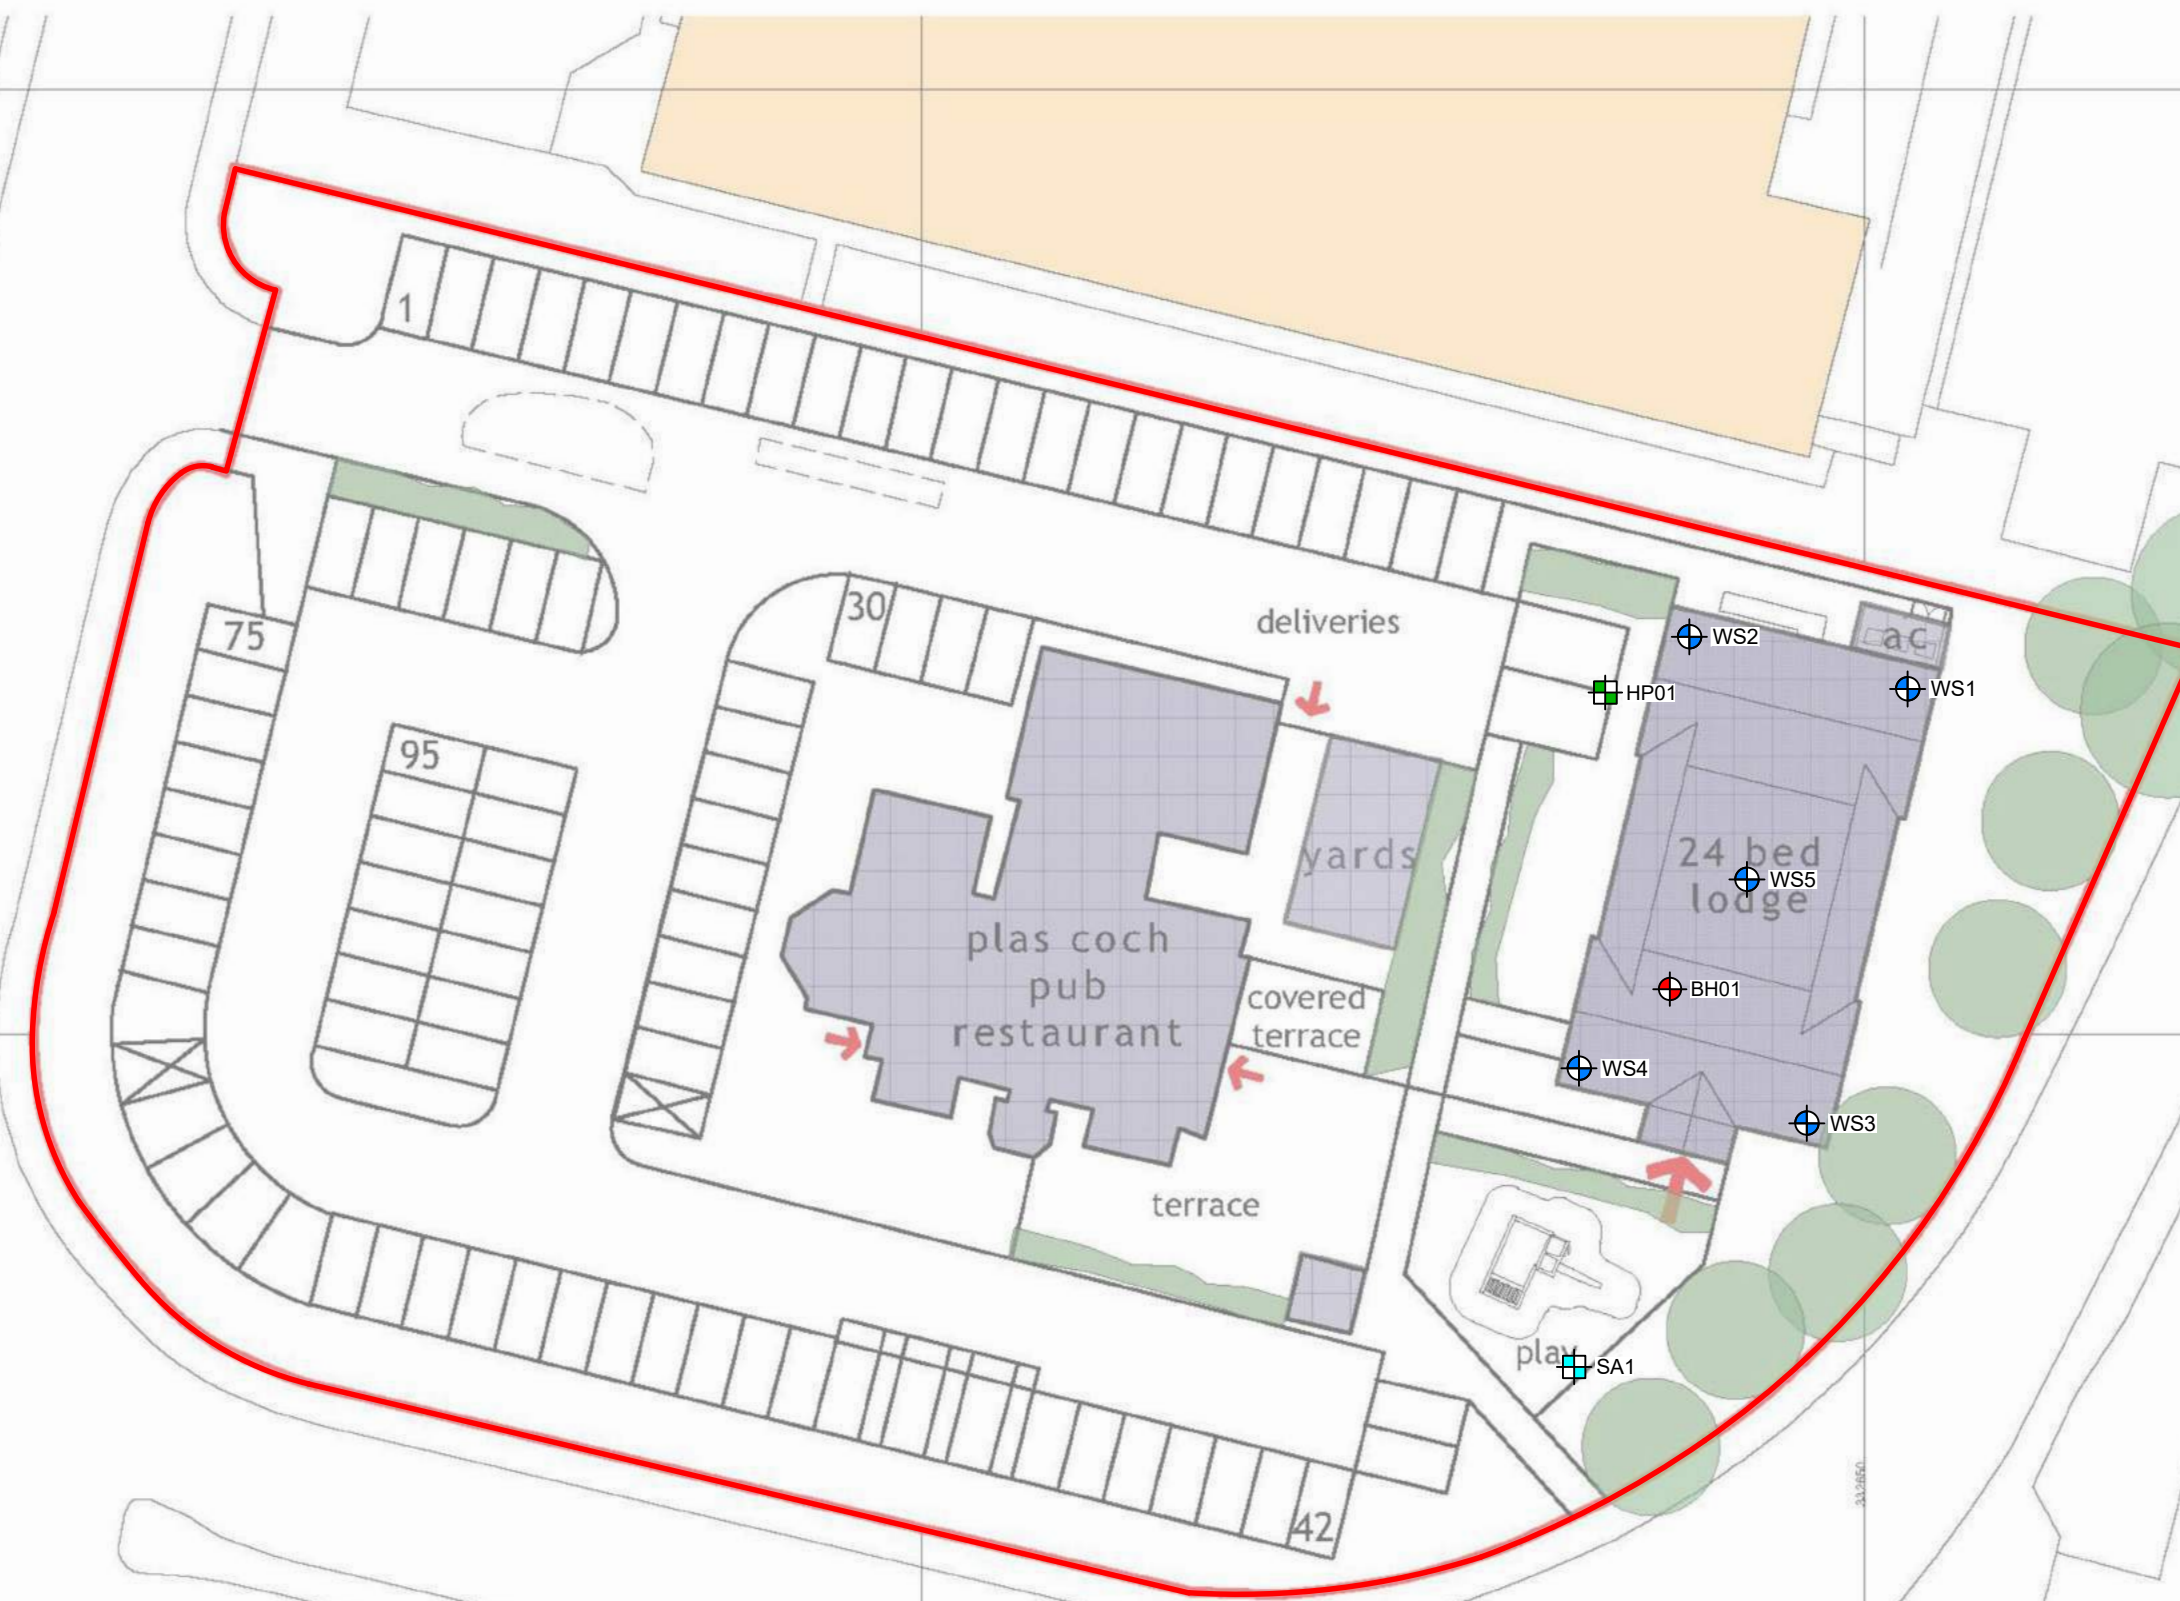
Soakaway Position (SA)  
(SA1)

Based on a BRE soakaway test undertaken at SA1 and within the Made Ground to 3.00mbgl a soil infiltration rate of  $5.5 \times 10^{-4}$  m/s has been calculated.
