## Coal Mining Risk Assessment

Wylfa

Bowers Road

Acrefair

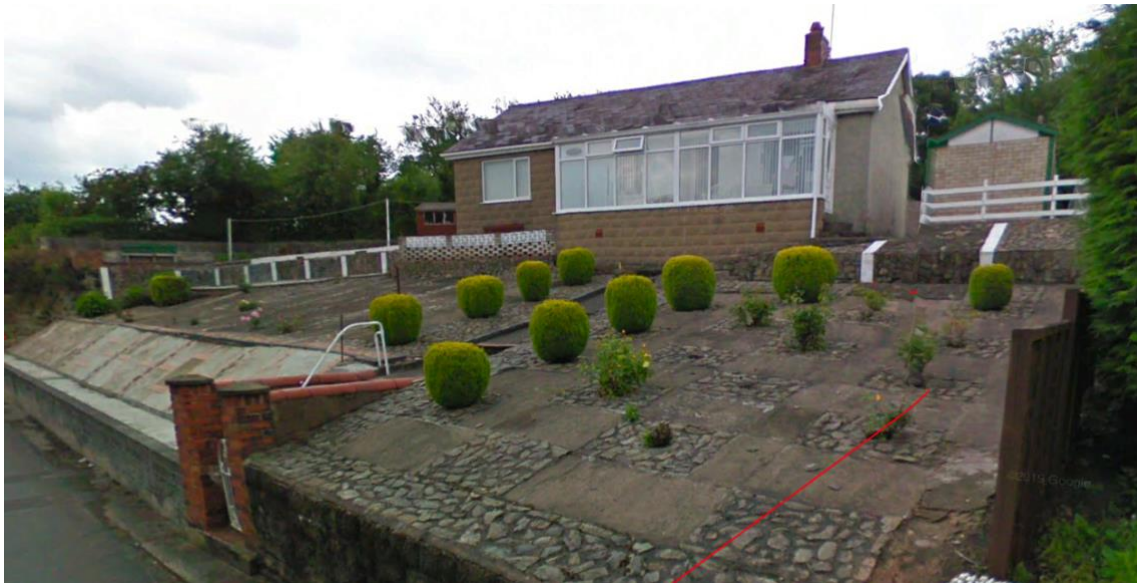
**Figure 2 Site Photograph**

- 2.1 The site is located approximately 917m north of Cefn-mawr village centre and lies at an elevation of 140m AOD (centre of site).
- 2.2 The approximate National Grid Reference for the centre of the site is SJ27674 43319 with the closest postcode being LL14 3TF.
- 2.3 The site is sloping forming part of a former mineral railway embankment and coal spoil heap. The southern boundary is formed by Bethania Road.
- 2.4 A location plan is shown below as Figure 1 together with an aerial photograph as Figure 2 (overleaf).
