## **Heritage Impact Statement** **Rev D**

Proposed removal of existing conservatory and construction of glazed extension, glazed link and internal alterations along with alterations to existing access' at The Stone House, Llay Road, Burton, Rossett, Wrexham, LL12 0HS.

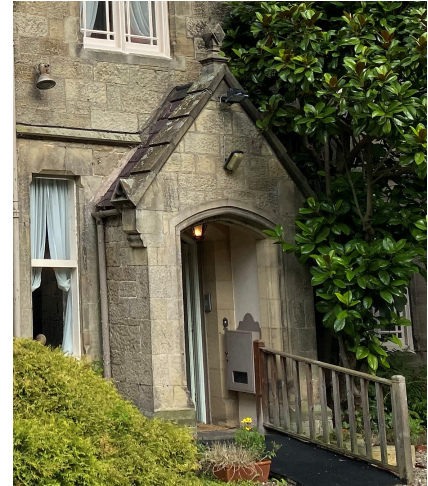
The front entrance porch has a vaguely gothic revival character. This is evident by the parapet wall extending beyond the roof line and the decorative stone kneelers with trifoiled stone detail above. The Gothic Revival was a conscious movement that began in England to revive gothic forms; starting in the second half of the Eighteenth Century and continuing throughout the Nineteenth Century.

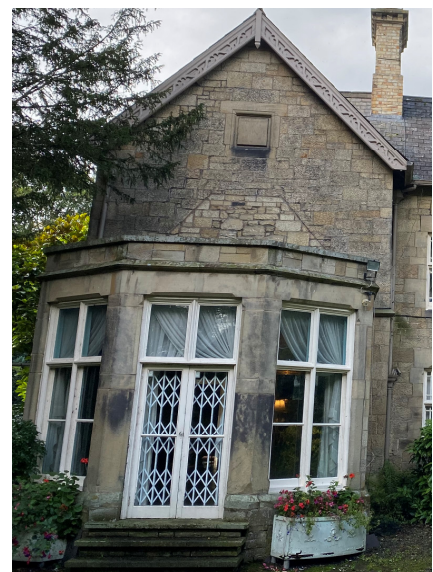
Since the building was originally constructed; a number of alterations have occurred at the property, including a flat roof extension to the lounge and a conservatory to the side. It is believed that the flat roof side extension replaced the third original bay (noted within the listing). There is evidence of the original roof line on the existing main wall (see picture).

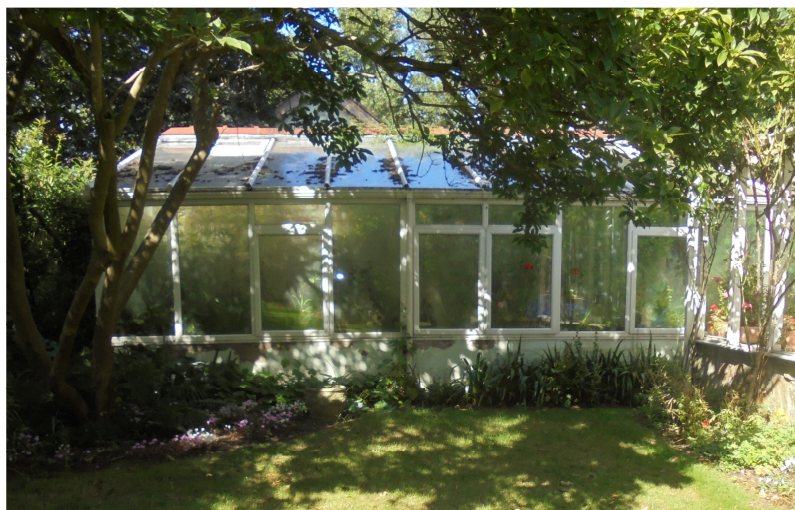
The existing conservatory extension, which we are intending to demolish, is constructed out of white uPVC window frames with white rendered walls at lower level. This is not a traditional construction method and is not in keeping with the rest of the buildings. We believe this extension was formerly built for functionality purposes only and no thought into external appearance was taken into account.

**Existing Conservatory which is to be demolished**

The existing structure, that is being demolished, is a conservatory and is mainly used as a garden room for the current owners. It is our client's intention, who is buying the property, to demolish this conservatory and replace it with a modern fully glazed structure. It can be said that this is such a modern form of construction that it will detract from the original building. However, the reason for this form of construction is to actually do the opposite. The construction is all glazed and has very little framework to the structure. Where the new glazing abuts the original dwelling; there is very little physical contact of materials as the glazing is sealed with a structural sealant. Therefore, ensuring minimal impact on the existing materials. Also, with the structure being all glazed; the existing features can still be seen through the new extension.

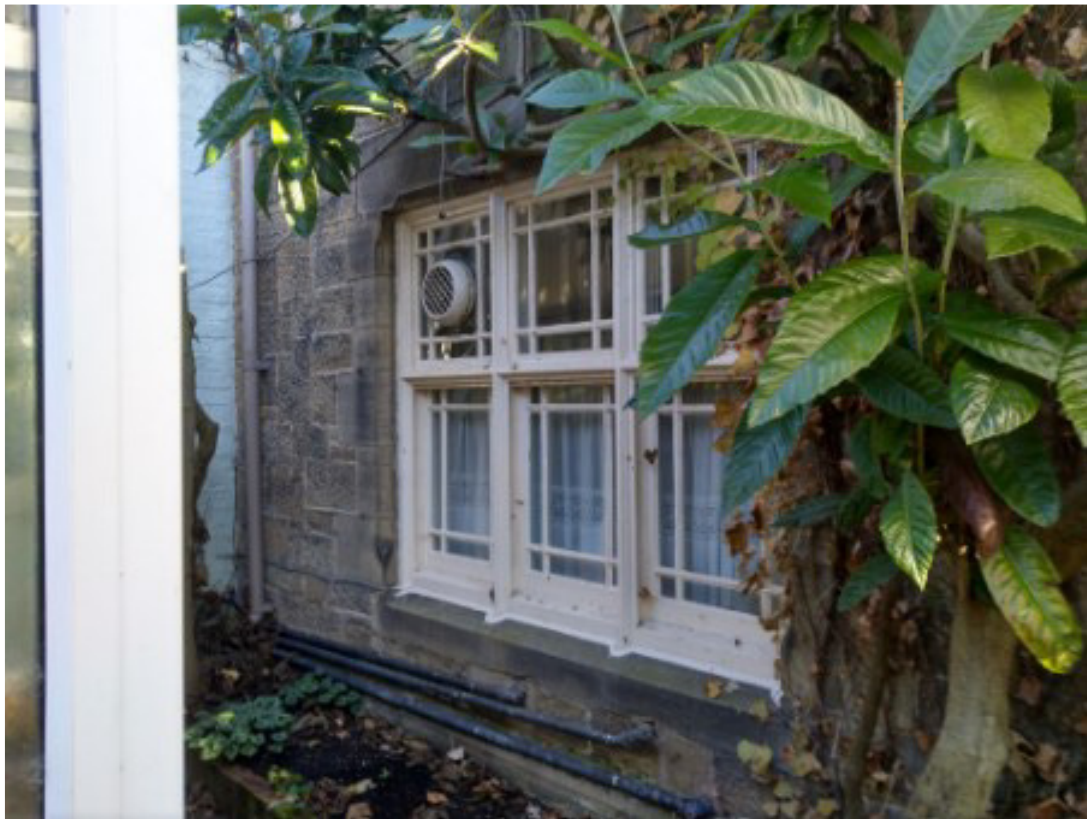
We are intending to remove the existing window frame located within the kitchen. This window currently looks out onto the existing conservatory. Our proposals are to keep the existing opening, but reduce the cill down to finished floor level to provide an entrance into the new glazed extension. To complete this; removal of the stone cill and stonework below the cill will be required. The quoin detailing to the side of the opening will be continued down to floor level. However, the chamfered reveal will not be continued down. This is to ensure that evidence is provided of where the existing opening was originally. Where the opening is formed through the existing stone plinth; contractor to saw cut the existing stone to provide a clean cut for the new stone quoins.

**Existing window which is to be removed, opening retained and lowered.**

One of the stone quoins just below the header is damaged. Therefore, we are going to replace this with a new stone quoin. This is to be made of a like for like basis to the original stone quoin, with the chamfered reveal detail included.

Internally; the timber panelling can be found on the chamfered returns. These chamfered returns are to be continued down to finished floor level. The timber panelling is to be replicated at the lower level. A small timber panel is to be installed between the old and the new to provide a break between the two sections. This will also give a subtle detail of where the original opening was. The architrave that surrounds the opening internally will also be continued down to the floor level. This will be purpose made to match the profile of the original and painted white.

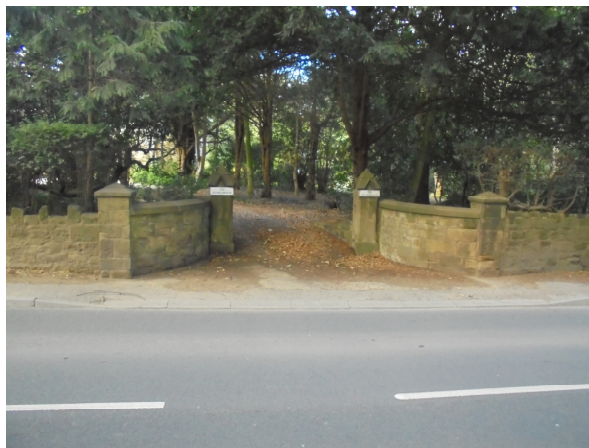
**Existing Main Access**

The main access has stone walls with a solid stone coping on top for the splays of the access. There are four stone pillars found at the entrance; two of which boast a high level amount of detail, constructed out of solid stone sections with chamfered corners matching detail found on the dwelling. A decorative coping topper is found on top of these pillars, with steep pitched detailing. These two pillars would have had gates attached to prevent intruders. This is evident by the cast iron hinges still found protruding out of the stonework. The second pair of pillars are simpler in design; comprising of simple dressed stone with a detailed coping stone topper. The dressed stone, topped with simply coping stone, also forms the splays of this access. The second access is of less importance, being the subordinate entrance, and just comprises of a rough stone walls splaying into the land. The only feature is the upright stonework which forms merlons and crenels. This continues along the boundary wall facing the main road.

We are proposing to alter the accesses to provide a safer entrance of the adjoining highway. Currently the accesses are located just off the highway and the visibility splay are well below to standards set out in manual for streets; the current situation is extremely unsafe. Our intention is to relocate the existing four pillars and splay walls further back into the grounds of The Stone House. By doing this, the visibility splays can be dramatically improved. Please refer to the existing and proposed access plans. If we were to not set back the pillars and reinstate gates in the positions currently; a vehicle would be unable to turn off the road and park in front of the gates when they are closed. By relocating the pillars further back from the highway; it allows a vehicle to pull off the highway and improve on existing highway safety, ensuring vehicles are not parking up on this very busy road. All works of relocating these pillars and splay walls are to be done by hand to avoid damage to the stonework. Extreme care is to be taken to ensure the outlook of the access is maintained, albeit in a slightly different location. New cast iron gates are to be installed to match the styling indicated on the access elevation and picture below. All this work will provide much safer entrances to the property whilst keeping the appearance of the street scene intact.
