CPAT Report No. 1674

# Marchwiel Mill House

Heritage Impact Assessment

Client name: Megan Boreham  
 CPAT Project No: 2390  
 Project Name: Mill Cottage, Marchwiel  
 Grid Reference: SJ3405648273  
 County/LPA: Wrexham  
 Planning Application: N/A  
 CPAT Report No: 1674  
 HER Enquiry No: [E6481](#)  
 Event PRN: 140302  
 Report status: Final

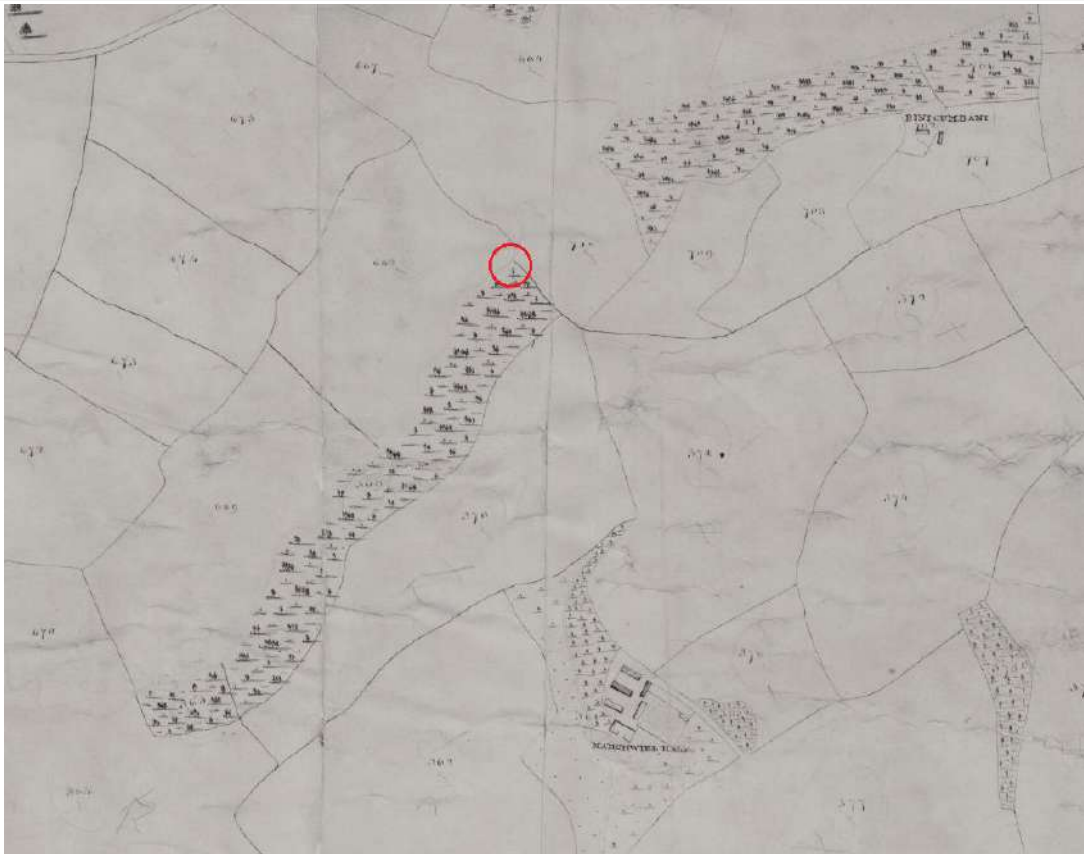
*Fig. 2 Tithe Map of 1840 showing the site of the mill in red*

- 4.8. The fields surrounding the mill site on the north and western sides were recorded in the tithe apportionment as 'Ruff Moor' and 'Meadow' and there is no reference to a mill.

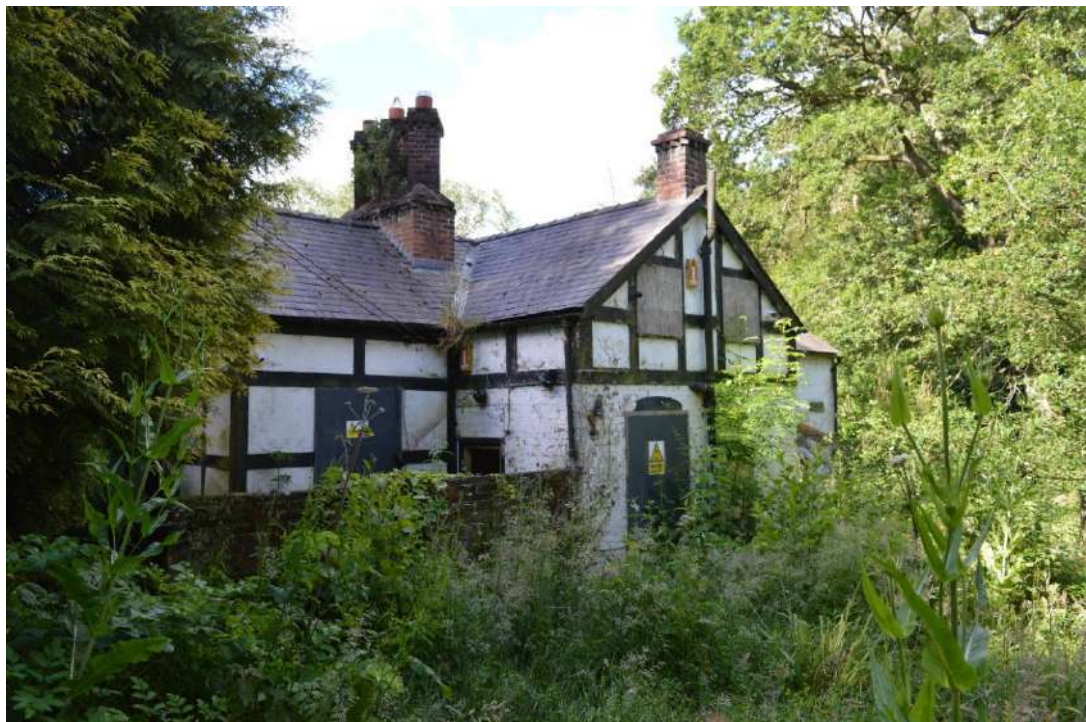
## Mill house

*Fig. 4. Northern elevation of the mill house. CPAT photo 4661-0005.*

- 
- 5.10. The northern elevation of the house had a projecting gable range with a square brick chimney at the apex (Fig. 4 above). This range – which housed a small kitchen and the stairs to the attic – was of brick construction with a timber-framed attic above with two small square wooden-framed windows. This elevation was markedly devoid of any decorative architectural details in comparison to the south and east elevations.

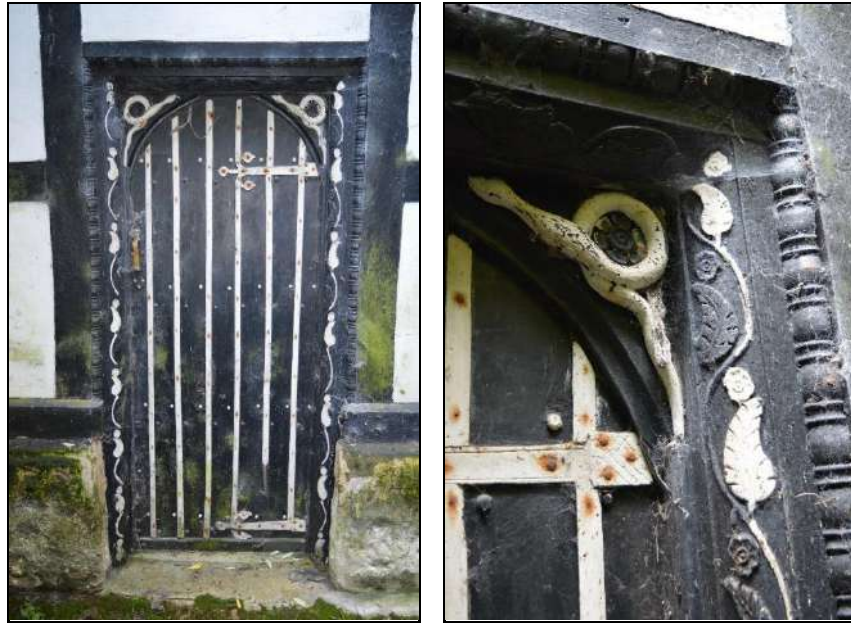
- 5.6. The house featured some highly decorative carved timber, particularly to the south and east elevations. The eastern elevation had an ornate single doorway to the ground floor painted in black and white (Fig. 5). The design of the door incorporated two wooden carved snakes and a decorative iron strap hinge. The wooden door jambs and lintel were ornately decorated with black and white painted leaves with beveled detailing around the edge.

*Fig. 5. Carvings on the mill house door. CPAT photos 4661-0002/0064.*

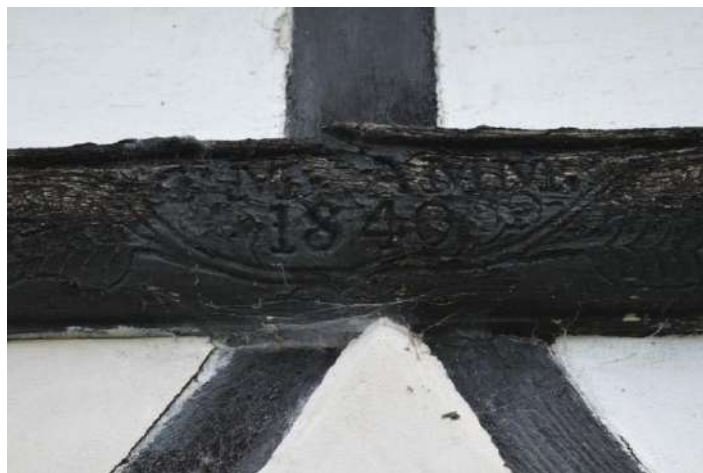
- 5.9. The southern elevation of the mill house was also timber framed and pegged, with a jettied dormer window to the attic at the centre, topped with a carved wooden finial (photo 4661-0017). Below the attic window the string course was ornately carved with foliage and bears the inscription 'TM. AMM 1840' (Fig. 6). On the ground floor, there are two tall cast-iron lozenge-patterned windows, with ornately carved timber surrounds (photo 4661-0019), in keeping with the entrance doorway on the east elevation.

*Fig. 6. Date carved on the southern elevation of the mill house. CPAT photo 4661-0021.*

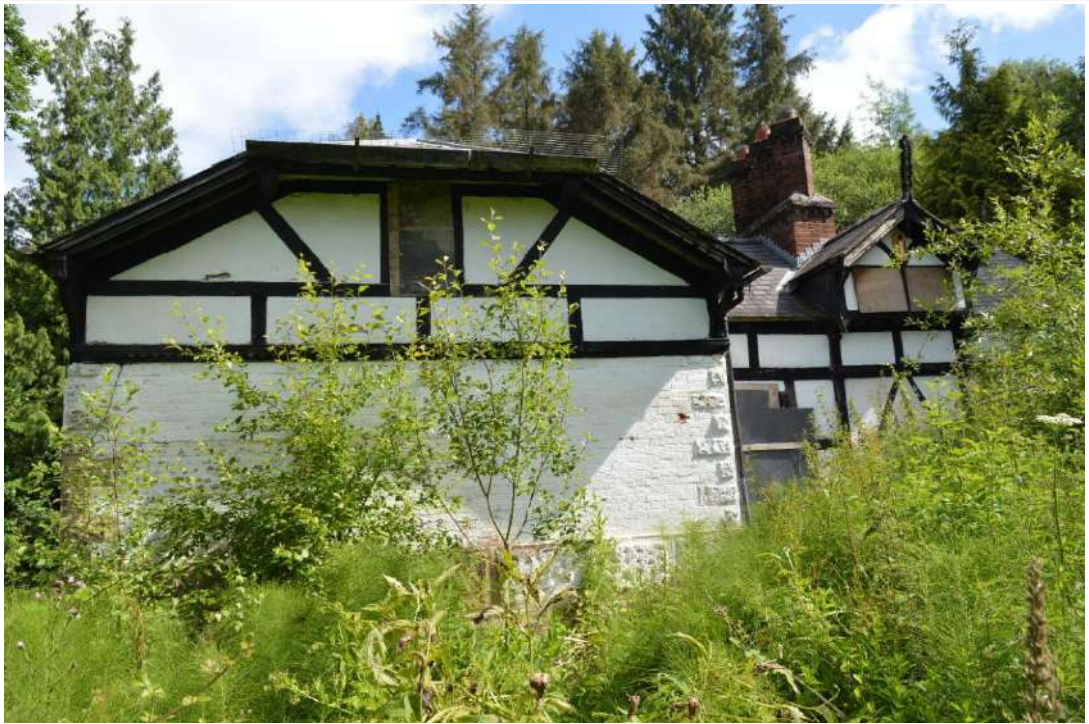
- 5.14. The mill building has a main working floor with an attic above and a cellar beneath.
- 5.15. Along the southern elevation, the mill building projected 1.67m further southwards than the back wall of the cottage. The mill structure was of brick construction with timber framing to the attic along the south elevation (Fig. 7). The decorative craved string course continued along below the attic of the mill building from the mill cottage and below this the construction was of white painted brick in a Flemish bond, set upon the decorative stone plinth. Decorative stone quoins were located at the corners (photos 4661-0022-26).

*Fig. 7. Southern elevation of the mill. CPAT photo 4661-0023.*

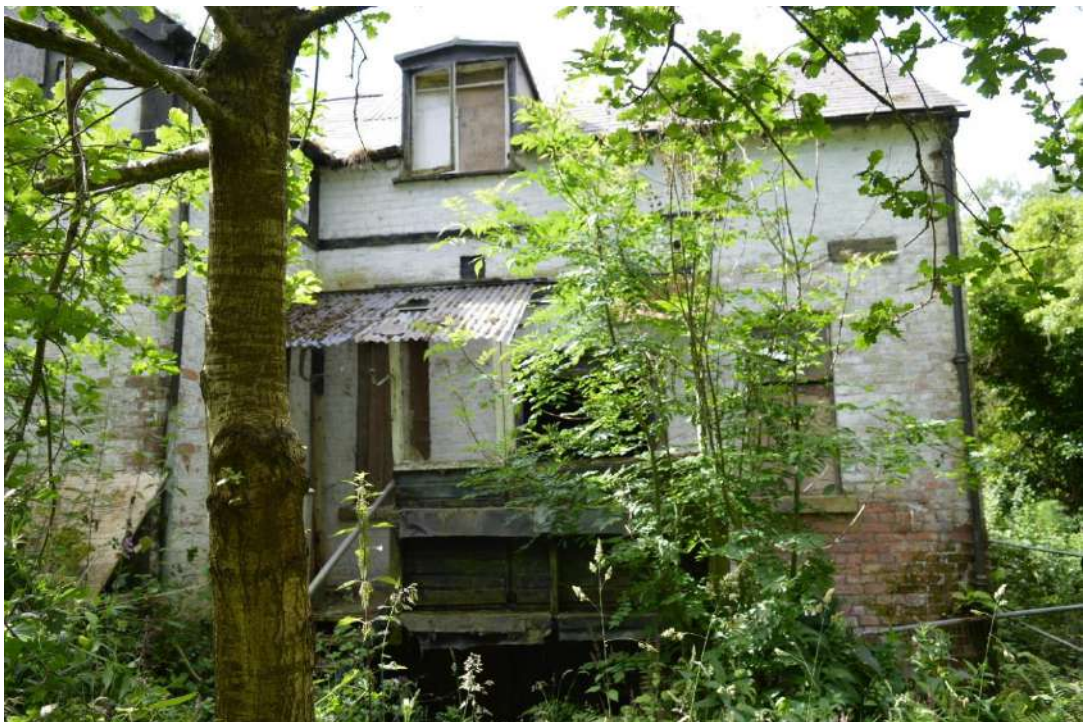
- 5.16. The remaining elevations of the mill were of brick. The western gable housed a tall cast-iron lozenge patterned window to the attic (photos 4661-0033, 0075). The wheel pit extended along the side of this elevation, but this was not easily accessible at the time of the survey, although a wide arched opening with a segmental brick header could be seen at cellar height, which would have housed the drive shaft for the water wheel. An additional arched opening was shown to the south of this on the elevation drawing provided by the client, however it was not possible to get photographs of this. The northern elevation of the mill had a small, plain dormer window to the attic (Fig. 8). The main mill floor was accessed via a set of iron steps leading up to a projecting covered balcony which allowed access into the mill via a wide wooden doorway (photo 4661-0060). There were two tall windows to either side of the doorway with sandstone sills and segmental brick arches above.

*Fig. 8. Northern elevation of the mill. CPAT photo 4661-0030.*

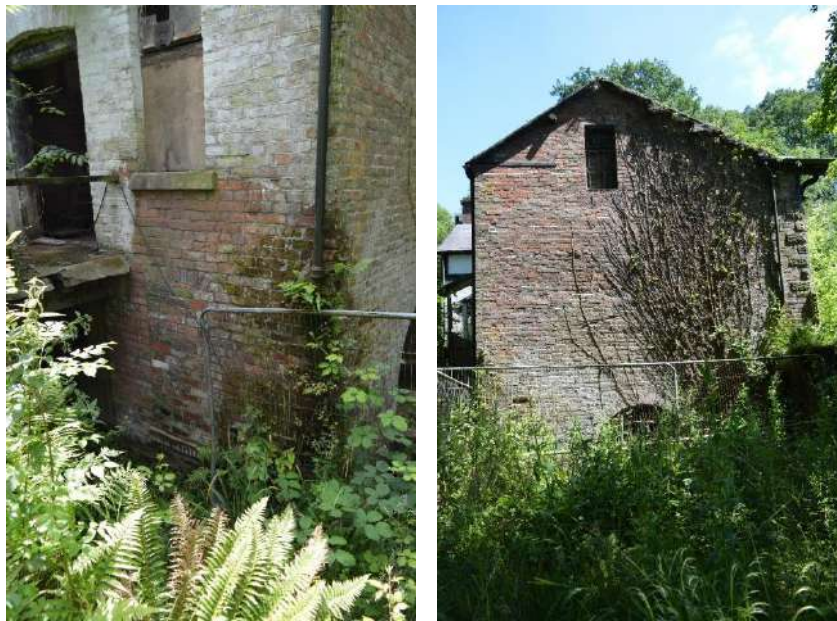
- 5.17. Accessed via a set of stone steps, an additional wide single doorway provided access into the lower floor of the mill. Like the upper floor, this door had two tall windows to either side which were later infilled with brick (Fig. 9; see also photos 4661-0034, 35, 36).

- 5.18. The stone steps led down to a 2m wide passage running alongside the northern side of the mill, with a stone wall continuing from the steps and beyond the wheel pit to the west. The passage provided access to the northern end of the wheel pit.

*Fig. 9. Left: blocked cellar windows at the north-western corner of the mill (CPAT photo 4661-0034); Right: the western gable (CPAT photo 4661-0075).*

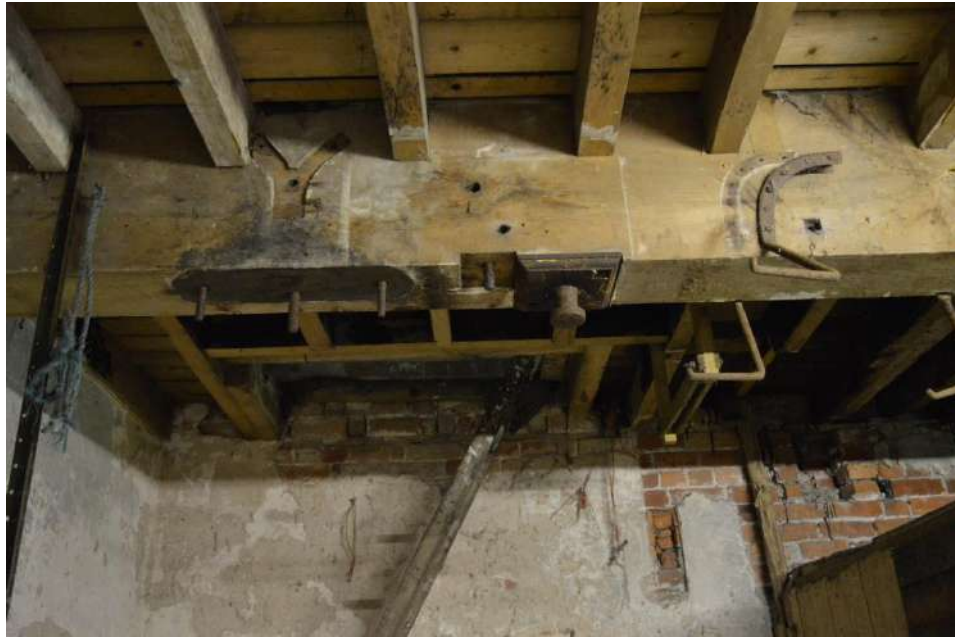
- 5.21. Wooden joists were supported by two substantial timber beams, which bear a number of heavy iron fixings, and remnants of bearing blocks and associated bolts (Fig. 10; see also photos 4661-0039-40, 50-55, 58-59). The positioning of the remaining iron work appears to relate to a number of recesses in the brick work and some of the joists bear wear marks from ropes or belts (photo 4661-0053). There are several areas where the joists have been cut through to house the former mill machinery (photo 4661-0055), probably hoppers and drive belts.

*Fig. 10. Fixings to the mill beams, viewed from the east. CPAT photo 4661-0059.*

- 8.3. Remnants of fixtures and fittings are visible within the mill, including iron bolts, remains of bearing blocks, worn joists (via ropes or belts) and a number of timber fixings. The wheel pit survives to the west, as well as additional stone walling, beyond it. It is possible that a culvert extends northwards from the wheel pit below ground.

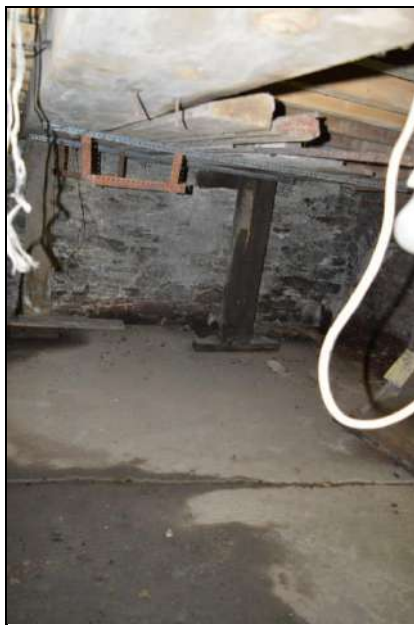
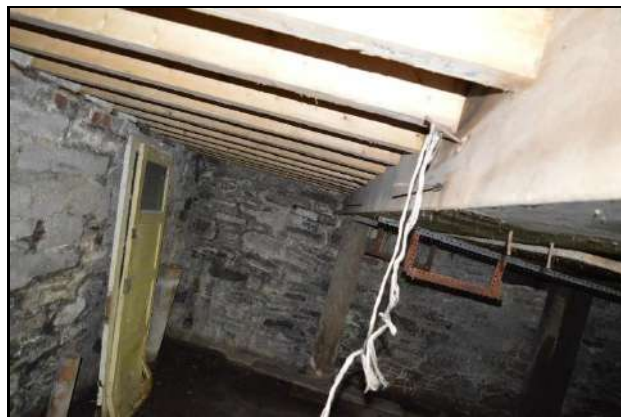
- 5.23. Access to the cellar of the mill building was not possible at the time of the survey however it was possible to obtain a few photographs via a hole through the floor above it (photo's 4661-0046-49). This revealed the southern and eastern walls of the cellar to be of stone construction. It was also possible to see a large upright beam located towards the southern wall and also a door way through the eastern elevation, which must lead to a cellar beneath the house.
- 5.24. A substantial timber beam could be seen supporting the joists to the floor above (photo 4661-0048) – the end of which can be seen projecting through the northern elevation of the mill (photo 4661-0036).

*Fig. 11. View of the mill cellar from the north. Note the large timber upright and the yellow doorway thorough the eastern elevation into the mill house. CPAT photo 4661-0048-49.*

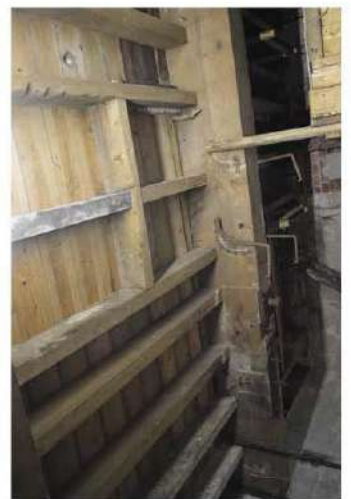
4661-0053.JPG

| 4661-0053 | S | Internal – mill joist detail showing wear marks to joists |
