## **Heritage Impact Statement** **Rev B**

Proposed removal of existing conservatory and construction of glazed extension, glazed link and internal alterations along with alterations to existing access' at The Stone House, Llay Road, Burton, Rossett, Wrexham, LL12 0HS.

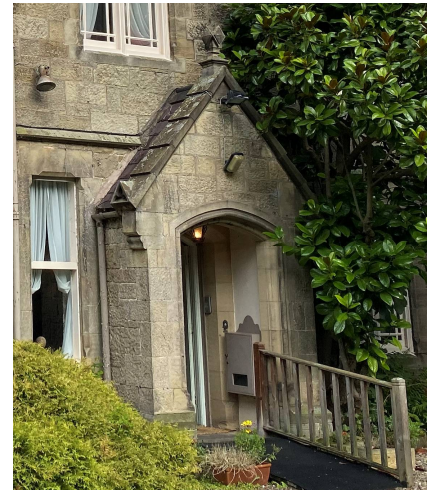
The front entrance porch has a vaguely gothic revival character. This is evident by the parapet wall extending beyond the roof line and the decorative stone kneelers with trifoiled stone detail above. The Gothic Revival was a conscious movement that began in England to revive gothic forms; starting in the second half of the Eighteenth Century and continuing throughout the Nineteenth Century.

The windows to the original property have a vertical emphasis and are usually found to be sash opening with margin glazing bars found to the sides and top/bottom of each pane. All the existing windows are constructed out of timber with a painted white finish. Each window on the main dwelling has stone details surrounds. Stone quoins with chamfered reveals can be found to the sides of the windows externally. Stone headers with the same chamfered reveal detail above and chamfered stone cills below. Some of the windows have timber panelling/shuttering internally. These can be found on the chamfered returns to the openings.

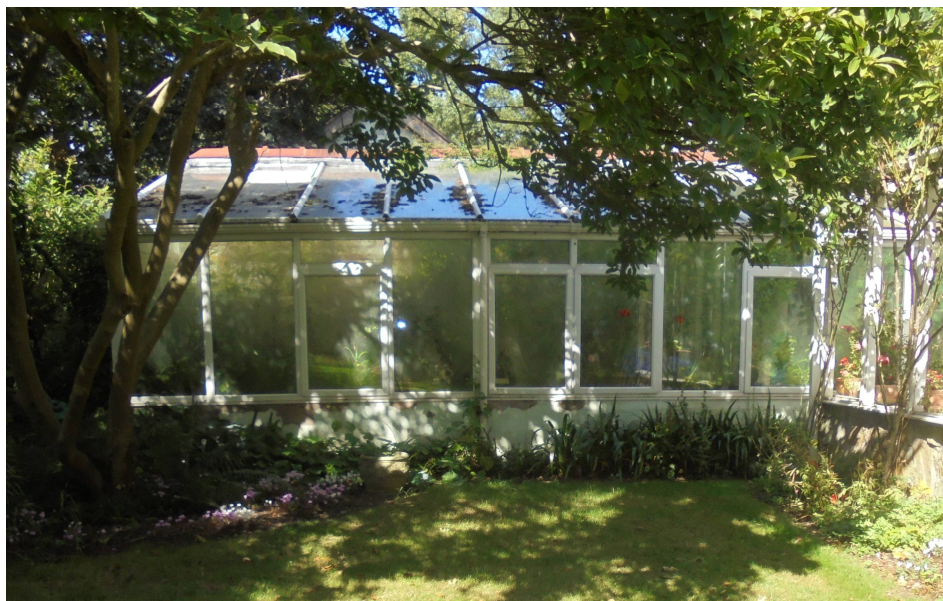
The existing conservatory extension, which we are intending to demolish, is constructed out of white uPVC window frames with white rendered walls at lower level. This is not a traditional construction method and is not in keeping with the rest of the buildings. We believe this extension was formerly built for functionality purposes only and no thought into external appearance was taken into account.

**Existing Conservatory which is to be demolished**

The existing structure, that is being demolished, is a conservatory and is mainly used as a garden room for the current owners. It is our client's intention, who is buying the property, to demolish this conservatory and replace it with a modern fully glazed structure. It can be said that this is such a modern form of construction that it will detract from the original building. However, the reason for this form of construction is to actually do the opposite. The construction is all glazed and has very little framework to the structure. Where the new glazing abuts the original dwelling; there is very little physical contact of materials as the glazing is sealed with a structural sealant. Therefore, ensuring minimal impact on the existing materials. Also, with the structure being all glazed; the existing features can still be seen through the new extension.

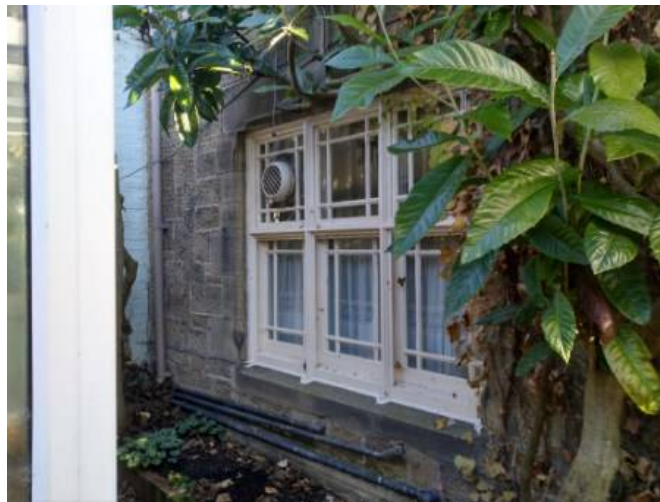
We are intending to remove the existing window frame located within the kitchen. This window currently looks out onto the existing conservatory. Our proposals are to keep the existing opening, but reduce the cill down to finished floor level to provide an entrance into the new glazed extension. To complete this; removal of the stone cill and stonework below the cill will be required. The quoin detailing to the side of the opening will be continued down to floor level. However, the chamfered reveal will not be continued down. This is to ensure that evidence is provided of where the existing opening was originally. Where the opening is formed through the existing stone plinth; contractor to saw cut the existing stone to provide a clean cut for the new stone quoins.

**Existing window which is to be removed, opening retained and lowered.**

One of the stone quoins just below the header is damaged. Therefore, we are going to replace this with a new stone quoin. This is to be made of a like for like basis to the original stone quoin, with the chamfered reveal detail included.

Internally; the timber panelling can be found on the chamfered returns. These chamfered returns are to be continued down to finished floor level. The timber panelling is to be replicated at the lower level. A small timber panel is to be installed between the old and the new to provide a break between the two sections. This will also give a subtle detail of where the original opening was. The architrave that surrounds the opening internally will also be continued down to the floor level. This will be purpose made to match the profile of the original and painted white.

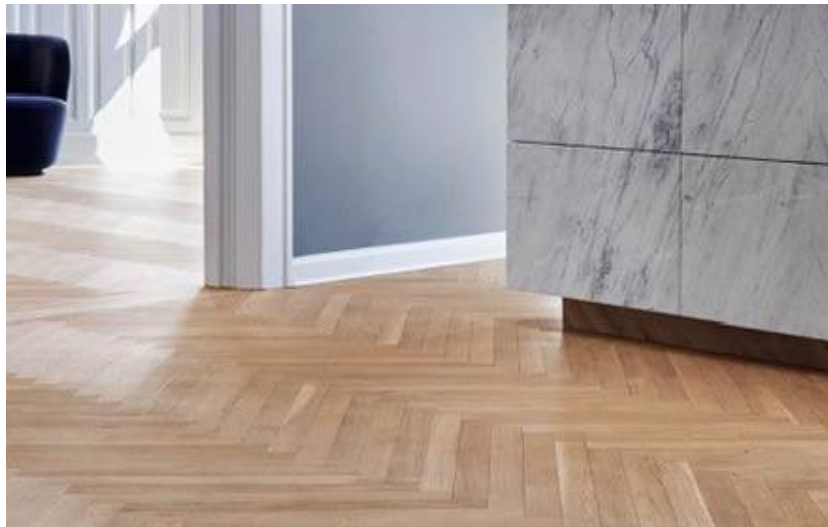
The floor finishes will be Oak Herringbone as per picture. This type of flooring is a material that would have traditionally been used within a property of this period and will be laid throughout the existing kitchen and the new dining/living room. Thus, ensuring that the new aspects of this build hint at the original features found throughout this property.

**Oak Herringbone Floor Finish**

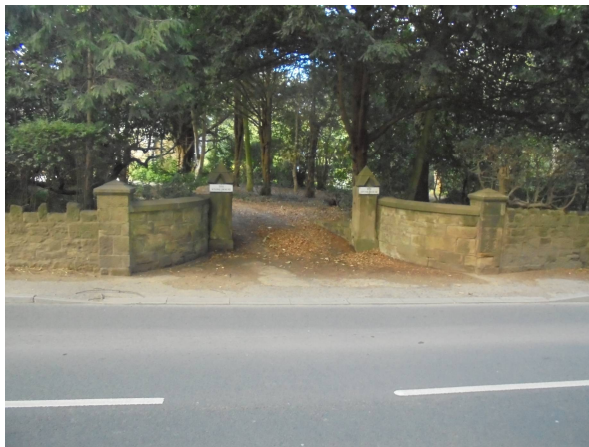
**Existing Main Access**

The main access has stone walls with a solid stone coping on top for the splays of the access. There are four stone pillars found at the entrance; two of which boast a high level amount of detail, constructed out of solid stone sections with chamfered corners matching detail found on the dwelling. A decorative coping topper is found on top of these pillars, with steep pitched detailing. These two pillars would have had gates attached to prevent intruders. This is evident by the cast iron hinges still found protruding out of the stonework. The second pair of pillars are simpler in design; comprising of simple dressed stone with a detailed coping stone topper. The dressed stone, topped with simply coping stone, also forms the splays of this access. The second access is of less importance, being the subordinate entrance, and just comprises of a rough stone walls splaying into the land. The only feature is the upright stonework which forms merlons and crenels. This continues along the boundary wall facing the main road.

We are proposing to alter the accesses to provide a safer entrance of the adjoining highway. Currently the accesses are located just off the highway and the visibility splay are well below to standards set out in manual for streets; the current situation is extremely unsafe. Our intention is to relocate the existing four pillars and splay walls further back into the grounds of The Stone House. By doing this, the visibility splays can be dramatically improved. Please refer to the existing and proposed access plans. If we were to not set back the pillars and reinstate gates in the positions currently; a vehicle would be unable to turn off the road and park in front of the gates when they are closed. By relocating the pillars further back from the highway; it allows a vehicle to pull off the highway and improve on existing highway safety, ensuring vehicles are not parking up on this very busy road. All works of relocating these pillars and splay walls are to be done by hand to avoid damage to the stonework. Extreme care is to be taken to ensure the outlook of the access is maintained, albeit in a slightly different location. New cast iron gates are to be installed to match the styling indicated on the access elevation and picture below. All this work will provide much safer entrances to the property whilst keeping the appearance of the street scene intact.
