## Technical Note

| Project: | <b>Holt Road, Wrexham</b> | Project No: | <b>10104</b> |
| Subject: | <b>Proposed Roadside Services</b> | | |

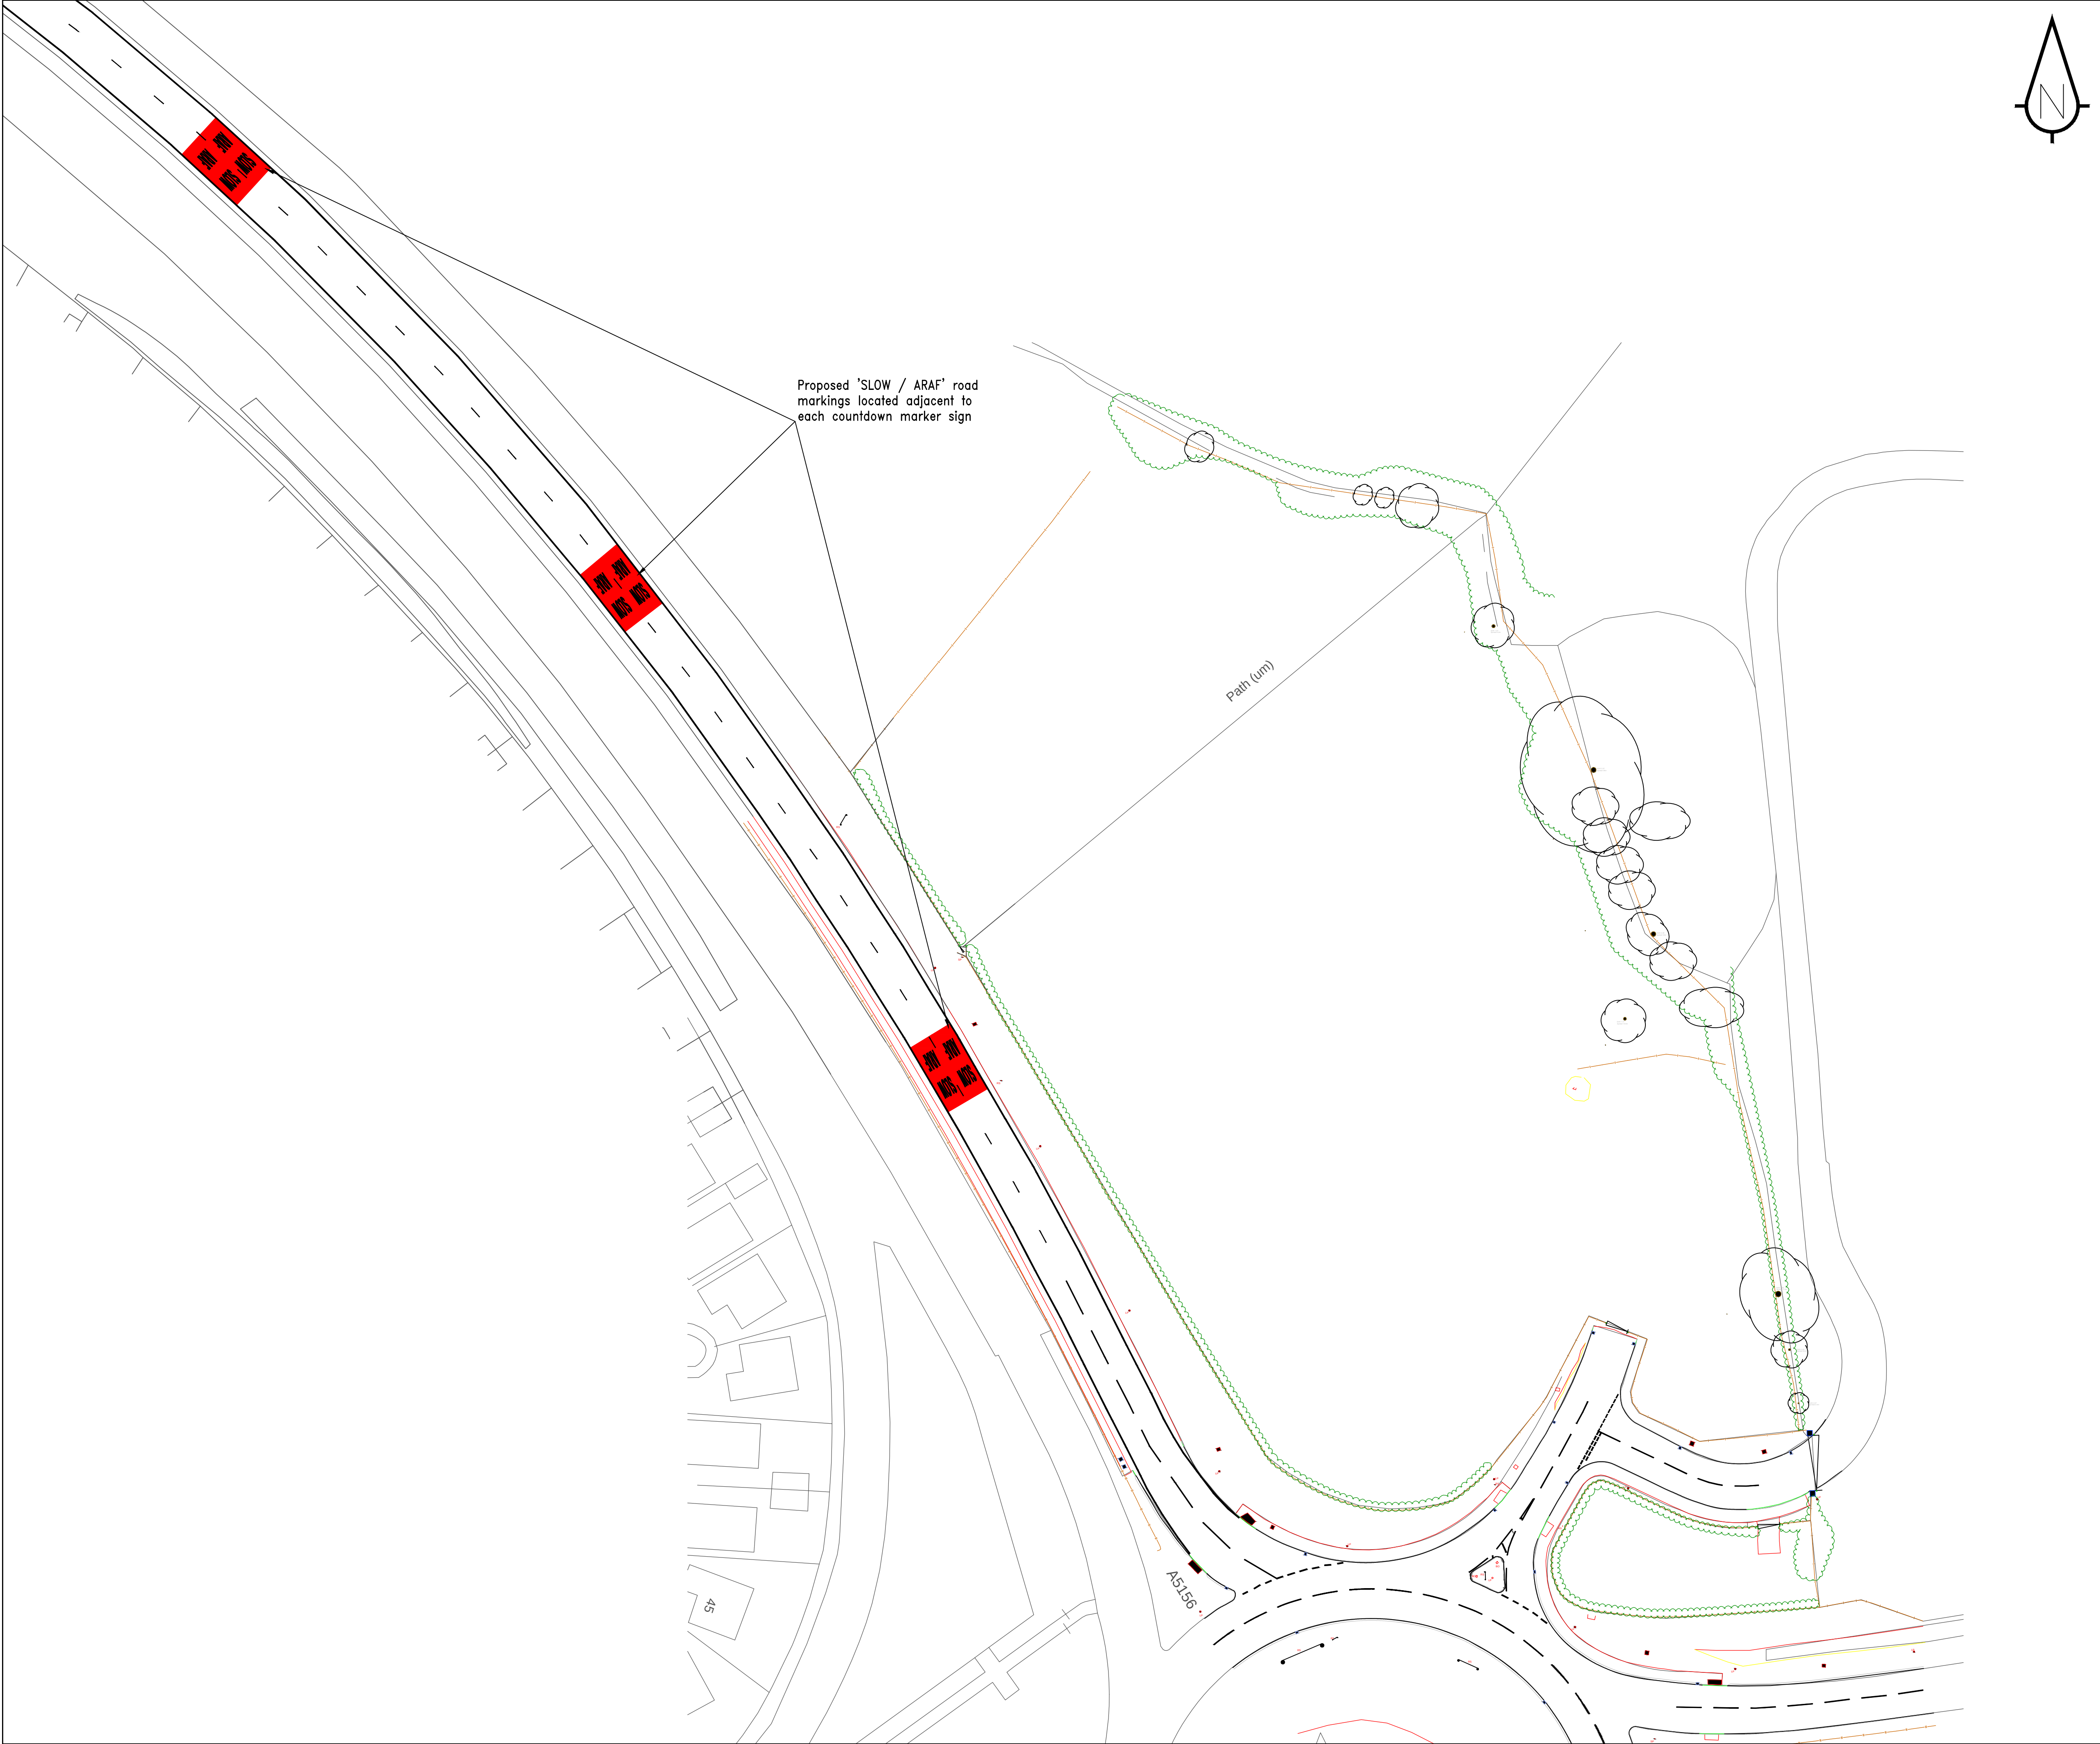
| 10104-003 | | | |

Drawing 10104-003 illustrate proposed carriageway markings in the form of 'SLOW / ARAF' markings in both lanes at each countdown marker sign. Drawings 10104-004 illustrate the proposed signage which could potentially be provided in both English and Welsh on the A5156 on approach to the roundabout and at the exit arm.

Following a telephone conversation between David Colley (Sanderson Associates) and Peter Douthwaite (Wrexham Highways) a proposed lining drawing 10104-003 and signage drawing 10104-004 have been produced and these are attached at **Appendix A**. These detail potential highway works in relation to vehicles approaching the A5156 / A534 roundabout southbound from the A5156.

Therefore based on the foregoing the proposals shown on drawings 10104-003 and 10104-004 have been provided to alert drivers of their approaching to the A5156 / A534 roundabout and that roadside services are provided.
