Project - Lower Honkley Farm  
Client - Nigel Darlington Esq.  
Detail - Sketch Indicating Main Beam Repair  
Drg No : 3326/15/01 B - Not to scale - Enlarge to A3  
Based on information provided by others  
James Brotherhood & Associates  
Golly Farm, Golly, Rossett, Wrexham LL12 0AL

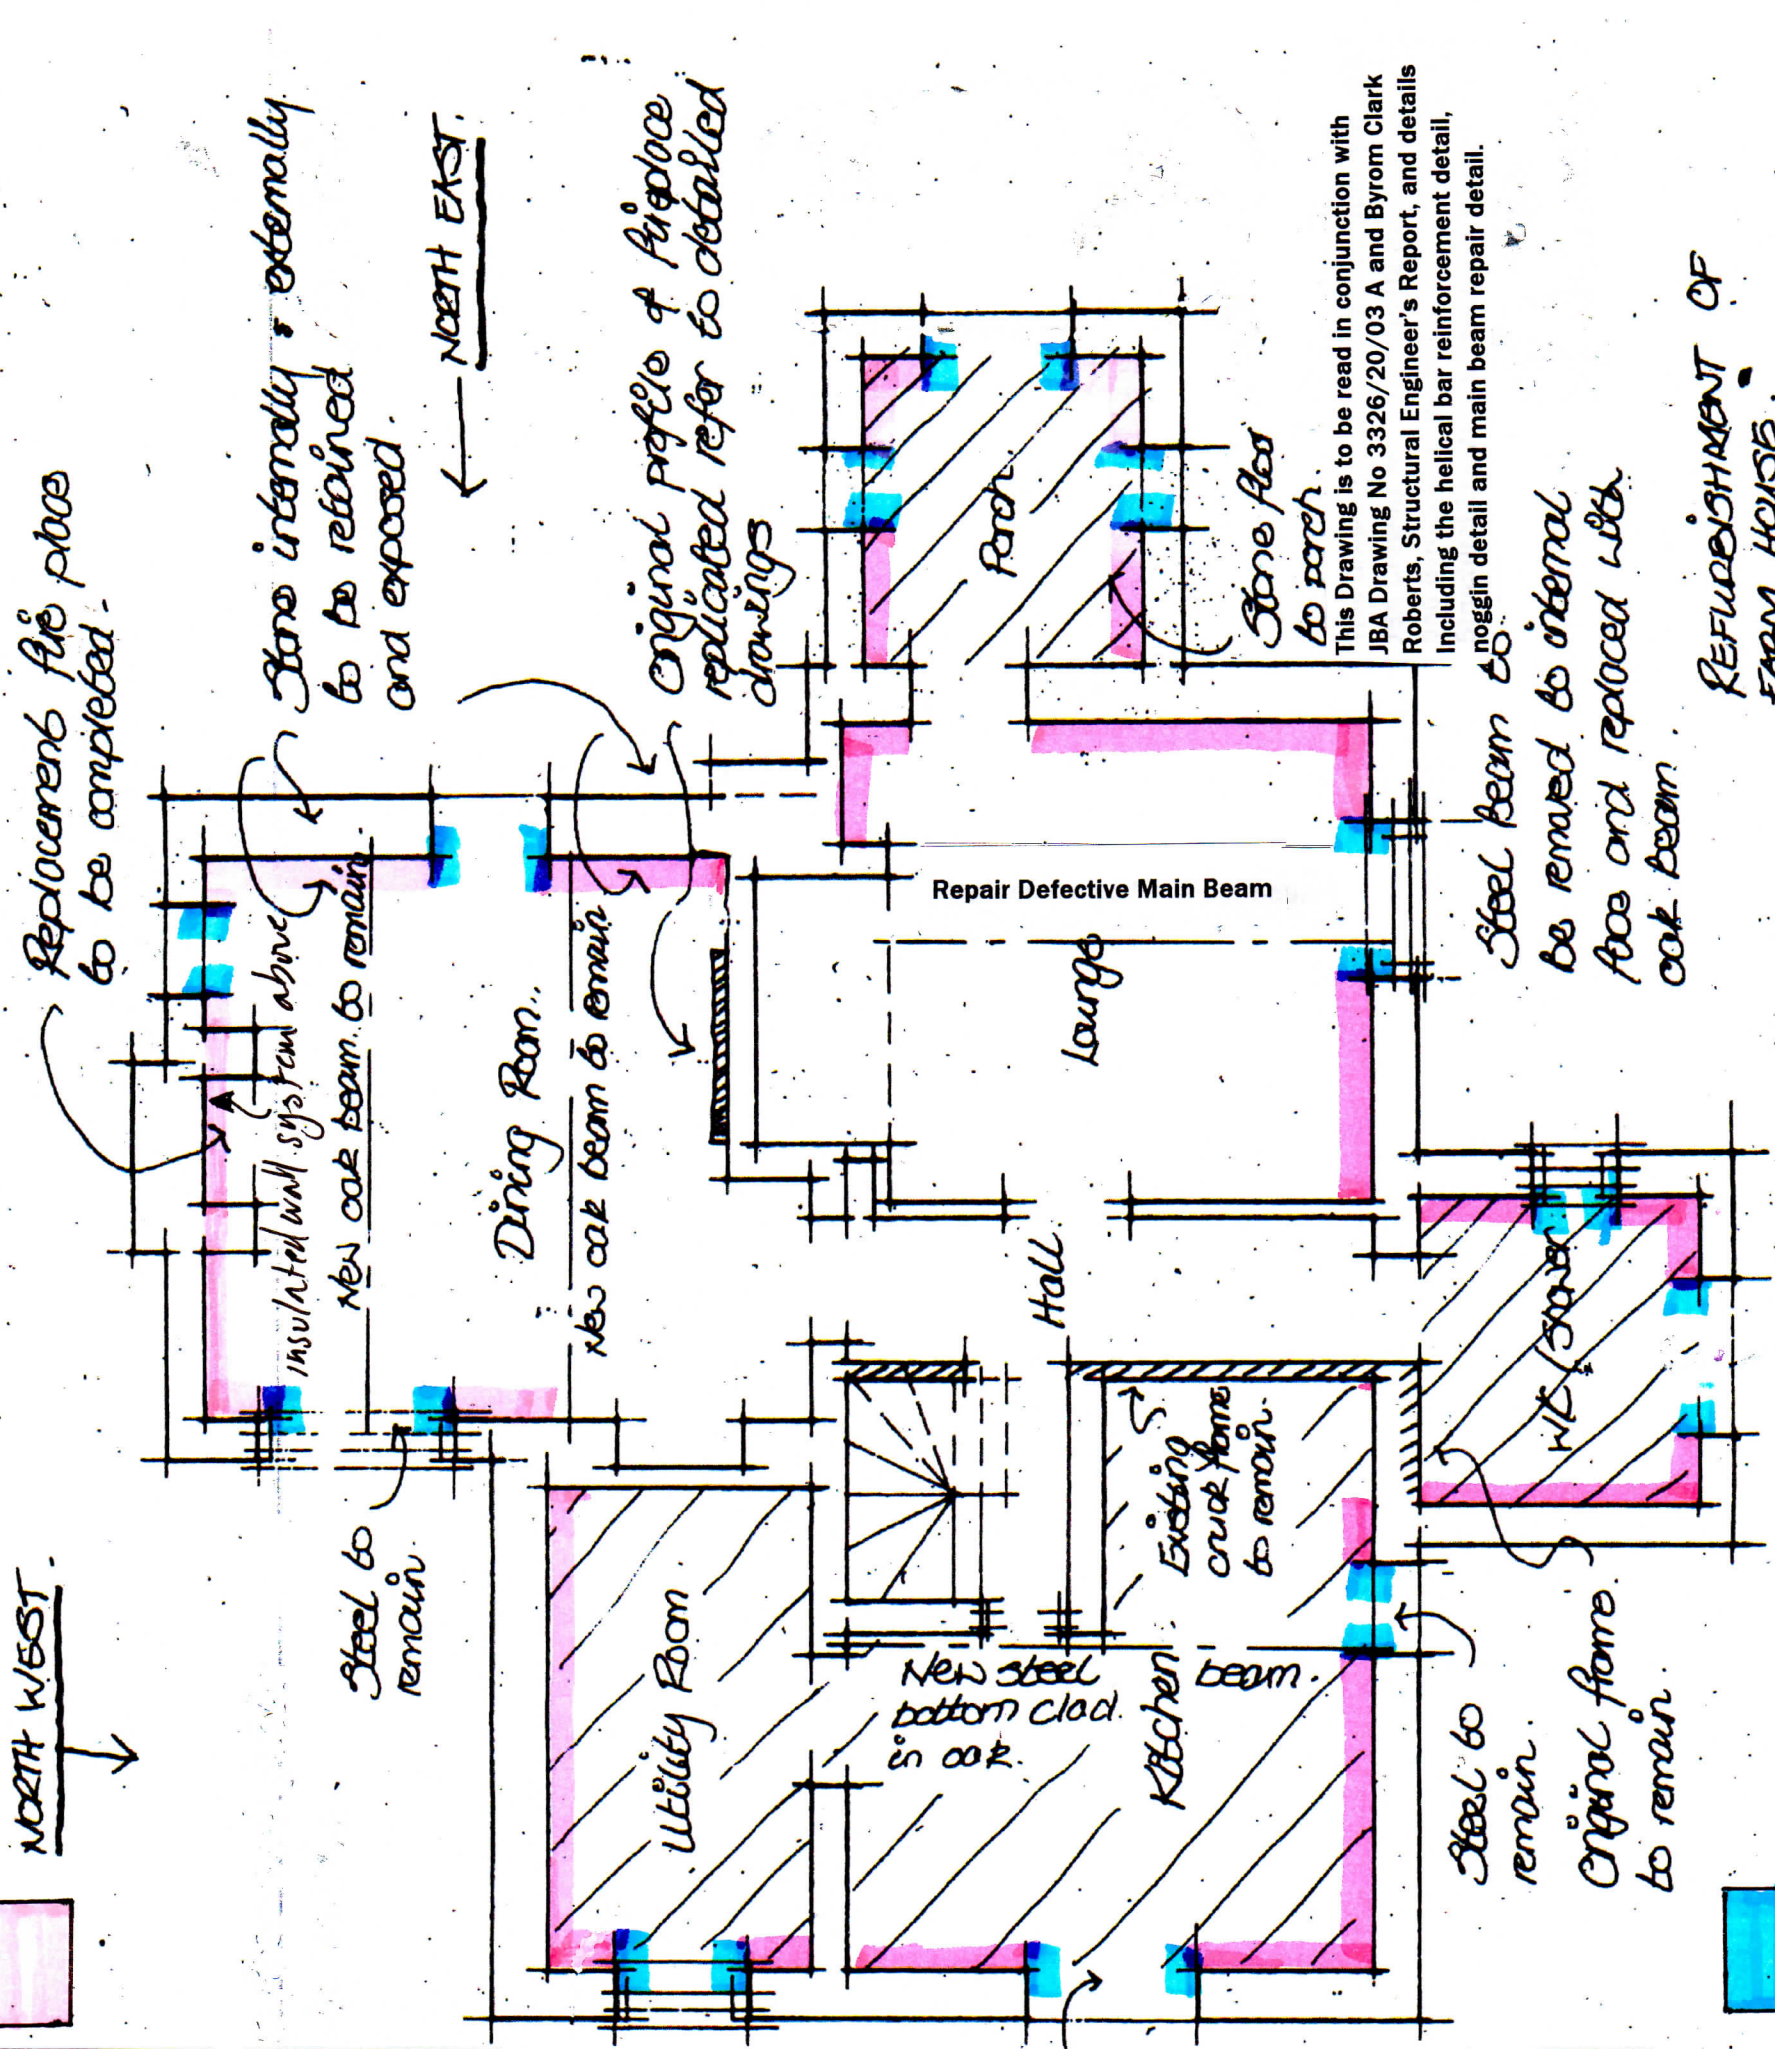
Repair Defective Main Beam

This Drawing is to be read in conjunction with JBA Drawing No 3326/20/03 A and Byrom Clark Roberts, Structural Engineer's Report, and details including the helical bar reinforcement detail, noggin detail and main beam repair detail.
