# Environmental Statement

## Appendix 10.2: Mineral Safeguarding Assessment

### Land at Ruthin Road, Wrexham

# MINERAL SAFEGUARDING ASSESSMENT

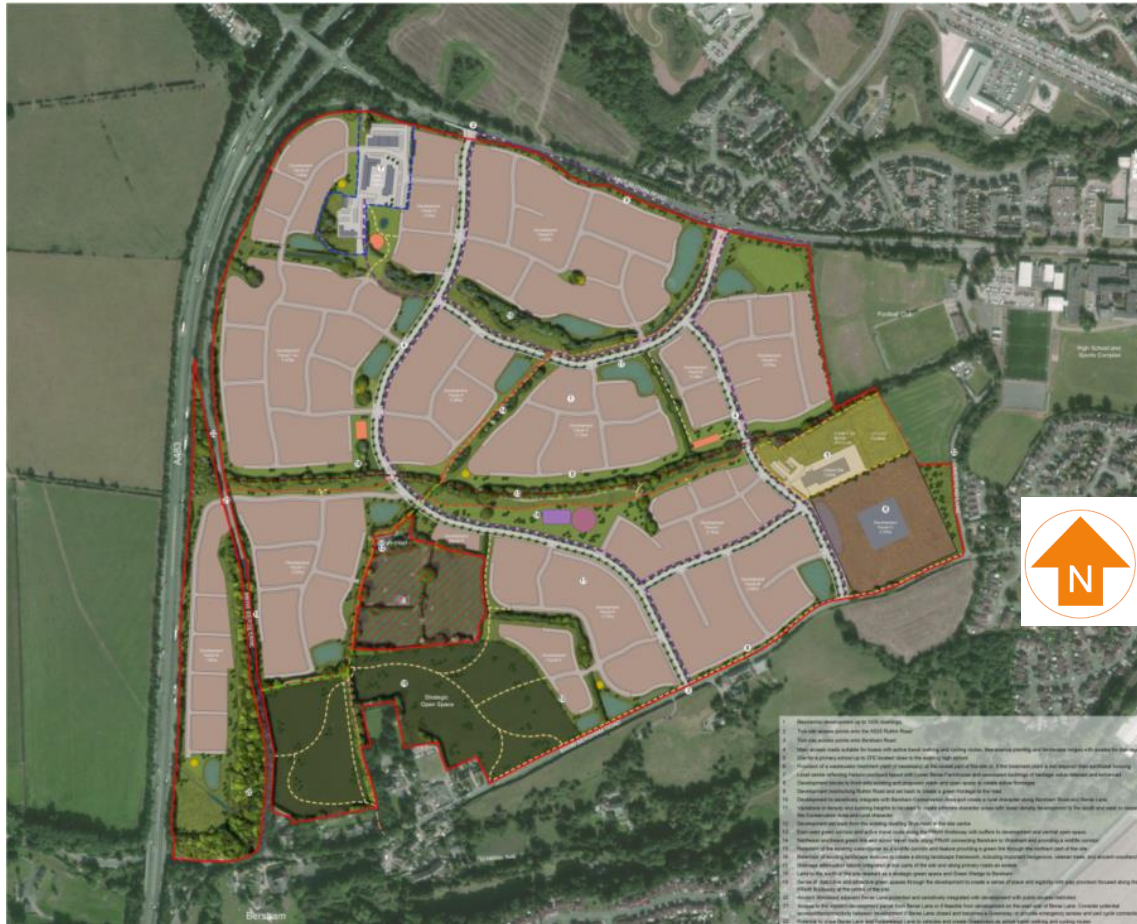
FIGURE 1.1 SNAPSHOT OF PROPOSED MASTERPLAN

A snapshot of the proposed masterplan layout is indicated in Figure 1.1.

Drawing 14-854-002 (Appendix III) identifies the proposed development layout.

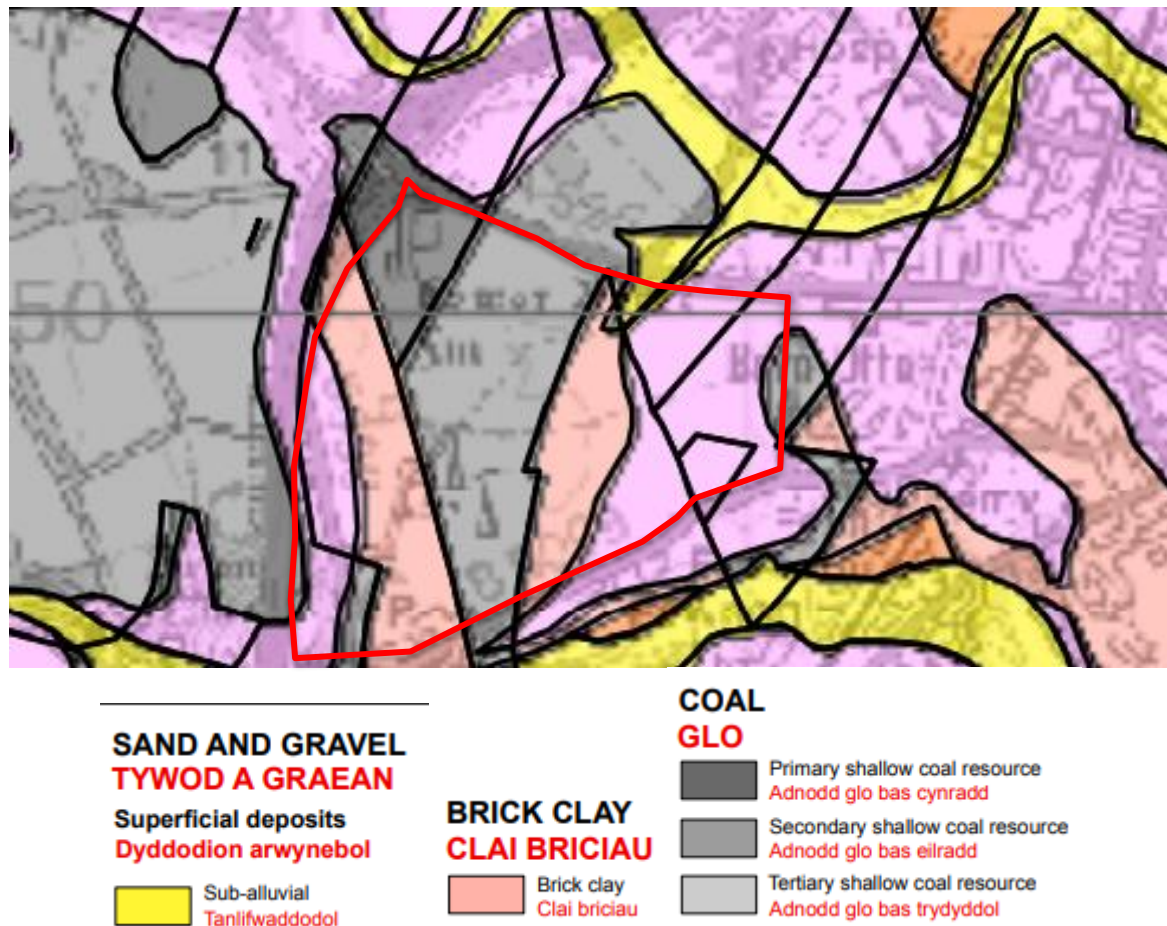
FIGURE 4.1 MINERAL SAFEGUARDING ZONE – TERTIARY SHALLOW COAL, BRICK CLAY AND OTHER SANDSTONE

The Welsh BGS mapping provides a number of plans that show relevant Mineral Safeguarding Areas. These maps are reproduced in Figure 4.1 and Figure 4.2 and show that the proposed development is located within both a tertiary shallow coal, brick clay and other sandstone and SAND and GRAVEL mineral safeguarding area.

Source: BSG Mineral Resources Map – North East Wales

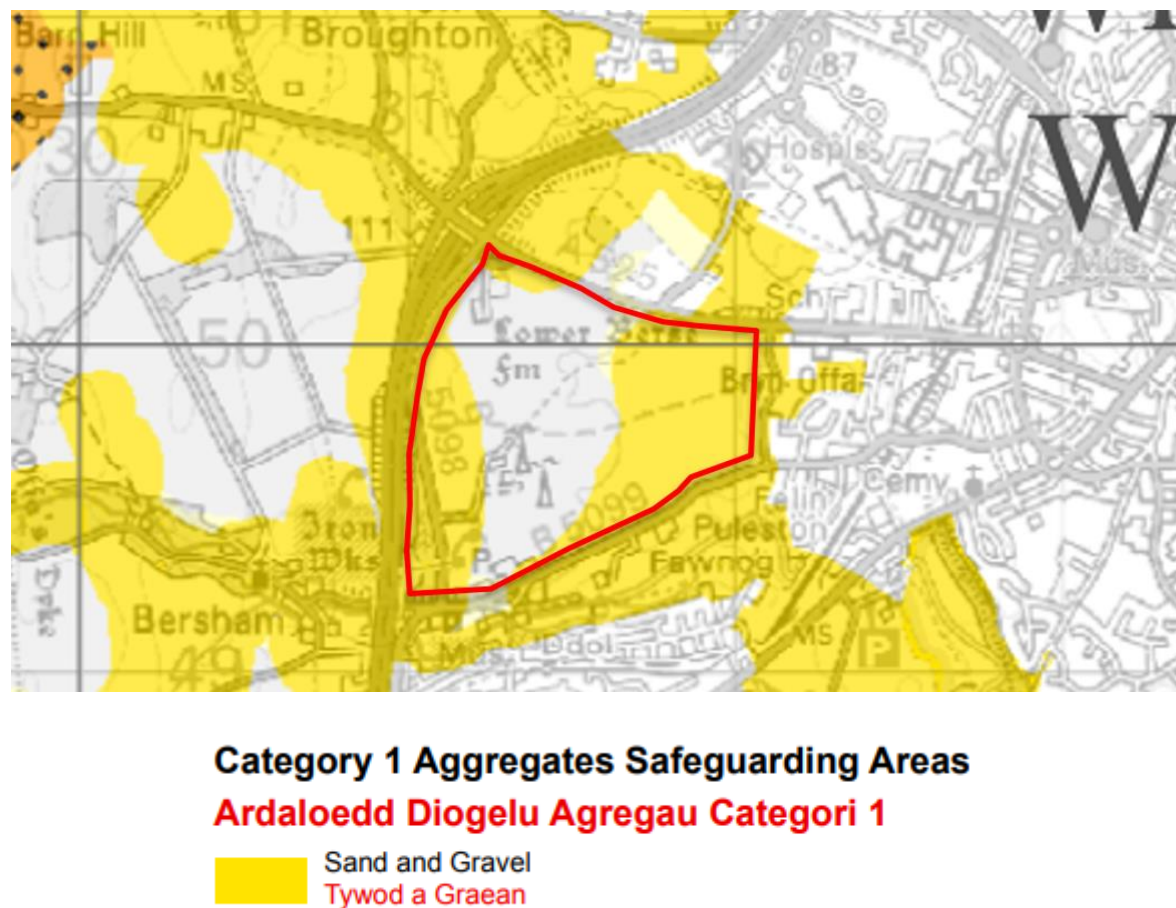
FIGURE 4.2 MINERAL SAFEGUARDING ZONE – SAND and GRAVEL

Source: BGS Aggregates Safeguarding Map of North East Wales.
