# Environmental Statement

## Appendix 10.2: Mineral Safeguarding Assessment

### Land at Lower Berse Farm, Wrexham

# MINERAL SAFEGUARDING ASSESSMENT

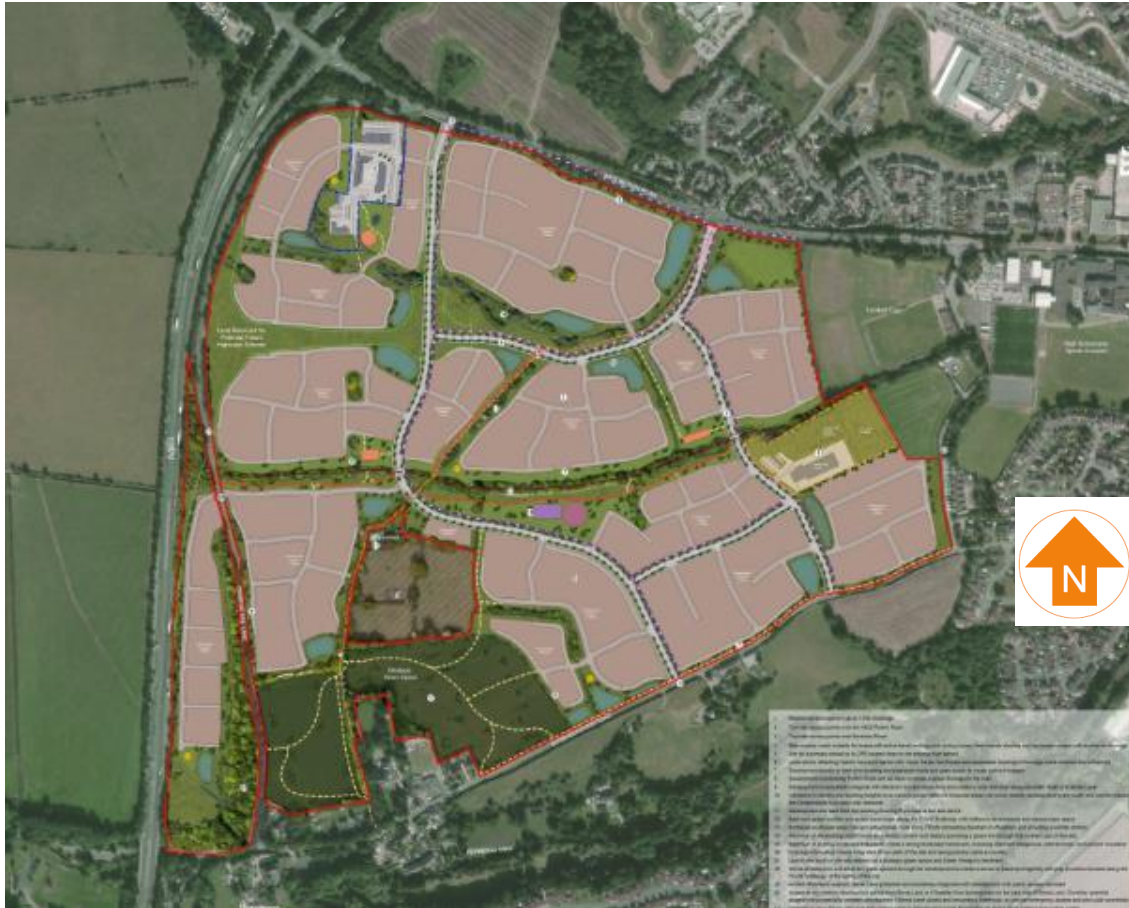
FIGURE 1.1 SNAPSHOT OF PROPOSED MASTRERPLAN

A snapshot of the proposed masterplan layout is indicated in Figure 1.1.

Redrow Homes are currently in a master planning phase with a view to constructing a residential development for up to 1450 dwellings, plus associated roads, open space, community facilities, a site for a primary school. An area has been safe-guarded to facilitate construction of future major highways infrastructure (should this continue).

Drawing 14-854-002 (Appendix III) identifies the proposed development layout.

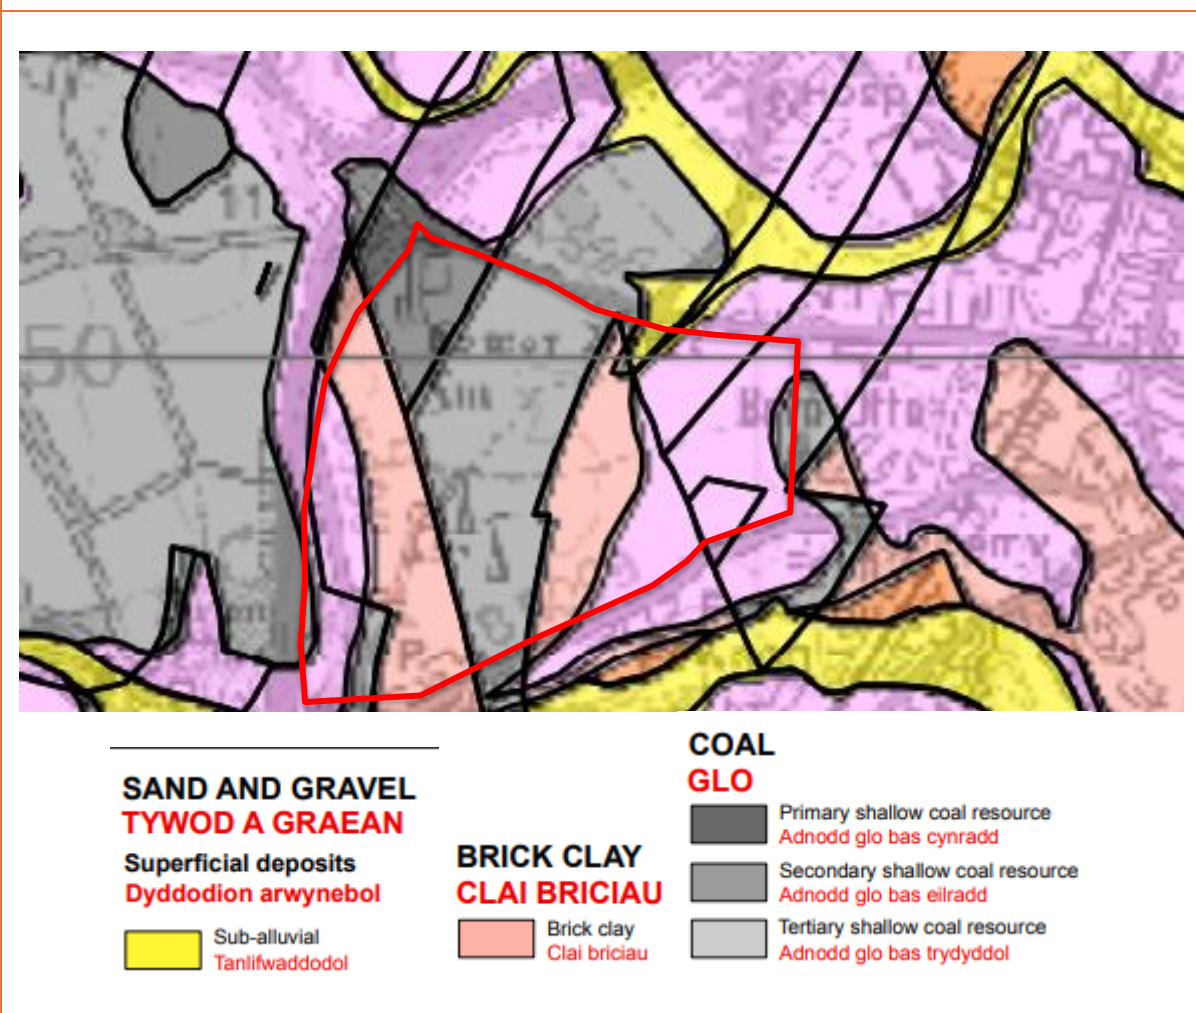
FIGURE 4.1 MINERAL SAFEGUARDING ZONE – TERTIARY SHALLOW COAL, BRICK CLAY AND OTHER SANDSTONE

The Welsh BGS mapping provides a number of plans that show relevant Mineral Safeguarding Areas. These maps are reproduced in Figure 4.1 and Figure 4.2 and show that the proposed development is located within both a tertiary shallow coal, brick clay and other sandstone and SAND and GRAVEL mineral safeguarding area.

Source: BSG Mineral Resources Map – North East Wales

Based on the regional extent of the mapped mineral deposits, it is considered likely that the development of 72.85ha of land in the region would potentially sterilise mineral resources within a very small area of the overall resource (likely to be over 1000s hectares).

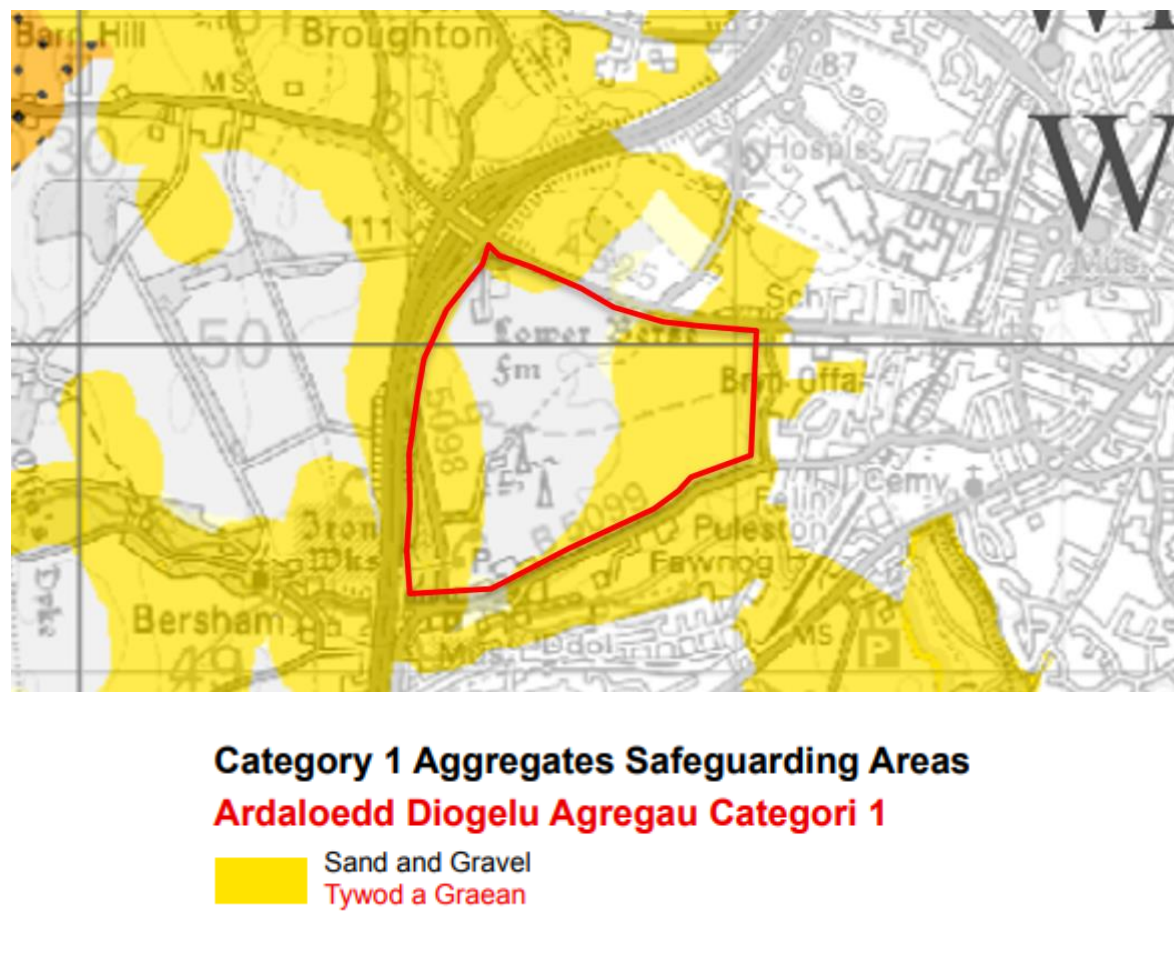
FIGURE 4.2 MINERAL SAFEGUARDING ZONE – SAND and GRAVEL

Source: BGS Aggregates Safeguarding Map of North East Wales.
