## Arboricultural Impact Assessment

Land at Mold Road  
Gwersyllt  
Wrexham  
LL11 4AX

Ref: P.1626.22

April 2022

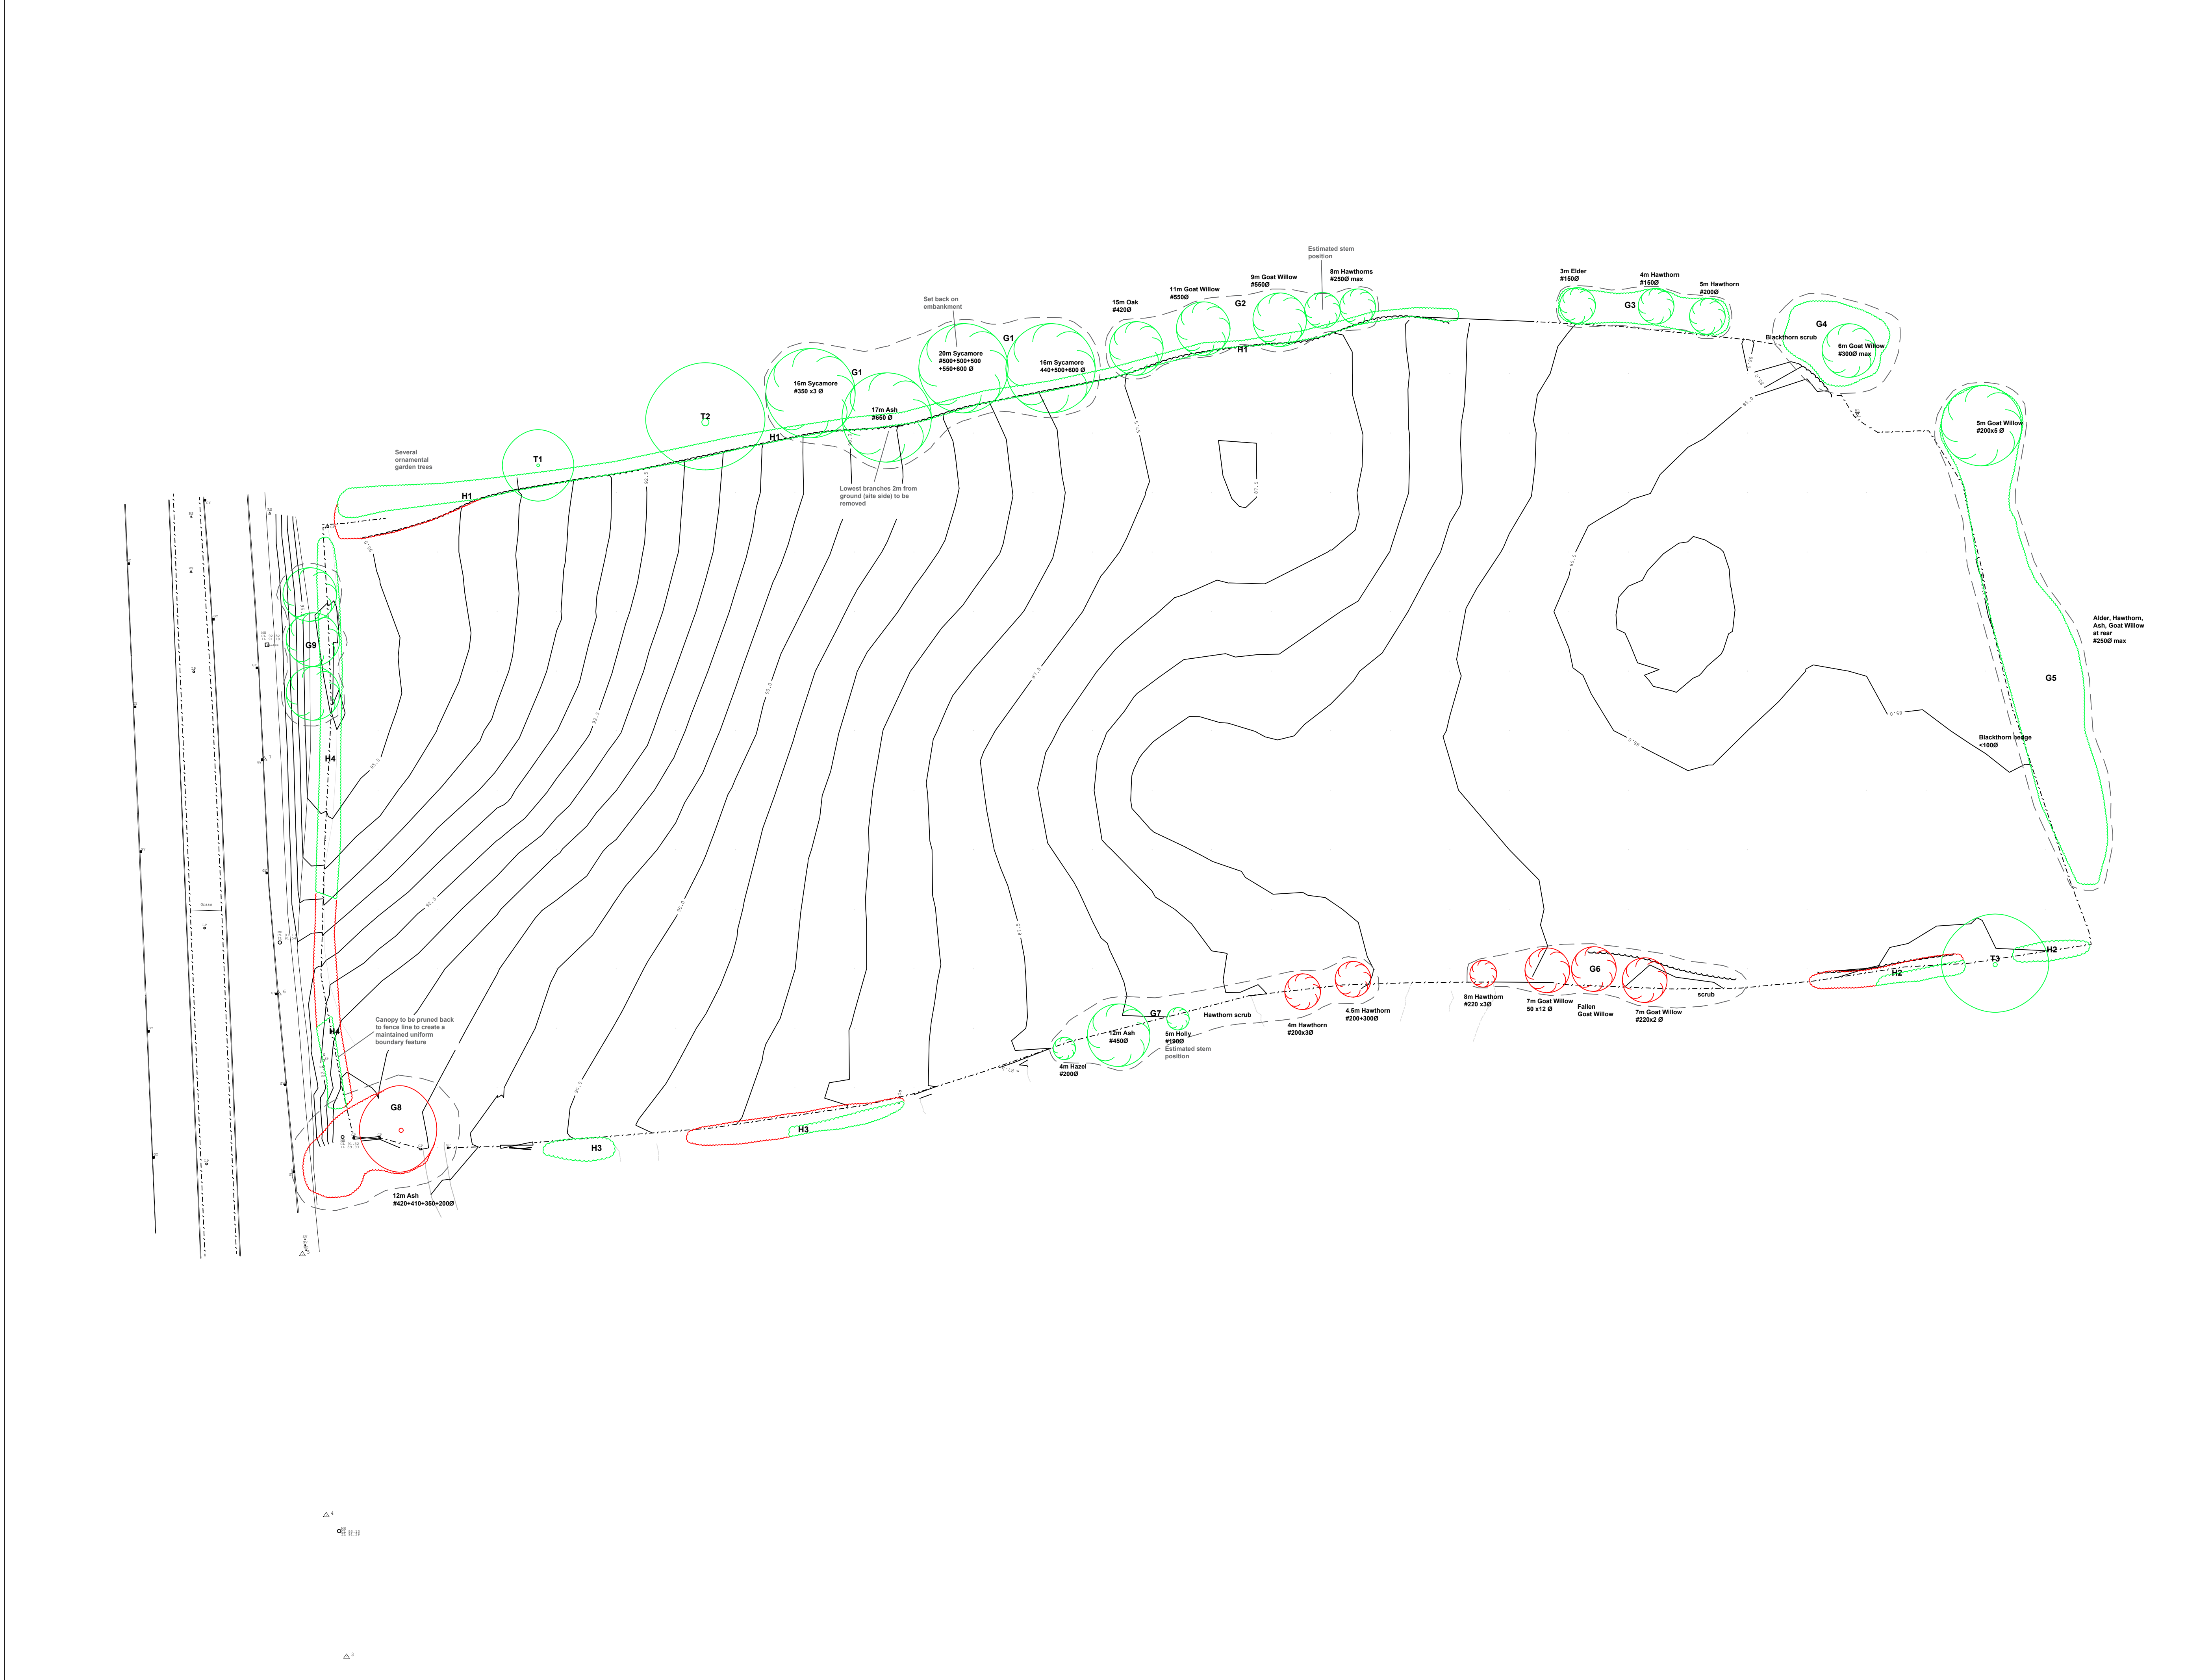
| DATE:<br>25/03/2021 | CHKD BY:<br>CP | P.1626.22.01 | - |

- 5.1 Existing Tree Cover:** Three individual, nine groups of trees and four hedges were recorded during our survey, the details of which can be found within Appendix 1 to this report and cross referenced with drawing P.1626.22.01 *Tree Survey*.

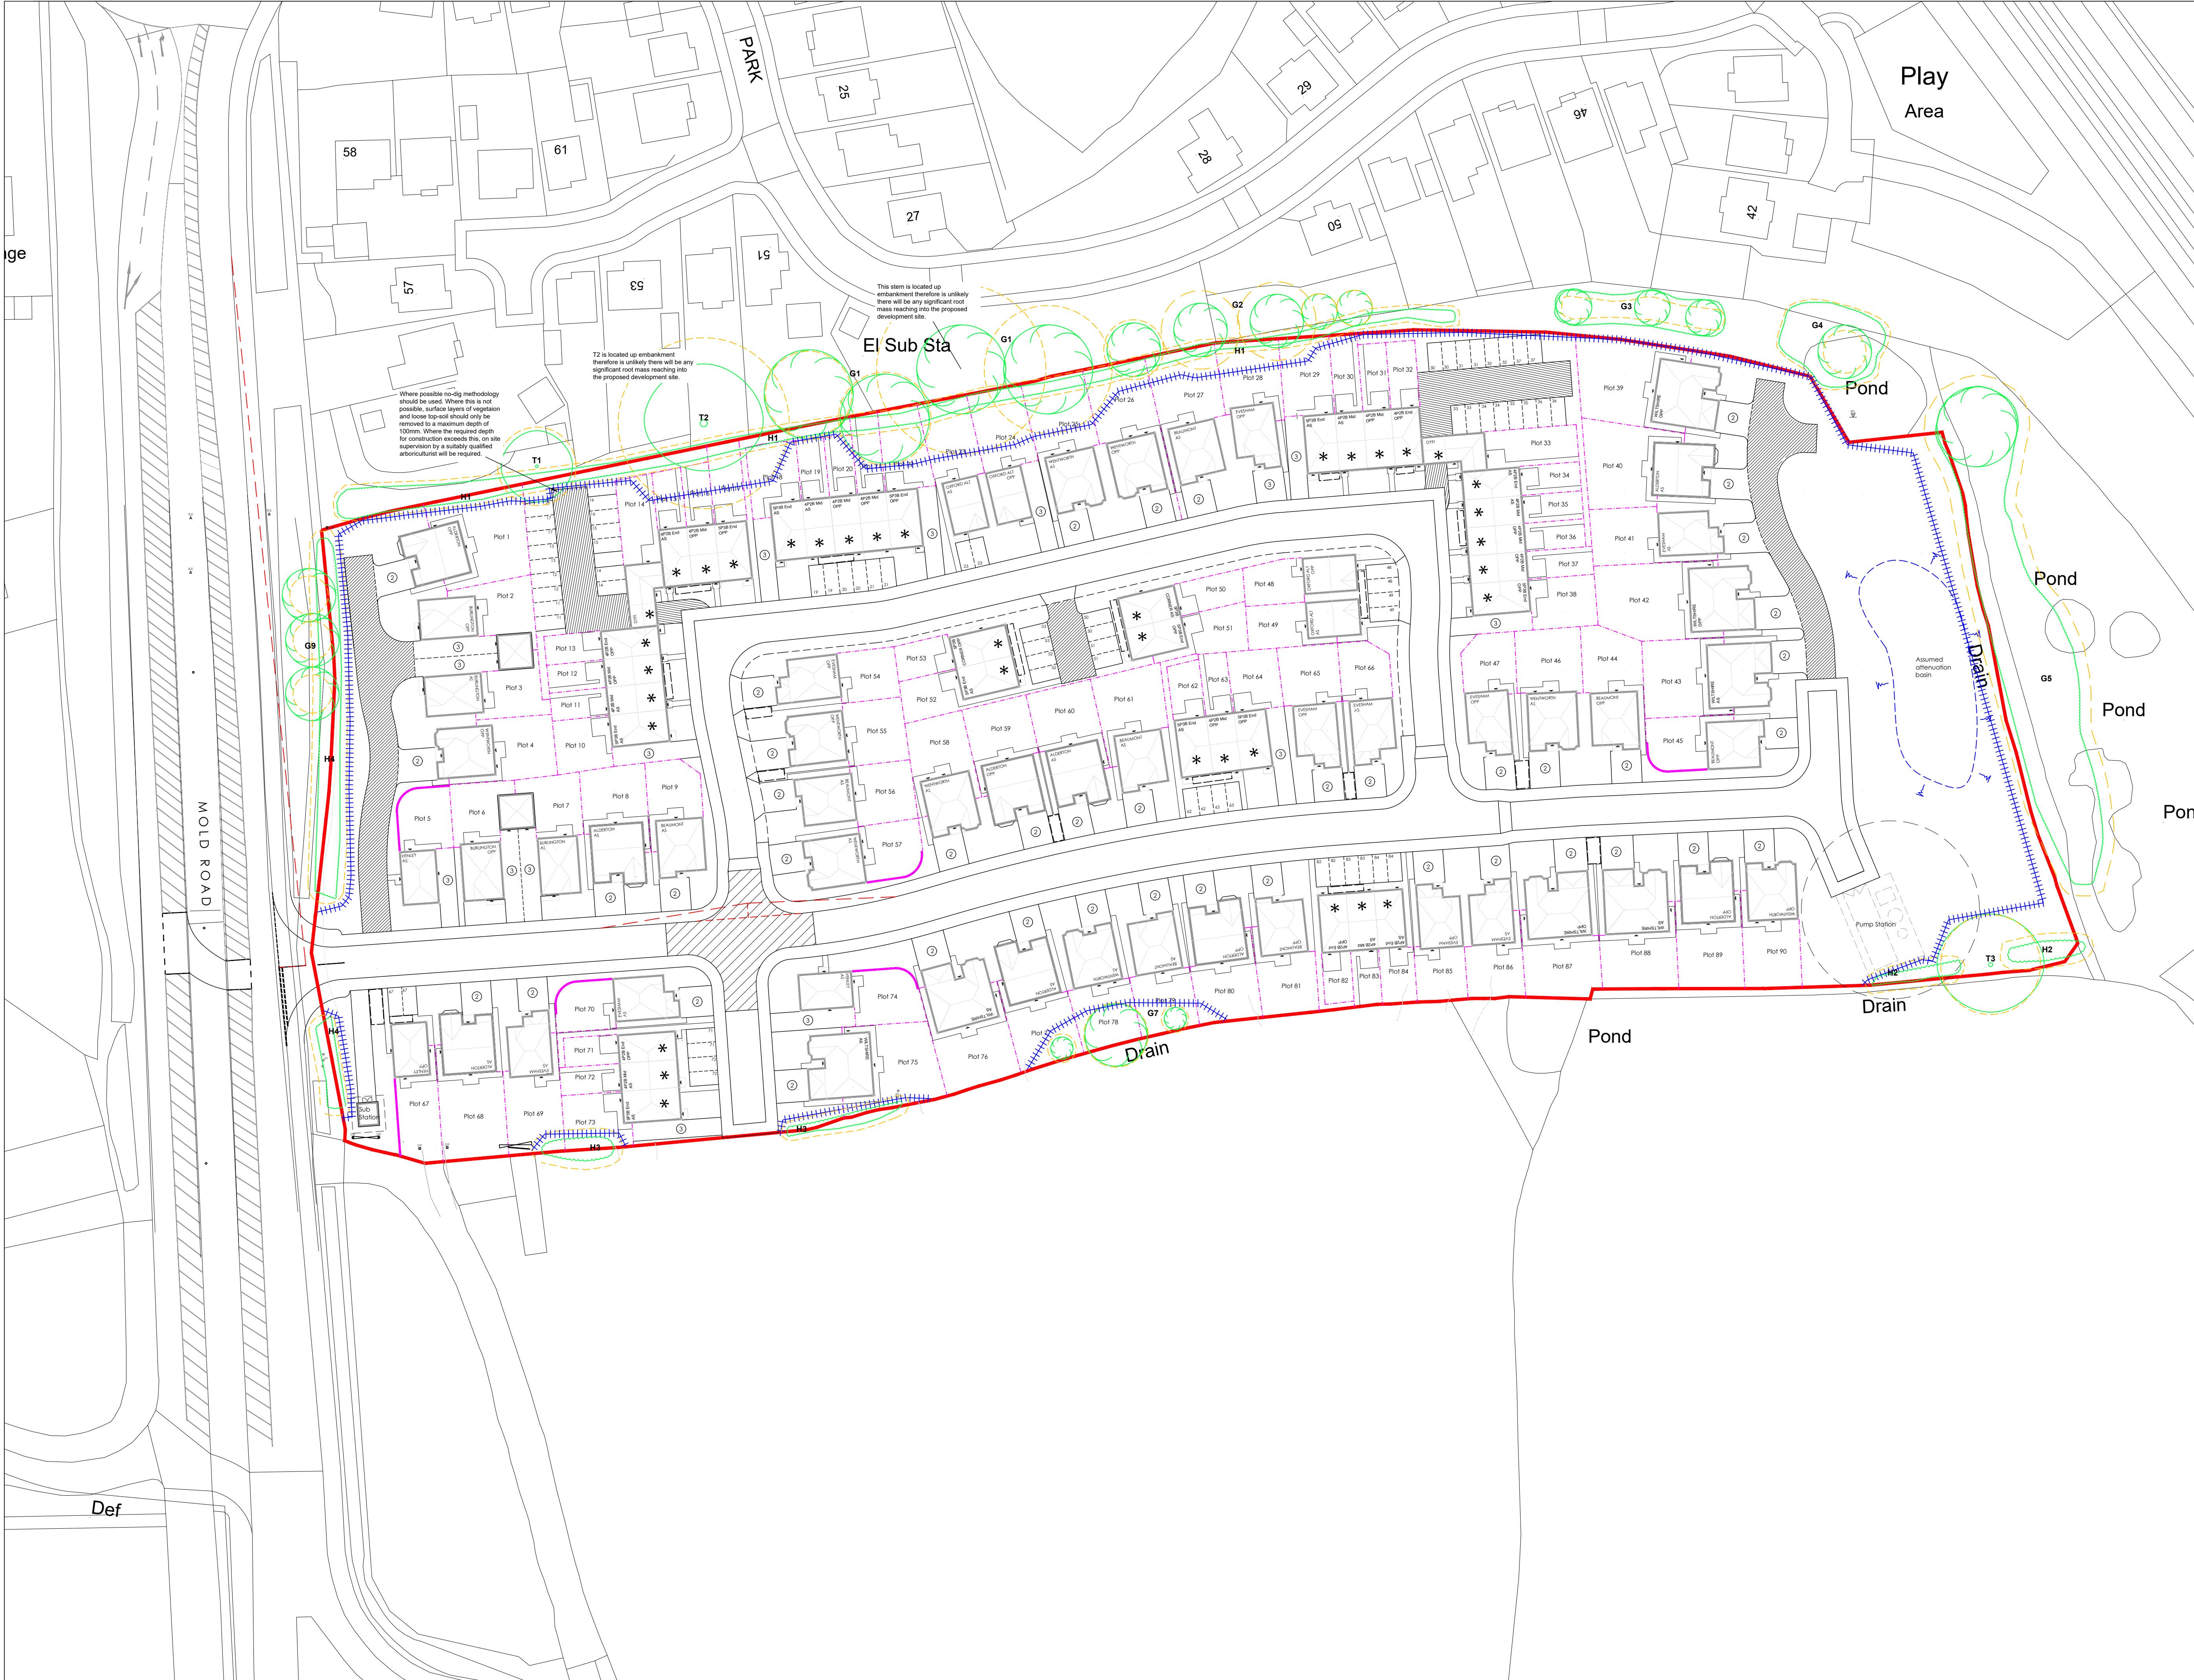
- 5.6 Potential Mitigation for Development Impacts:** Mitigation of the direct impacts from the development of the site can be provided in the form of the erection of protective fencing as indicated on the attached drawings.

- 5.12 Proposed Areas of Hard Standing:** Areas where proposed hard surfaces encroach within or are immediately adjacent root protection areas of retained trees are marked on the drawings appended to this report and the extent of precautionary measures required in order to safeguard retained trees are also indicated.

Extent of Root Protection Area for retained trees in accordance with BS5837: 2012 *Trees in relation to design, demolition and construction - Recommendations*

- 6.1** Based on the proposed layout and those trees proposed for retention, the drawings attached to this report show our preliminary recommendations for the physical protection of retained trees throughout the construction phase. The plans indicate the location of protective barriers, as well as the specification for construction of the protective fencing in accordance with Figures 2 & 3 of the Standard. These barriers will form construction exclusion zones around the retained trees. Provided that these measures are implemented in advance of, and throughout the course of the construction phase, there should be no specific requirement for an Arboricultural Method Statement.
