# **The Bridgeway Centre Wrexham Industrial Estate**

## **Arboricultural Impact Assessment and Method Statement**

Report Ref: 197/R/400

November 2024

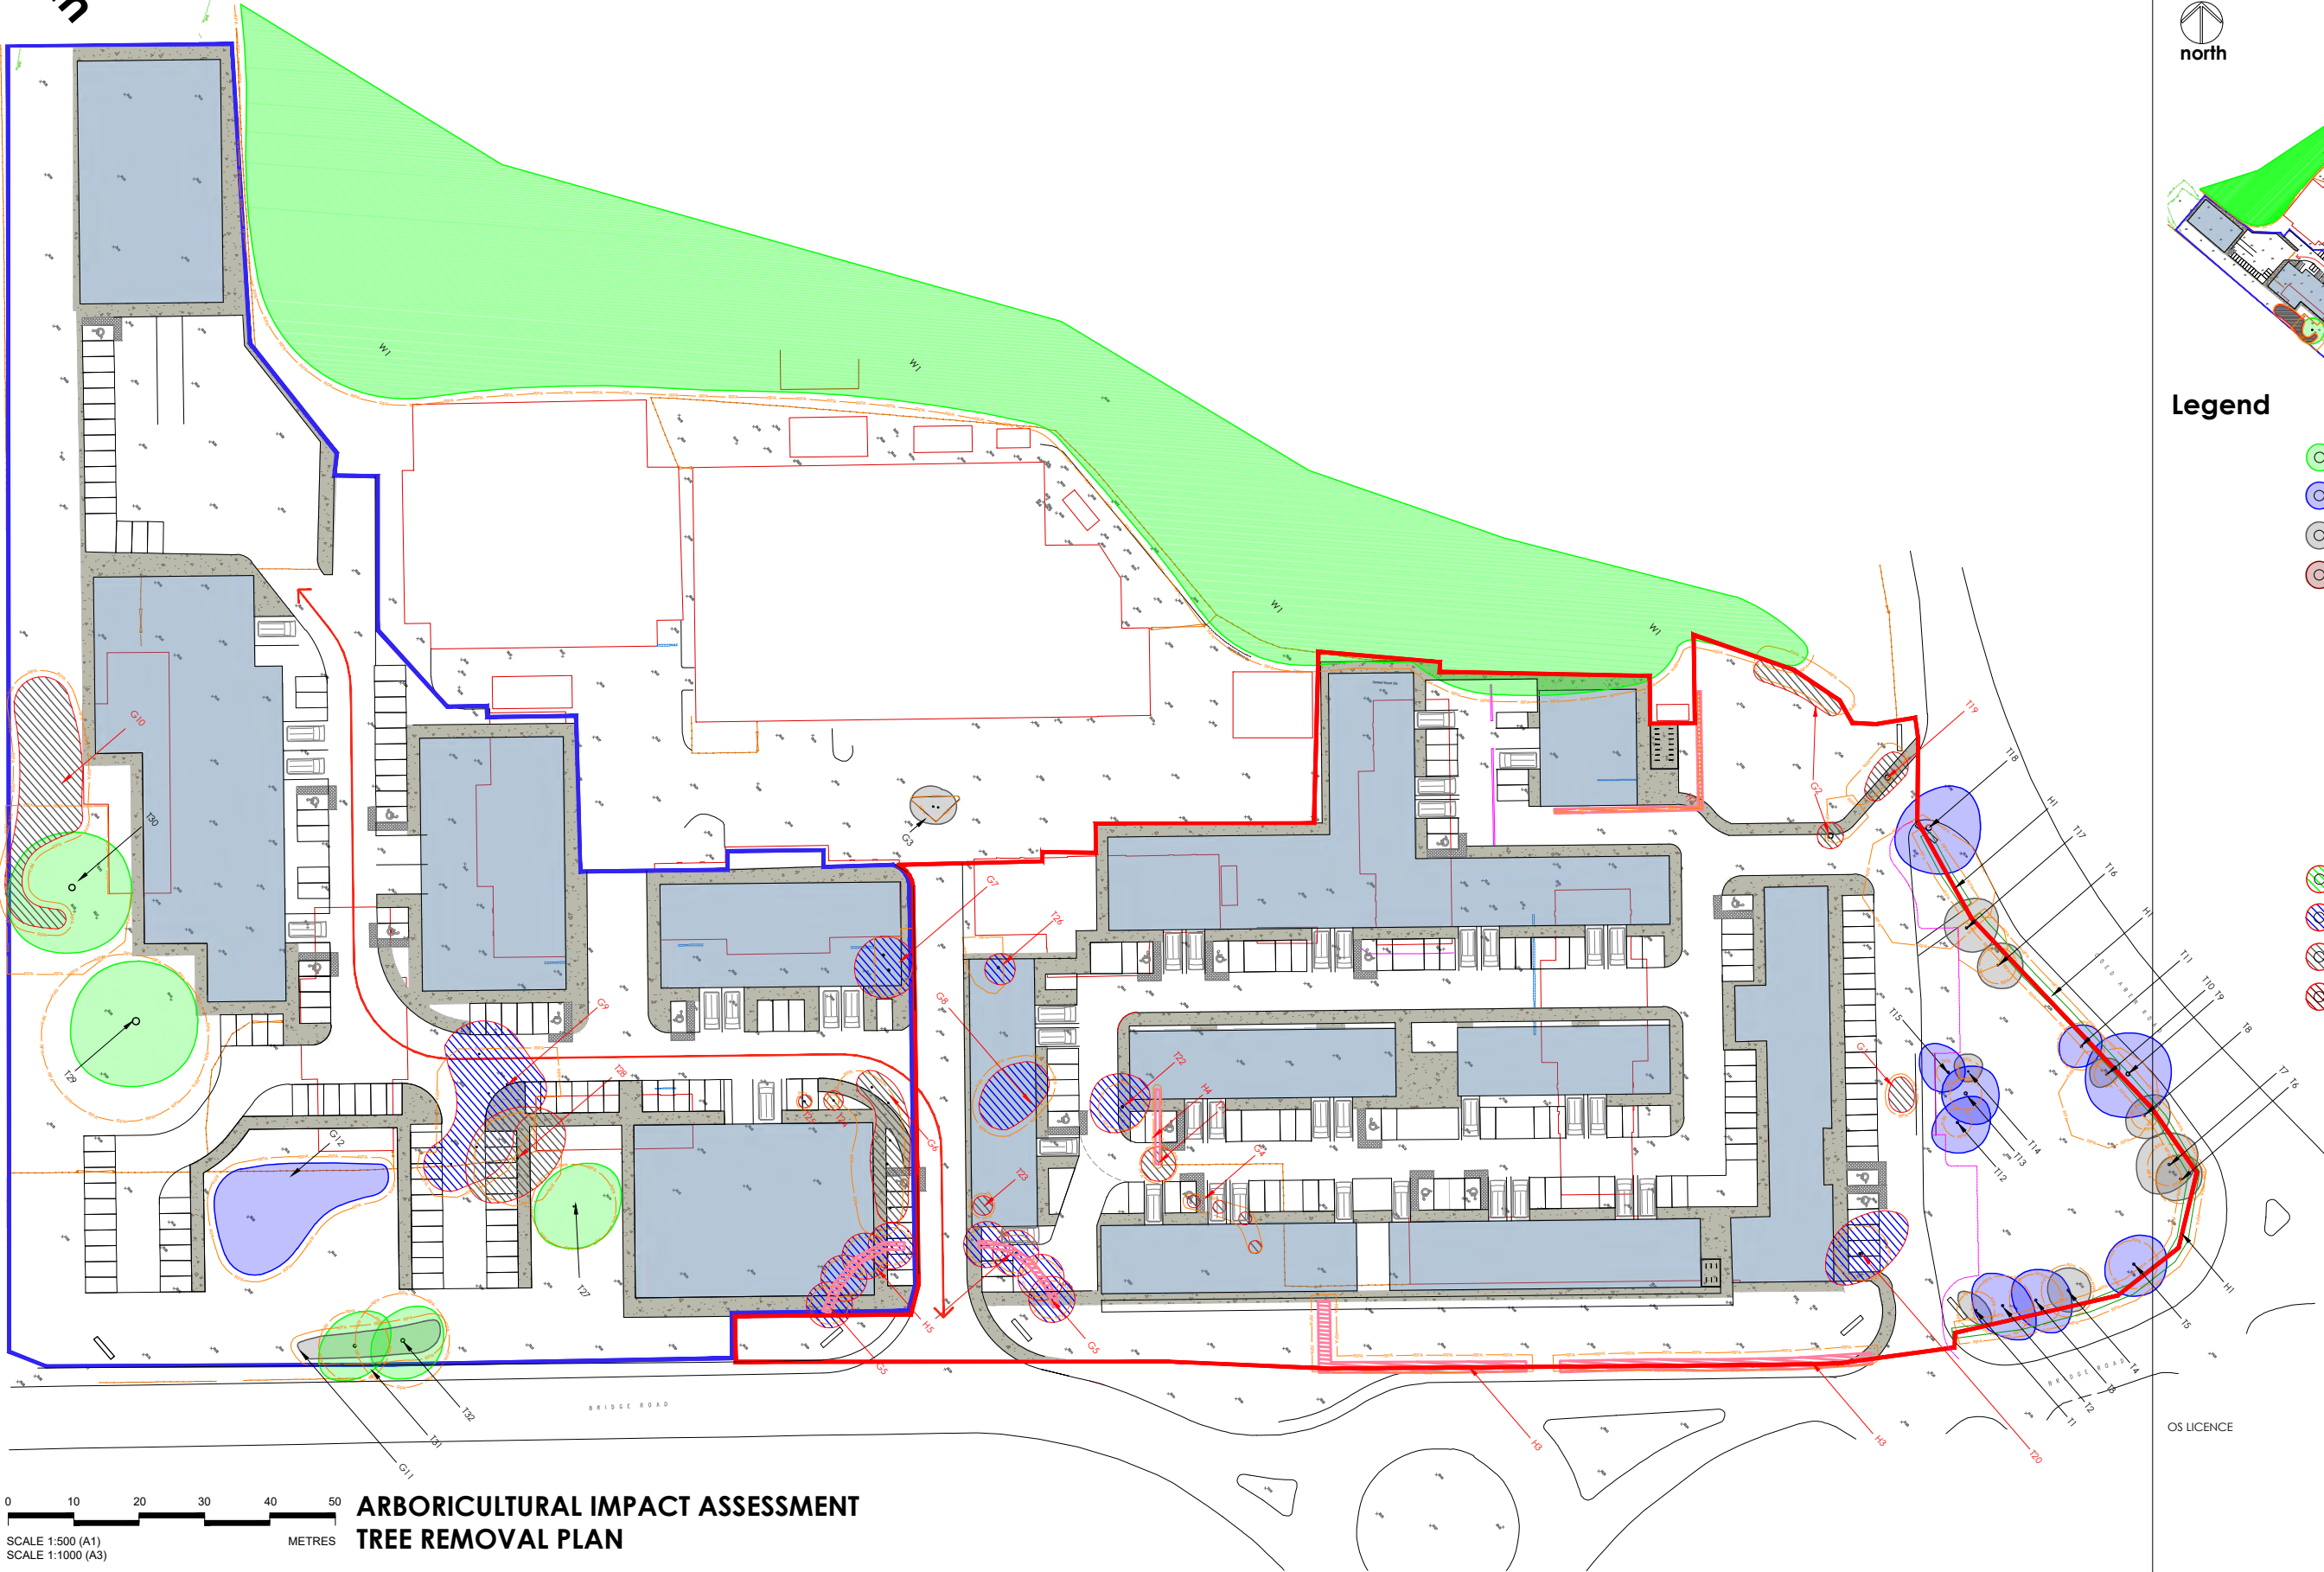
ARBORICULTURAL IMPACT ASSESSMENT  
TREE REMOVAL PLAN

- CATEGORY A - high quality tree / group to be retained
  - CATEGORY B - moderate quality tree / group to be retained
  - CATEGORY C - low quality tree / group to be retained
  - CATEGORY U - unsuitable for retention
  - ROOT PROTECTION AREA (RPA)
  - HEDGE CANOPY EXTENTS
  - T, G, W, H REFERENCE - tree, group, woodland, hedge retained
  - PROPOSED DEVELOPMENT
  - DETAILED APPLICATION
  - OUTLINE APPLICATION
- FEATURES TO BE REMOVED

- CATEGORY A - high quality tree / group to be removed - none
  - CATEGORY B - moderate quality tree / group to be removed
  - CATEGORY C - low quality tree / group to be removed
  - CATEGORY U - unsuitable for retention to be removed - none
  - HEDGE TO BE REMOVED
  - T, G REFERENCE - tree, group, hedge to be removed

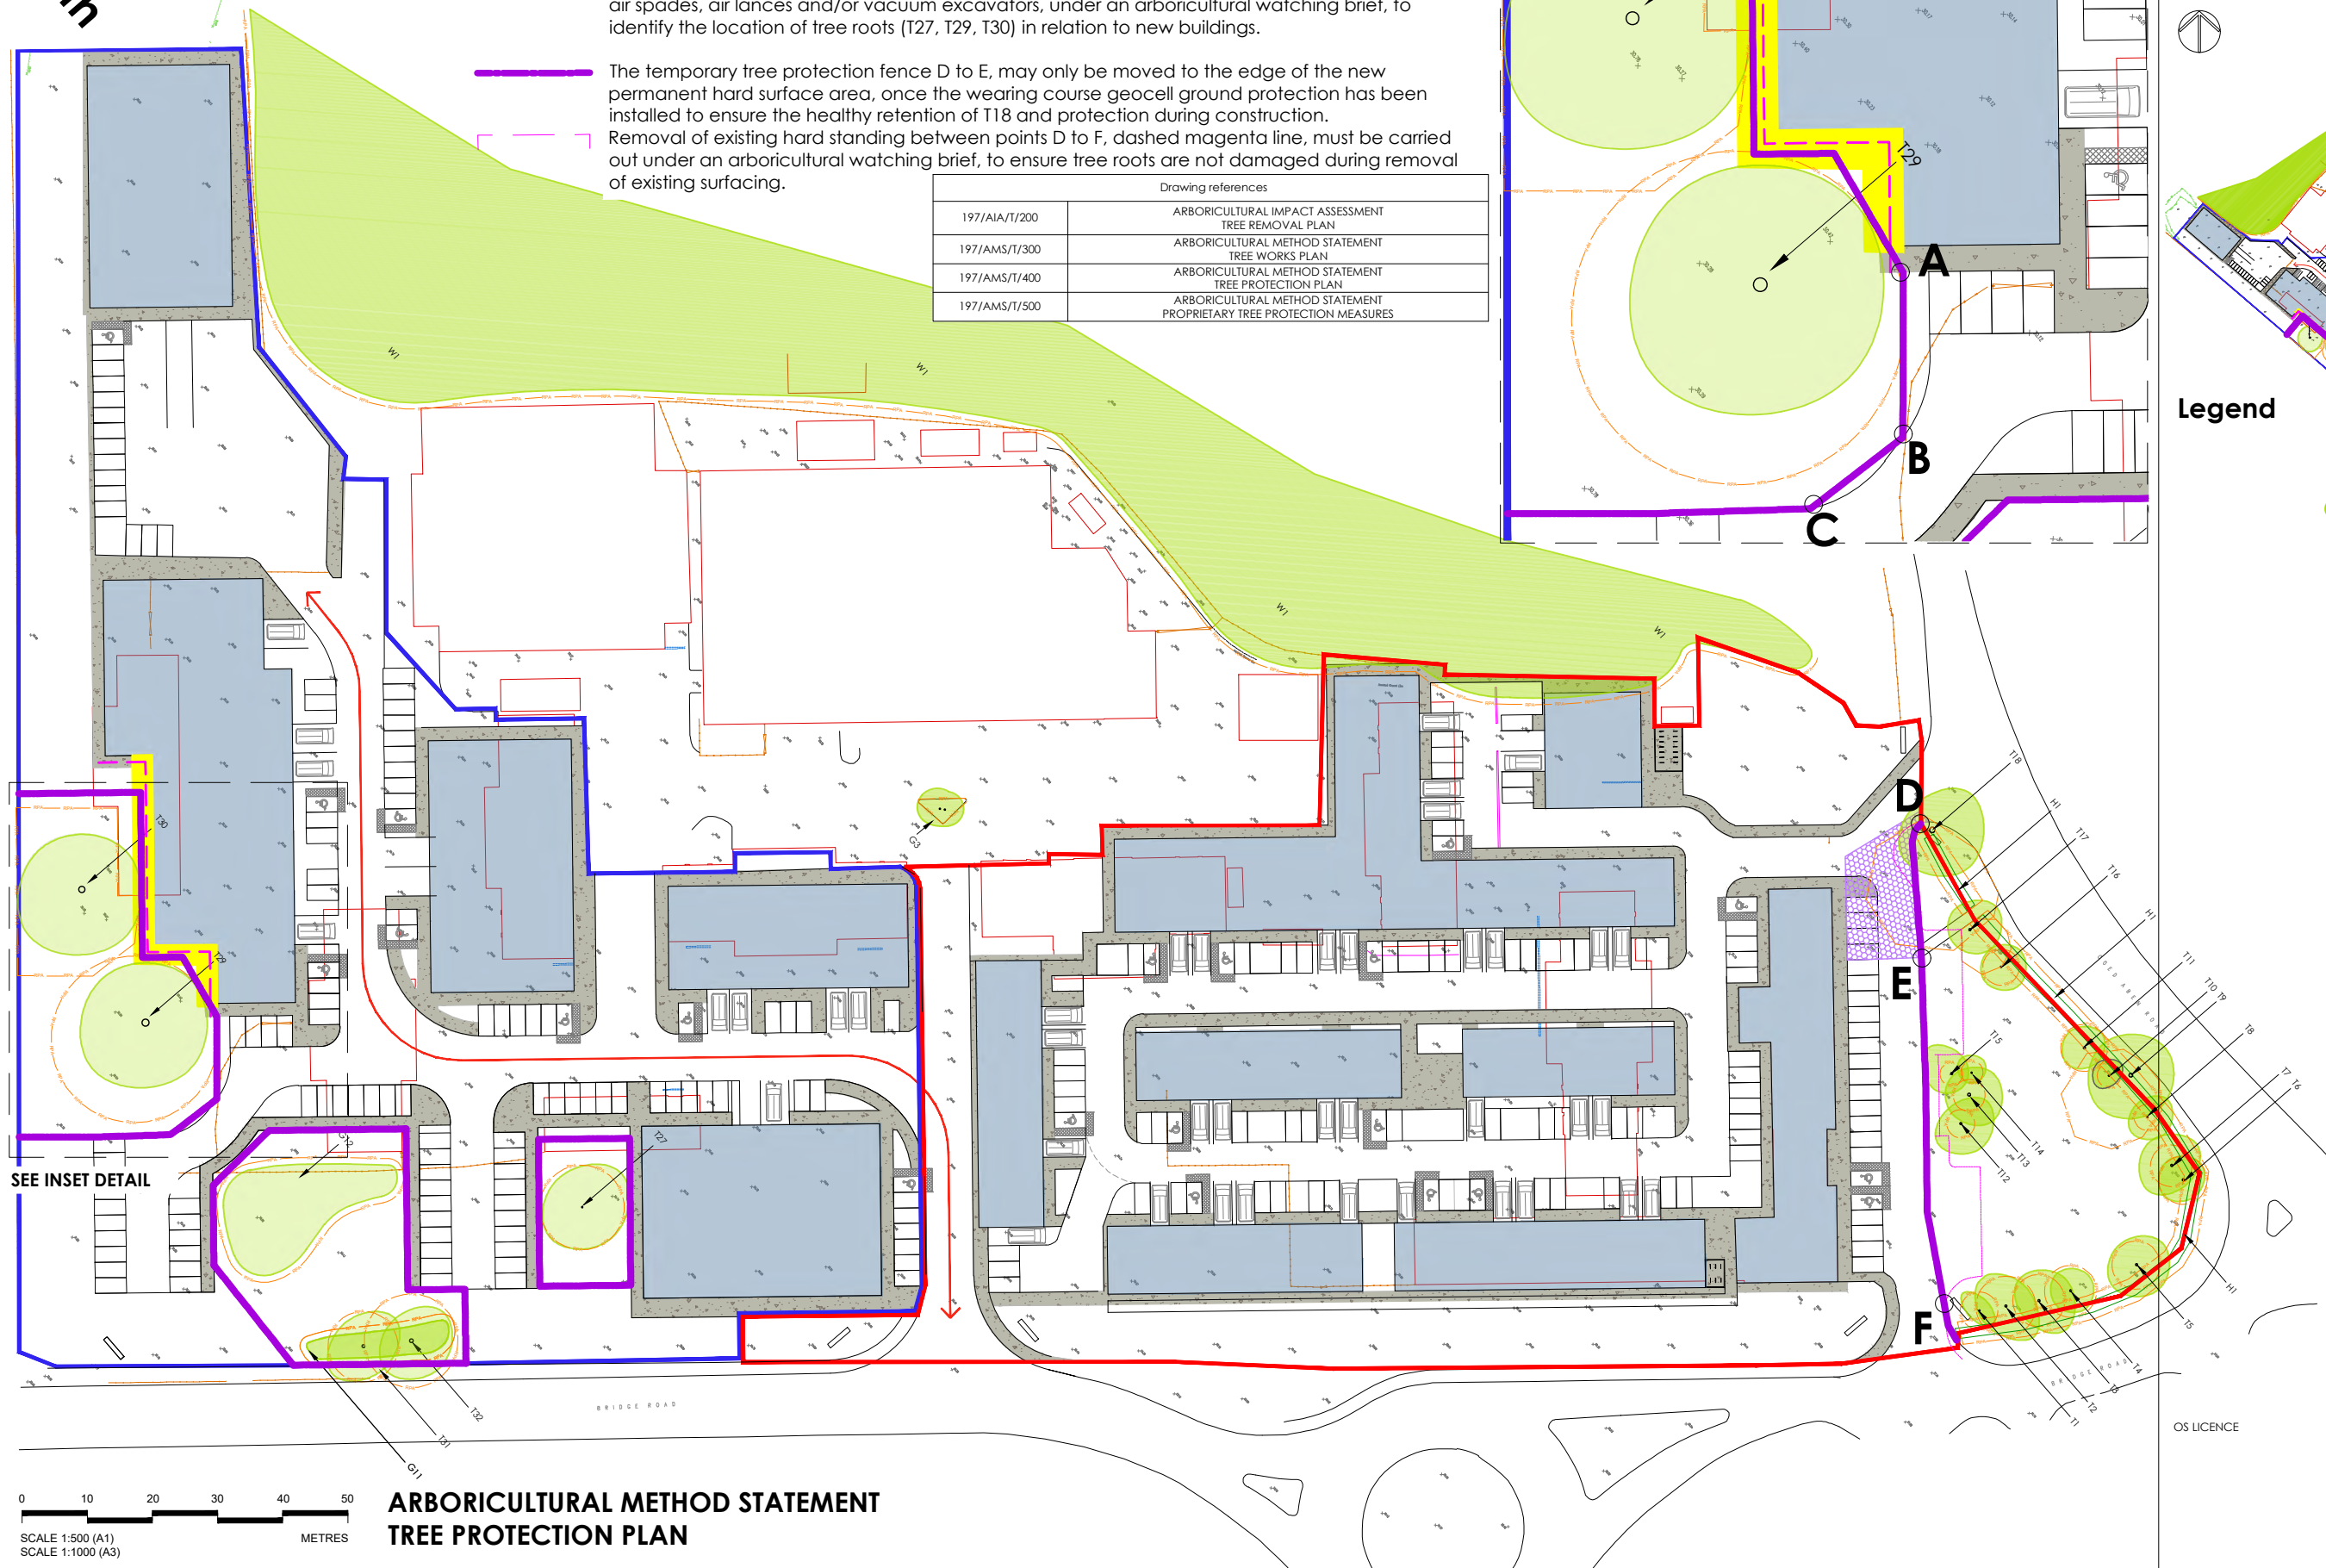
**ARBORICULTURAL METHOD STATEMENT  
TREE PROTECTION PLAN**

- TREES TO BE RETAINED
- ROOT PROTECTION AREA (RPA) BS5837:2012 CALCULATION
- POTENTIAL ASYMMETRIC RPA DUE TO HARD SURFACING AND BUILDINGS
- HEDGE TO BE RETAINED
- T, G, W, H REFERENCE tree, group, woodland, hedge
- TREE STEM
- PERMANENT GROUND PROTECTION TO RPA
- PERMANENT ROOT PROTECTION BARRIER TO BE INSTALLED
- EXISTING ROAD TO BE REMOVED
- TEMPORARY TREE PROTECTION FENCE
- PROPOSED DEVELOPMENT
- DETAILED APPLICATION
- OUTLINE APPLICATION

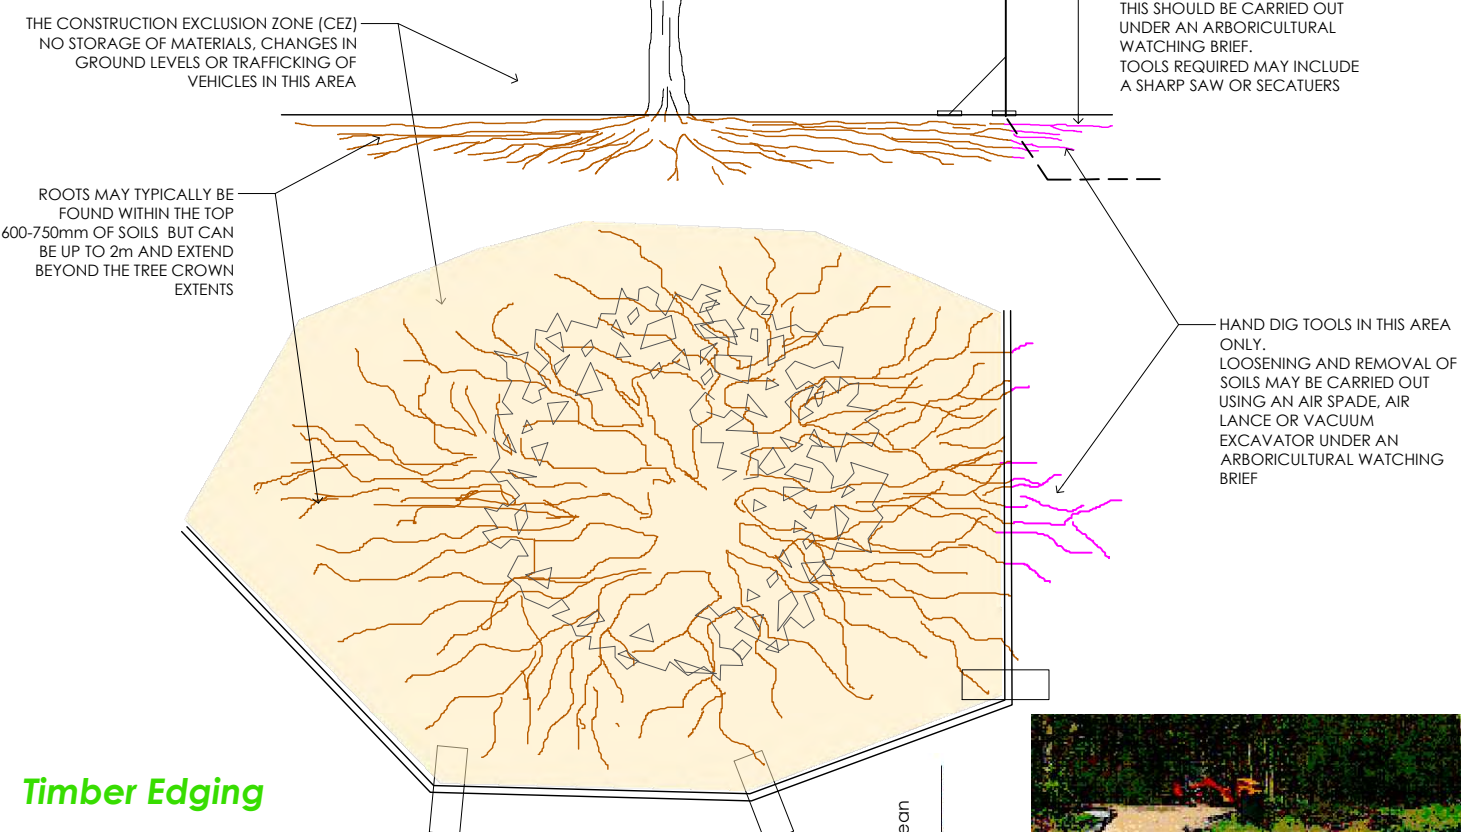
Establishment of the tree root protection area

Work within the RPA and any potential pruning requirements must be identified to the Arboricultural consultant to allow a watching brief to be carried out.

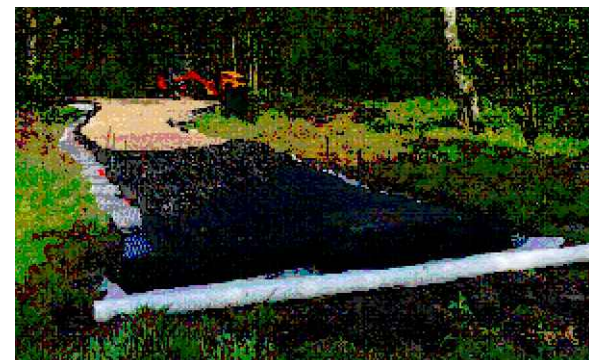
Example of heavy duty ground protection matting for temporary vehicular access

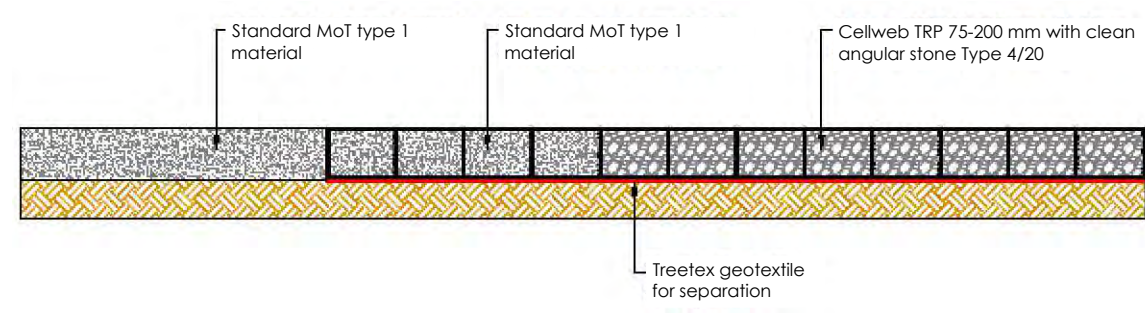
Example of temporary and permanent ground protection systems such as CellwebTRP

Transition from Cellweb TRP to Crushed Hardcore or MoT Surfacing

Information taken from Cellweb TRP Product Information; please refer to website and Manufacturer for further information and specification

- 7.11.1 The new footpaths and roads in the vicinity of mature oak trees to be retained must be installed using a 'no dig' construction method using a 3D cellular confinement system such as Cellweb, in accordance with the Manufacturer's recommendations.

- Install geotextile to the ground surface and lay 3D cellular confinement mat (e.g. Cellweb) to the recommended thickness for the proposed access use on top of this membrane. Expand the mat to its full length and trim to the desired length and width. Carefully peg down the matting with proprietary staking pins to keep the cells open. Fill all the cells with a 20-40mm no fines angular granular stone working from the area furthest from the tree first. Continue filling all the cells using the previously filled cells as a working platform.

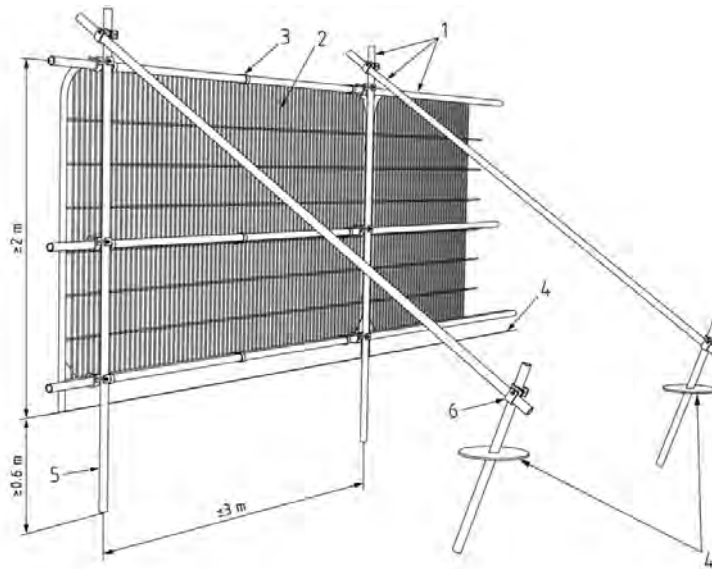
10.

- 1 Standard scaffold poles
- 2 Heavy gauge 2 m tall galvanized tube and welded mesh infill panels
- 3 Panels secured to uprights and cross-members with wire ties
- 4 Ground level
- 5 Uprights driven into the ground until secure (minimum depth 0.6 m)
- 6 Standard scaffold clamps

Default specification for protective barrier

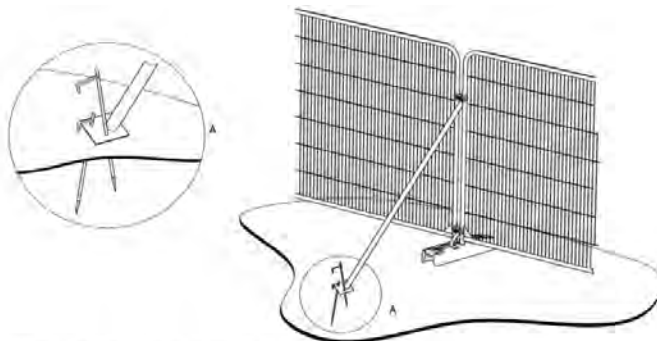
a) Stabilizer strut with base plate secured with ground pins

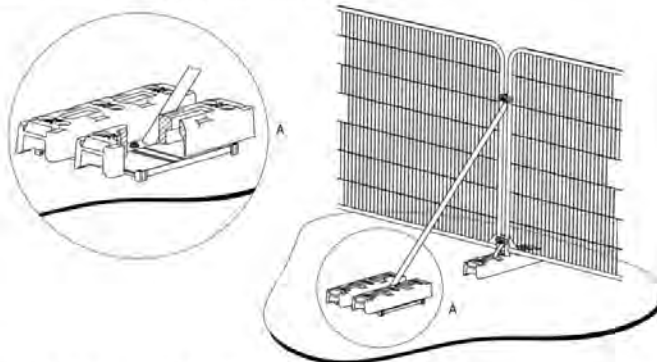
11. b) Stabilizer strut mounted on block tray
