**GREEN INFRASTRUCTURE ASSESSMENT**  
**RETROSPECTIVE APPLICATION**  
**FARM ACCESS TRACK AND SITE LEVELLING**  
**LAND EAST OF BERTHENGRON FARM**

**Project name:** Land East of Berthengron Farm, Sontley,  
Wrexham

**Date:** 15/05/2024

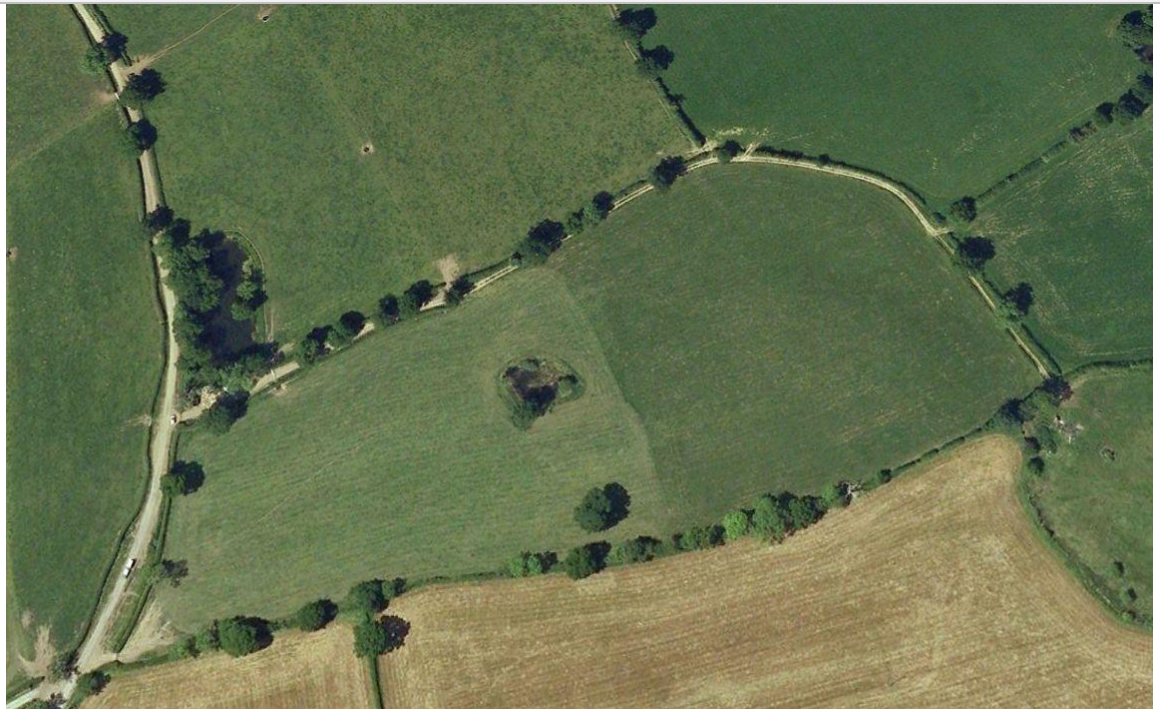
**Aerial photo  
of site taken  
in 2006**

| GREEN INFRASTRUCTURE ASSESSMENT | |
|---|---|
| <b>BASELINE</b> | <p>No previous ecological assessments have been carried out at the site.</p> <p>The site lies 580 metres to the east of Berthengron Farm and 1.7 kms to the south of the edge of Wrexham. The upgraded trackway leads eastwards from a minor road and allows access to blocks of land now in the ownership of Berthengron Farm. It passes between a hedgerow on the north side and a fence to the south which form the boundaries of arable fields to each side.</p> <p>No hedgerow removal or tree removal has been necessitated by the works to the track.</p> <p>An area of land to the south of the track, measuring approximately 0.34ha, is now incorporated into the arable field and there is no evidence on the ground of previous land use or presence of other habitats. However, various maps indicate the presence of a small area of open water and aerial photographs from 2006 indicate a possible pool with surrounding scrub and one mature tree. In 2006, the cleared area appears to be part of, and indistinguishable, from the remainder of</p> |

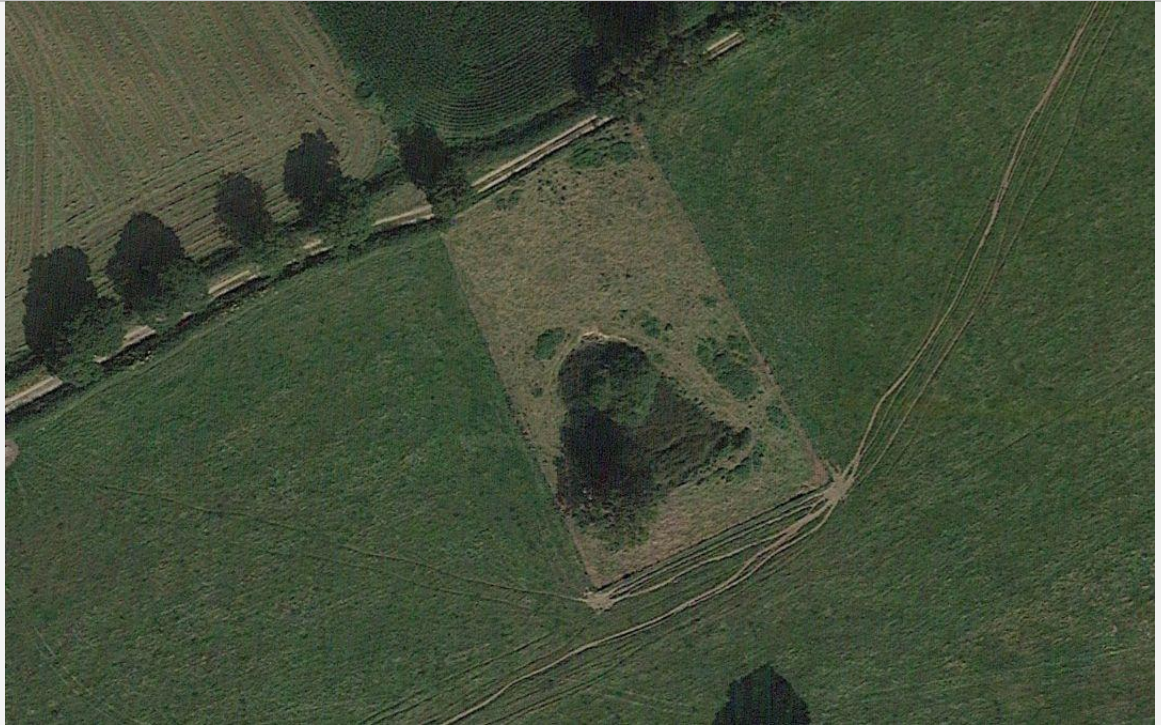
Aerial photo  
dated 2021

the field which was grassland. By 2021, the aerial photograph indicates that the area had possibly been fenced and appears to be rough grassland. The clearance of the site therefore has probably resulted in the change of most of the area from improved grassland to arable which probably does not represent a significant ecological loss. However, the works have resulted in the loss of a pond and associated bankside scrub.

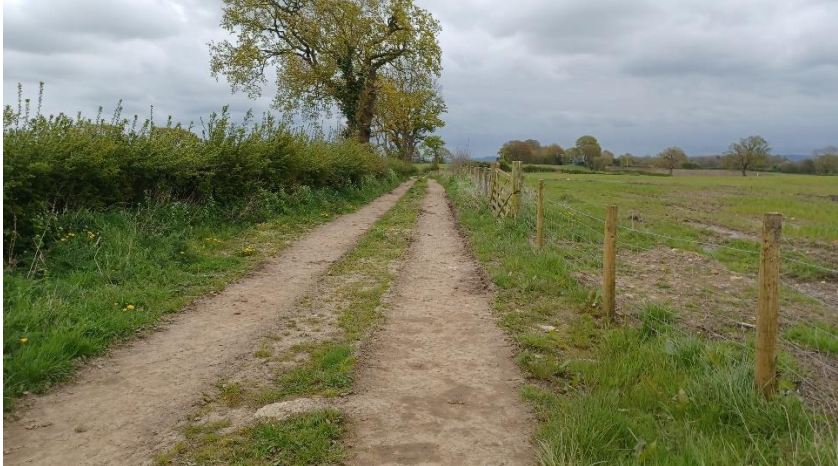
| | UPGRADED TRACK |

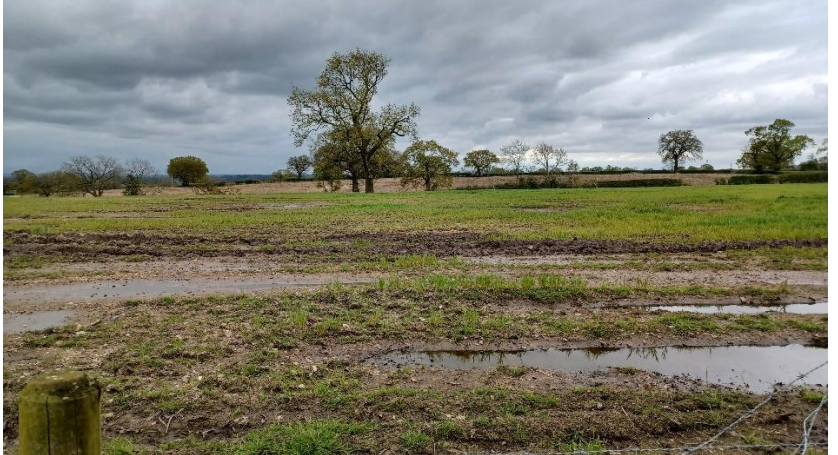
| | SITE RETURNED TO ARABLE USE |

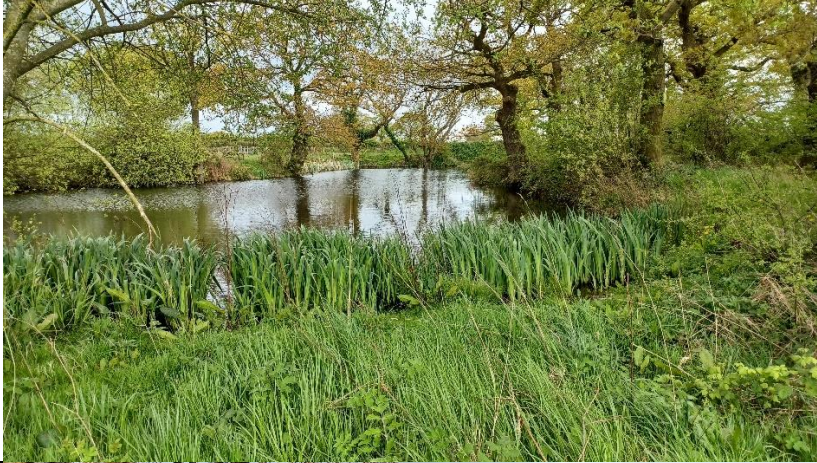
EXISTING POOL TO BE  
MANAGED AS WILDLIFE  
CONSERVATION AREA

Biodiversity enhancements plans for the site revolve around works to optimise the significant ecological value of the existing pond at the site. This will include the planting of new native hedgerow and native trees to extend the existing tree cover around the pool. This will contribute to carbon sequestration in addition to habitat benefits.

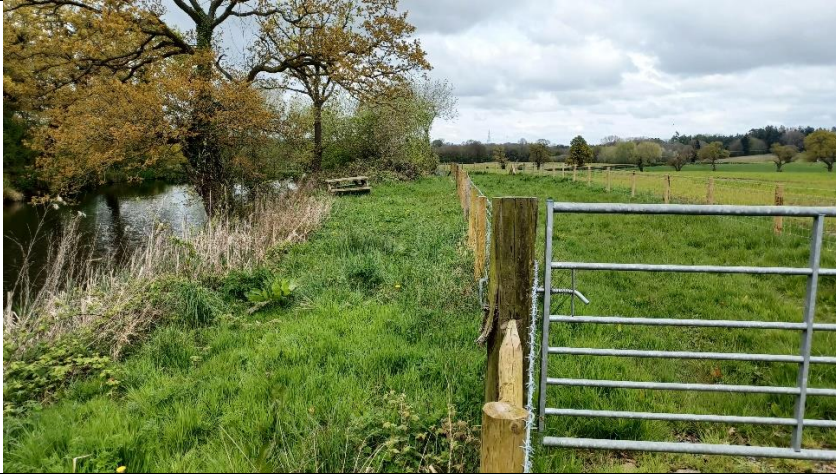
POOL AND WOODLAND AREA  
NOW FENCED TO PREVENT  
ACCESS BY STOCK. HEDGE TO BE  
PLANTED ALONG LINE OF FENCE

New woodland planting will buffer existing woodland habitat. The pond area has now been securely fenced to prevent stock access to the area of open water and its
