## SOAKAWAY ASSESSMENT

| <b>Project Number:</b><br>PT1346 | <b>Site Address:</b><br>Land Off St Mary's Avenue, Wrexham, LL13 0EQ | |
| <b>Weather:</b><br>Heavy Rain | <b>Date Of Testing:</b><br>21/11/2022 | <b>Client:</b> |

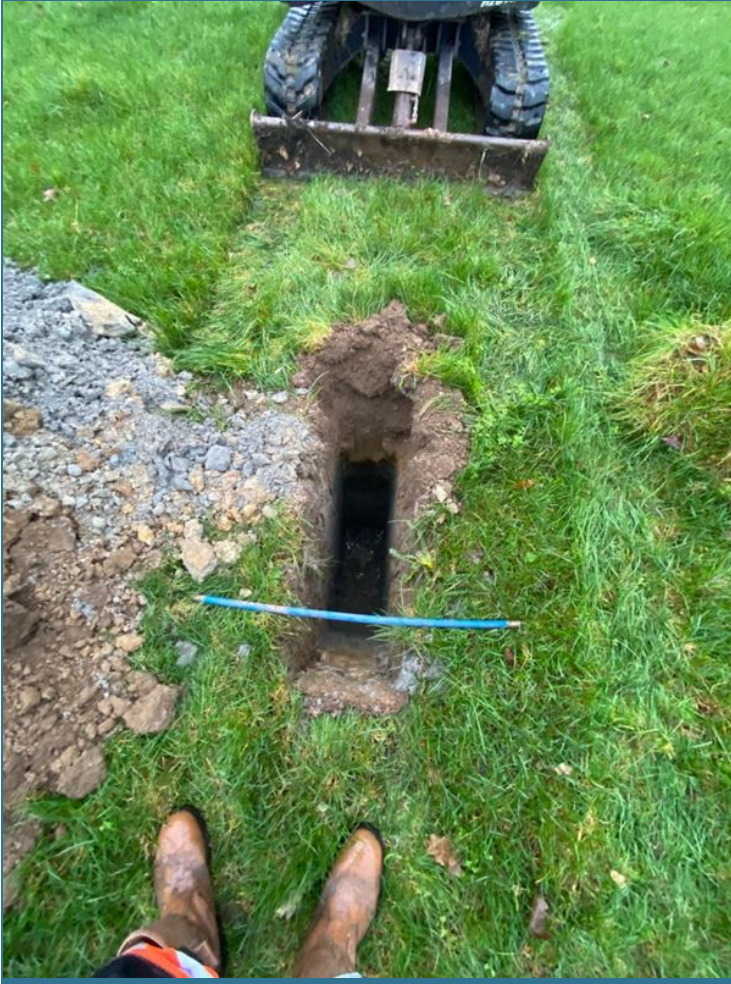
Trial Pit A

**Notes:**  
Ground Water encroached during excavation, trail pit left open for remaining time on site - 1.7m bgl

| Ground Water Encroached During Excavation | Depth Of Ground Water |
| Yes | 1.7m BGL |

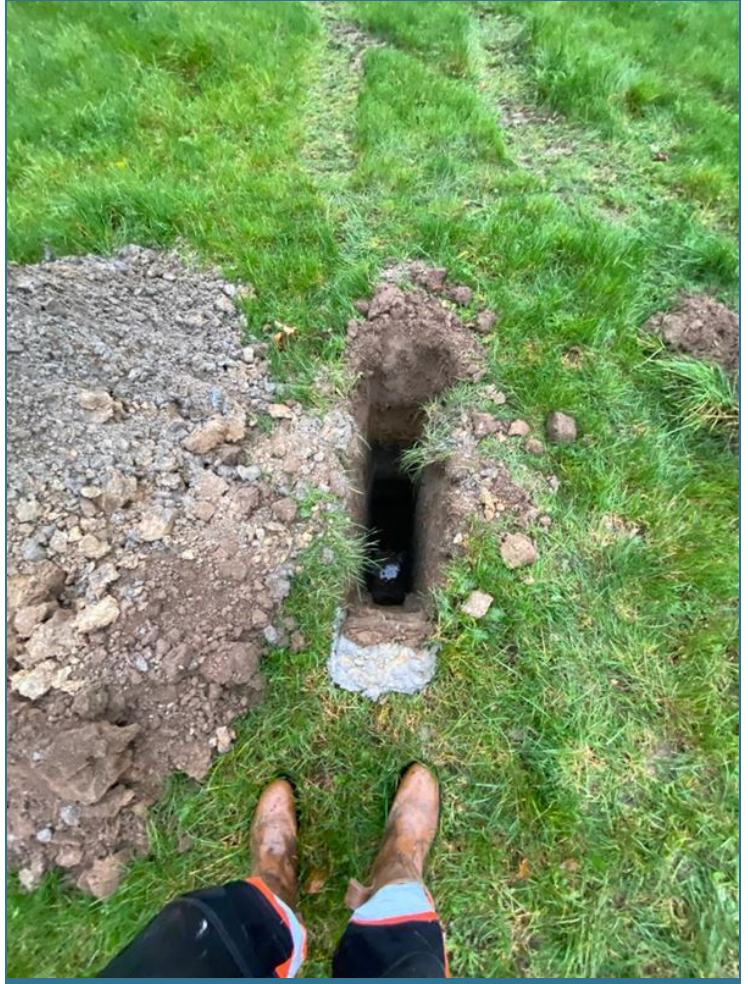
Trial Pit B

**Notes:**  
Ground Water encroached during excavation, trail pit left open for remaining time on site - 1.5m bgl

| Ground Water Encroached During Excavation | Depth Of Ground Water |
| Yes | 1.5m BGL |
