## HERITAGE IMPACT ASSESSMENT

10 Park Street, Ruabon LL14 6LE

Grade 2 listed

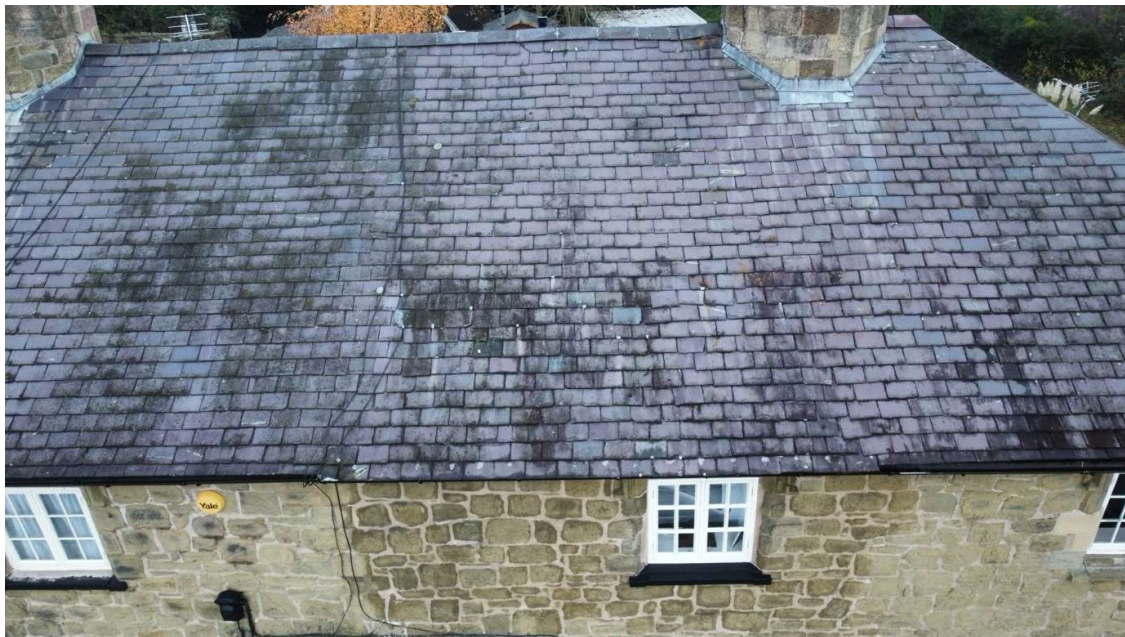
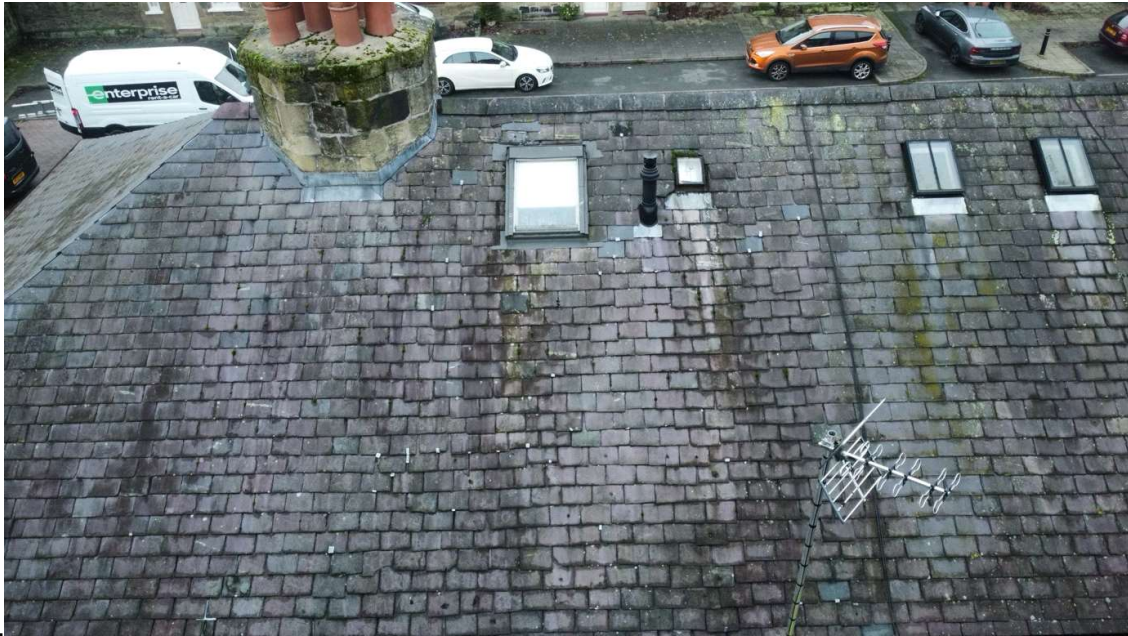
To replace the defective roof to maintain the integrity of the property, and replace the current non-compliant velux roof window with a conservation roof window. The roof may be suffering with nail rot and would account for the very large amount of lead tags holding the slates in.

To remove the roof slates and retain as many as possible to re-use, using new nails to fix. Additional slates required will be matched as closely as possible. Original material will be moved from rear to front to maintain appearance on front elevation.

To remove the current non-compliant velux roof window and replace with a conservation roof window. (Keylite data sheet has been provided)
