# BRYMBO IRON AND STEELWORKS, HERITAGE CENTRE

## LIGHTING PLAN REVIEW

Report Ref EE.672.24e.RC

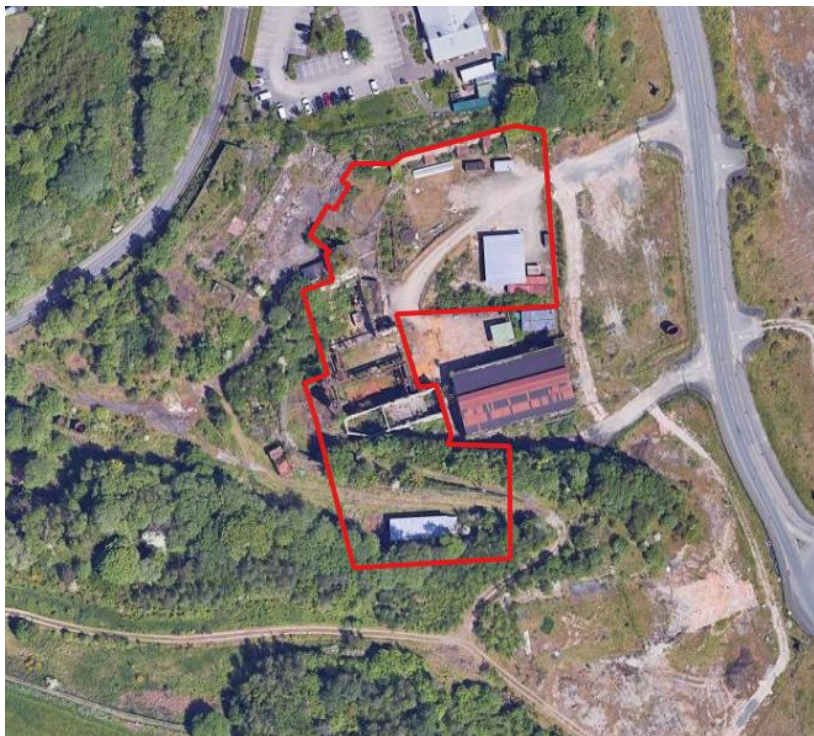
**FIGURE 3.1: SITE LOCATION – THE APPROXIMATE SITE BOUNDARY IS SHOWN IN RED.**  
BACKGROUND IMAGE ©GOOGLE MAPS 2024

3.2.1 The development area is centred on the former steelworks area of the Brymbo Heritage Area, which is predominantly hardstanding and ephemeral/short perennial habitat, and includes several industrial buildings in various states of repair (Figure 3.1). The wider Brymbo Heritage Area extends to the west of the steelworks, and to the south to Brymbo Fossil Forest area.

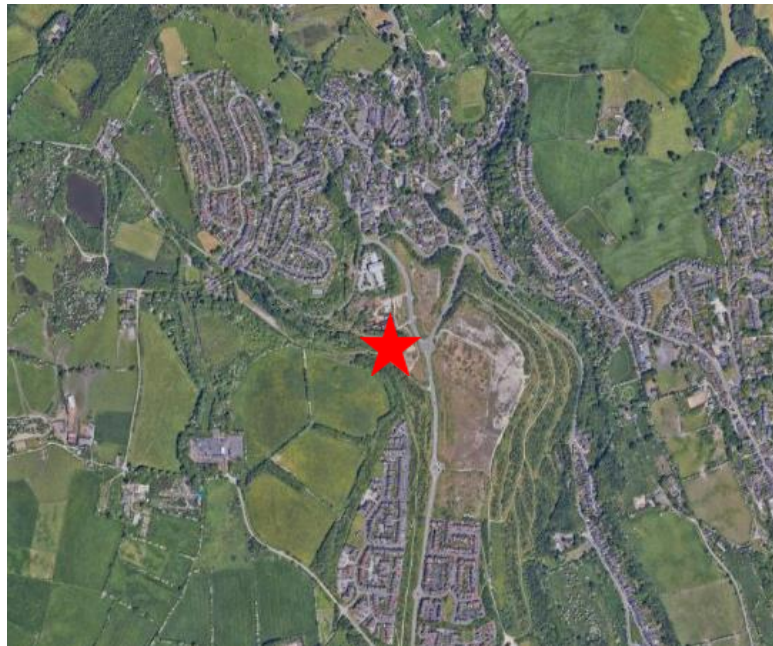
**FIGURE 3.2: WIDER SITE LOCATION – THE APPROXIMATE SITE BOUNDARY IS SHOWN BY THE RED STAR.**  
BACKGROUND IMAGE ©GOOGLE MAPS 2024

The site is located in a rural area on the southern outskirts of Brymbo village (Figure 3.2). To the south and west of the site is a large area of fields bounded by scattered trees and hedges. Part of the former steelworks lies to the east of the survey area, beyond a trunk road, and consists of a mixture of bare ground with patchy vegetation, semi-improved grassland and scattered scrub.

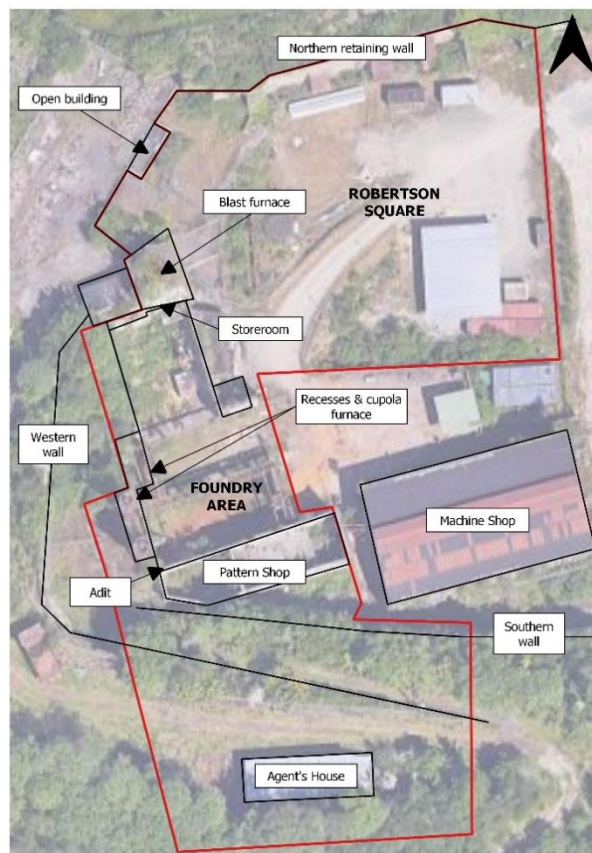
**FIGURE 3.3: BUILDINGS AND FEATURES IN THE STEELWORKS AREA AT BRYMBO HERITAGE AREA.**  
BACKGROUND IMAGE ©GOOGLE MAPS 2024

3.2.2 Key buildings and features referred to in this report are shown in Figure 3.3.

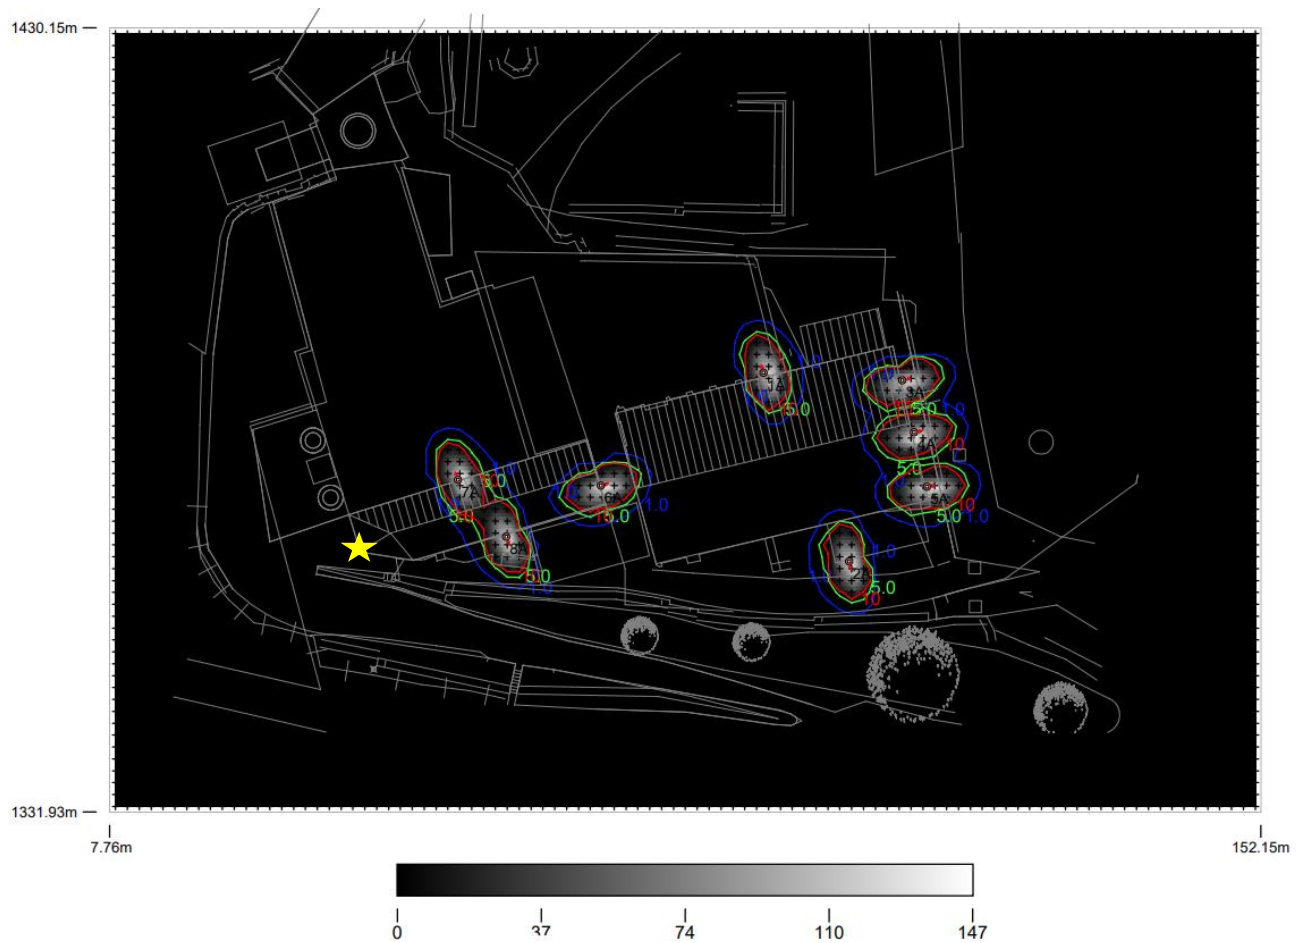
**FIGURE 4.1: LOCATIONS OF LUMINAIRES AND MODELLED HORIZONTAL LUMINANCE (LUX) FOR THE PROPOSED LIGHTING PLAN (POSITION OF ADDITIONAL EMERGENCY LIGHT SHOWN BY THE YELLOW STAR).**

- 4.1 The lighting plan for the works in the Foundry Area has been created by Carpenter Davies Partnership (2023). Modelled (horizontal) light levels for the proposed lighting plan has been provided to Enfys Ecology and is shown in Figure 4.1.

- 4.3 The lighting plan specifies the installation of eight external 'Opus Wallpack Dextra 0' luminaires, mounted with no tilt. The product specifications note a very low (less than 2.5%) upward light spill for this model of luminaire. The lights will be controlled by photocells and timers, with manual overrides.

- 4.4 The luminaires specified have a light flux of 2.00 klm and a colour of 4000K, and are all to be mounted at a height of two metres.
- 4.5 One additional external light (star on Figure 4.1) will be a non-maintained light for emergency use only.

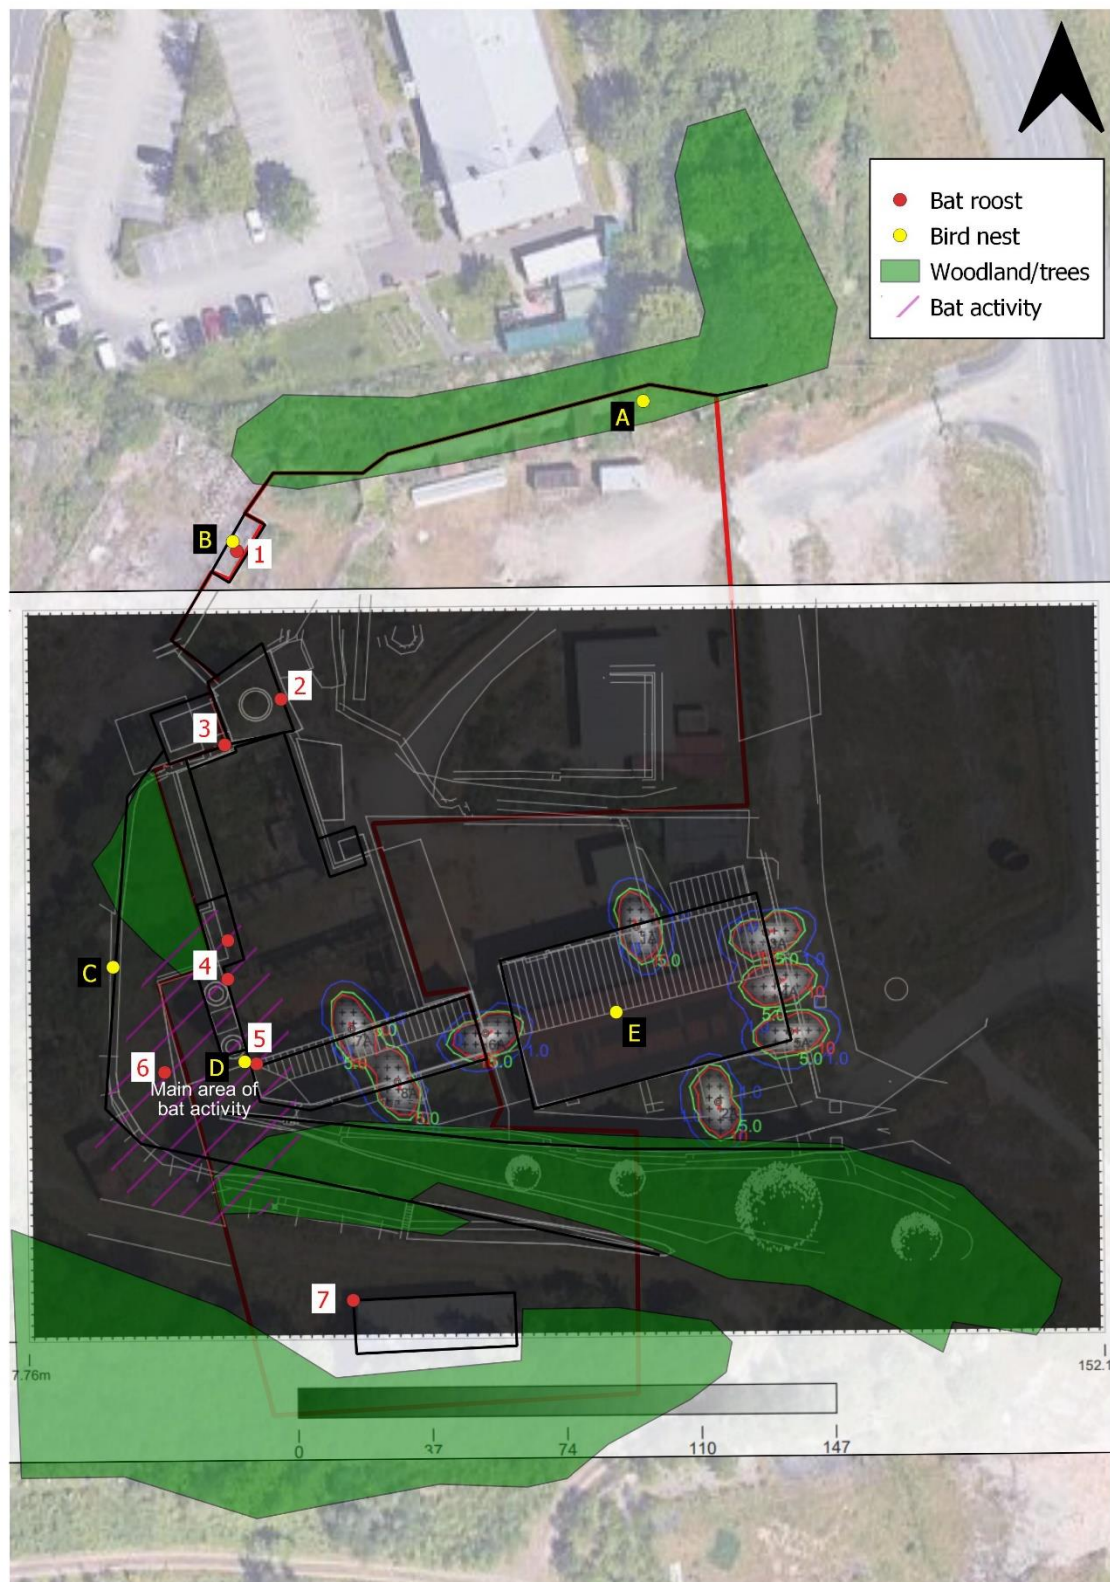
**FIGURE 5.1: MODELLED HORIZONTAL LUMINANCE (LUX) FOR THE PROPOSED LIGHTING PLAN WITH LOCATIONS OF BAT ROOSTS, BIRD NESTS, AND HABITAT FEATURES (SEE SECTION 3.3 FOR DETAILS OF ROOSTS AND NESTS)**

- 3.3.2 Previous ecological surveys (Cutts, 2023) identified many features which could potentially be used by roosting bats, and the following bat roosts have been observed within the Foundry Area (also see Figure 5.1; the numbers below refer to locations on the map):

- 3.3.4 There are numerous opportunities for nesting birds both within/around the structures in the Foundry Area, and in the adjacent habitats, especially the woodland to the west and south. Birds have been reported or observed from the following places within the Foundry Area, which could potentially be nesting locations (also see Figure 5.1; the letters below refer to locations on the map):

- 5.1 Figure 5.1 overlays the positions of known bat roosts and bird nests with the horizontal luminance plan; also illustrated are the main blocks of woodland/trees along the edges of the Foundry Area, and the focus of bat foraging activity (to the south-west of the Foundry Area) as observed during bat activity/emergence surveys (Cutts, 2023). Vertical light spillage will be very low due to the design of the selected luminaires.

- 5.2 As the luminaires are located around the northern, eastern and southern elevations of the Machine Shop and Pattern Shop, there will be no direct illumination of any known bat roosts or bird nests, with the possible exception of swallow nests in the Machine Shop (see Section 5.5, below). Modelled horizontal illuminance show that there will be no additional light spillage reaching these features.
