# Arboricultural Impact Assessment (AIA)

**April 2024**

**Wrexham County Borough Museum and Archives**  
Regent Street  
Wrexham  
LL11 1RB

| <b>Title:</b> | Arboricultural Impact Assessment | | | |

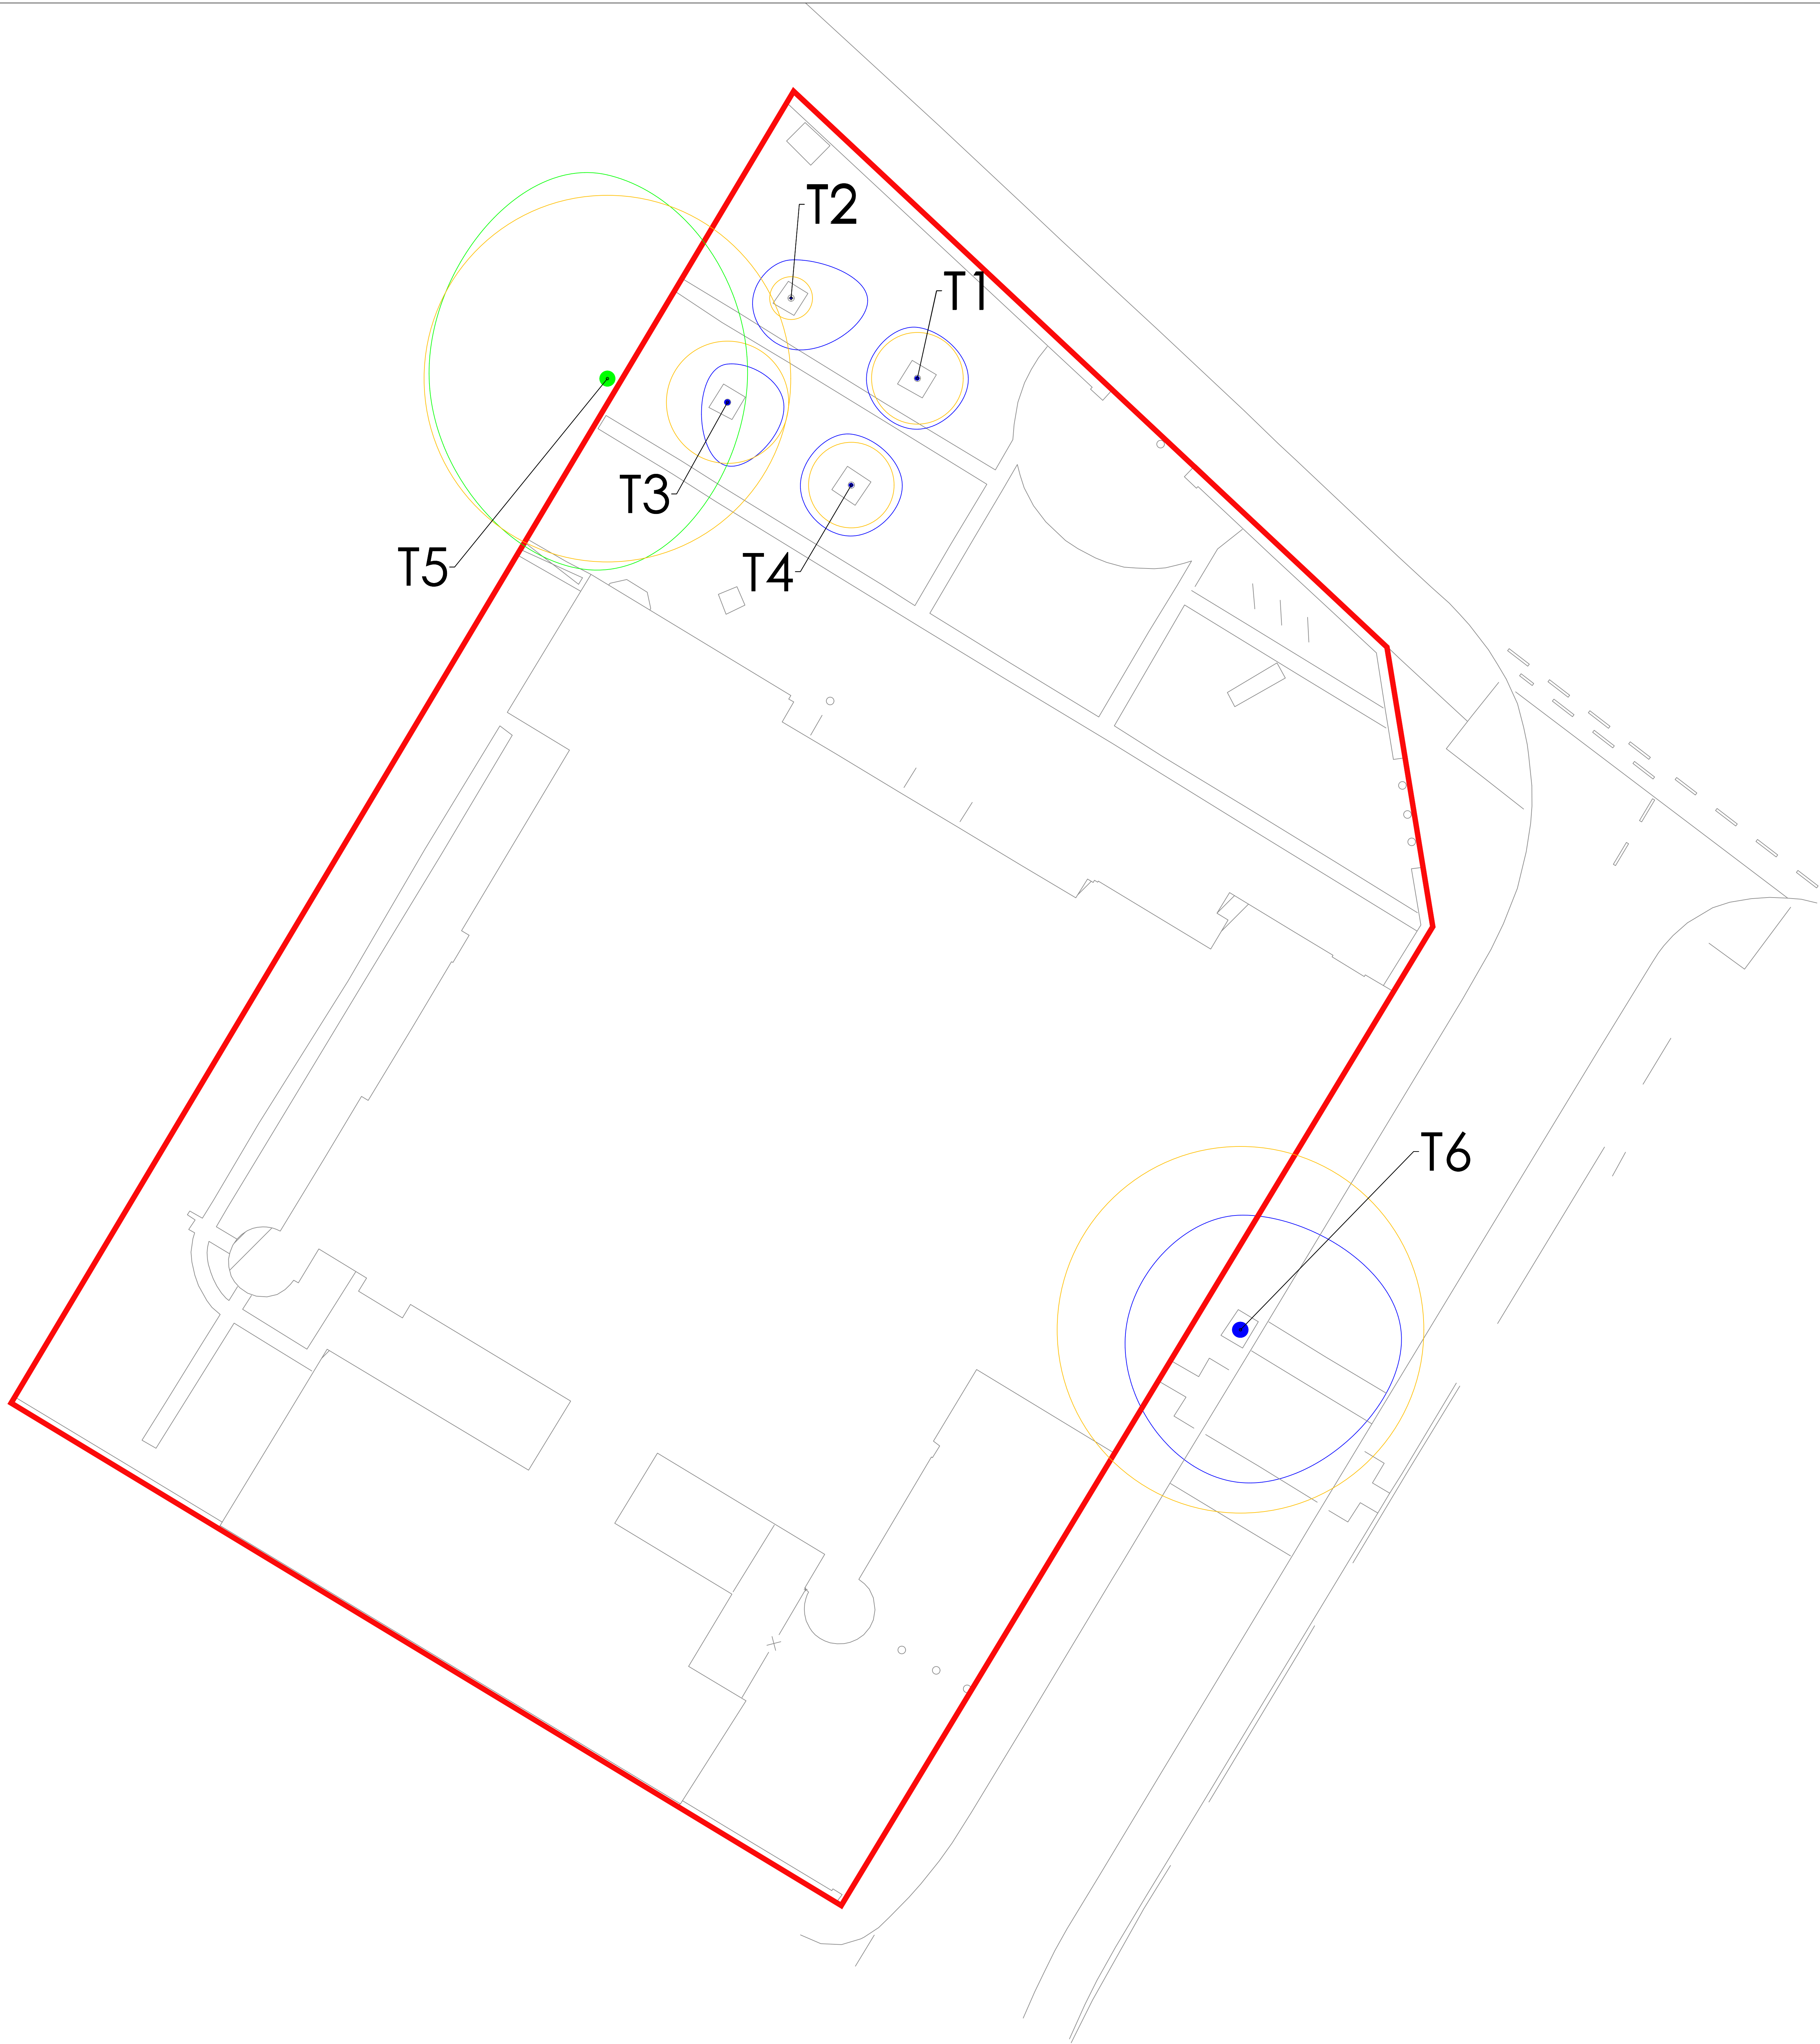
| UG_1678_ARB_TCP_01 | 00 | | |

- Tree Constraints Plan
- Tree Removal Plan
- Tree Works Schedule
- Tree Protection Plan
- Tree Protection Inserts

- 1.1.7. Tree protection fencing will need to be installed at the alignment shown on the Tree Protection Plan in Appendix 4 before any construction activity takes place.

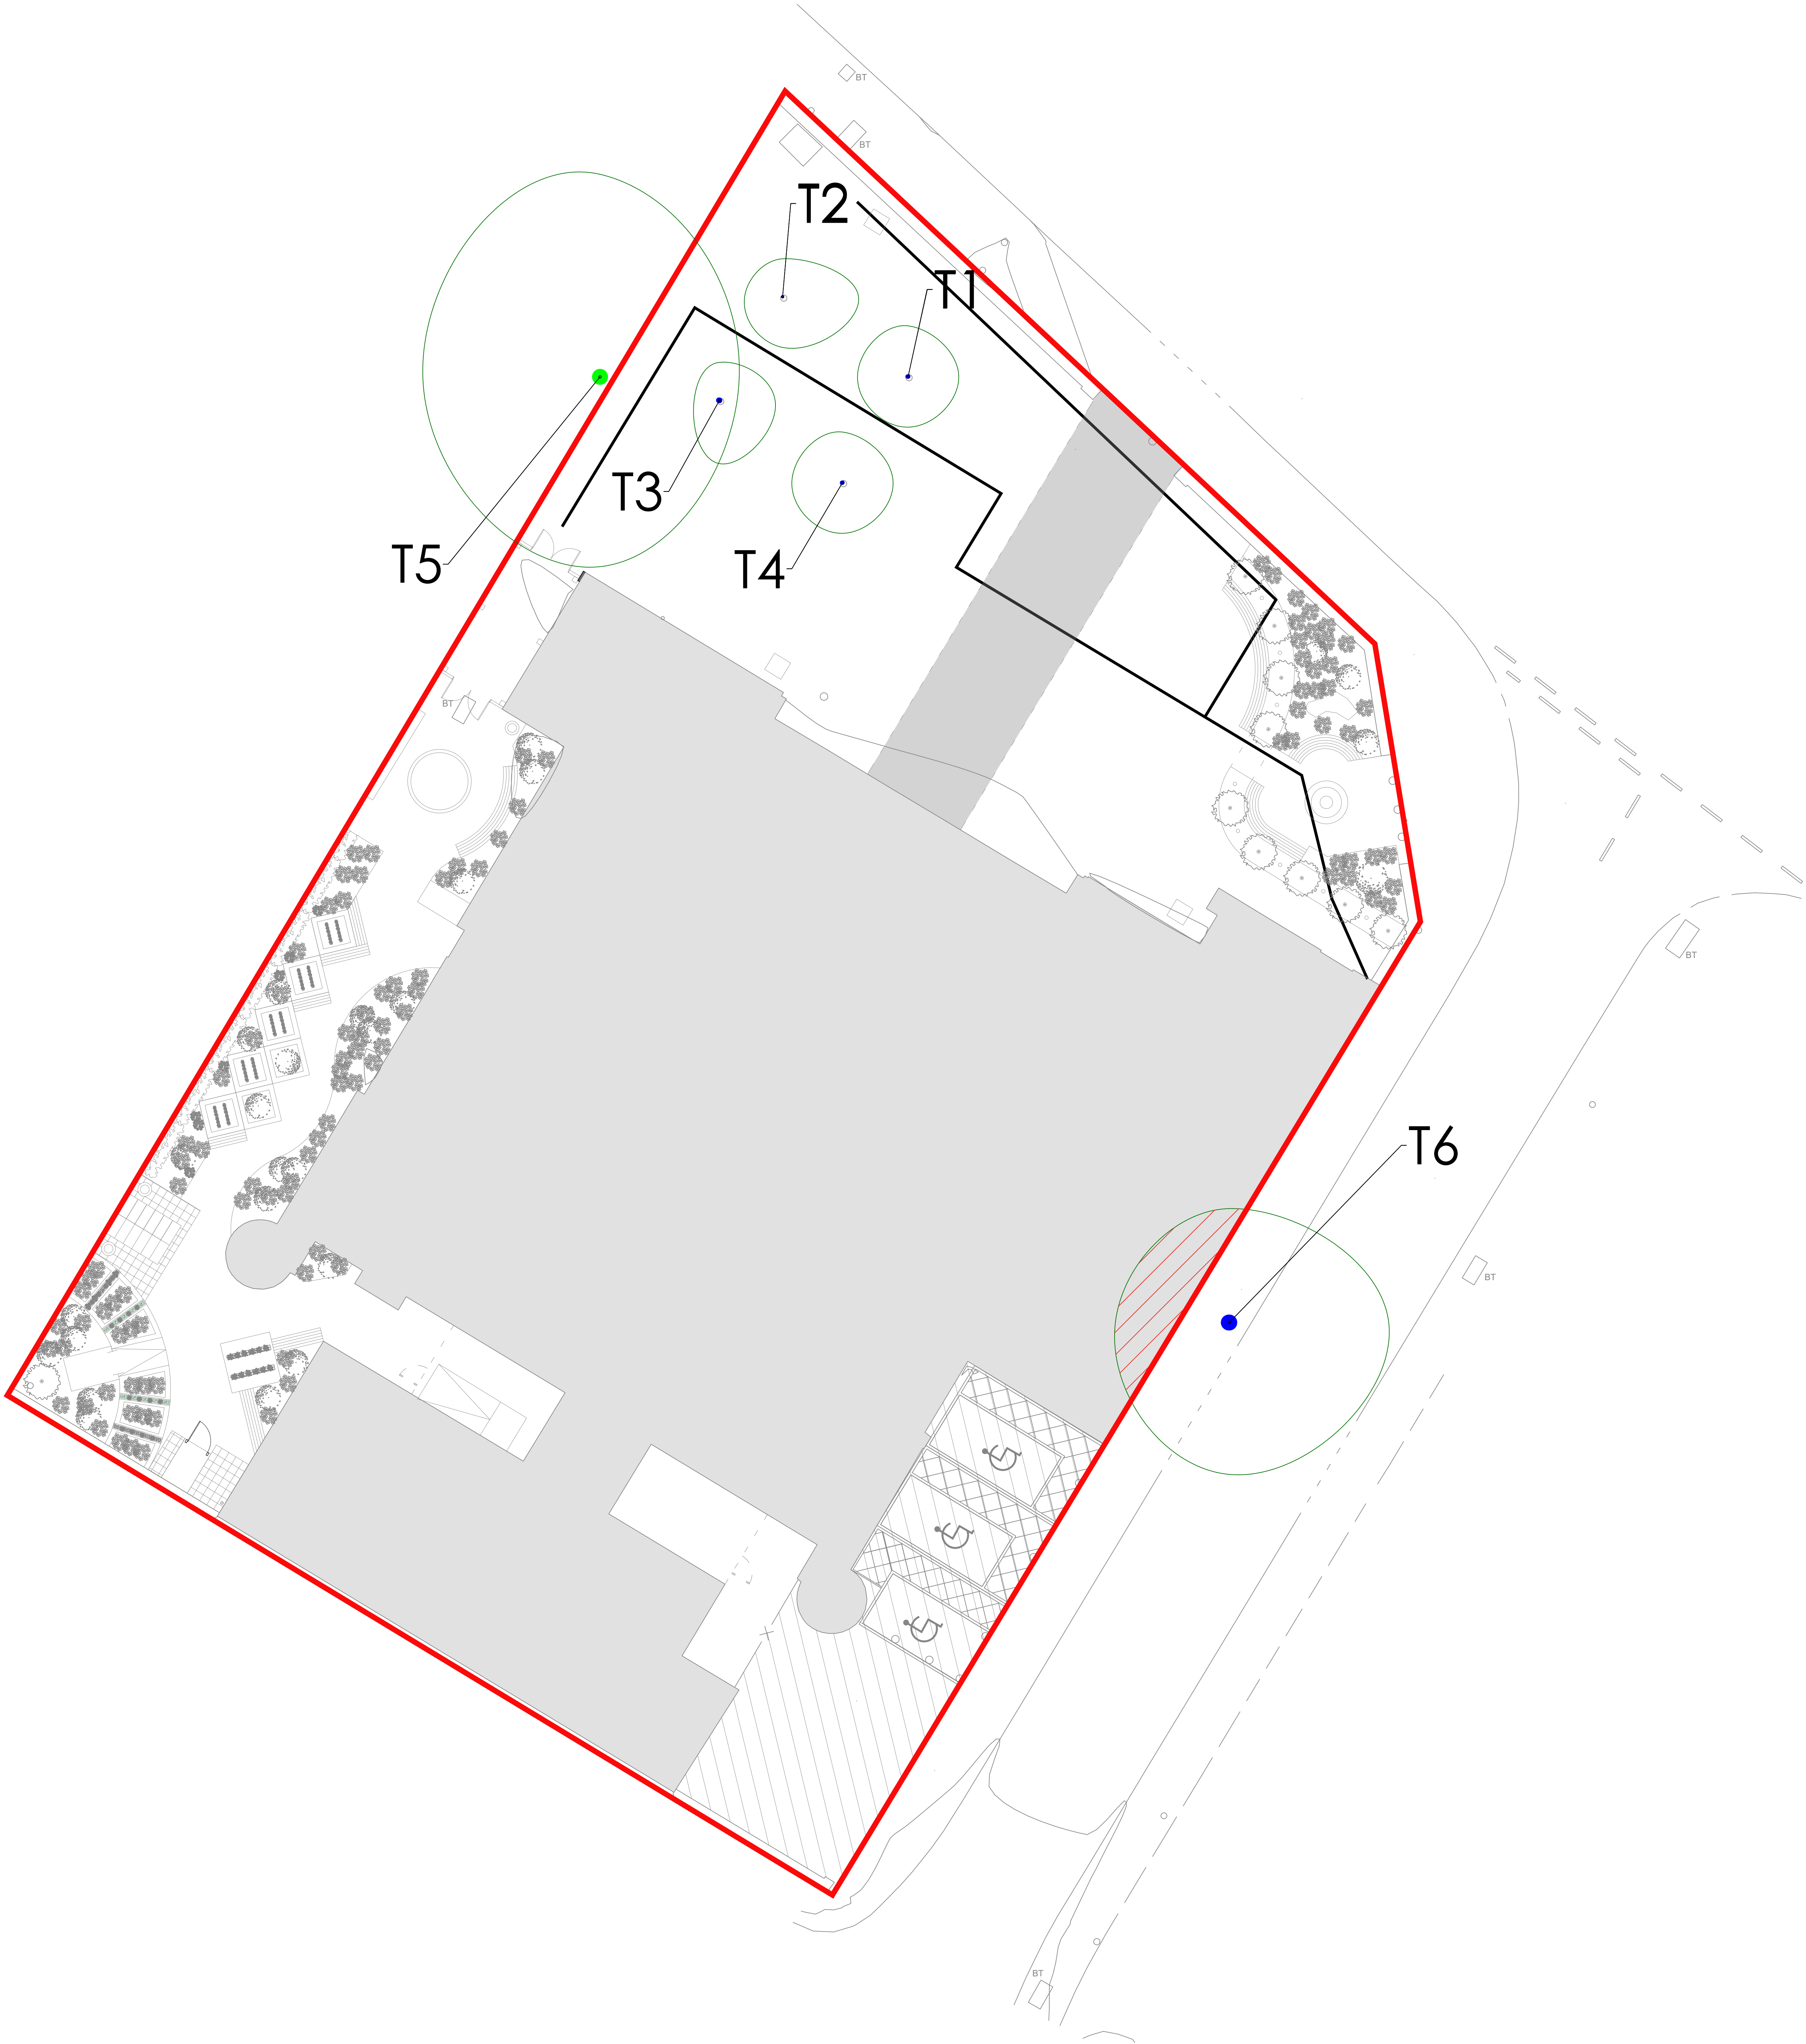
- 2.3.1. A scaled plan has been provided with tree positions already plotted. Any extra trees found on site that were not included on the original plan have been plotted according to measurements taken on site and/or using aerial photography.
- 2.3.2. Tree locations which have been estimated are illustrated on the Tree Protection Plan in Appendix 4. The exact locations of these trees must be verified, and any discrepancies discussed with the Arboricultural Consultant before starting works on site.
- 2.3.3. A plan outlining the development proposals has been overlaid with the Tree Constraints Plan in order to assess the potential impacts.

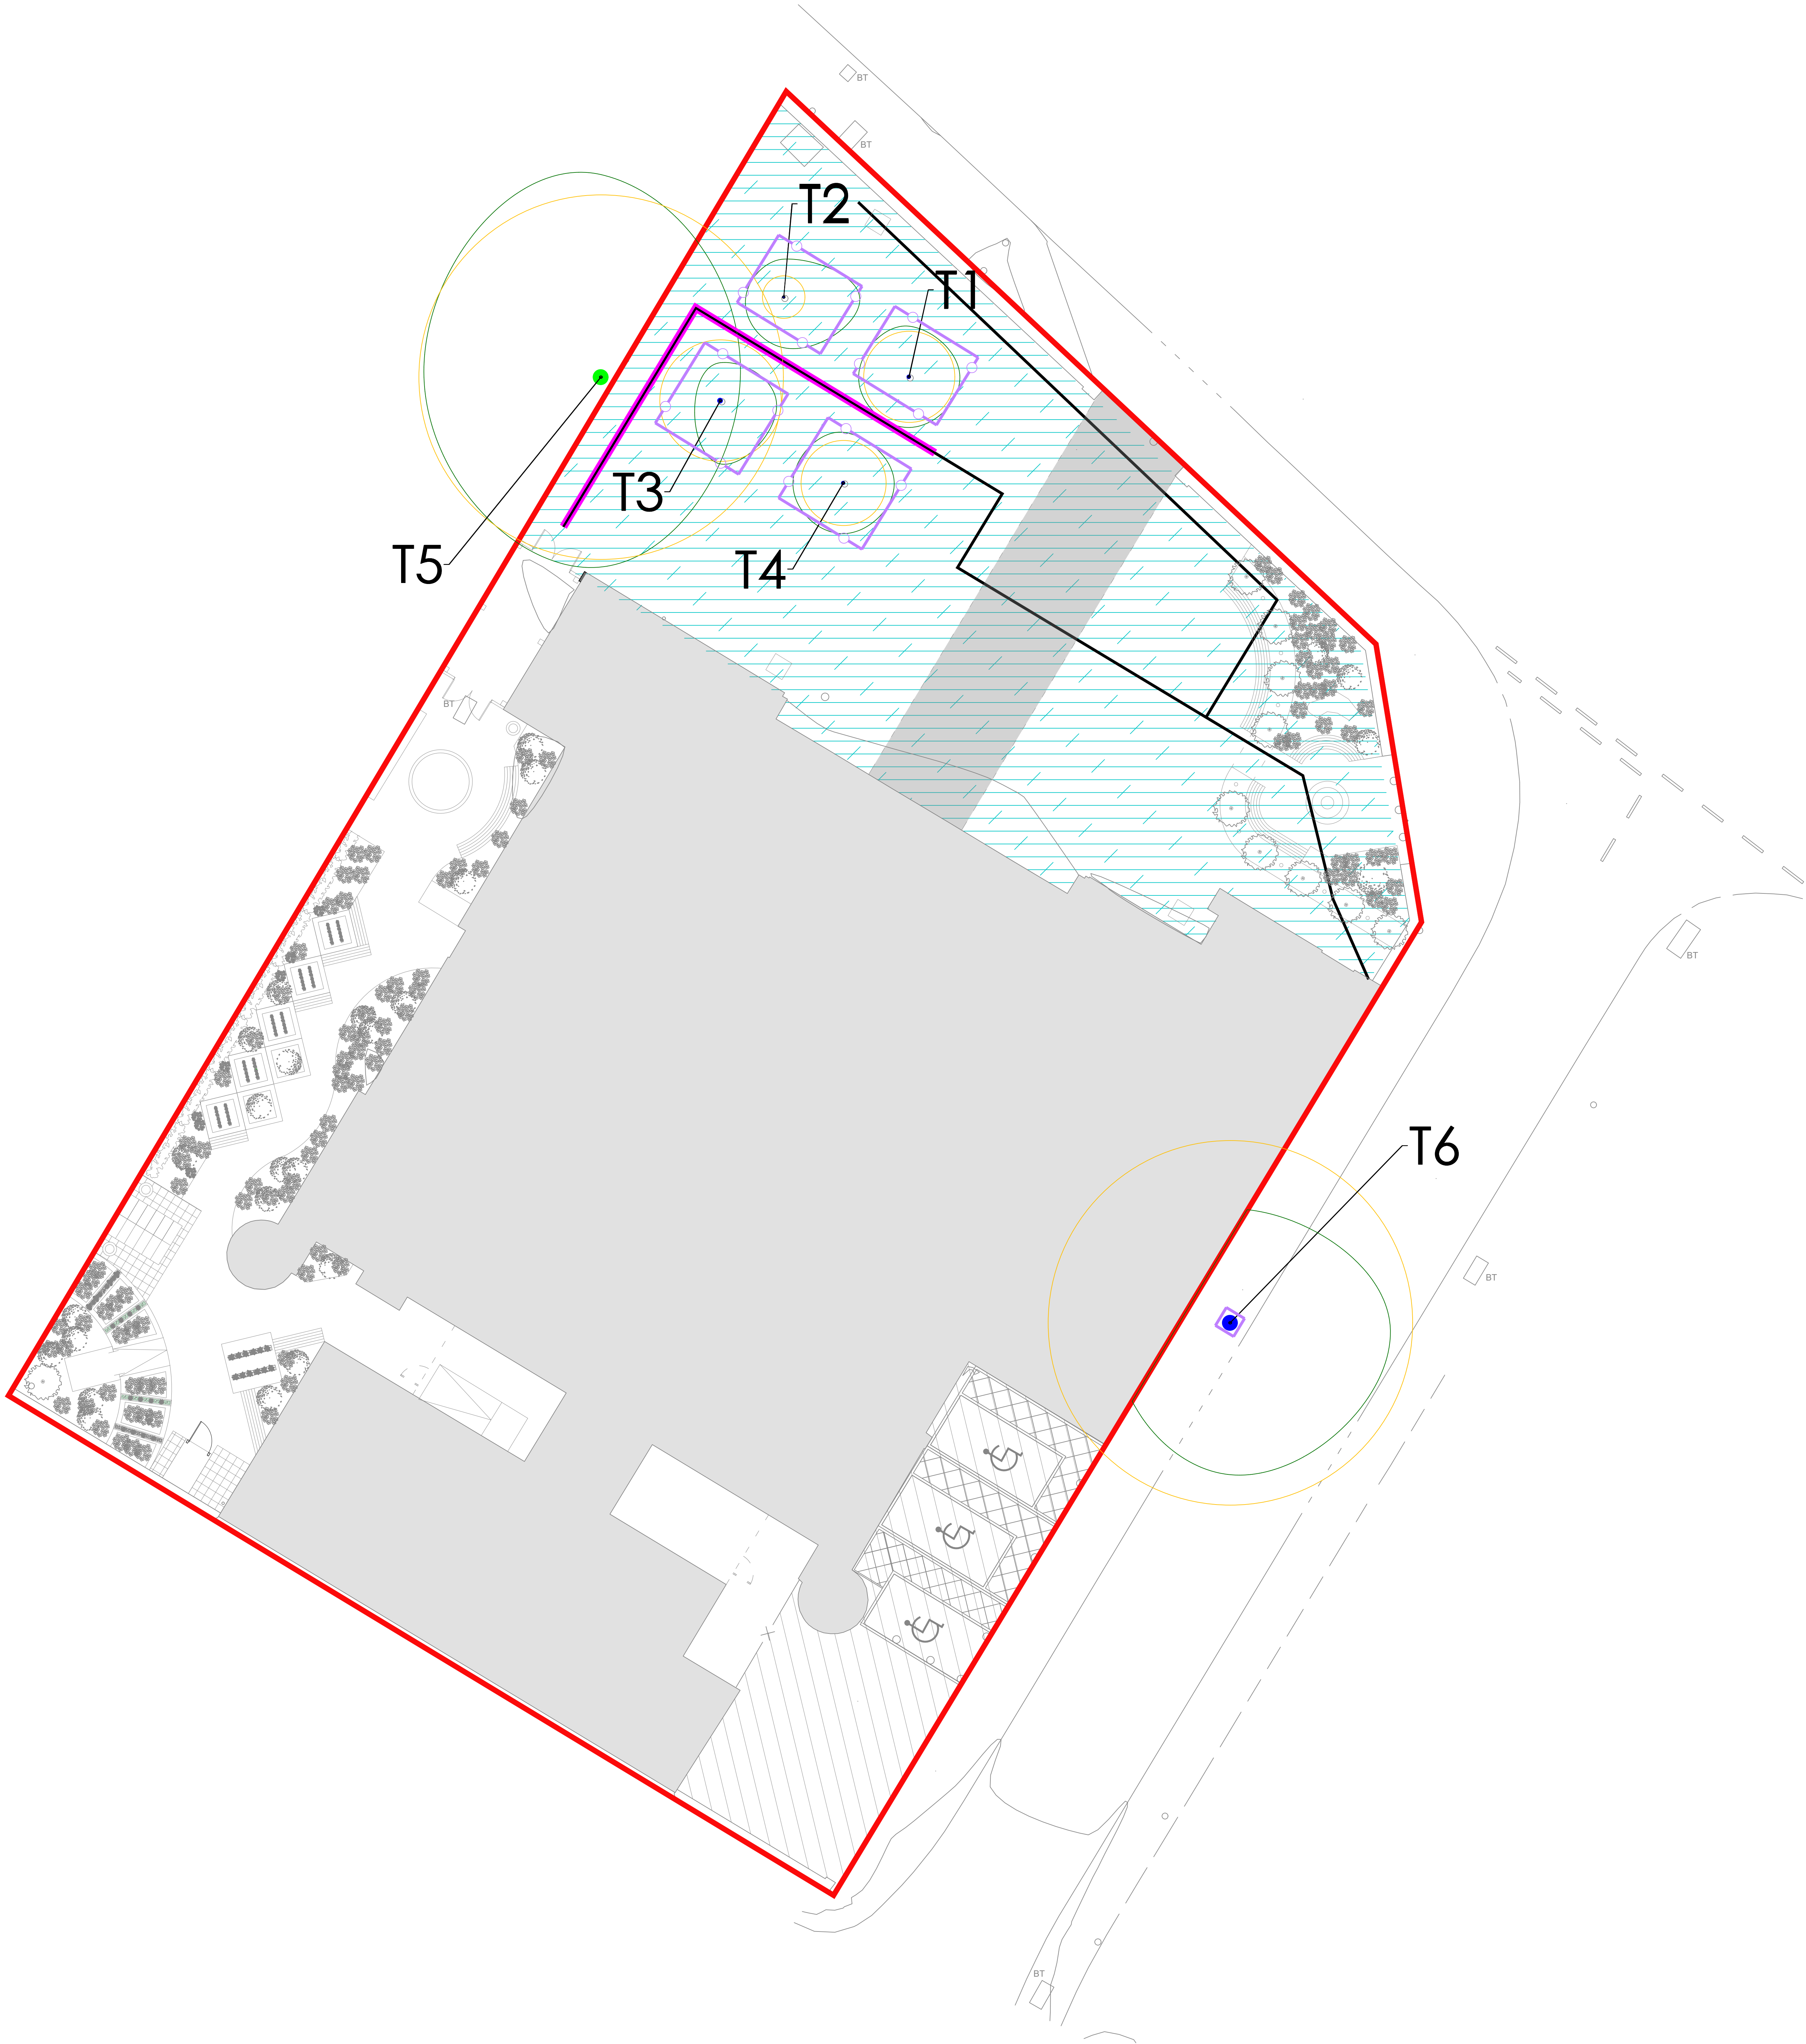
| 01 | 04/04/24 | EXTERNAL ELECTRICAL SERVICES ADDED | AB | HM |

- 4.7.1. Temporary protective fencing will need to be installed at the alignment indicated on the Tree Protection Plan in Appendix 4, prior to the commencement of any construction activities on site including the delivery of materials and site facilities.

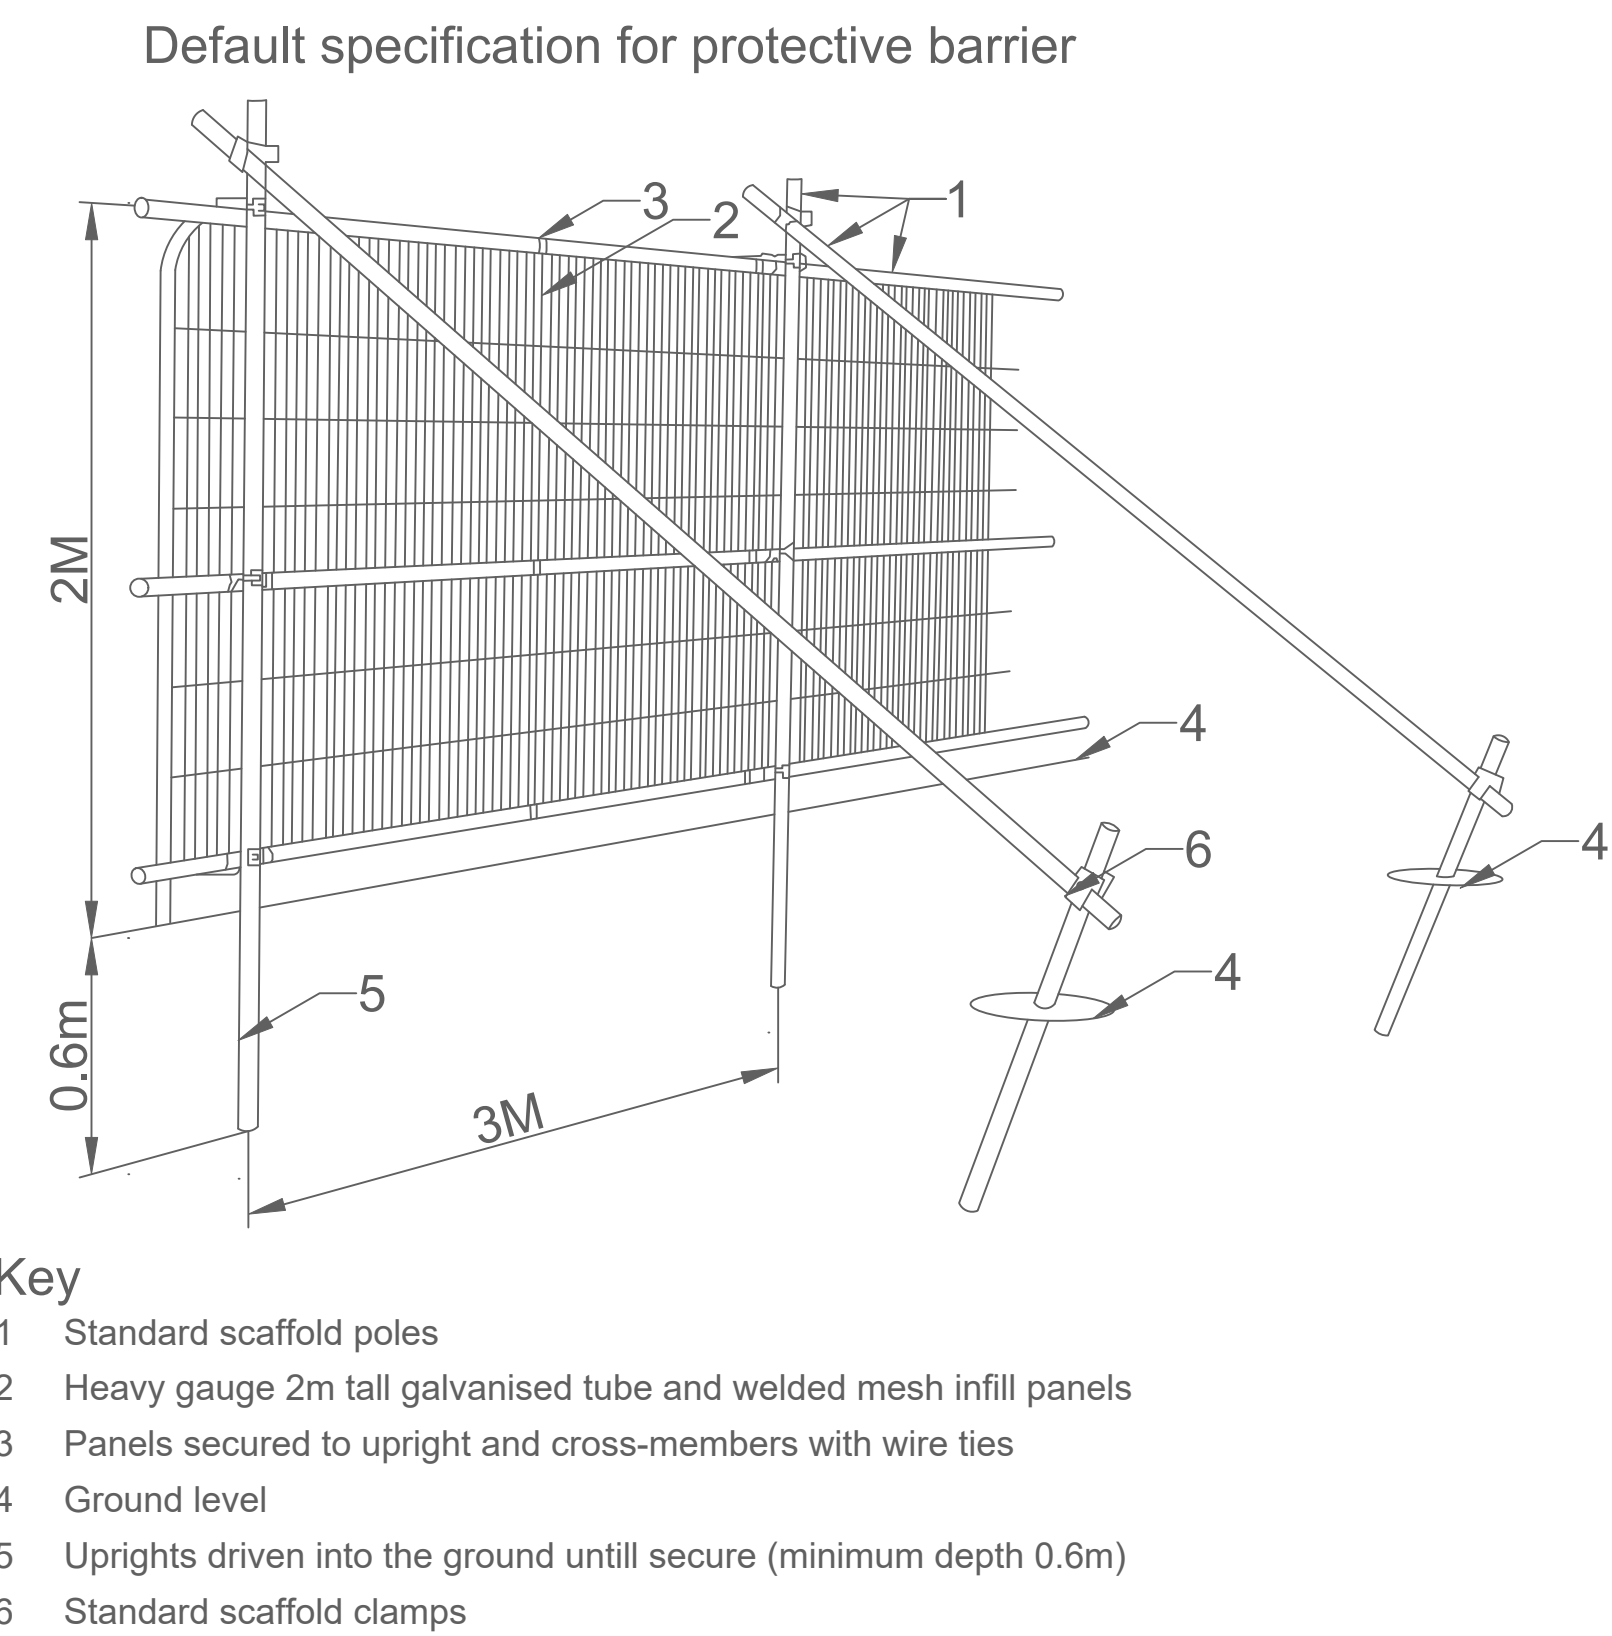
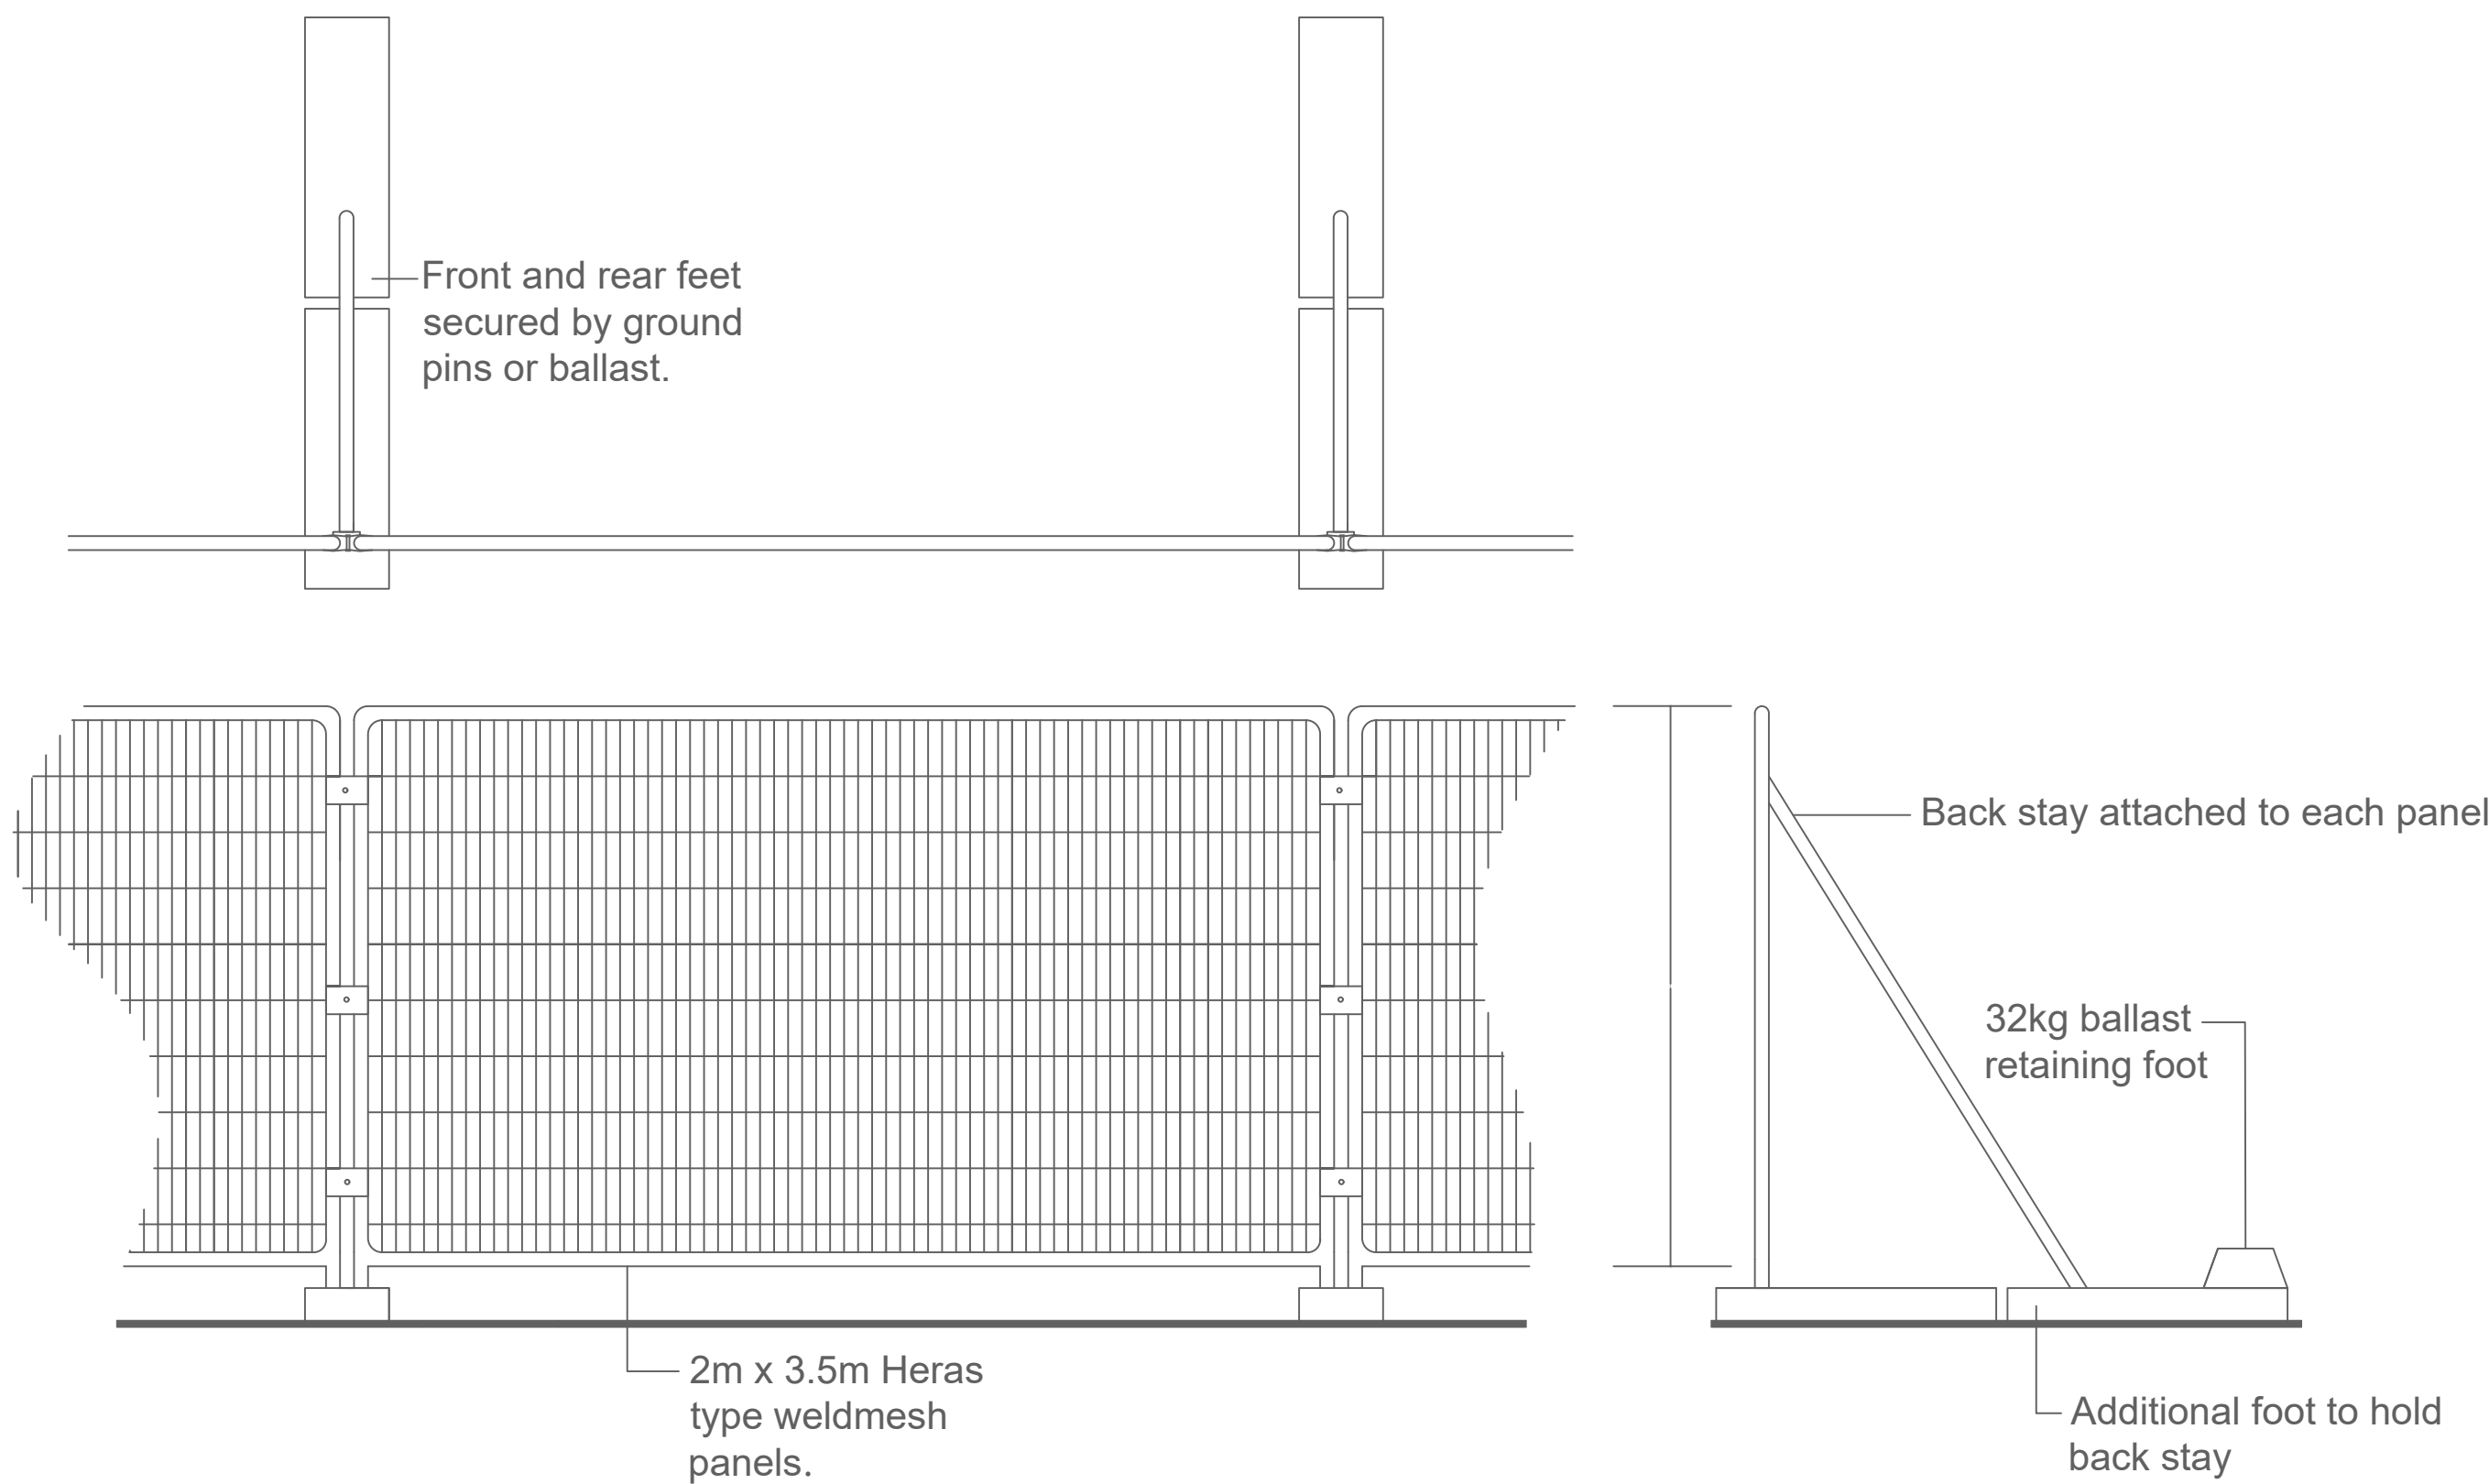
Insert 1: Tree protective fencing specification

Back-stay support

- 4.7.3. The required specification for protective fencing is illustrated in the Tree Protection Plan (Insert 1).
- 4.7.4. The 'in-ground' system involves driving vertical scaffold poles approximately 0.6m into the ground onto which are affixed horizontal scaffold poles and bracing struts. 2m high anti-climb weldmesh panels are then wired to the scaffold framework. The vertical scaffold poles should be at a maximum of 3m apart.

- 4.7.5. No fixing shall be made to any tree and all possible precautions shall be taken to prevent damage to the tree roots when locating uprights.
- 4.7.6. A 600mm x 300mm warning sign reading "TREE PROTECTION AREA KEEP OUT" shall be fixed to every 10m of protective fencing, as illustrated on the Tree Protection Plan (Insert 2).
