# BS 5837:2012

## Arboricultural Impact Assessment

**Report No.** LTM0907.AIA.02

**Project:** Land adjacent to Smithy View  
Garage

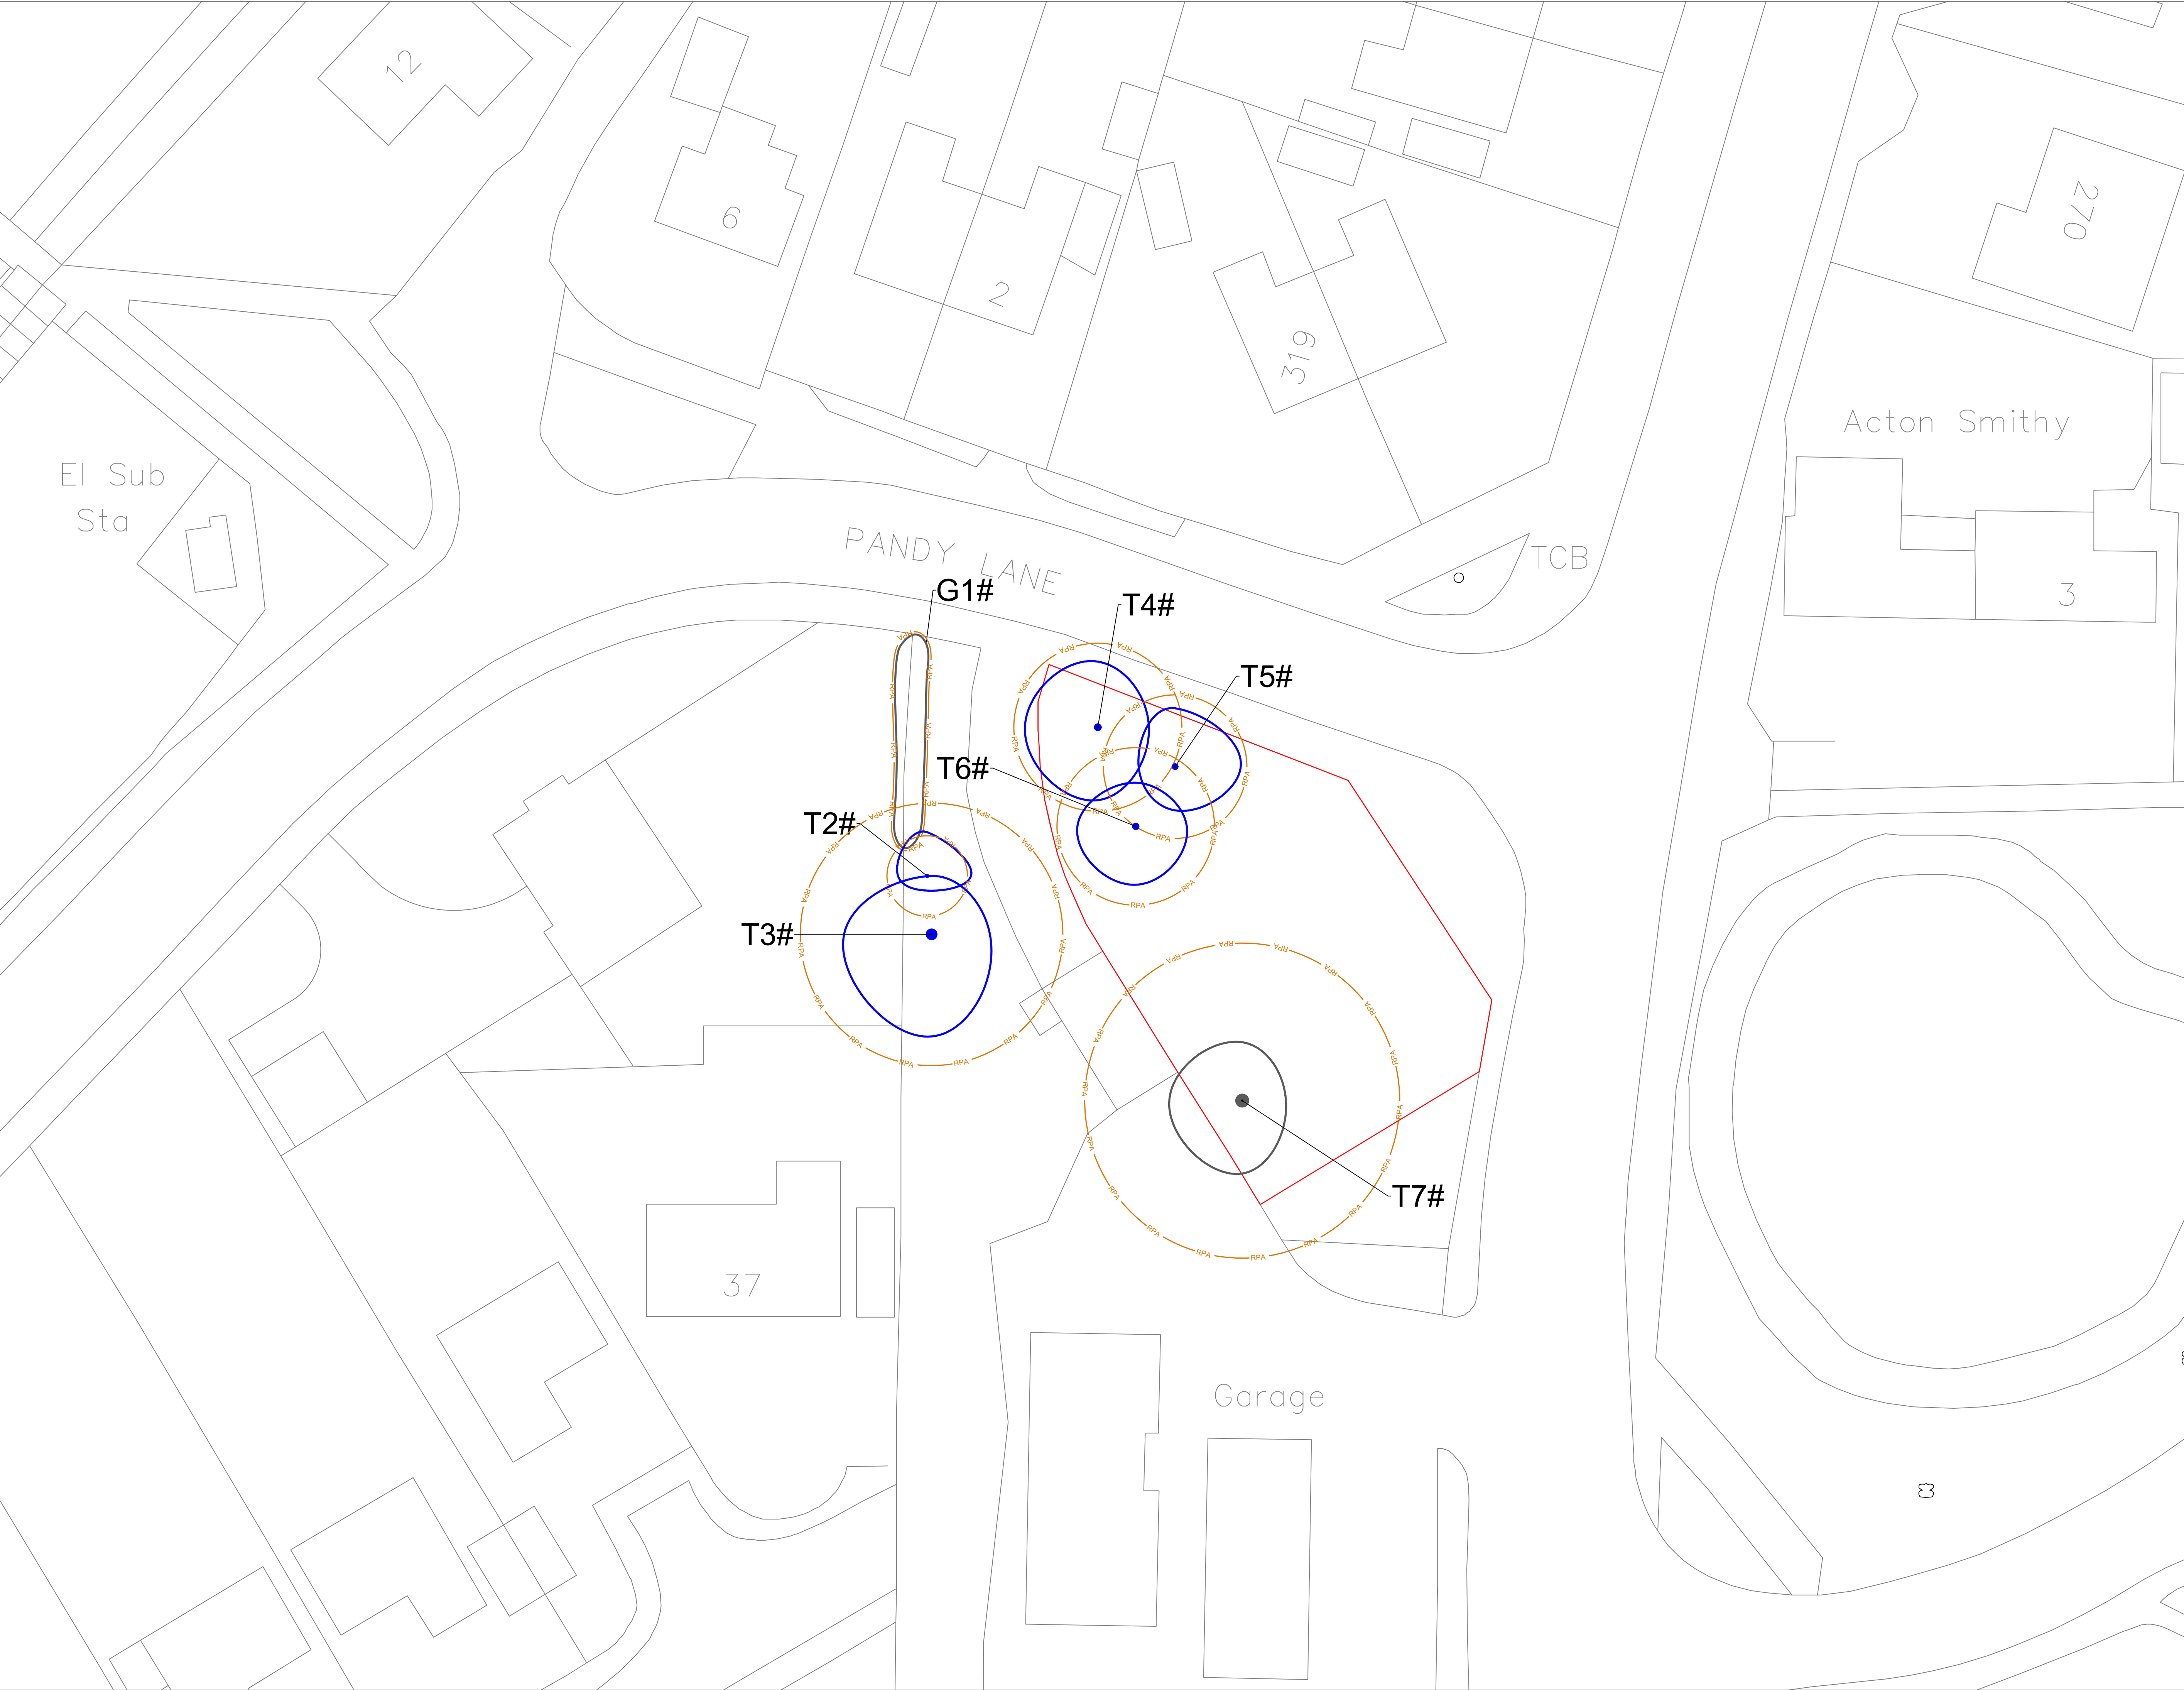
**TREE CONSTRAINTS PLAN**

- 2.2.1. I have shown the Root Protection Area (RPA) on the plans in appendix IV for each tree as a circle centred on the base of the stem which is based on the recommendation of the British Standard. Due to the presence of roads, structures, topography (and past tree management) the RPA is likely to be a simplified representation of the tree roots actual morphology and disposition. However, I have avoided any detailed modifications to the shape of the RPA as this would largely be based on conjecture.

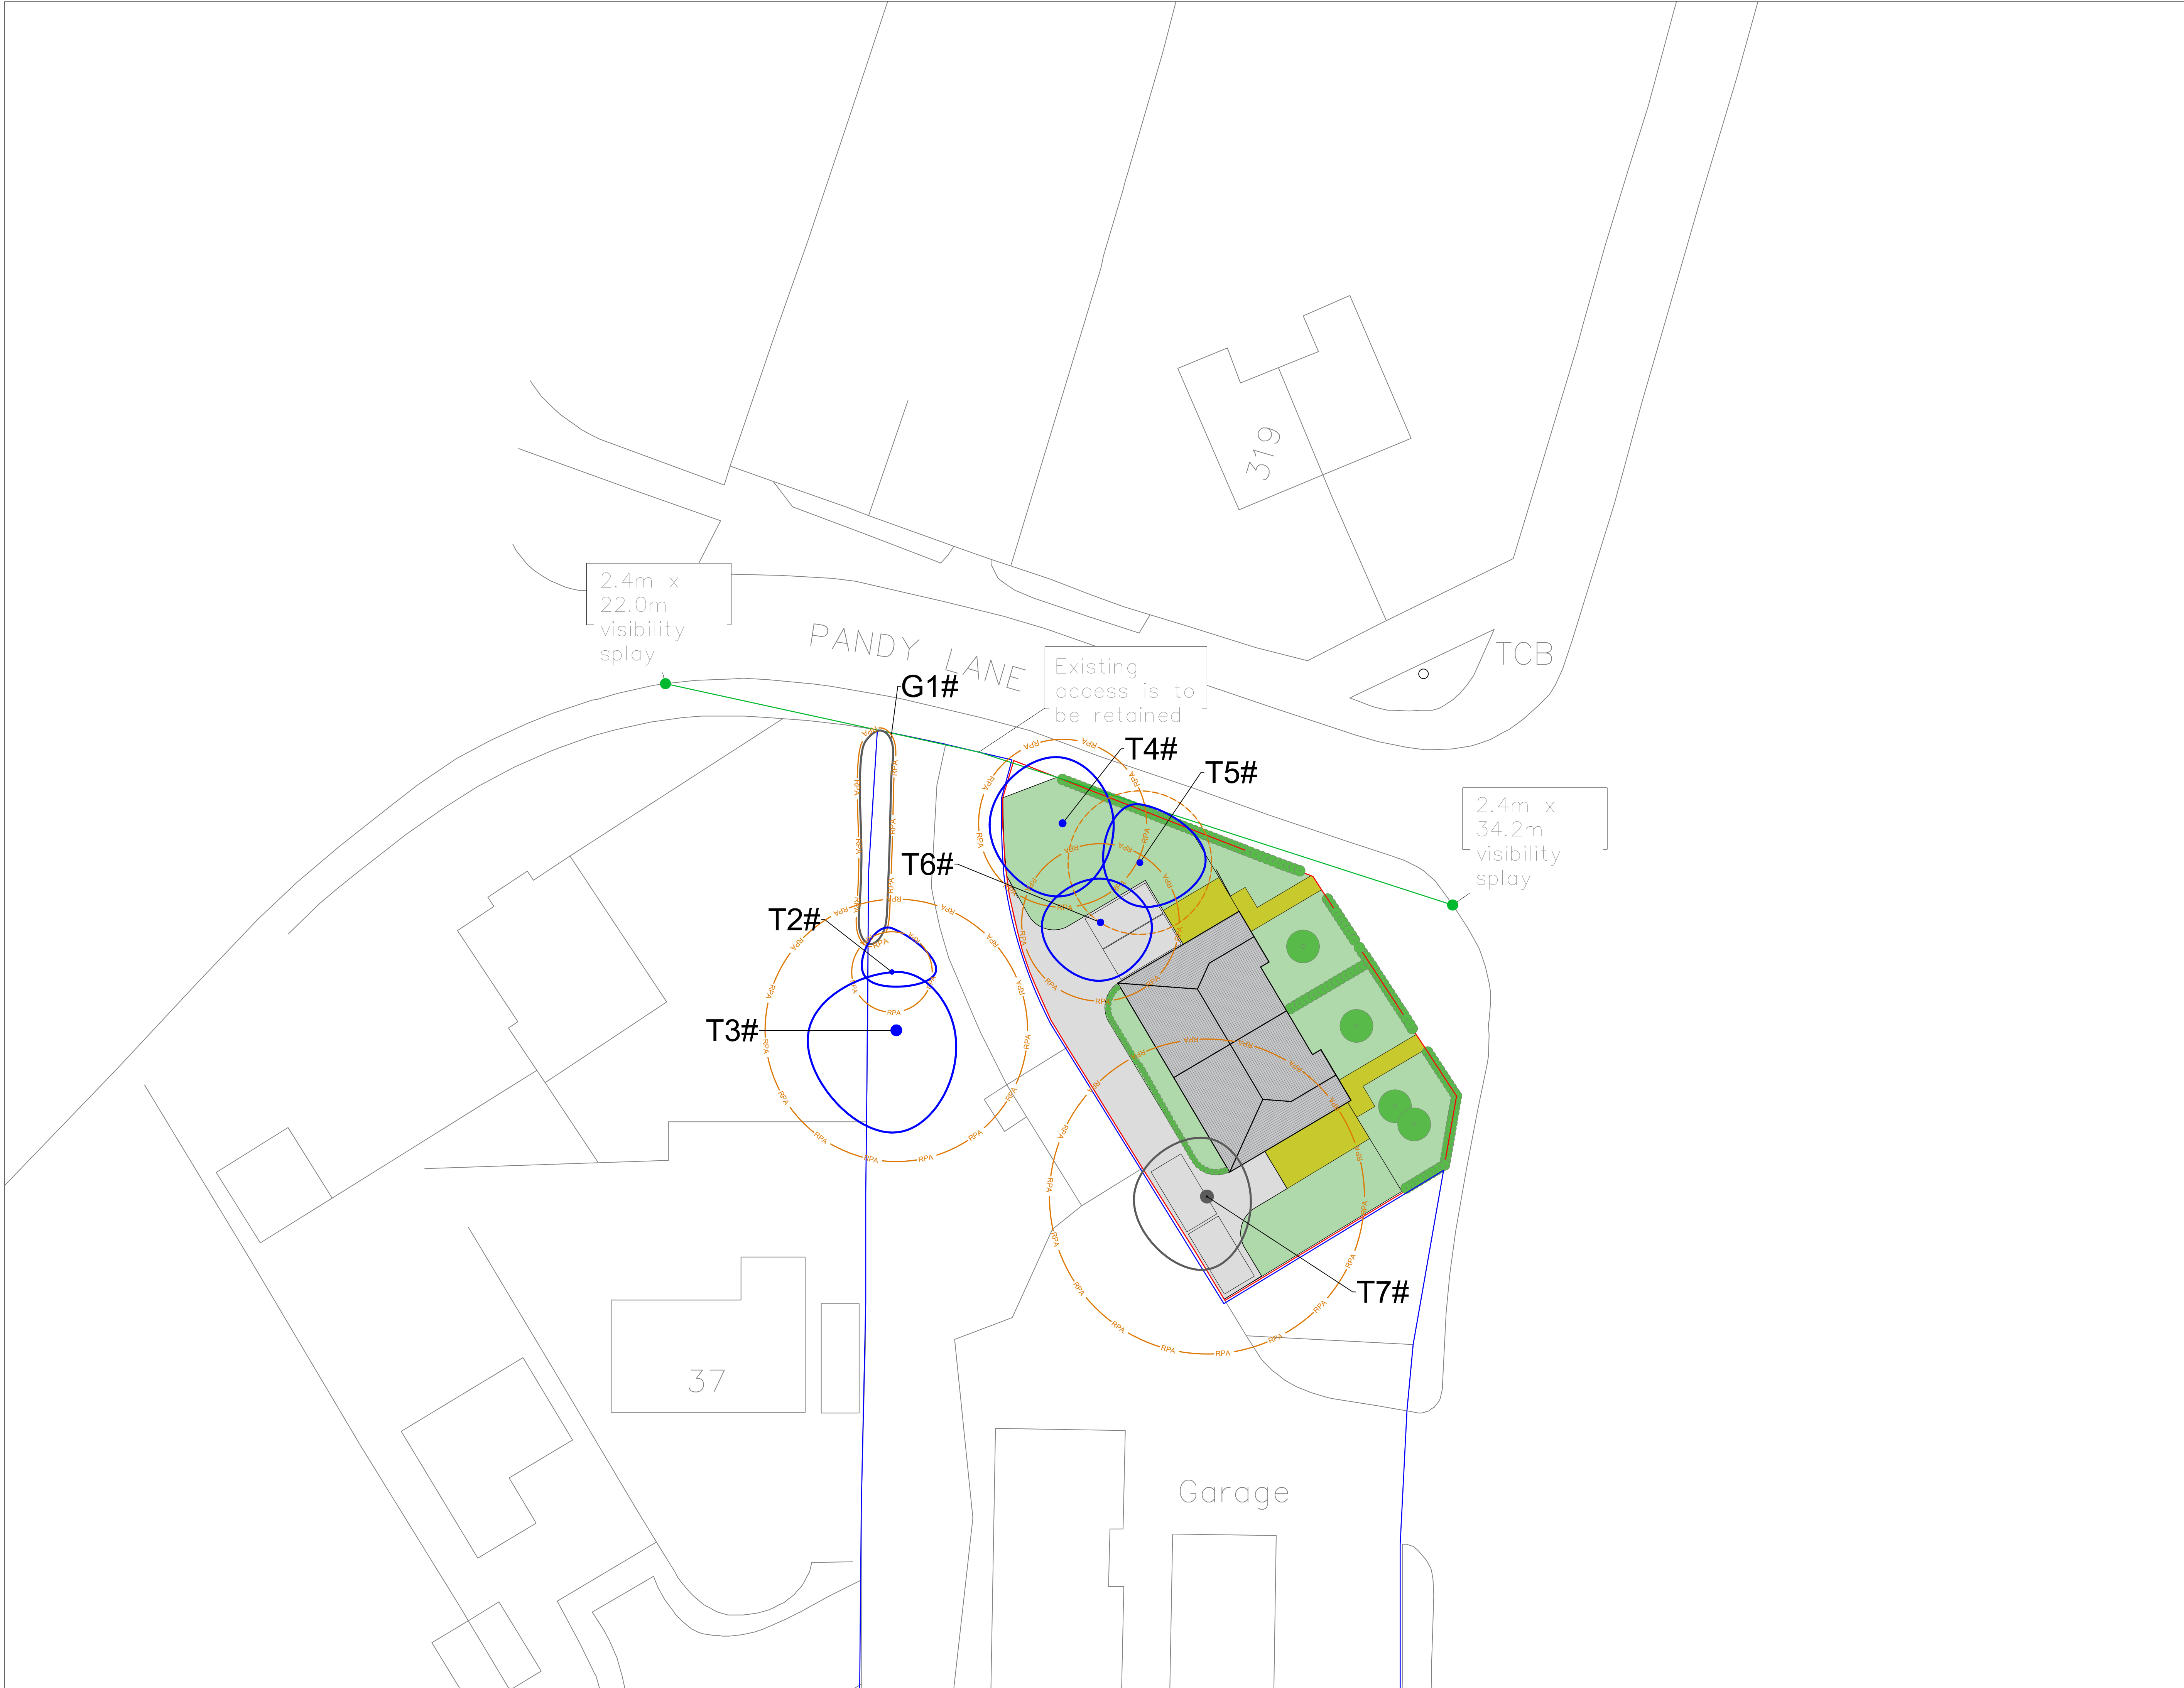
**ARBORICULTURAL  
IMPLICATIONS PLAN**

- 6.2.1. I have overlayed the proposed site plan titled Planning Site and Location Plan Rev b.dwg onto the existing site plan using computer aided design software and found a number of locations in which there are conflicts with existing trees. I have made this plan available in appendix IV titled Arboricultural Implications Plan.
- 6.2.2. In order to fully assess the impact of the proposals, I have created an Impact Table below (Table 2) in which I detail each tree, showing the proximity of the associated works to the trees and if they can or cannot be retained.

- 7.2.3. As can be seen from table 5 the proposed structure does not exceed 20% of the RPA and is line within the recommended guidance limits.
- 7.2.4. If ground levels remain the same, the detrimental effects the driveway would have on this tree would be: -

- Compaction, resulting in oxygen depletion, caused from creating the access way.
  - The loss of a permeable surface.
- 7.2.5. It is now possible with the use of a cellular confinement system to be able to create hard surfaces very close to trees without having a detrimental effect.

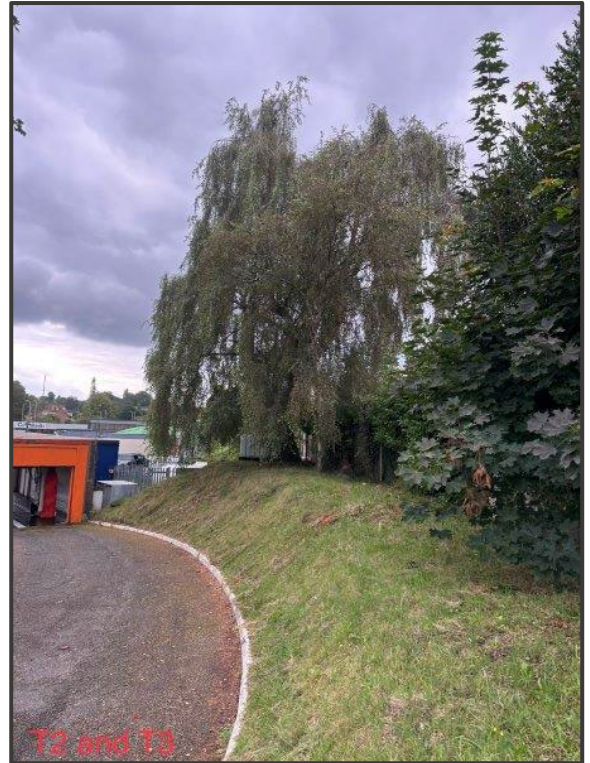
**Picture 2. T2 & T3**

| Tree No. | Species | Stem Dia (mm) | RPA (m <sup>2</sup> ) | RPA Radius (m) | Height (m) | Age Class | Crown Spread (m) | | | | Crown Clearance (m) | Condition | Comments | Recommendations | Remaining Contribution | BS5837 Retention Category |
|---|---|---|---|---|---|---|---|---|---|---|---|---|---|---|---|---|
| T3# | Birch | 750 | 255 | 9 | 16 | M | 4 | 4 | 7 | 6 | 0.5N | A | An ivy clad tree located on bank adjacent to car wash. Codominant stems. Vitality is within normal range. No significant risk features observed. Highly visible from public viewpoints. | No action | 40+ | B1 |

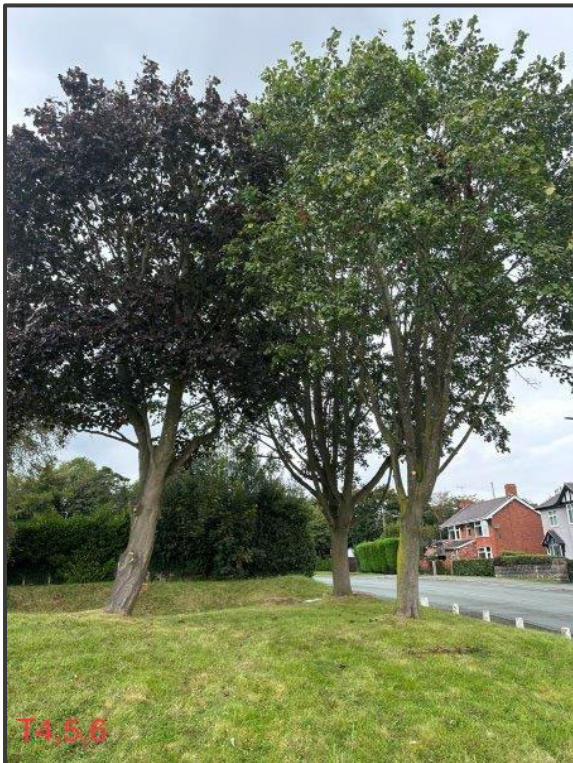
**Picture 3. T4, T5 & T6**

| Tree No. | Species | Stem Dia (mm) | RPA (m <sup>2</sup> ) | RPA Radius (m) | Height (m) | Age Class | Crown Spread (m) | | | | Crown Clearance (m) | Condition | Comments | Recommendations | Remaining Contribution | BS5837 Retention Category |
|---|---|---|---|---|---|---|---|---|---|---|---|---|---|---|---|---|
| T5# | Norway Maple | 410 | 76 | 4.92 | 12 | SM | 4 | 4.5 | 3 | 2.5 | 5N | A | Asymmetrical crown due to adjacent trees. Recently pruned. Vitality is within normal range. No significant risk features observed. Tree appears stable. | No action | 40+ | B2 |
| T6# | Purple Norway Maple. | 450 | 92 | 5.4 | 12 | EM | 3 | 3.5 | 4 | 4 | 4S | A | Asymmetrical crown due to adjacent trees. Recently pruned. Vitality is within normal range. No significant risk features observed. Tree appears stable. | No action | 40+ | B2 |

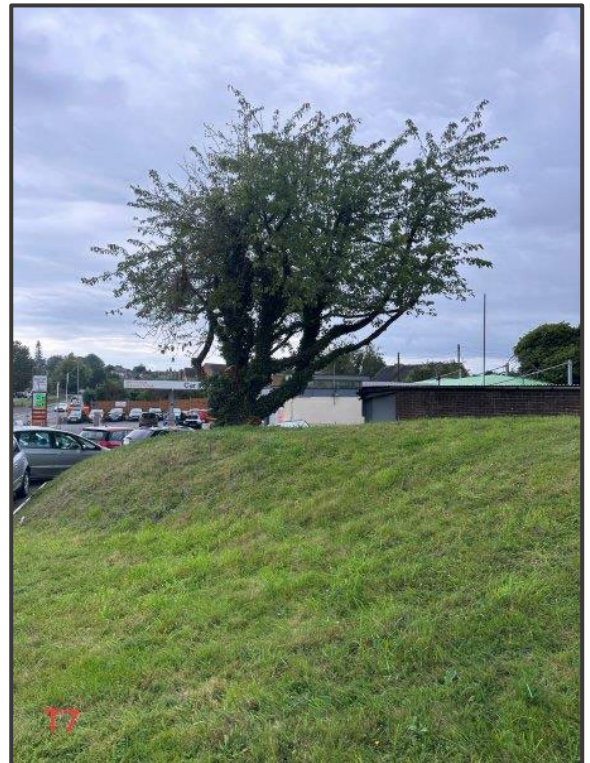
**Picture 4. T7**

| Tree No. | Species | Stem Dia (mm) | RPA (m <sup>2</sup> ) | RPA Radius (m) | Height (m) | Age Class | Crown Spread (m) | | | | Crown Clearance (m) | Condition | Comments | Recommendations | Remaining Contribution | BS5837 Retention Category |
|---|---|---|---|---|---|---|---|---|---|---|---|---|---|---|---|---|
| T7# | Cherry | 900 | 366 | 10.8 | 6 | EM | 4 | 3 | 5 | 5 | 4N | B | Any ivy clad tree. Bees and wasps in ivy prevented an accurate stem measurement. Heavily pruned giving poor appearance. Vitality is within normal range. Located on a bank. Possible soil level increased around stem but unable to ascertain. | No action | 20+ | C1 |
