| Project: Proposed Extension to<br>Bridgewater<br>Church Street<br>Holt<br>LL13 9JP | |
| Title:<br>Planning: Wall<br>Elevation | Scale: (A2)<br>1:50 |

| Drawing No:<br>DC143/006 | Sheet:<br>1 of 1 |

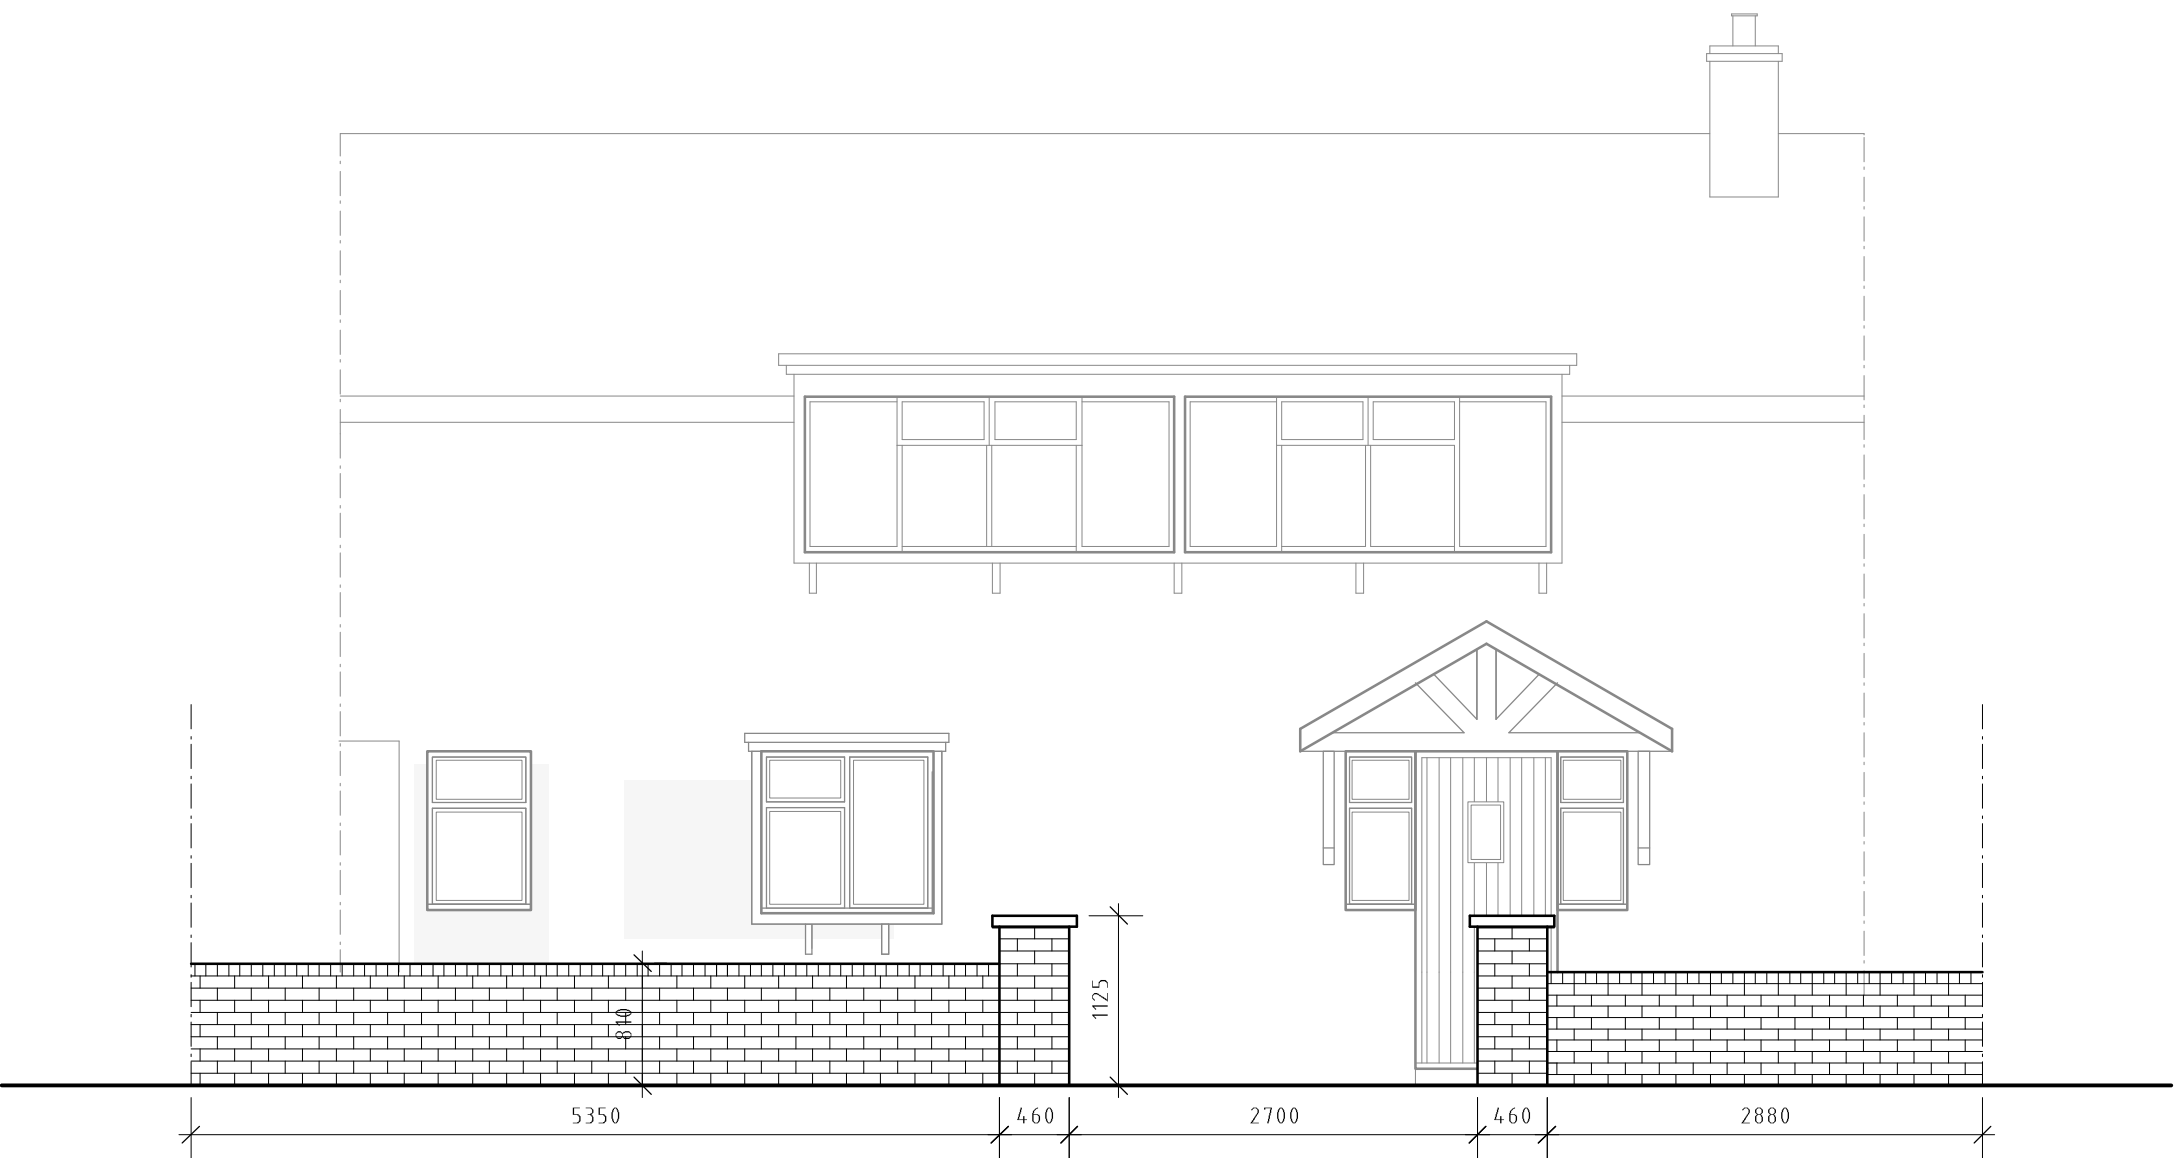
Demolished Front Boundary Wall 1:50

The existing front boundary wall has been removed as it was unsafe and leaning to one side presenting a potential hazard.

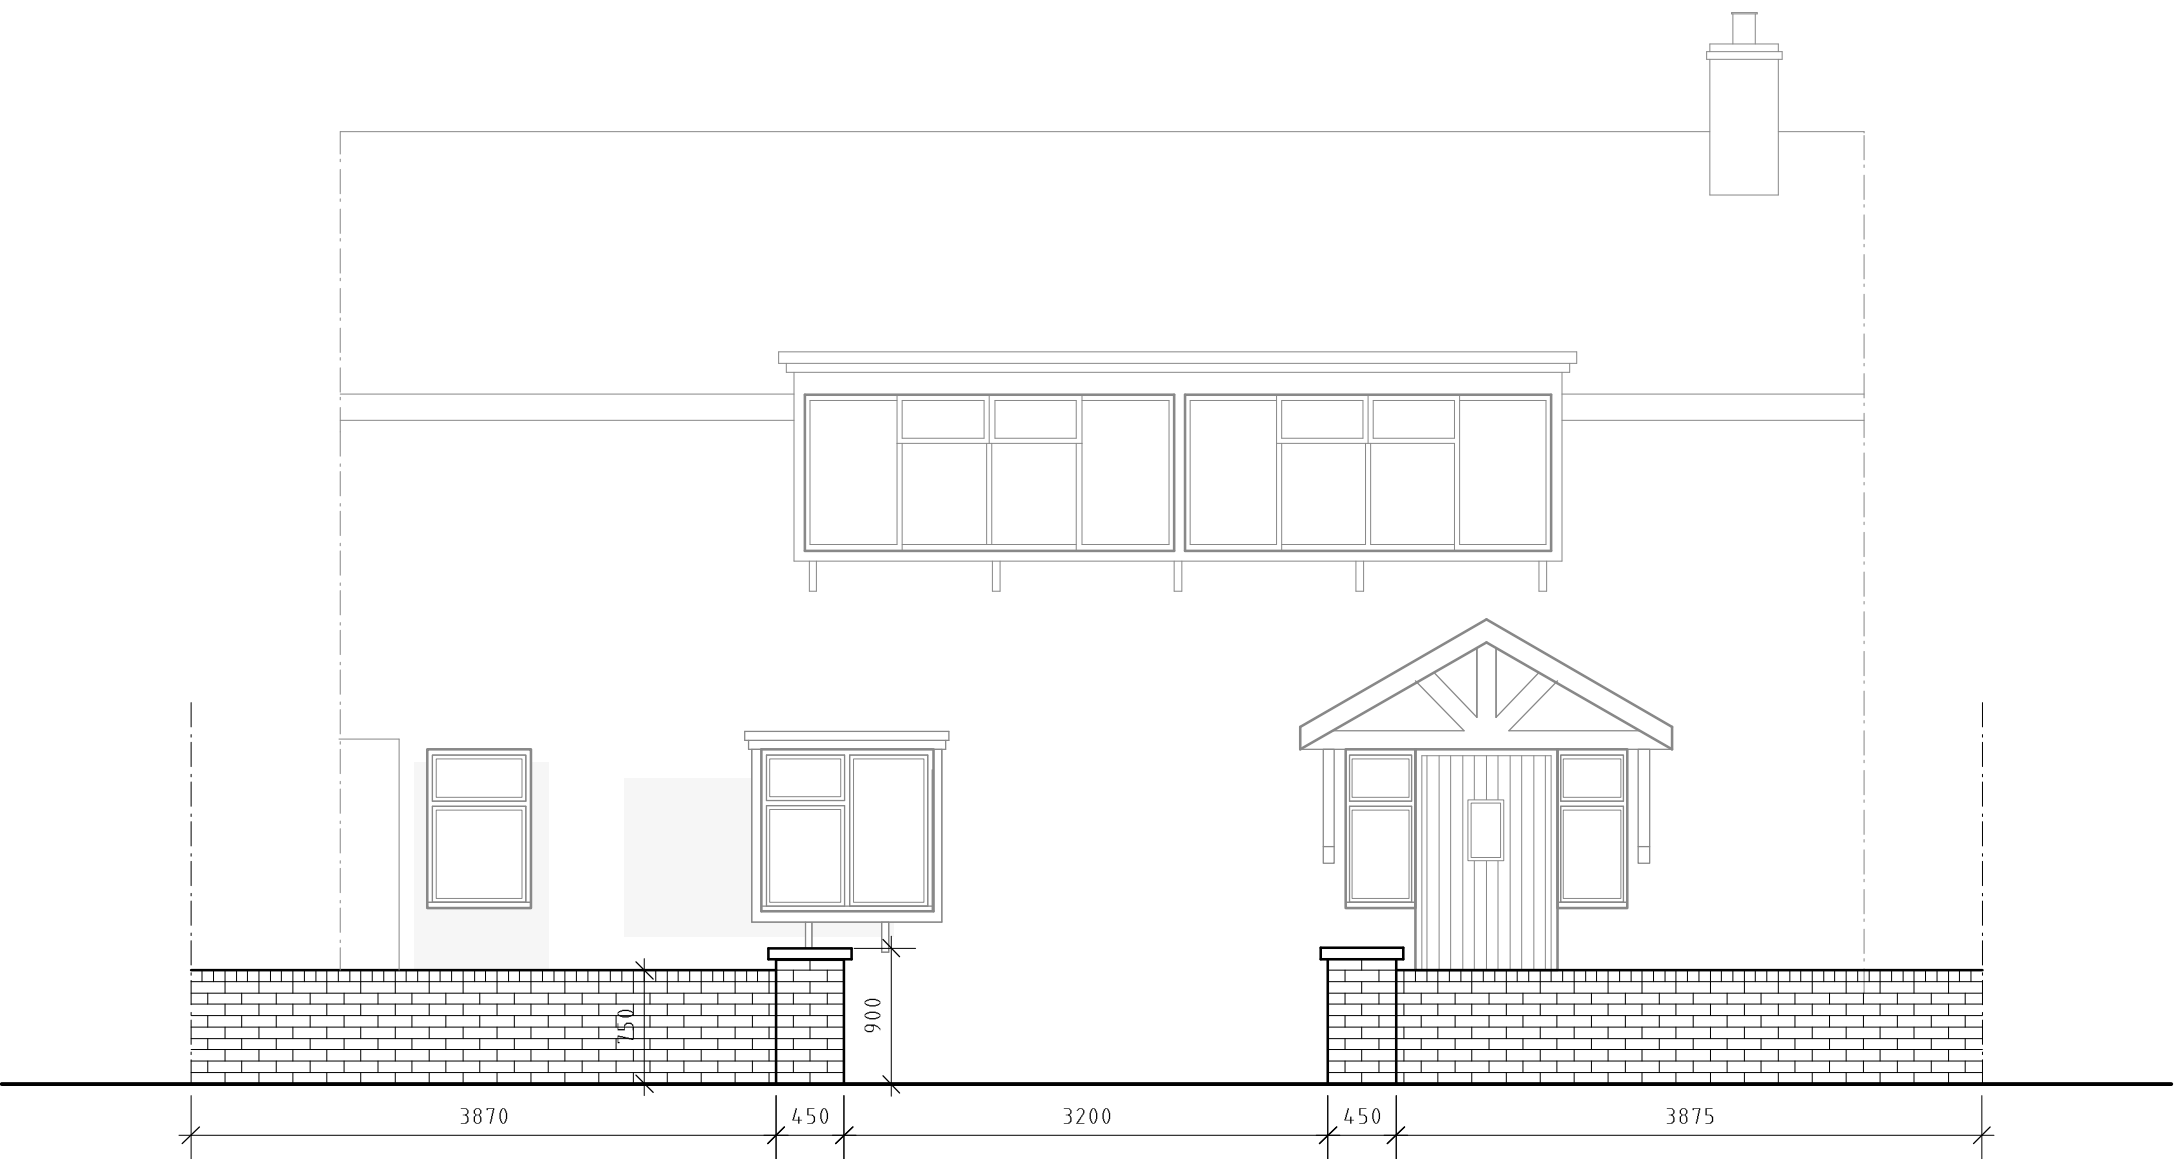
Proposed Front Boundary Wall 1:50

The proposed wall has been designed to match the original wall and is to be brickwork with sandstone caps to the piers.
