| <b>Project Title</b> | “Maes y Rhedyn”, Gresford Road, Llay |
| <b>Document Title</b> | Validation Report For Placement of Inert Cover For Plots 351-353 |

# INERT COVER VALIDATION REPORT FOR PLOTS 351-352

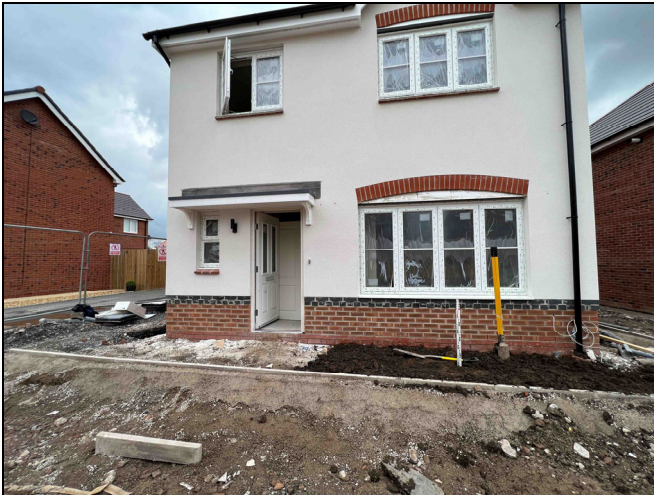
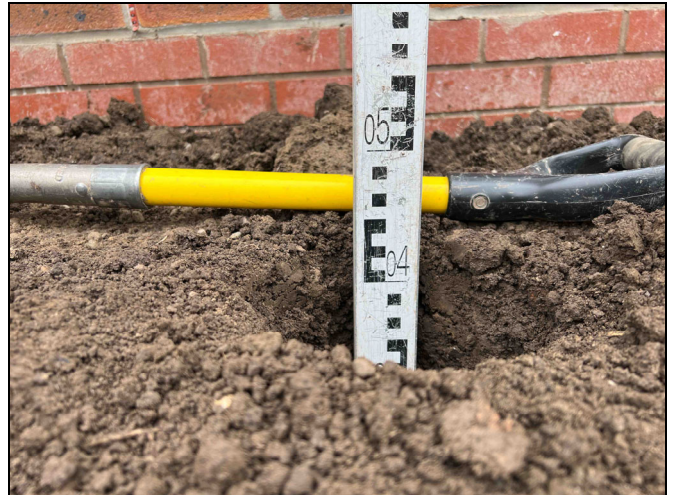
### PLOT 351 FRONT

| Plot Number of validation holes | Plot Range Covered by Validation Hole | Front / Rear / POS | Base of Topsoil | Base of Subsoil | Total Depth of Inert Cover | Description of Topsoil (see photographs) | Description of Subsoil (see photographs) | Source of Topsoil | Source of Subsoil | Sample/Lab References (Appended) |
|---|---|---|---|---|---|---|---|---|---|---|
| 351 | 351-353 | Front | 450mm | N/A | 450mm | Dark brown, slightly silty, sandy, clayey TOPSOIL | N/A | Site won | N/A | Topsoil Samples referenced in DETS Report Ref. 23-10549, dated 12 <sup>th</sup> May 2023. |

*Photographs 1 & 2: Showing the depth of the inert cover and location of the validation hole within the front garden of Plot 351 and the depth of inert cover achieved. Photographs taken 20<sup>th</sup> June 2023.*

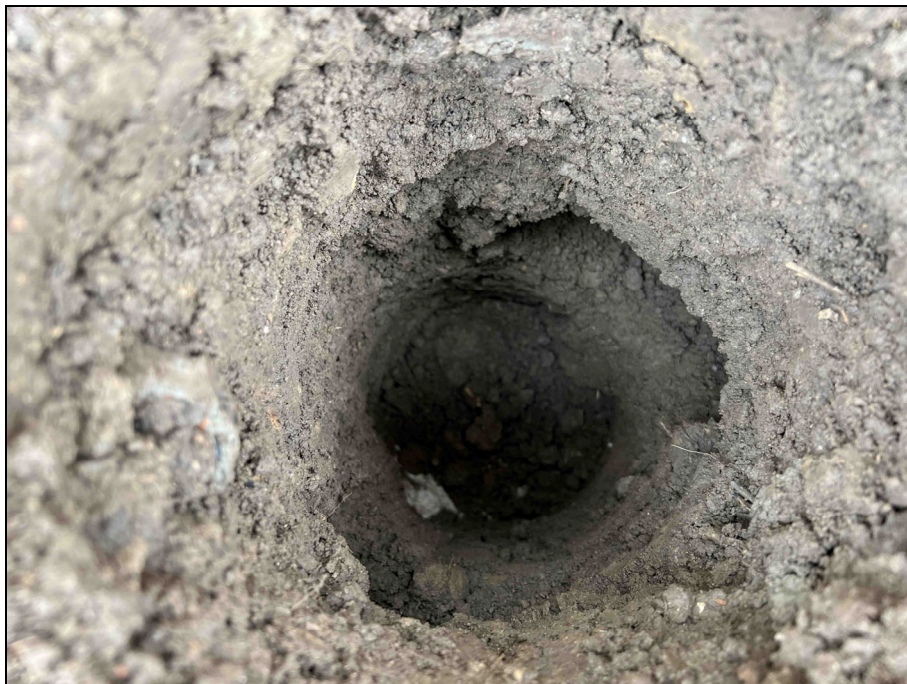
*Photograph 3: Photograph shows the nature of the inert cover within the validation hole in the front garden of Plot 351. Photograph taken 20<sup>th</sup> June 2023.*

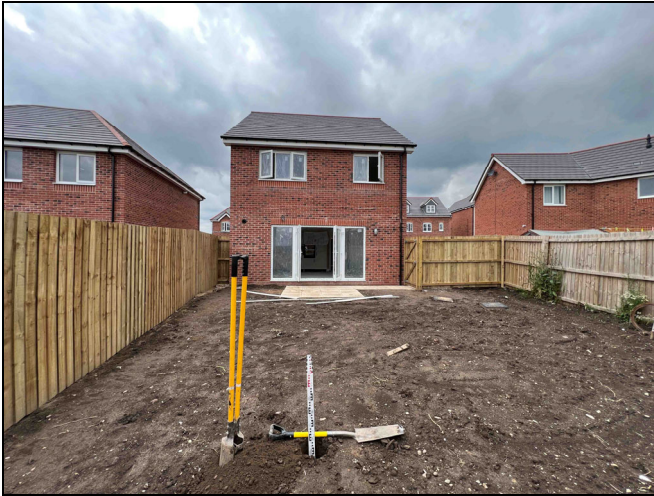
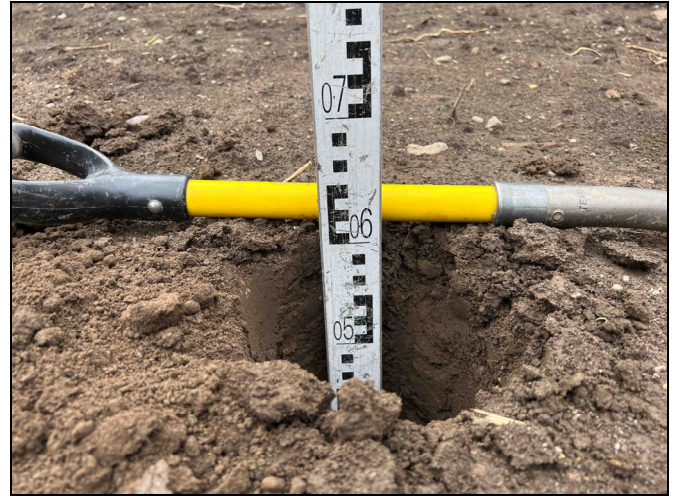
**PLOT 351 REAR**

| Plot Number of validation holes | Plot Range Covered by Validation Hole | Front / Rear / POS | Base of Topsoil | Base of Subsoil | Total Depth of Inert Cover | Description of Topsoil (see photographs) | Description of Subsoil (see photographs) | Source of Topsoil | Source of Subsoil | Sample/Lab References (Appended) |
|---|---|---|---|---|---|---|---|---|---|---|
| 351 | 351 | Rear | 620mm | N/A | 620mm | Dark brown, slightly silty, sandy, clayey TOPSOIL | N/A | Site won | N/A | Topsoil Samples referenced in DETS Report Ref. 23-10549, dated 12 <sup>th</sup> May 2023. |

*Photographs 4 & 5: Showing the depth of the inert cover and location of the validation hole within the rear garden of Plot 351 and the depth of inert cover achieved. Photographs taken 20<sup>th</sup> June 2023.*

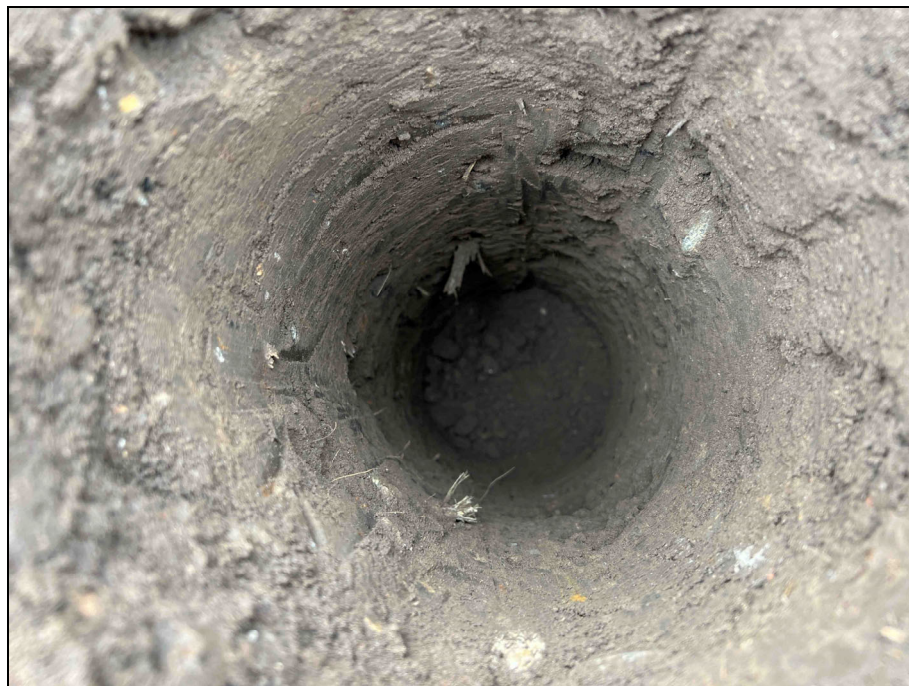
*Photograph 6: Photograph shows the nature of the inert cover within the validation hole in the rear garden of Plot 351. Photograph taken 20<sup>th</sup> June 2023.*

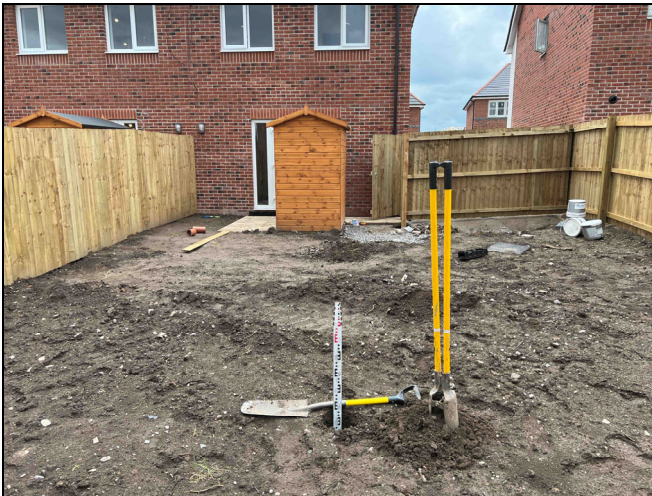
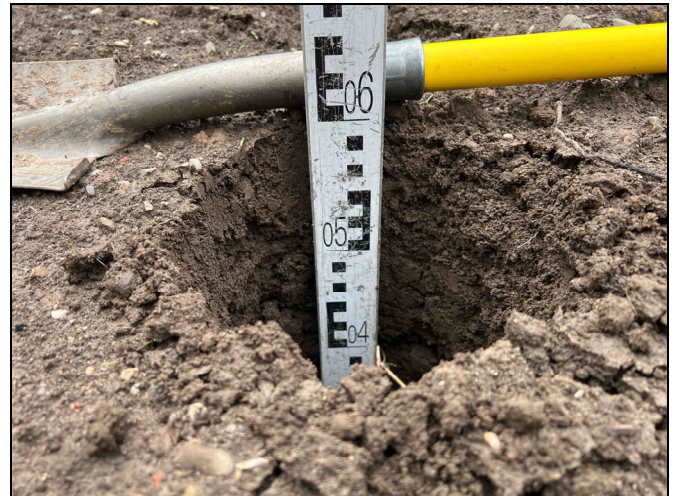
**PLOT 352 REAR**

| Plot Number of validation holes | Plot Range Covered by Validation Hole | Front / Rear / POS | Base of Topsoil | Base of Subsoil | Total Depth of Inert Cover | Description of Topsoil (see photographs) | Description of Subsoil (see photographs) | Source of Topsoil | Source of Subsoil | Sample/Lab References (Appended) |
|---|---|---|---|---|---|---|---|---|---|---|
| 352 | 352 | Rear | 600mm | N/A | 600mm | Dark brown, slightly silty, sandy, clayey TOPSOIL | N/A | Site won | N/A | Topsoil Samples referenced in DETS Report Ref. 23-10549, dated 12 <sup>th</sup> May 2023. |

*Photographs 7 & 8: Showing the depth of the inert cover and location of the validation hole within the rear garden of Plot 352 and the depth of inert cover achieved. Photographs taken 20<sup>th</sup> June 2023.*

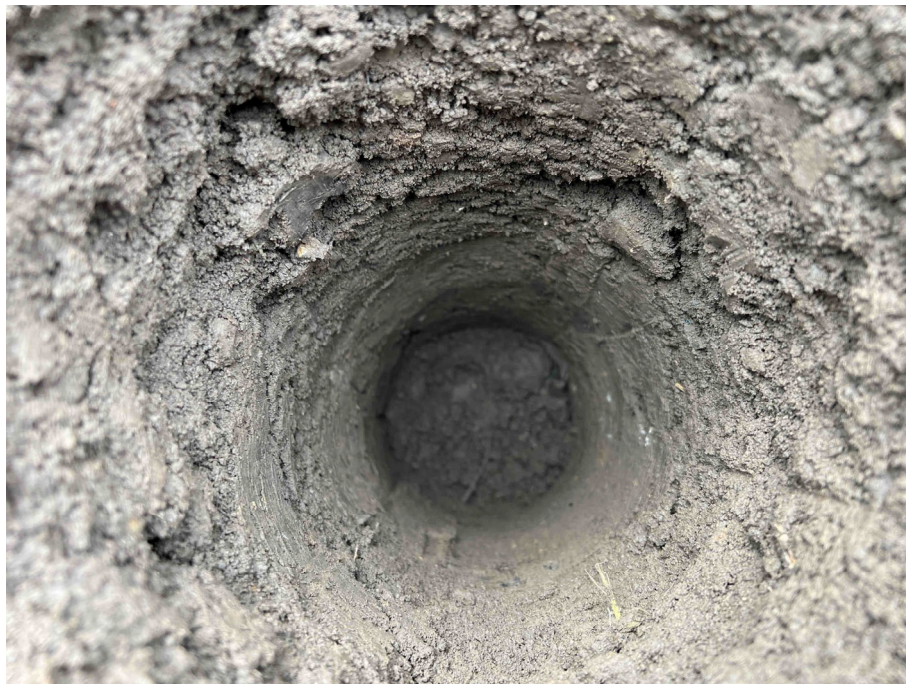
*Photograph 9: Photograph shows the nature of the inert cover within the validation hole in the front garden of Plot 352. Photograph taken 20<sup>th</sup> June 2023.*
